**CONVERSION OF SUNNY BANK BARN, BROXA LANE, HACKNESS
SCARBOROUGH YO13 OJW TO SINGLE DWELLING**

**Conversion of Sunny Bank Barn
to single dwelling including
alterations to the existing access**

TREE REPORT

SUPPLEMENTRY TREE REPORT

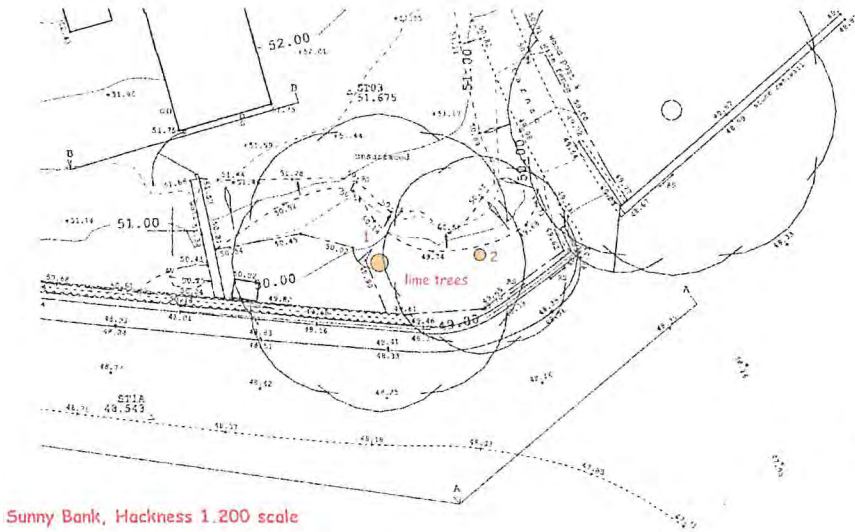
Fig 2 Tree positions and spread

Species	<i>Tiliax europaea</i>
Common Name	Common or European Lime
Height	IRO 30 Meters
Approximate Age	80+ Years
Girth at 1.5 Meters	1.0 Meters
Crown Spread North	6.0 Meters
Crown Spread to East	6.0 Meters
Crown Spread to South	7.0 Meters
Crown Spread to West	6.0. Meters
Overall Condition	Good

Species	<i>Tiliax europaea</i>
Common Name	Common or European Lime
Height	IRO 35 Meters
Approximate Age	80+ Years
Girth at 1.5 Meters	1.2 Meters
Crown Spread North	6.0 Meters
Crown Spread to East	4.0 Meters
Crown Spread to South	5.0 Meters
Crown Spread to West	2.0. Meters
Overall Condition	Good

There are several short pegs left from previous pruning, most showing dieback, numerous minor healed and healing lesions from minor limb removal.

The trees are located within 1.5- 2 m of a retaining wall which form as a sharp change of level of sum 1.3m. There is no sign of heave or root damage to this wall and the roots appear to have established to accommodate the level change.

There was slight late leafing out towards the top of the tree on the northern side but other than this no major issues observed there is moderate to light suckering at the base. Aphid residue is present as expected for the species but there are no signs of gall might or fungal disease
Trees 1 and 2 are in good to excellent condition.

The tree showed signs of late leafing and early leaf drop. There was also minor crown dieback on all three stems. The tree is showing signs of stress but as no obvious cause can be found and the stress response is general and uniform it is likely to be from age or water table or climatic issues rather than mechanical root damage. The lack of corresponding stress in the trees at Sunny Bank make environmental factors unlikely. The tree is currently in fair condition but this condition can be expected to deteriorate in the near the medium future.

It is recommended that the wall be taken down and rebuilt in sections **on the line of the existing** wall to avoid any issues with stability of the retained soil and trees.

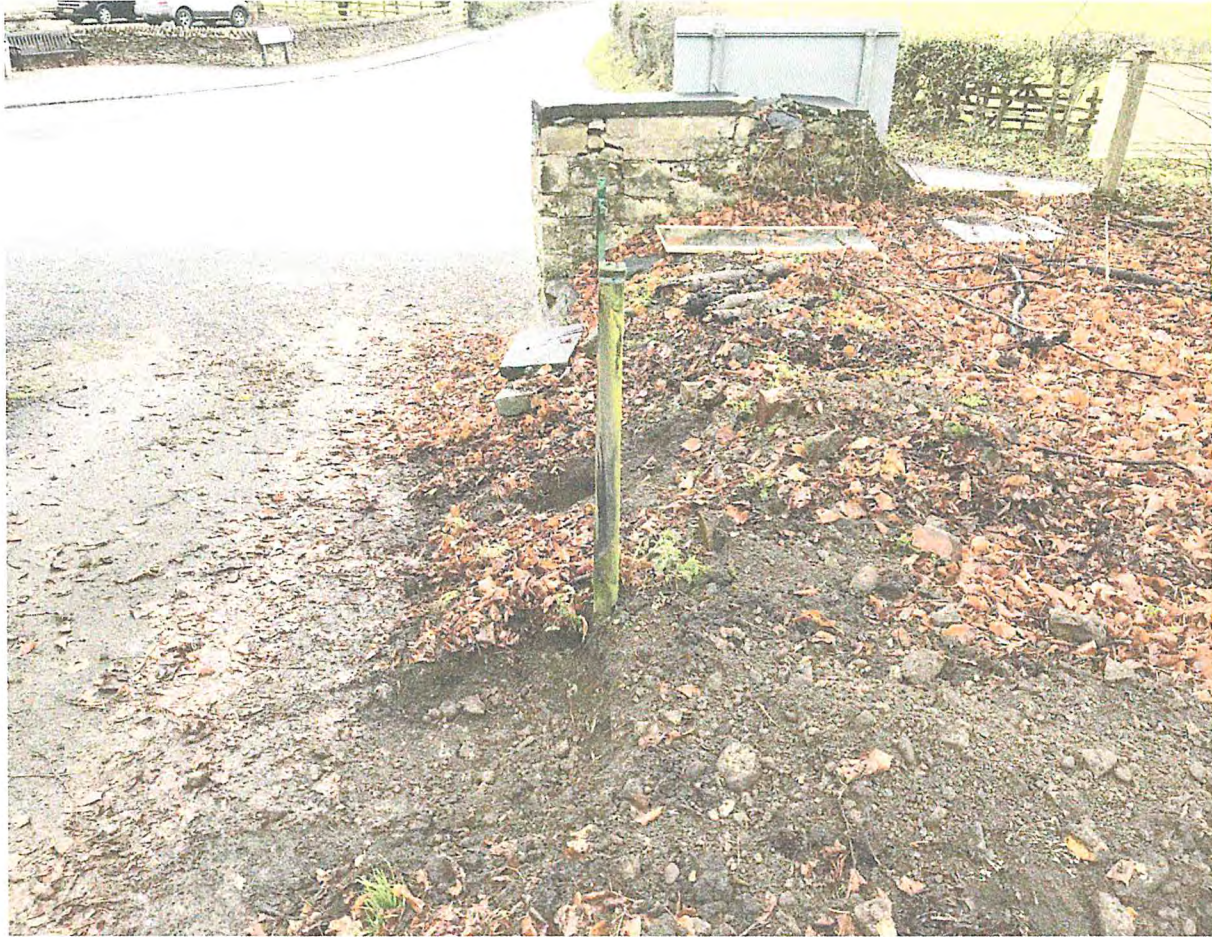
Photo 1 - Site entrance from inside the site

The conditions imposed by the North Yorkshire County Highways requires the access to be widened to 4.0M, from its current 3.6M and extending 6.0M into the site
