REDMIRE FARM
TRANMIRE
NORTH YORKSHIRE
YO212BW

PROJECT STATEMENT
(What has happened to date)

12 SEPTEMBER 2016

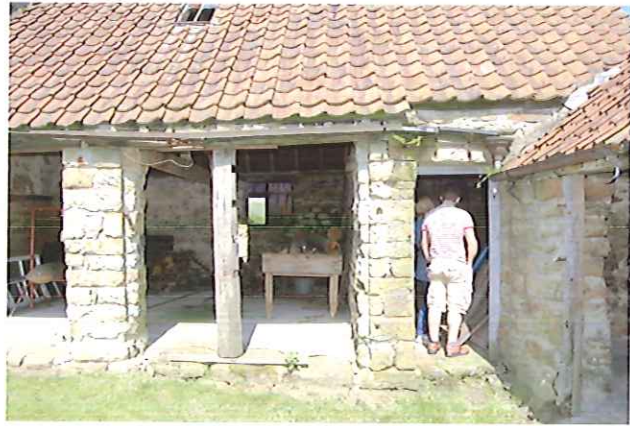
As the work progressed on site it was found that part of the existing structure was very unsound and, in fact, dangerous. This was only evident when work had started to underpin the walls.

It was found that there were no foundations and that any attempt to disturb the structure resulted in sections of the building collapsing (which happened). The decaying roof timbers further aggravated the work.
