29 SEP 2013

REPORT ON VISUAL INSPECTION OF OUTBUILDINGS AT TROUTSDALE MILL.
CONVERSION OF OUTBUILDINGS INTO DOMESTIC RESIDENTIAL ANNEX

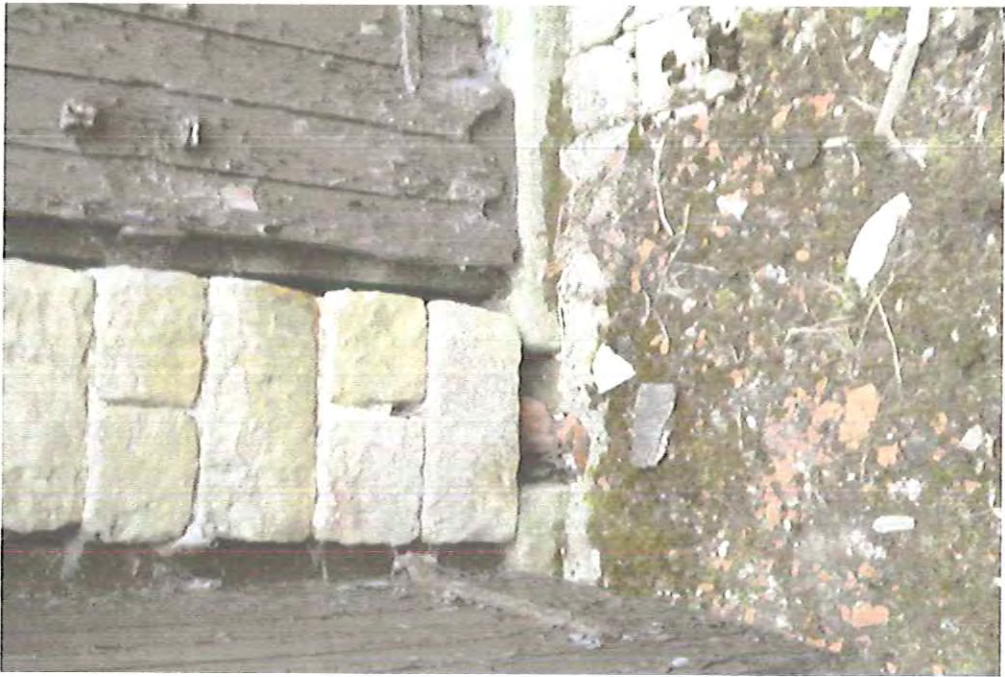
Figure 18 - STORE 5 ROOF

This store is completely open to the elements there being no wall to the East elevation. The roof is unfelted as for Store 4, The severe vertical cracking observed in Store 4 where the division wall abuts the East wall was particularly bad on this side of the wall.

We consider that it is feasible for the outbuilding to be converted into habitable accommodation. Some rebuilding work will be required but the majority of the walls can be retained subject to repair. It would be safer & simpler to replace the whole of the timber roof structure although subject to a thorough examination & inspection it may be possible to retain parts of the structure. Following removal of the roof covering it will be necessary to expose the ends of all rafters & purlin where built into masonry to check for any rot or fungal attack. This would require replacement or repair as necessary before making good the masonry around the purlin ends & solidly building in. Should any of the roof structures be retained then it is recommended that ridge purlins or horizontal ties be provided to eliminate the lateral load at eaves level & purlin ends.
