Location:
**Thirley Cotes Farm
Harwood Dale**

Report Type:
**Arboricultural Survey
Arboricultural Impact Assessment
Arboricultural Method Statement
Tree Protection Plan**

Ref:
ARB/AE/1671

Date:
October 2017

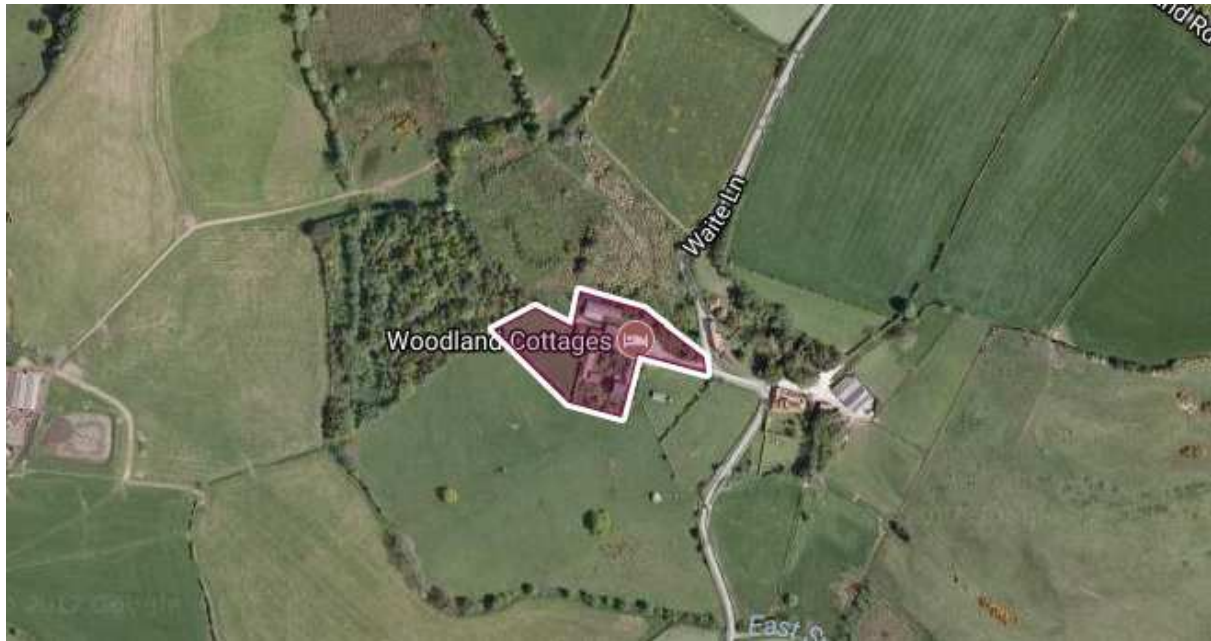
Figure 1: Site extent highlighted

- 2.1 Thirley Cotes Farm is a group of converted farm buildings and cottages that serve as holiday accommodation. Access to the site is directly from Waite Lane to the east. Figure 1 shows the extent of the site:
