# **JK ARBORICULTURE**

## **Arboricultural Survey & Implication Study**

### **Hillside Farm, Littlebeck, Whitby**

February 2018

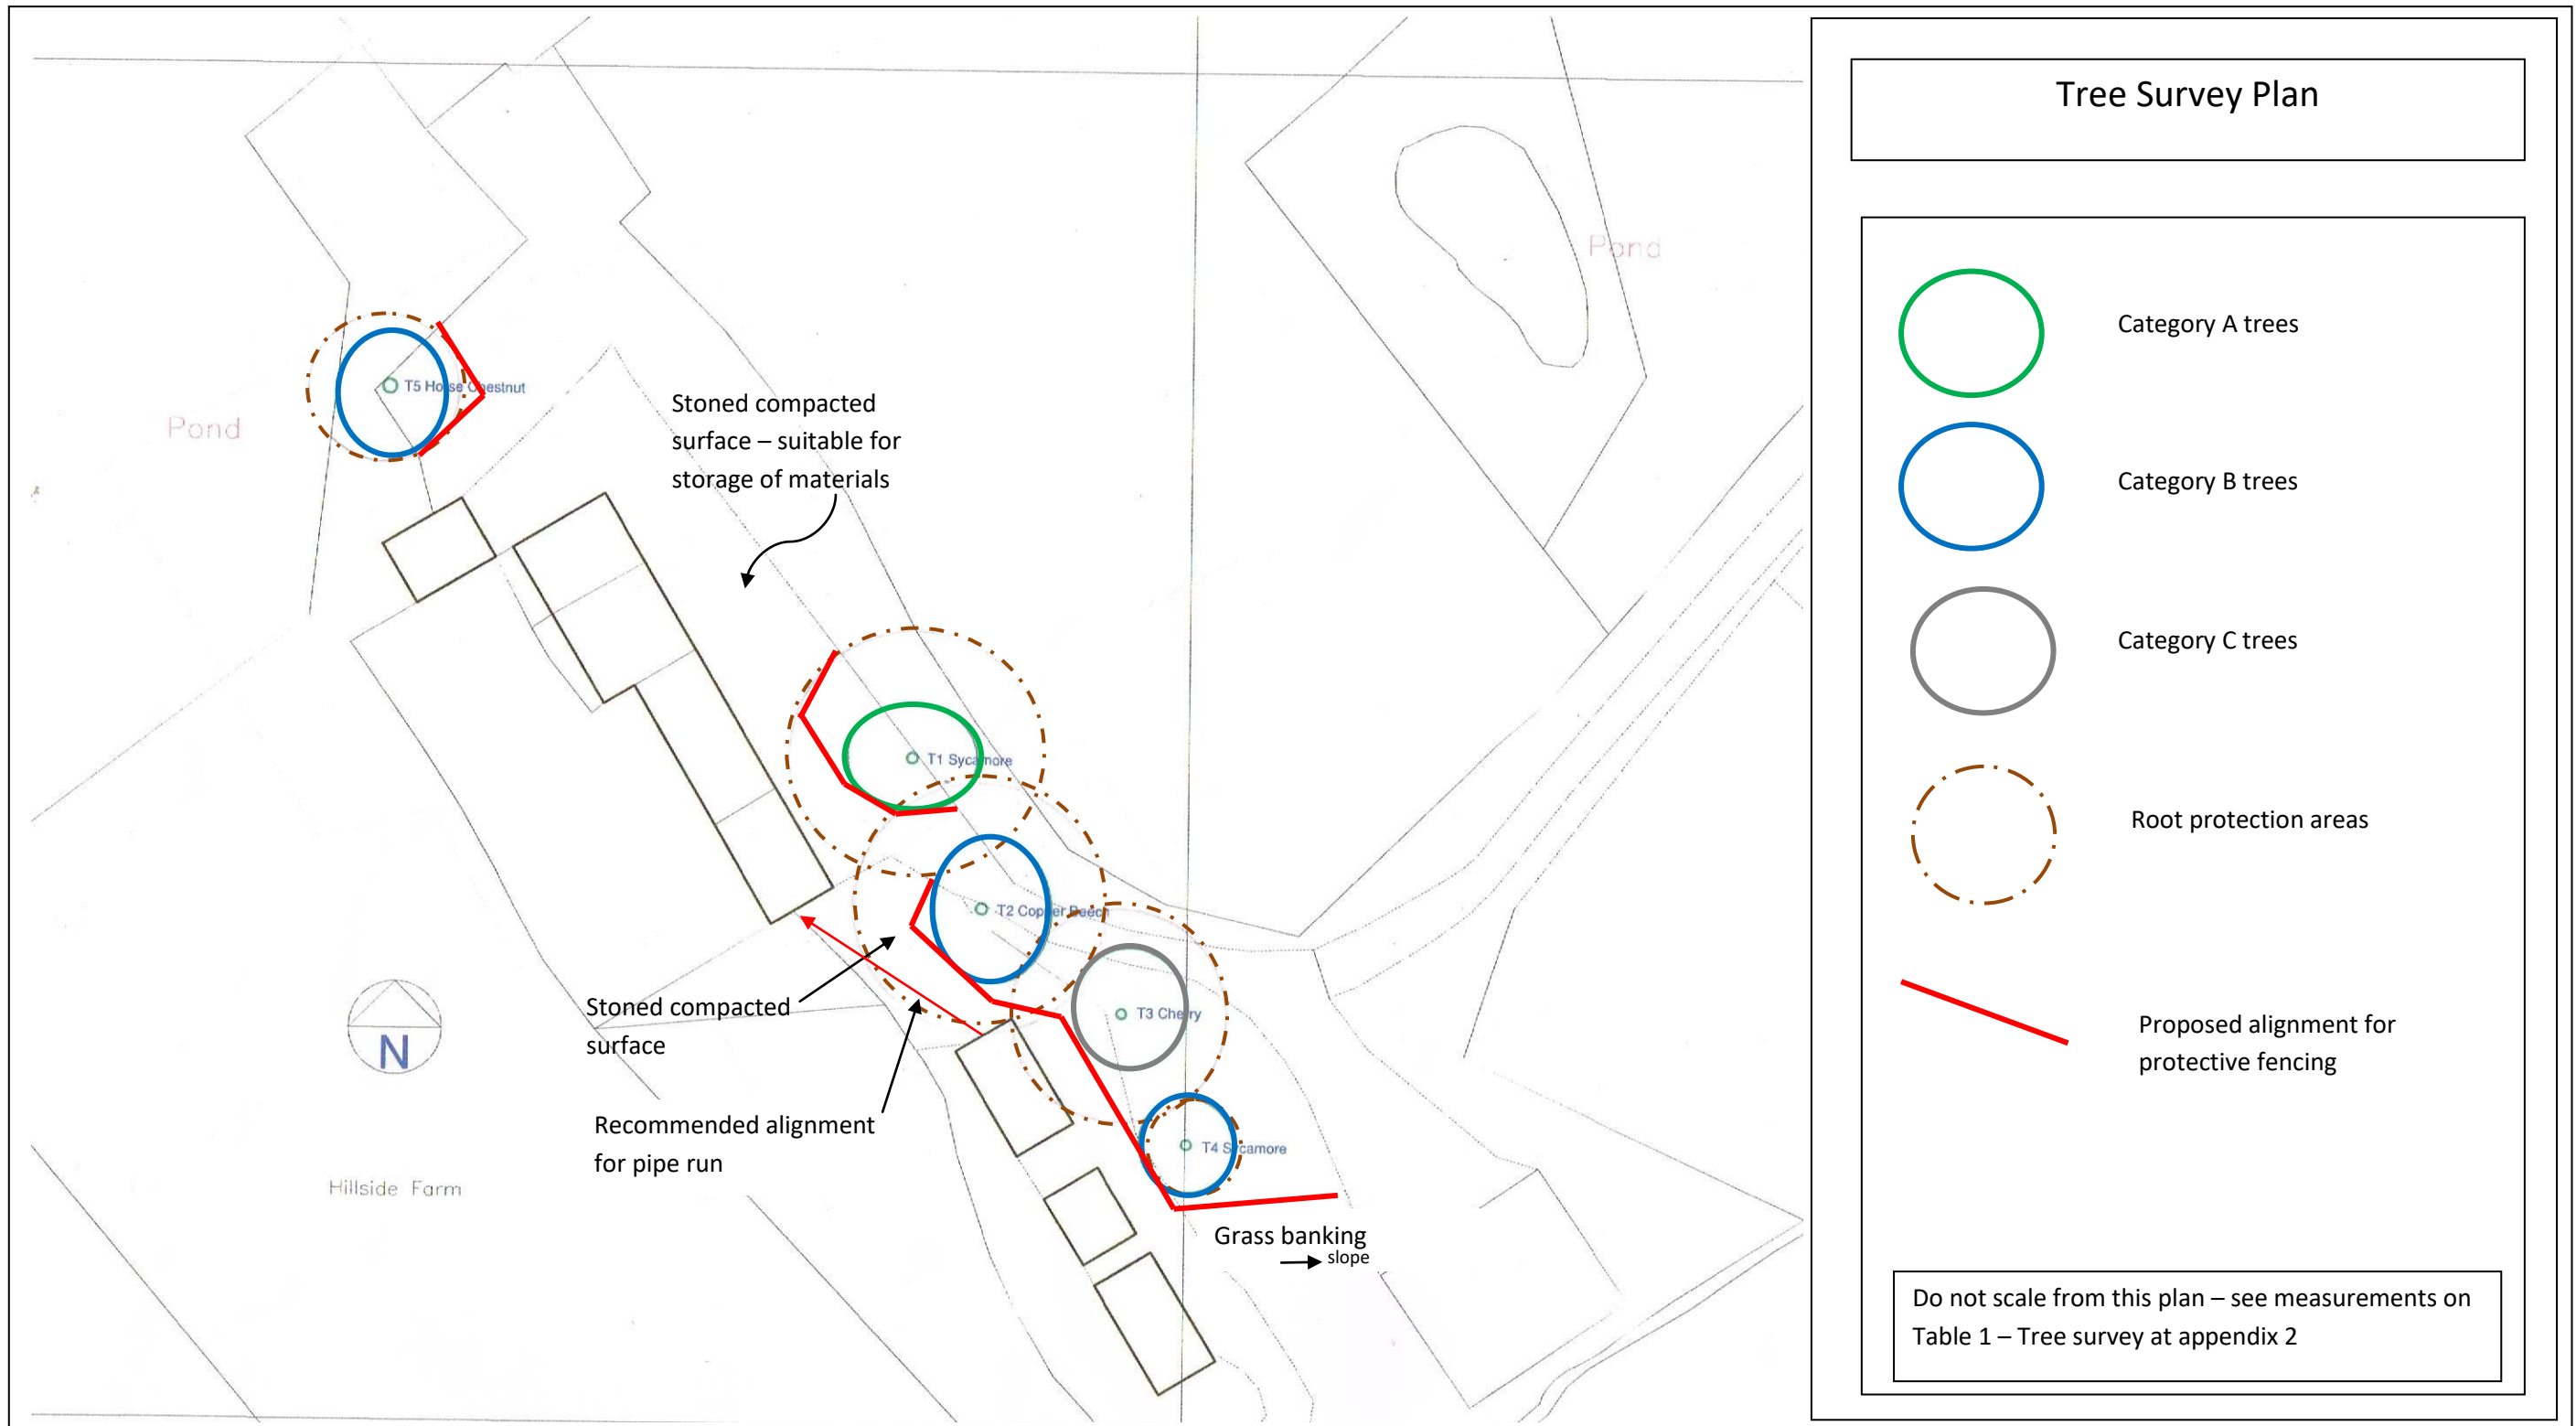
### Tree Survey Plan

The root protection areas of T1 T2 and T5 are totally under compacted stoned surfacing therefore to allow access to carry out the development it will only be necessary to fence off individual trees along the outer edge of crown spreads to ensure that the upper parts of the trees are not damaged by construction traffic. The alignment of protective fencing is annotated on the Tree Survey Plan at
