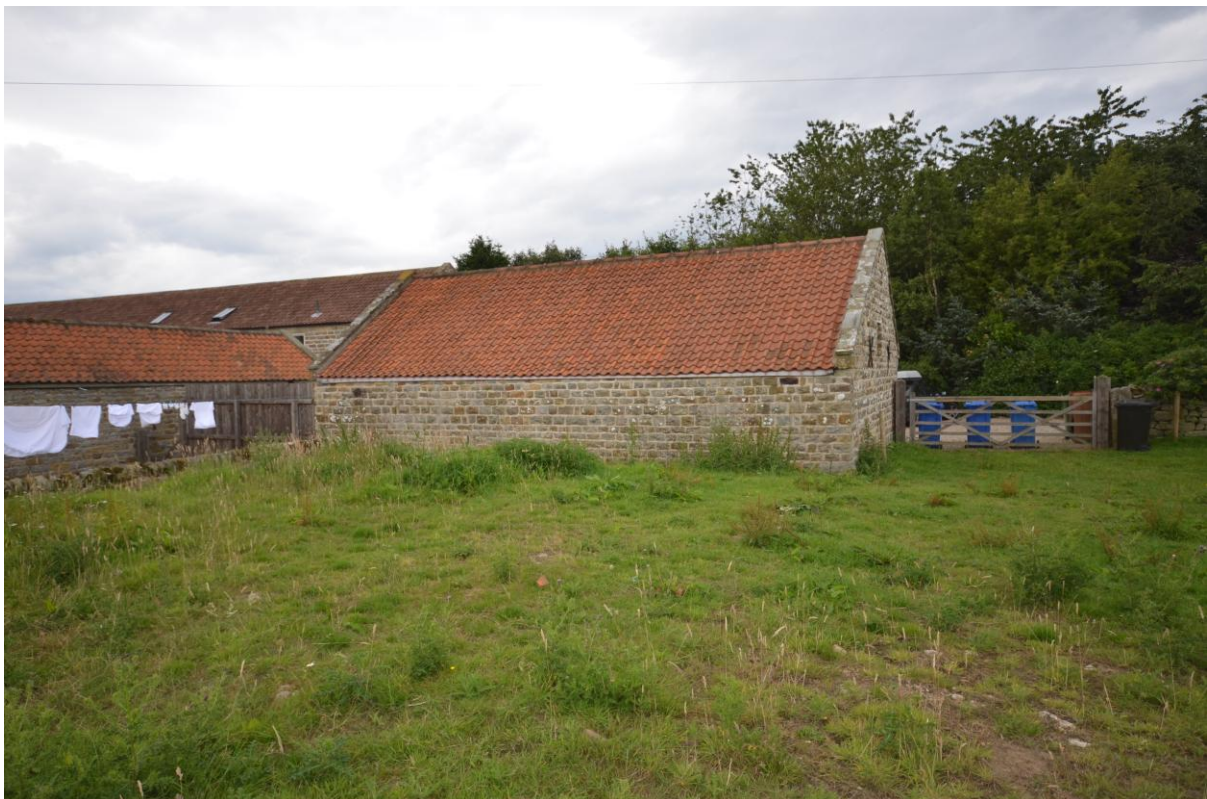
1. North elevation of Rowan Barn. This building has been re-roofed and refurbished in the last few years.
2. North elevation of Rowan Barn.

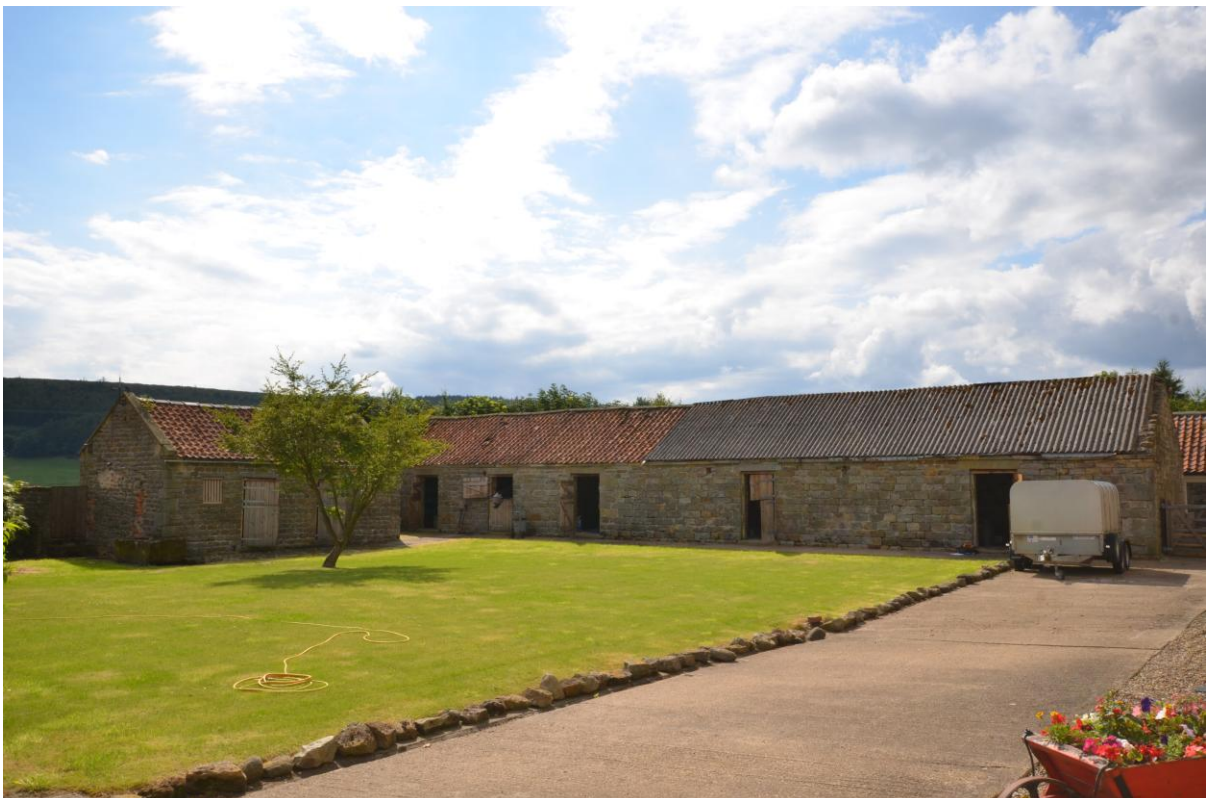
5. Internal view at the junction between Mulberry Barn and Hornbeam Barn showing the existing king post trusses which are generally in sound condition although there is evidence of damp penetration.
6. General view across the courtyard to Hornbeam Barn and Mulberry Barn.
