Bat Building Assessment

Hearn Head House Farm,
Troutsdale
North Yorkshire

Report Reference: CL611/005/001

Prepared by
Clear Environmental Consultants Limited
June 2010

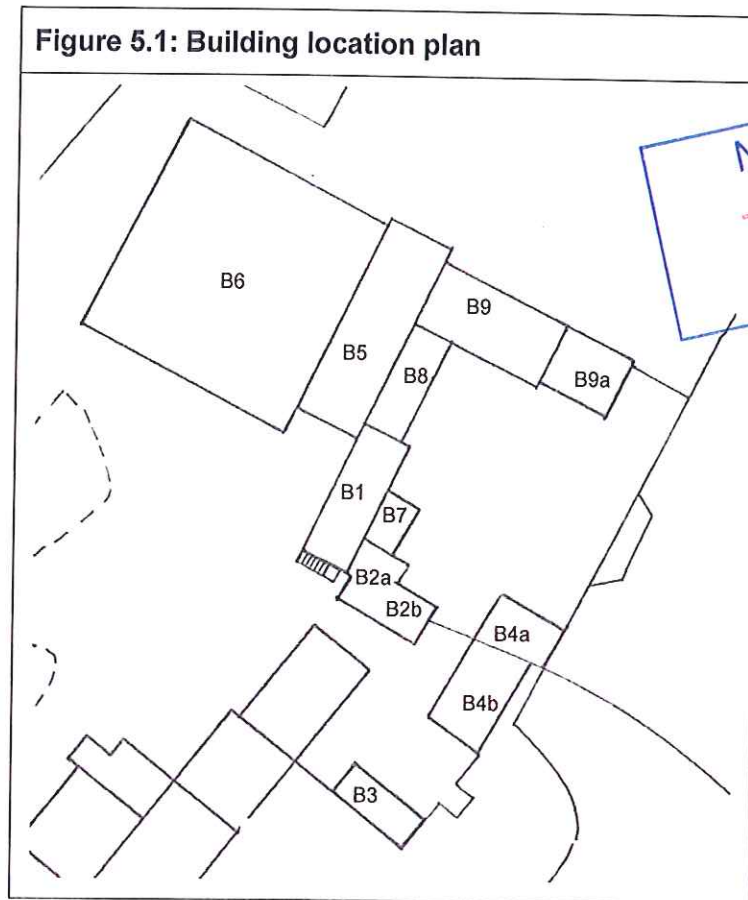
A total of twelve separate building compartments were present on site. See figure 5.1 for details of the building layout on site and appendix 1 for internal and external photos of the buildings.
