***elliottconsultancy*ltd.**
Arboricultural Consultants

Location:
**Land on Beacon Way
Sneaton**

SurveyType:
**Pre-development Arboricultural Survey
Tree Constraints Plan
Arboricultural Implications Assessment
Arboricultural Method Statement
Tree Protection Plan**

Ref:
AE/ARB/545

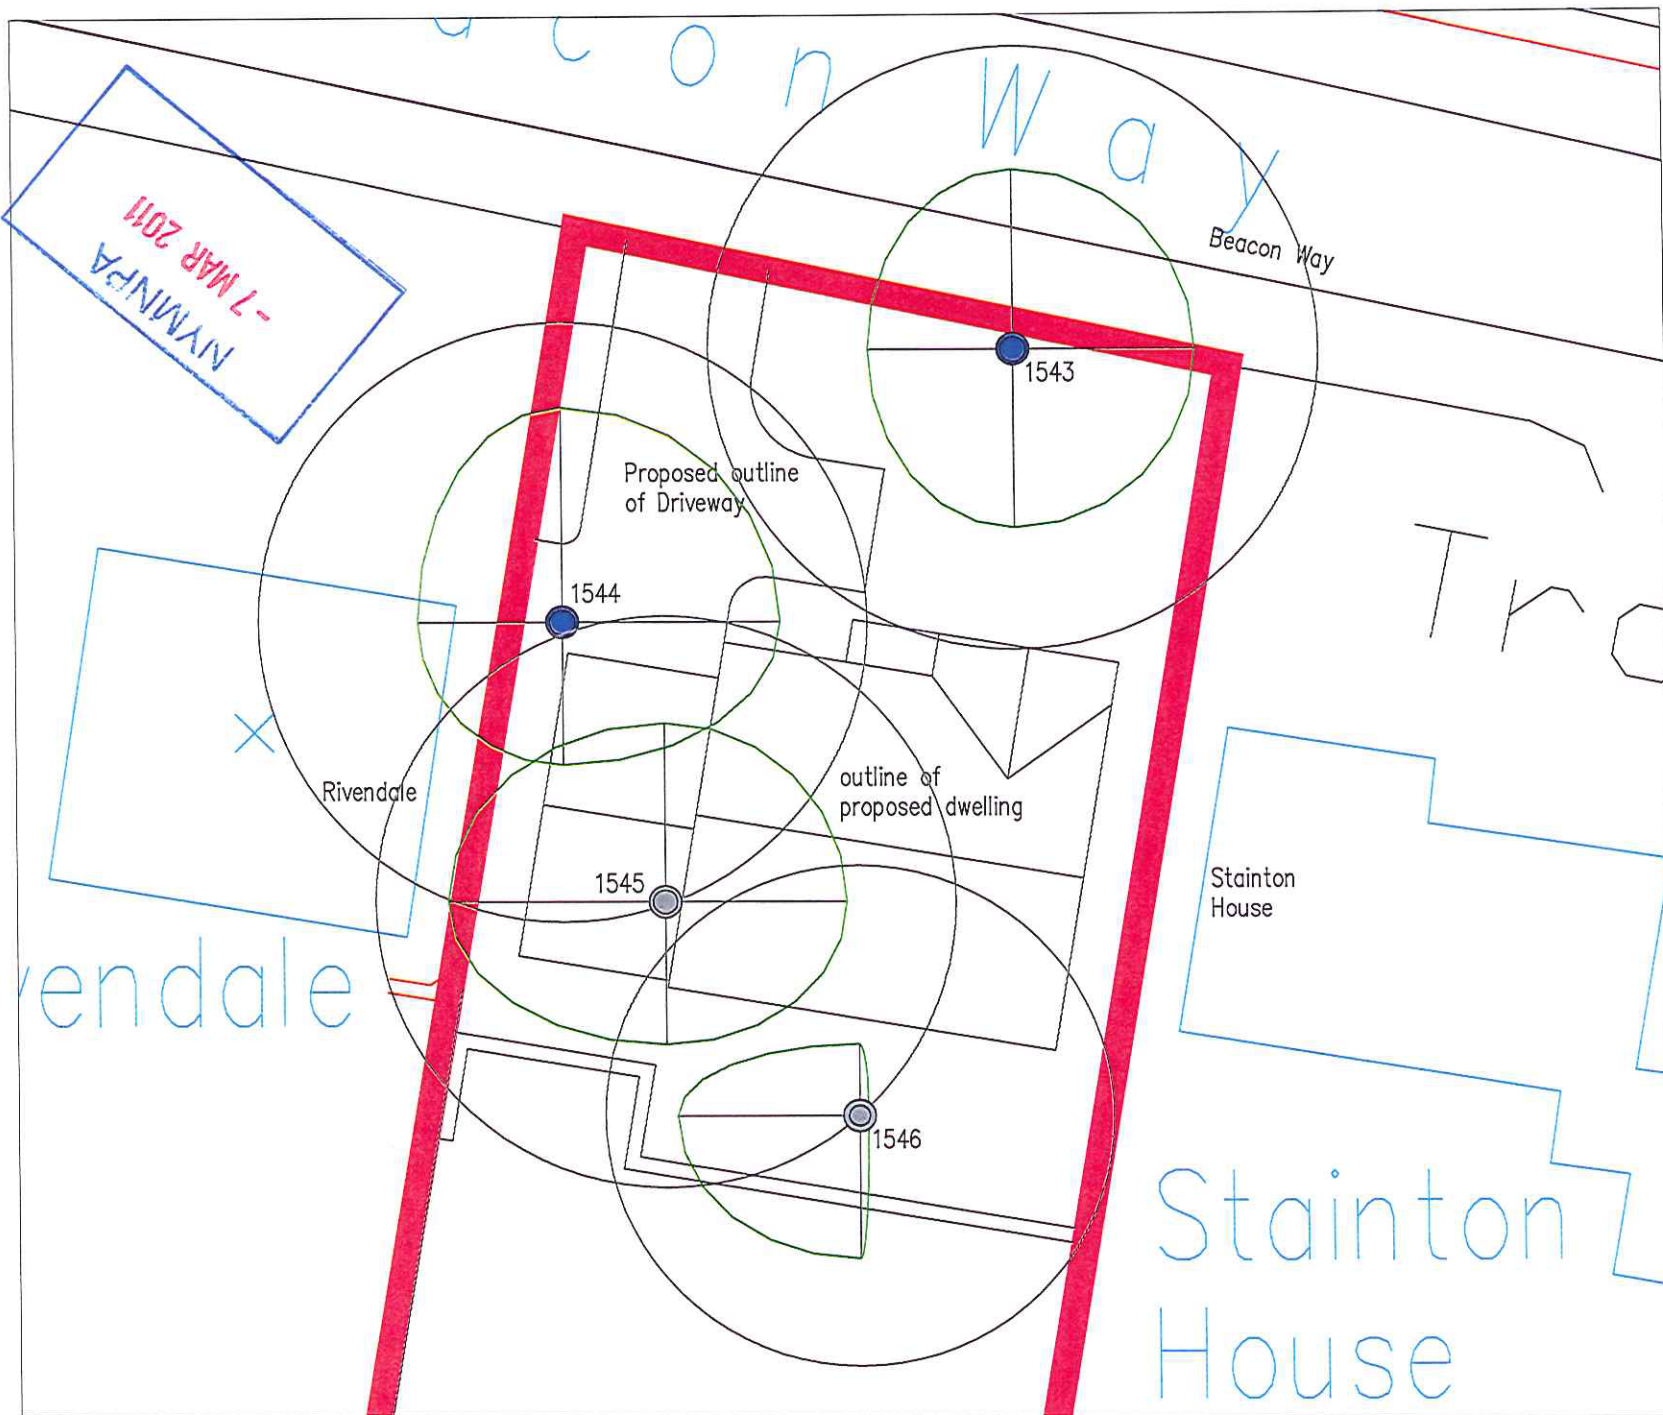
Appendix 4

- 4.2 **Potential Conflict 1:** Location of building and Trees 1545 & 1546.
The proposed location of the building will necessitate their removal.
Countermeasure: No countermeasure is recommended. As the trees are all Category C trees their removal would normally be considered as acceptable.

- 4.3 **Potential Conflict 2:** Proximity of new building and driveway to Tree 1544.
The proposed location of the building will be in close proximity to the tree, with the access driveway also being around the trees base – it would be necessary to remove the tree.
Countermeasure: No countermeasure can be recommended.
Compensatory planting in and around the village may be considered as an option.

4.5 **Potential Conflict 4:** Location and construction of access driveway and the root protection area of Tree 1543.

Damage would be caused to underlying root tissue by the installation of a conventionally constructed driveway

Countermeasure: The ground in this area is already compacted to a degree due to past vehicle usage. However it would still be recommended that the driveway is constructed using a no-dig construction design. This will require the vegetation to be removed by hand, any undulations in the ground levelled using inert sand, onto which a cellular system is laid and then filled with appropriate aggregate, followed by a final wearing layer – which must be permeable to allow gaseous exchange and water penetration. This access must be constructed prior to any development works being undertaken on site.
