PART STRUCTURAL REPORT  
ON OUTBUILDINGS AT  
EVERLEY HOTEL  
HACKNESS  
SCARBOROUGH  
YO13 0BT

**PART STRUCTURAL REPORT ON OUTBUILDINGS AT  
EVERLEY HOTEL, HACKNESS, SCARBOROUGH, YO13 0BT**

Project Reference: MCB/PS/35305

Date: 28<sup>th</sup> January 2014

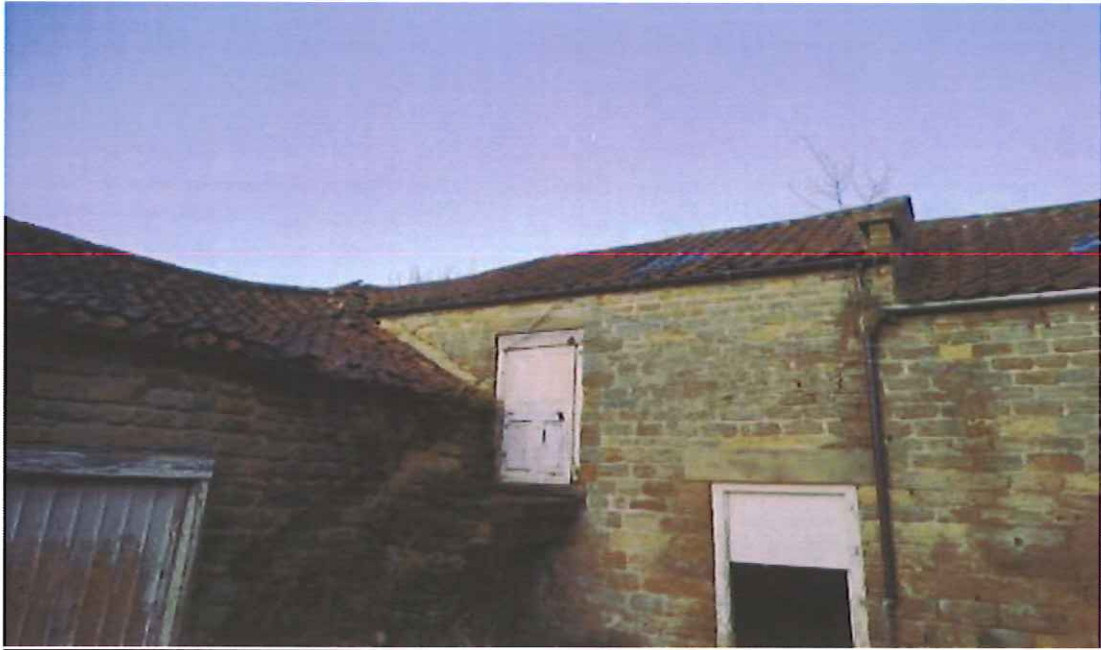
Photo 8

Roofs typically sagging, poor guttering maintenance, wash out of pointing.  
Re-pointing, guttering replacement and re-roofing required.
