**Manor House Farm, Troutsdale
Preliminary Bat Survey Report**

September 2015

**Survey of Farm Buildings
at Manor House Farm, Troutdale.**

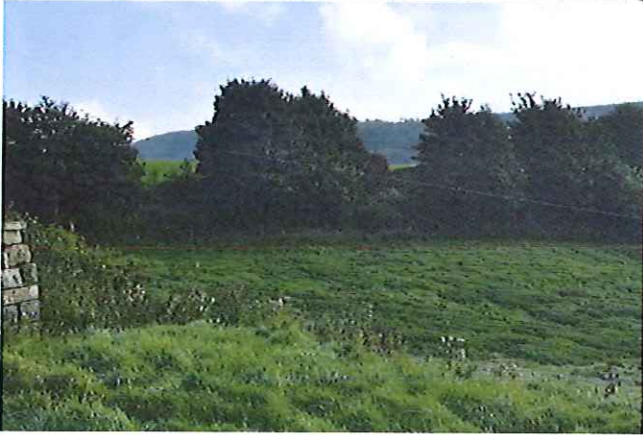
Photo 1: Farmland to southeast

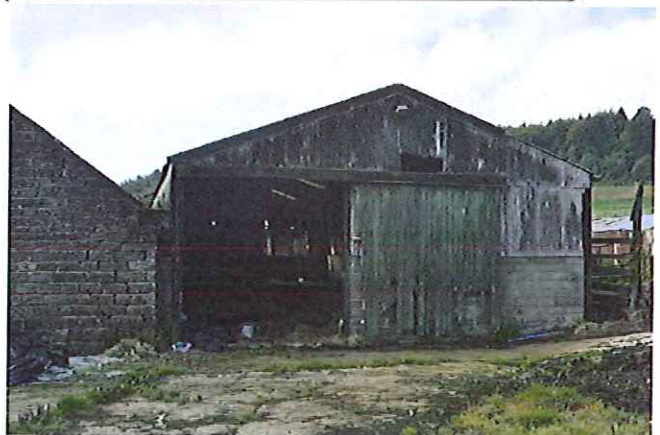
Photo 2: Adjoining cattle shed

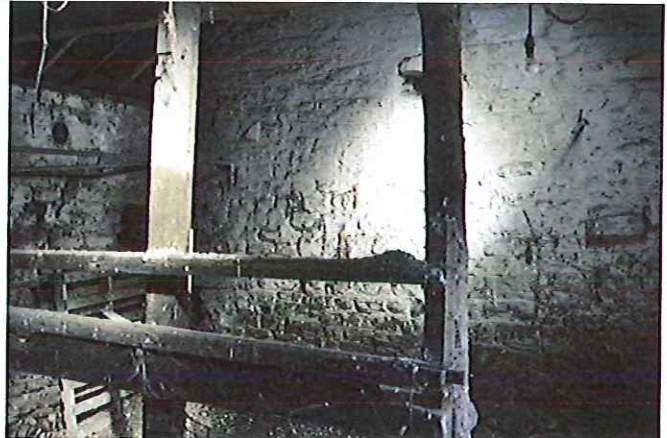
18). The floor is concrete however it is covered in leaked effluent from the adjacent cow shed. There are also some holes in the sarking in this room aswell (Appendix 4, photo 19).

Photo 18: Interior of second room

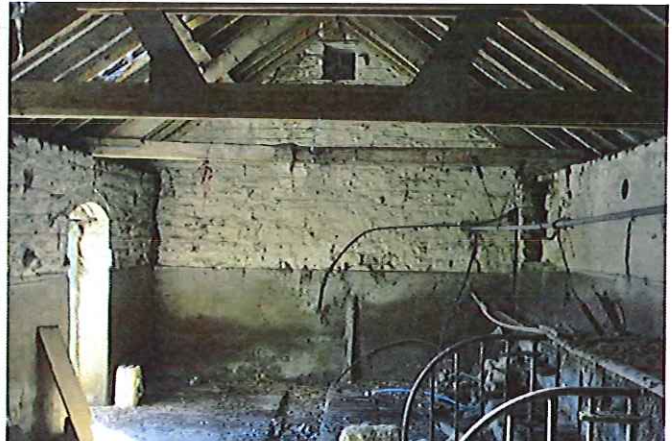
The third area is the largest space within the structure. It is very similar in nature to the other two rooms, with white painted walls and a concrete floor, however the lower area of the walls has been rendered in the past (Appendix 4, Photo 20). This room has one window with two missing panes and also contains a window aperture on the gable end that is fitted with a close gapped grill.

Photo 20: Interior of main area.

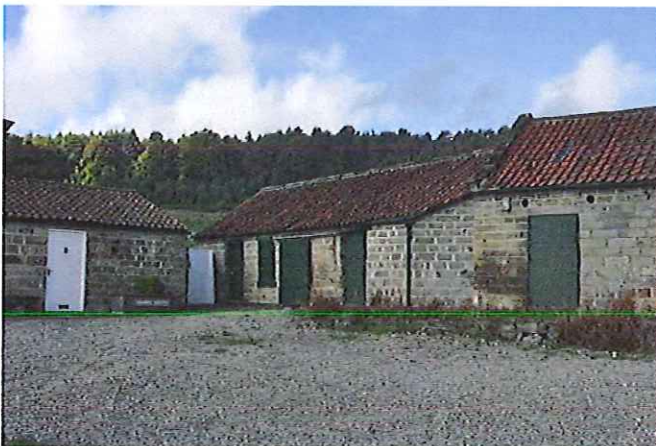
Adjoining the stable block/cow byre is a series of three store rooms (Appendix 4, Photo 21). These rooms were also given a full inspection. The building is of a similar construction to the main building; dressed sandstone, with a clay pantile roof.

Photo 21: Adjoining store

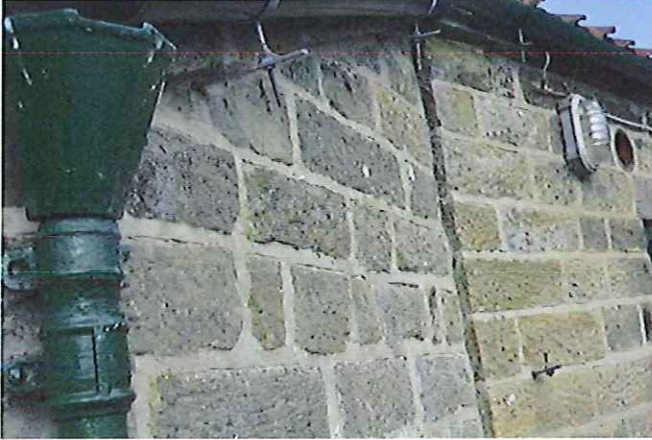
The roof is in generally good condition; however there are some occasional lifted and broken tiles (Appendix 4, Photo 22). The stone work is in good repair the pointing is all sound (Appendix 4, photo 23). The rear of the building is in slightly poorer condition, with some degradation to the mortar and the lower three rows of tiles on the roof being displaced (appendix 4, photo 24).

Photo 23: Walls and guttering

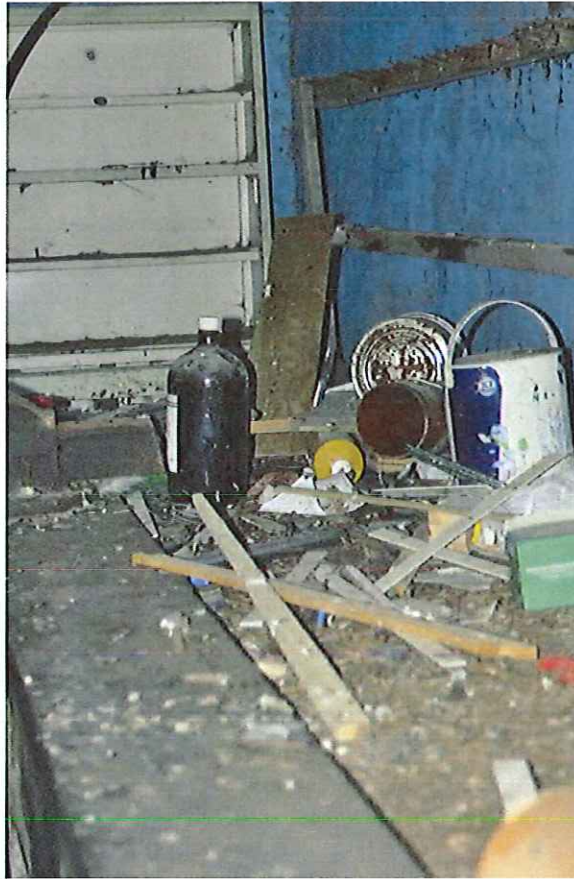
The second store room is disused and mostly contains old furniture and accumulated debris (Appendix 4, photo 26).

Photo 26: Workbench.

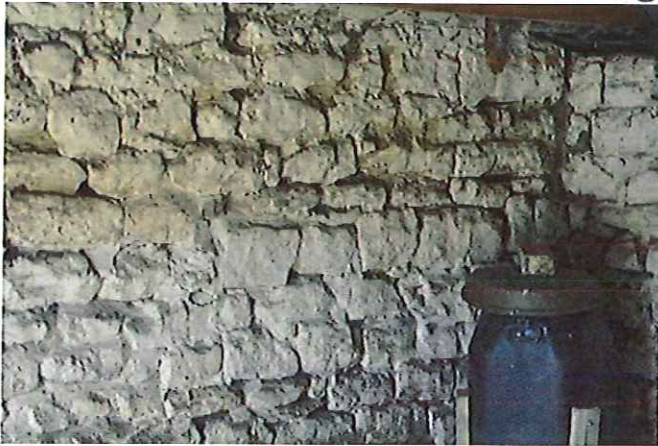
The final store room is used for the storage of game bird feeders, but is currently mostly empty (Appendix 4, photo 27).

Photo 27: 3rd store room.
