Faceby Lodge Farm Complex.

Heritage Statement.

- 1.1 This statement is prepared for S.J. and J. Monk in support of an application for the conversion of farm buildings at Faceby Lodge Farm, Carlton-in-Cleveland. The development proposes to include the Non-designated heritage assets of the farm building group and is in the setting of the grade II listed building known as Faceby Manor which comprises The Cottage and West View. A heritage statement is therefore required.

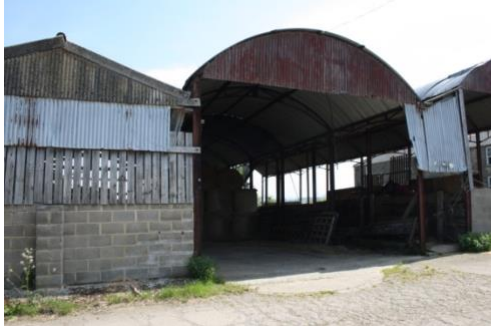
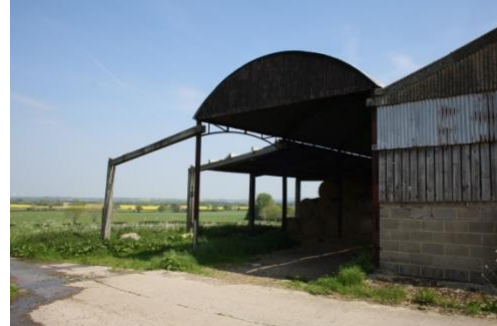
2.5 The Dutch barns are identified as 5 on the building identification plan and comprise three steel framed arched roof structures linked together and in filled

with a fourth pitched roof to form a single covered space. An additional pent roof timber structure has been added to the north side of the building and various modern infill walls of block work, Yorkshire Boarding and corrugated sheet have created enclosed spaces within the structures. Low walls have also been created using large baulks of timber, some of which have been reclaimed from scrapped railway vehicles. Only the arched roof buildings are of much age or interest, the remaining structures being functional ad hoc constructions of no significance.

constructed probably within the last 30 years. The space between the three Dutch barns has been infilled and a further bay added possibly during the last quarter of the 20th century and the three large sheds were built at the south end of the site. All these operations took place after the survey of 1952 and the poor condition of the buildings suggest that they were constructed during the 1970's or 80's.

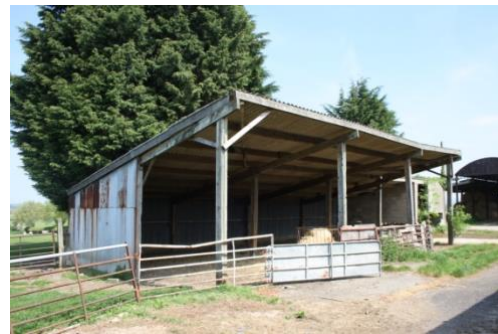
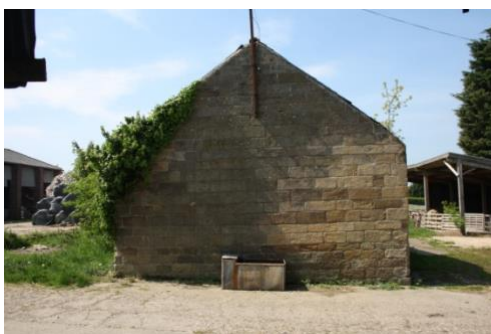
- 2.6 The smaller store buildings to the right of the approach track are numbers 4 and 6 on the identification plan. They contribute little to the farm group as they are visually detached, are of very limited size, lack any prominence and are more visually associated to a nearby small group of trees. The pole barn at the western end of the buildings is open fronted and constructed of substantial timbers with corrugated sheeting to the roof and rear walls. It currently serves as an animal shelter and is of no significance. The rest of the store structures are also of limited interest being open fronted sheds constructed of block work with corrugated roofs.

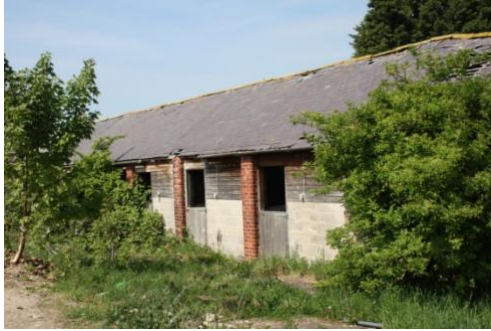
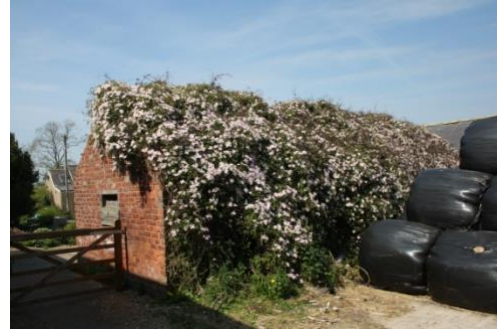
- 2.8 In detail the stables exhibits clear evidence of two phases with a straight joint separating the converted dwelling from the remainder of the building. There are no openings to the gable wall adjoining the track and only a single modest window with a hopper light ventilation opening at the west end of the rear wall, although the adjoining cottage has a significant number of domestically proportioned openings facing north on this wall. The roof has only one ventilator which is similarly positioned at the west end of the application

section of this building, although sections of the roof are in very poor condition and the bay at the eastern end adjoining the gable has a failed ridge. The south facing front wall has been converted from an open cart shed arrangement to a closed loosebox format with the insertion of block work walls and various stable doors to enclose the space.

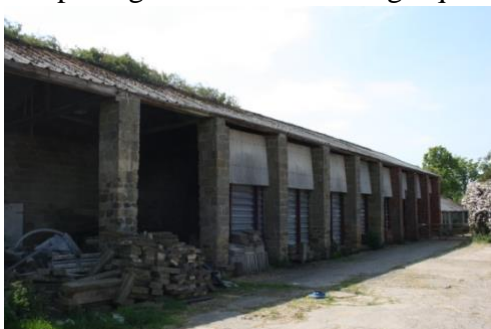
- 2.9 Opposite the stable building is an open fronted hay barn. This lies outside the development site but is a distinctive building which contributes to the character of the open space and is a key structure in the wider building group. It comprises a range of 11 bays defined by stone or brick piers which support the roof on heavy wall plates. The rear wall is a solid masonry structure with no openings and formed of high quality dressed stonework throughout. Each pier supports an open framed truss, some with kingposts others without, and these carry the roof which is now a sheet material but is likely to have originally been either natural slate or pan tiles. The building may be of two phases responding to the different forms of pier, the western four being of brickwork whilst the remainder are

Each pier supports an open framed truss, some with kingposts others without, and these carry the roof which is now a sheet material but is likely to have originally been either natural slate or pan tiles. The building may be of two phases responding to the different forms of pier, the western four being of brickwork whilst the remainder are

stone. An alternative possibility is that the new brick piers were a repair to the building as the rear wall shows no evidence of rebuilding but the truss design varies between the groups of piers with kingposts to the brick piers and open trusses to most of the rest.

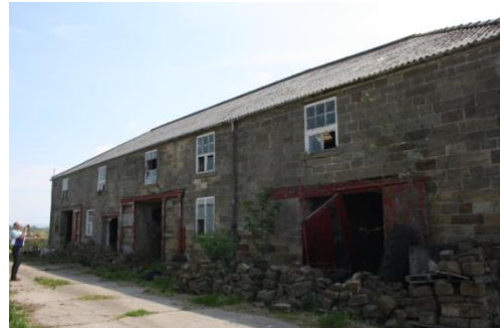
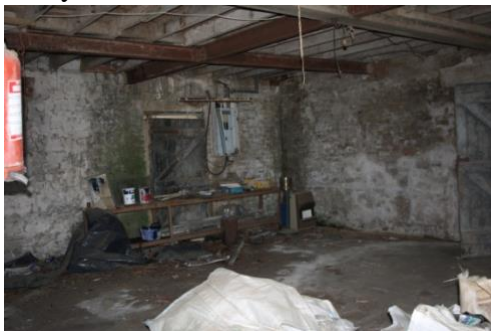
2.10 The hay barn, number 2 on the identification plan, adjoins the main granary building to the east and faces across an open space to the Dutch barns. This granary building is the principal structure on the site, has a deep plan form and is of two storeys, constructed in well dressed coursed stone with a roof covering of corrugated sheets. The ground floor

comprises three main spaces ranged on each side of a central access through to the yards to the south. To the west the two spaces have most recently been used as workshops and low level stores but are now empty. There is no evidence of any previous notable use however a large sliding door which accesses the passage suggests a need for substantial sized items being brought into the building. The west wall of the furthest space has a notable circular glazed

window set high in the wall but its purpose is unclear. To the eastern half of the building one of the space has had milking stalls inserted but subsequently removed leaving scar evidence and a typical concrete floor with drainage gulleys set into

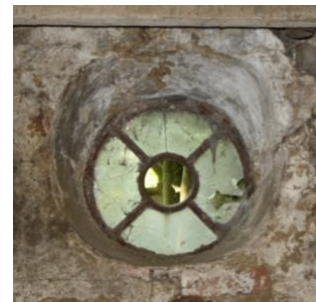
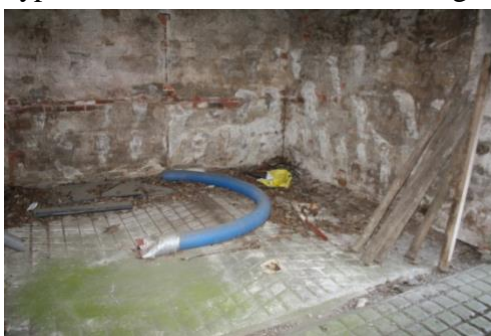
it. A panel on the wall close to the entrance previously held control units for machinery but is now stripped of these except for the makers plate. A long narrow room with a blue colour wash is positioned behind this and may have accommodated electrical or power plant.

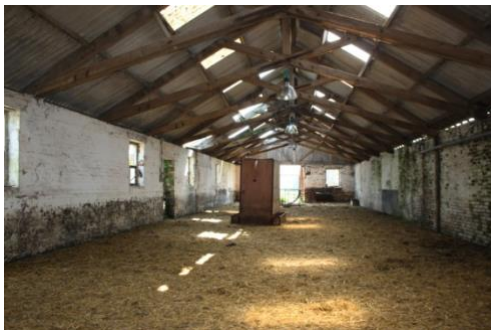
- 2.13 To the rear of the granary lie three large shelter sheds formed of the original two wings to the farm and a later inserted overall roof which created a large open space for stock but has now collapsed throughout most of its length. This group of structures is noted as number 7 on the identification plan. The eastern wing has a brickwork inner wall and good quality cut and dressed stonework walls to the east and south elevations. The roof is supported on timber scissor trusses and has a corrugated sheet roof with panels of clear corrugated sheeting to light the interior. Internally any divisions have been removed to create a large shelter shed for livestock. The internal, western wall to the courtyard has no openings however the eastern external wall has a number of agricultural window openings and a centrally positioned single door whilst the south gable has had a large vehicle access door inserted alongside and earlier window opening.

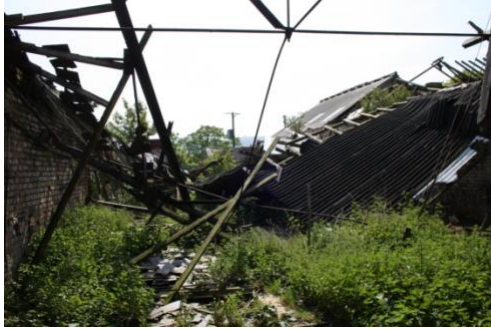
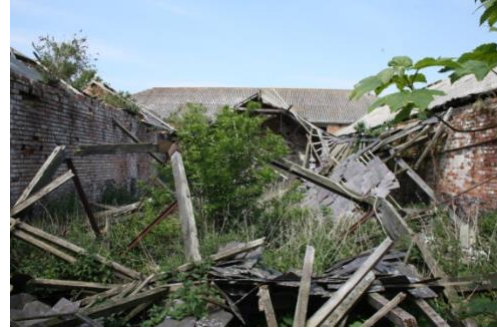
- 2.14 The central section of the outbuildings was formed by roofing over a courtyard with a lightweight steel and timber truss roof with a corrugated sheet covering. It is thought that this created additional shelter shed capacity for livestock however it has collapsed along $\frac{3}{4}$ of its length and was not considered safe to inspect in close detail. The walls of this part of the building comprise the internal brickwork to the two older flanking wings and a single possibly hipped roof gable end at the south of the building which is constructed in stone but is now much collapsed.

- 8.8. The loss of the central roof to the stock yard is of limited historic impact as the roof, although not conventional by today's standards, is not a rare item and is not of notable quality. Similarly it is expected that the matching adjoining roof over the western wing will need to be replaced as it too is in poor condition and is unlikely to lend itself to the creation of upper floors in the roof space. The revised scheme for the piggery is a significant improvement for that single building and on the wider development as a whole. The

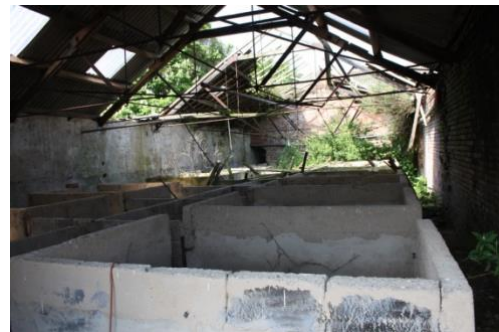
- 2.15 The western wing mirrors its eastern counterpart in scale and form however with certain important differences. The roof is a lightweight steel and timber construction matching the remains of the central section, and this too has failed in one area. The walls to both sides are brick with only the end gable being constructed in local stonework and the interior of the building retains a layout of concrete sty's and pens. There are no openings to either of the long flanking walls, notably the external western wall remains solid as this is in very close proximity to the farm house.

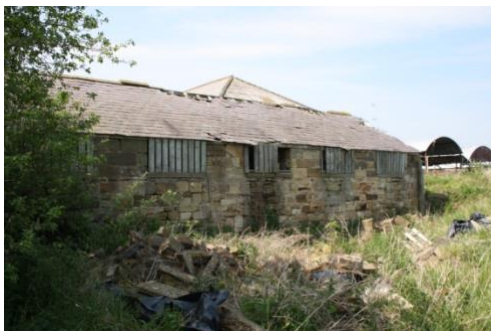
- 2.16 To the east of the principle outbuilding lies building 3, the piggery. This is another stone building of matching construction to the better quality buildings on the site and for the most part this retains its slate roof which has raised

stone ridge tiles to provide ventilation to the building. It stands across a change in level on the site presenting a low single storey to the access track on the west but a much taller elevation to the east where the land falls away to the open fields. The piggery is the most intact of the buildings on the site retaining many of its earlier features and most of its

original masonry. The long elevations retain 6 horizontally proportioned low windows and a door with surrounding sills and heads to each side, those on the east being set at the same height as the western openings towards the eaves level. The southern gable is a solid masonry wall which has a notable presence in the farm group whilst the northern gable has had a vehicle door

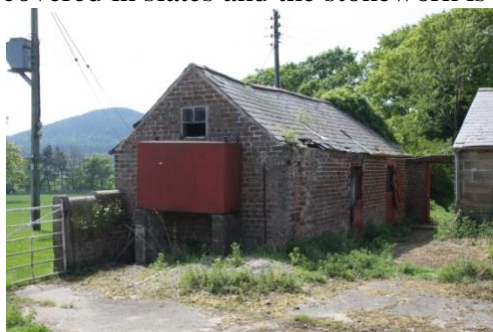
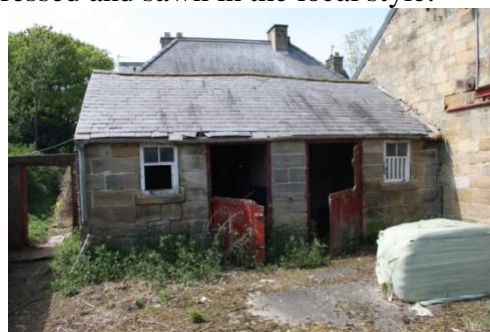
- 2.18 Two smaller incidental buildings, 10 and 11 on the plan, lie close to the southern corner of the main outbuilding range. These have most recently been in use as stables but now appear disused. Building 10 is a single storey pitched roof brick structure with two small internal spaces each accessed from a separate door on the north elevation. The roof is slated and there is a small high level window in the east gable. This building stands tight against the boundary wall and is an important component in closing the views into and out of the site. Building 11 is a stone structure of traditional vernacular construction comprising two loosebox type stables with a traditional stable type window and stable door to each on the east elevation. The roof remains covered in slates and the stonework is dressed and sawn in the local style.

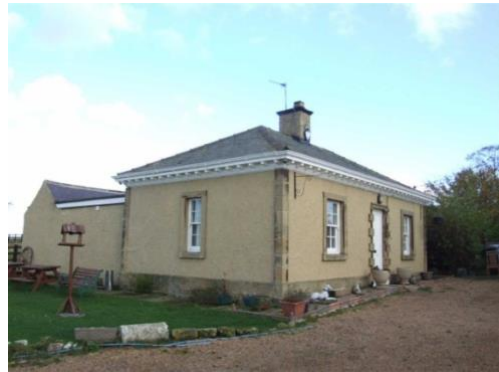
2.21 Also of similar relevance to the wider historic site is Faceby Manor Lodge which stands to the north of the main A172 road at the point where the original drive to Faceby Lodge met the main Stokesley Road. This is a small lodge house originally oriented westwards to accept visitors to the estate arriving by road, however subsequent road improvements have repositioned the main road to the south of the building and it now faces onto its own access road and open farmland with its back to the principal thoroughfare.

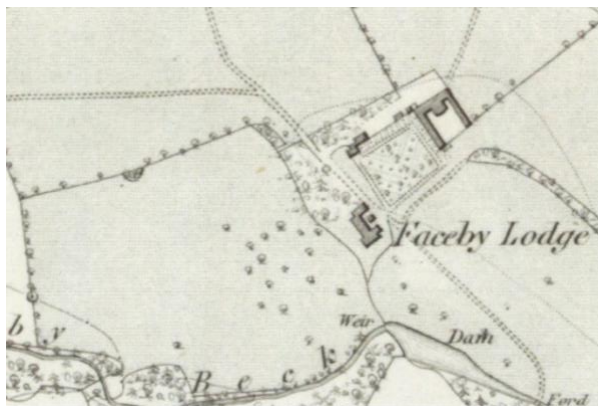
available plans are the OS first edition maps surveyed in 1854 and published three years later in which the site appears with a substantial house facing southwest and accessed from the present drive to the manor. A lodge building at the northern head of the drive is also present on this survey but not on the subsequent edition of 1895 suggesting that the current building was a replacement contemporary with the 1895 rebuilding of the main house.

- 3.3 The farmstead is represented by the main granary building with two wings running southeast from each end of the building to form an open ended courtyard. This layout relates well to the older buildings currently on site and also includes smaller buildings within what is now the open space to the stables, and others lying to the west at the corner of the well defined garden. Of important note is the square block feature on the southern side of the

granary building which could be a gin-gang or horse engine house. These were established features of larger farms where mechanisation required a power source for grain threshing or other operations. This building has been lost and no significant traces of it remain within the walls of the current building on site suggesting a partial rebuild at some point. The presence of the granary and gin-gang confirm the mixed farming origins of Faceby Lodge with both livestock and cereal being produced.

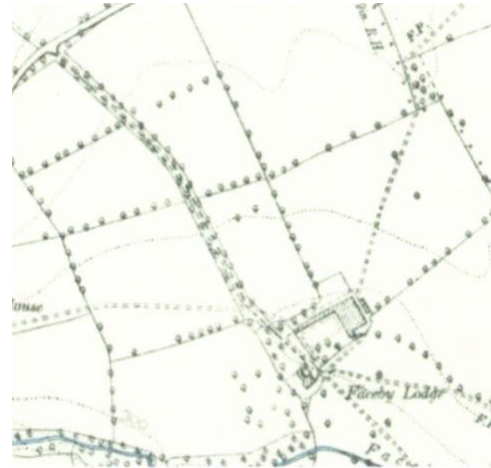
3.4 The second Ordnance Survey forty years later shows a rather different layout to the farm suggesting an extensive development and alterations to the buildings. This may coincide with a major investment in the property culminating in the 1895 rebuilding of the main house. To the farmstead the courtyard has been roofed over, a single long run of buildings now extends west from the northwest corner of the granary and the piggery is shown in place. Access to the whole site is still from the original driveway to the main house but no lodge building is shown at the road side. The buildings shown on this plan correspond to some of those on site today, and although the roofed central yard has now collapsed the construction style and form is typical of this late Victorian date.

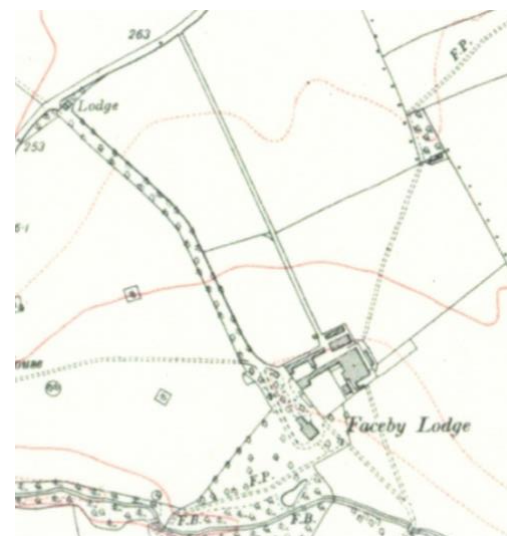
3.5 The early 20th century additions to the site appear on the third OS map of 1919 which was surveyed in the later Edwardian period in 1911, publication being delayed by the First World War. This map shows three of the five Dutch barns in place, probably the three arched roofed structures, the stables building complete in its current form to the north of the main group and, importantly, the new farmhouse and small outbuildings at the southern corner of the main sheds. Also of importance is the new access track to the farmstead leaving the original driveway to serve the house which is still called Faceby Lodge at this time. The enclosures shown on this early 20th century plan suggest that the farmstead was becoming separated from the large house, with less emphasis on the relationship of the house to the garden and more on the relationship to the open almost parkland to the southwest.
