From: Frnc Sinc  
Sent: 30 July 2019 22:34  
To: Mark Hill; Ailsa Teasdale; Building  
Subject: Attn Suzanne Lilley-Building Conservation Team -10 South End Osmotherley- NYM/2017/0722/LB-Window, Insulation & roof pantile details.

10 South End Osmotherley- NYM/2017/0722/LB-Window, Insulation & roof pantile details.  
Attn:  
Suzanne Lilley-Building Conservation Team  
Mark Hill Head of Planning  
Ailsa Teasdale - Senior Planning Officer

No 10 SOUTH END CAMPTONARLEY  
PROPOSED WORKS TO FORM ONE  
DWELLING AND REPAIR & MAINTAIN  
EXISTING FABRIC.  
DRNG 4 PROPOSED REPLACEMENT  
OF NON HISTORIC FABRIC VERTICAL  
SLIDING SASHES NOT REQUIRING REPLACEMENT  
WITH SIMILAR PROPORTIONS BUT MORE RESILIENT

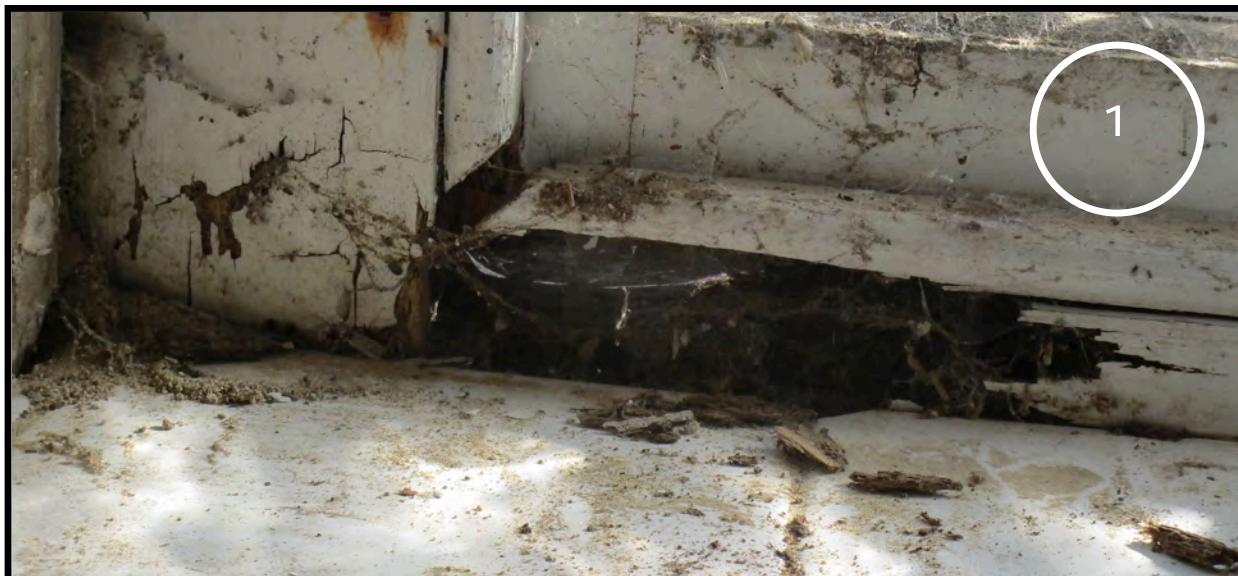
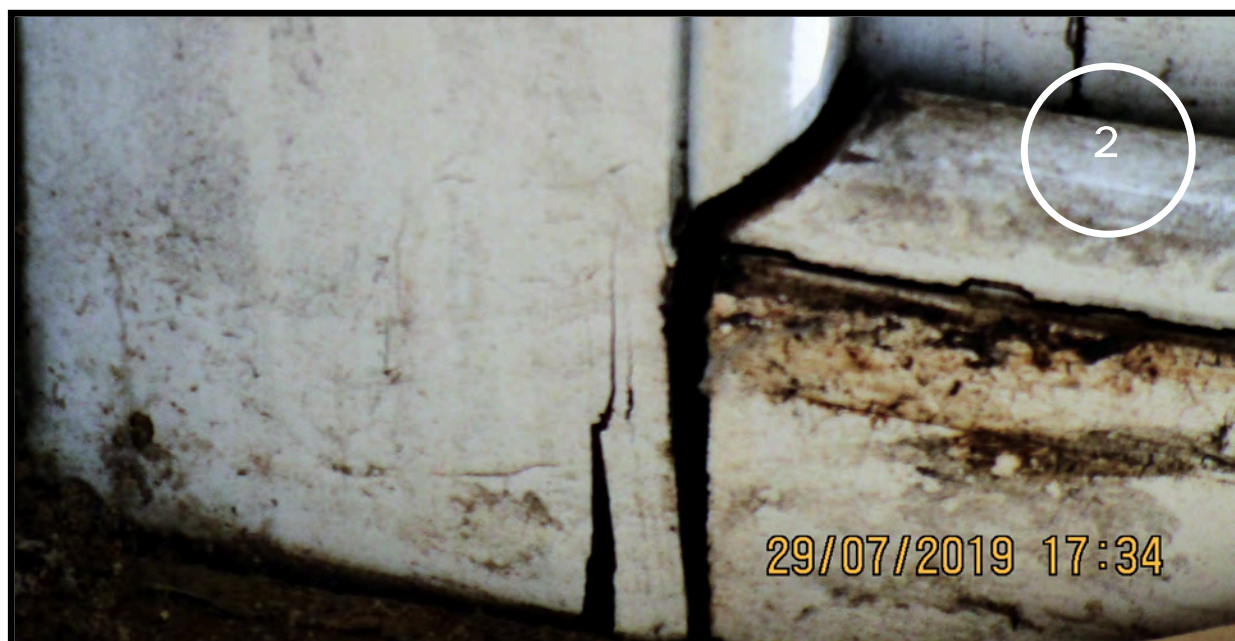
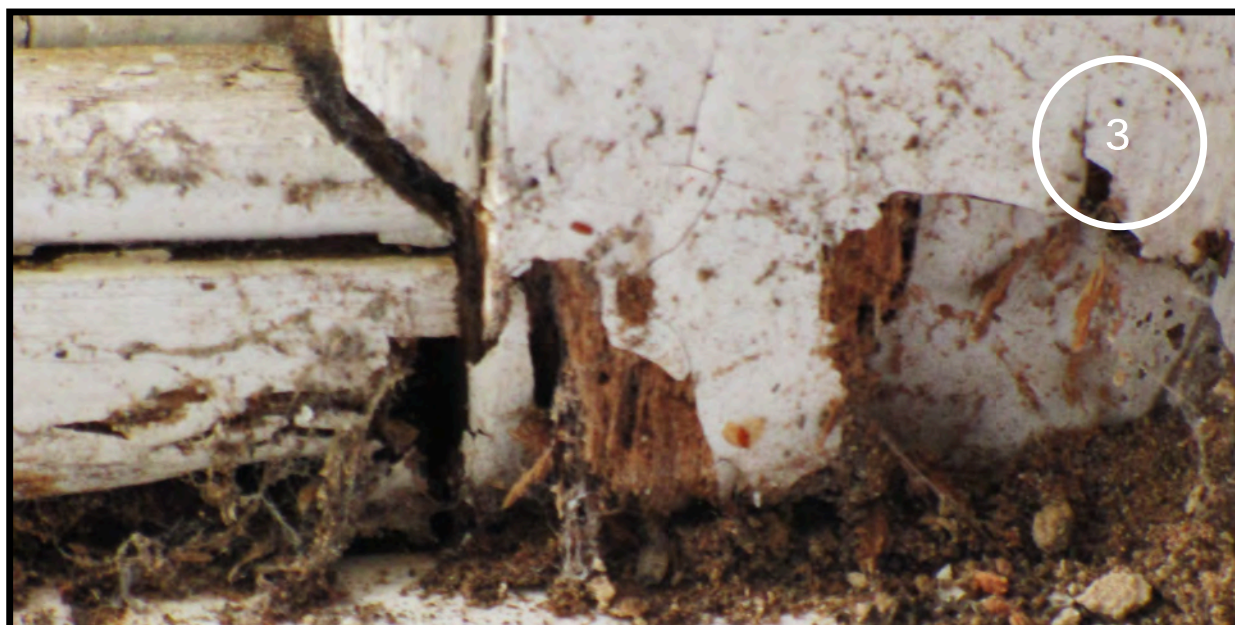
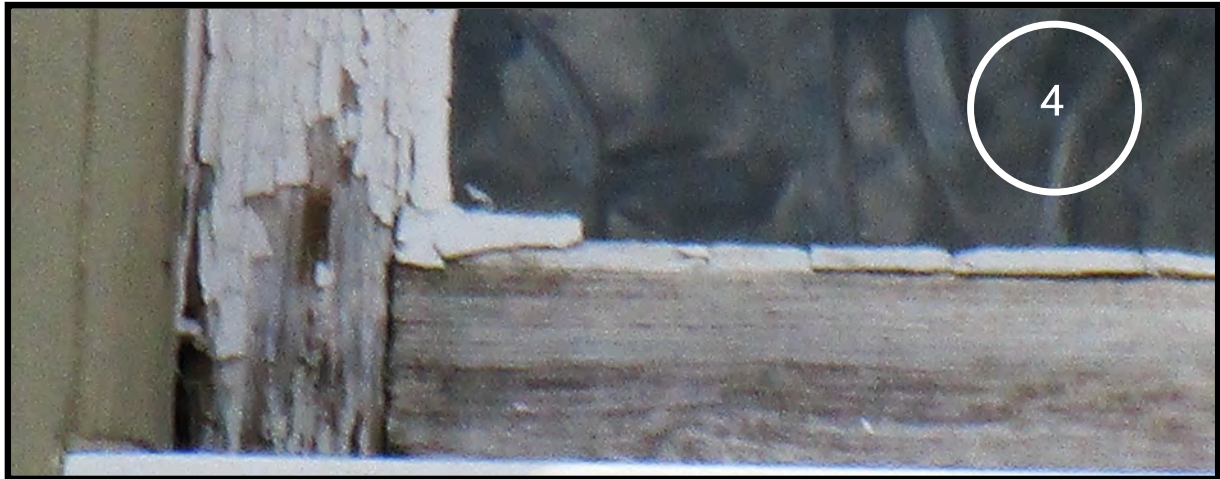
**Proposed replacement of single glazed softwood, non heritage fabric, vertical sliding sash windows with resilient timber and hardwood heritage, slimline double glazing to meet requirement for replacement of existing vertical sliding sashes to rear of property.**

All of the windows to the rear of the property were replaced in their entirety in 1985. The workmanship was basic and used softwood. The windows were due for external painting at the end of 2018 but this has been held back in the hope of being able to provide new units rather than paint over a dilapidating situation. The property is very exposed on this façade to the elements with extremes of harsh blizzards and baking hot sun. The level of condensation, rain and ice is such that the softwood frames are unable to withstand the extremes of temperature and this has caused the frames to lose their integrity with the expansion and contraction of elements causing movement and rot especially at the junctions. In some cases, minimal pressure on the rotting timber would create an opening between the outside and the inside.

The current frames are disintegrating and although not obvious, the photo at No 4 shows apparently unpainted wood when in fact the bonding of the softwood timber bead glued to the surface has failed, dropping off the window and removing the protection previously afforded from the elements. Photos 1 to 3 show internal views of the varying degrees of rotting and movement of the vertical sliding sashes to the rear of the building. As the movement in the frames continues to cause gaps to occur, the integrity of the frame is lost and the glazing becomes less secure especially with the loosening and banging of frames, with the give and take, during high winds. The down draughts associated with single glazing impact on the internal environment making it difficult to keep the rooms warm and still retain an element of daylight whilst giving rise to a high level of condensation impacting on the current softwood frames.
