6.0 PHASING AND DISCUSSION

West range elevations and cross-section

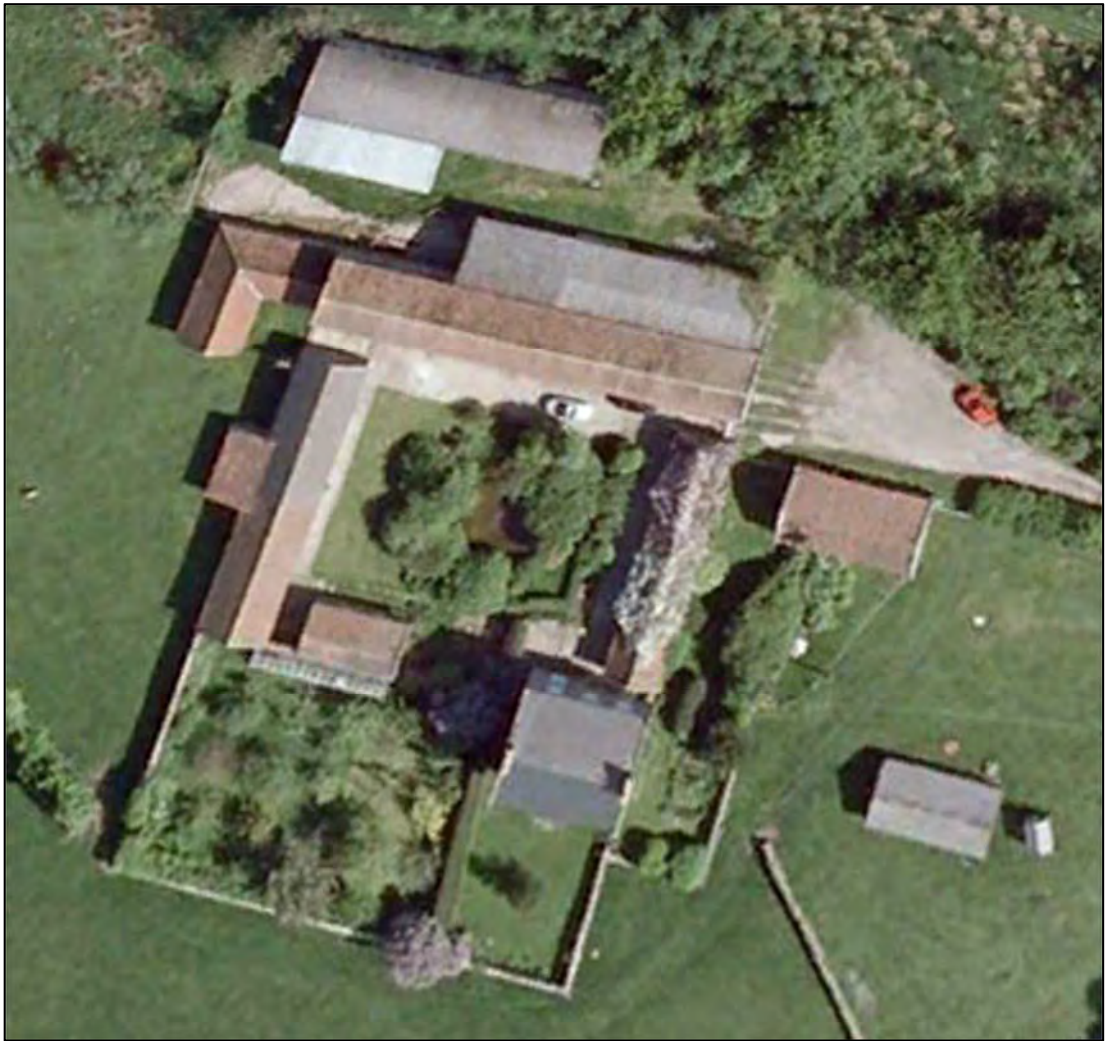
Figure 9: historic Google Earth imagery (2009) of Thirley Cotes farm prior to its development as holiday accommodation. The demolished 'greenhouse' building is visible extending to the rear of the south range. Also visible are a series of modern agricultural building with corrugated roofs, all of which have since been demolished.

- 6.7 Cartographic evidence indicates that the demolished building abutting the south range to the rear (south) was originally smaller than those footings that remain in-situ today would suggest (Fig. 4). At some stage the building was extended east, probably in the mid to late 20th century and converted for use as a greenhouse. This was demolished between 2009 and 2017. At the time of the NAA survey only the lower wall footings

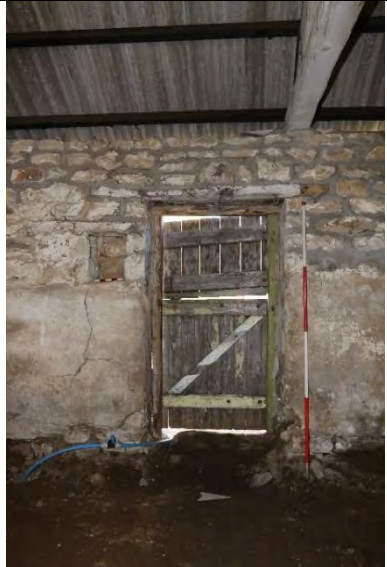
No.	Name	Description	Related Feature	Date	Significance	Photo
103 west 104 east	Lamp niche or keep hole	Two niches located to the side of both doors (101 and 102). The west niche (103) is to the south of door 101. The east niche (104) is to the north of 102. These niches were used for storage or holding lamps. (Photo shows niche 103 and door 101).	203 central room – lamp niche or keep hole 101 west door 102 east door	Early 19 th century	High evidential value as part of the original fabric of the building.

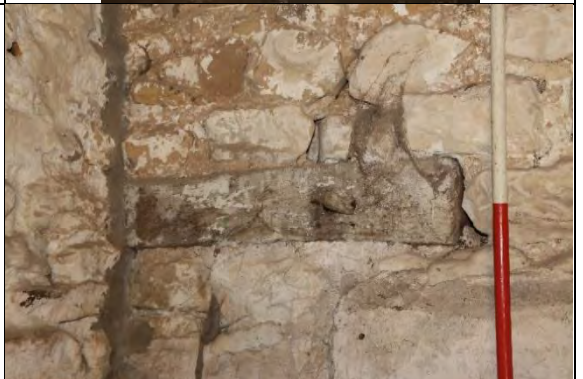
105 106 107 110	Horizontal timbers	Horizontal timbers associated with feeding trough (later modified). Timber 106 in SW corner features the remains of a tack hook. (Photo shows horizontal timber 106).	303 south byre west - horizontal timber 305 south byre east – horizontal timber	Early 19 th century	Moderate as evidence of associated features.

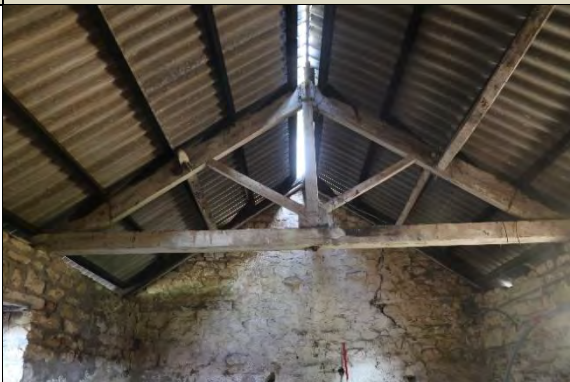
No.	Name	Description	Related Feature	Date	Significance	Photo
108	King post trusses	Six king post trusses run the length of the three main rooms. These are marked with carpenter's marks I-VI and were probably built off-site and assembled in-situ. (Photo shows king post truss number VI located in room 100).	100 north room 200 central room 300 south room	Early 19 th century	High evidential value. These trusses provide evidence for the original layout of the building. Furthermore, the carpenter's marks have historic value in demonstrating historical construction techniques.

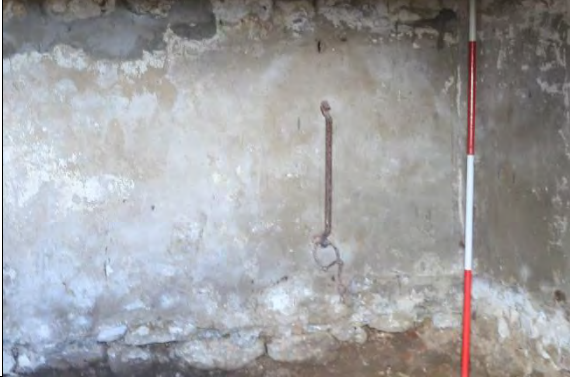
109	Tethering bar	A metal bar in the north-west corner of the room.	205 northern and central byre – timber uprights	20th century	Low evidential value of final phase of room use—modern.

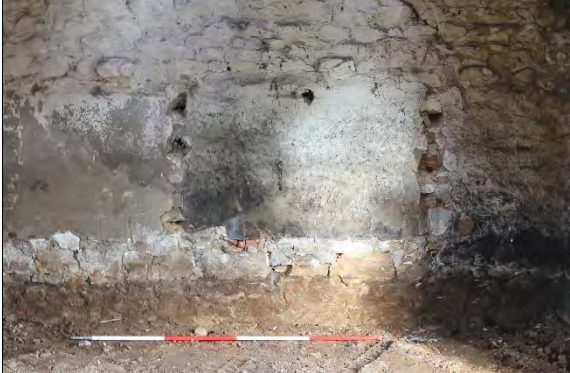
111	Joist holes	Two columns of three joist holes used to support two stall partitions. Previous photographs indicate these were of concrete.	112 stall partitions 204 central byre - joist holes 206 stall partition scar	20th century	Moderate–low value as evidence for the use of the space but relate to final use of building.

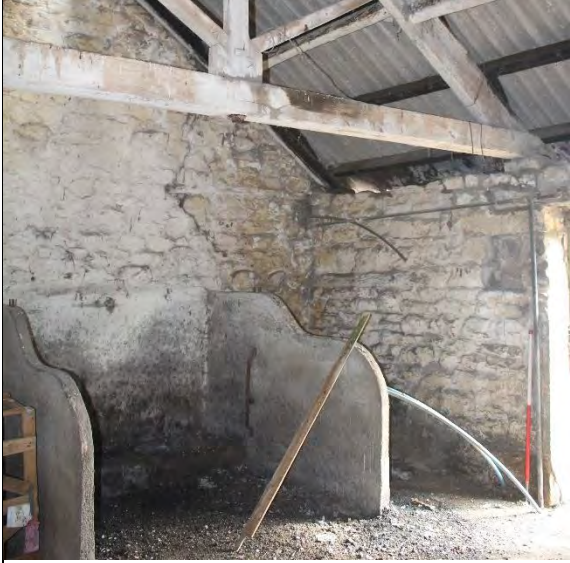
No.	Name	Description	Related Feature	Date	Significance	Photo
112	Stall Partitions	<p>Recorded by CS Archaeology, but no longer present during NAA survey.</p> <p>Photo by CS Archaeology 2018.</p> <p>Two modern concrete stall partitions with tethering bars on either side. Thus, creating three stalls which could of housed two animals each.</p> <p>There is a corresponding tethering bar (109) on the west wall and it is assumed that there would have been a similar one on the east wall.</p>	<p>109 tethering bar 111 joist holes 113 trough 204 joist holes 206 stall partition scar 207 trough</p>	19th –20th century	Moderate–low value as evidence for the use of the space but relate to final use of building.

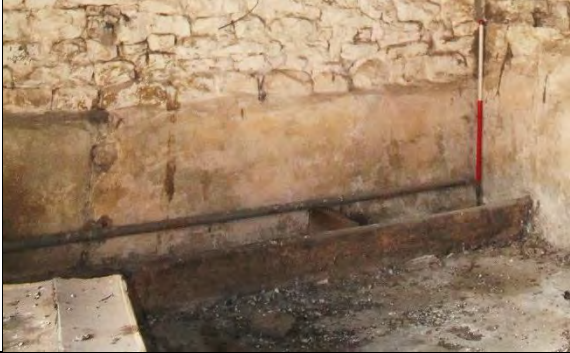
No.	Name	Description	Related Feature	Date	Significance	Photo
114	Trough	Recorded by CS Archaeology, no longer present during NAA survey. Photo by CS Archaeology 2018. Modern wooden feeding trough which spans the whole width of the southern wall.	208 trough scar	19th – 20th century	Moderate–low value as evidence for the use of the space but relate to final use of building.

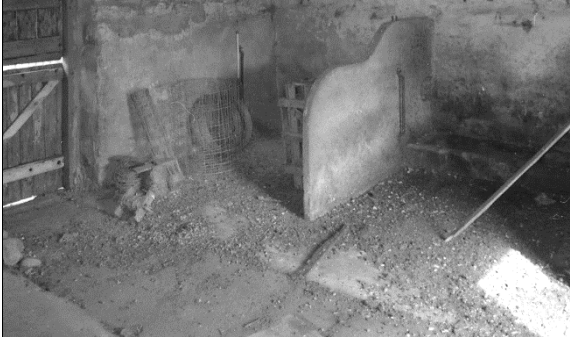
115	Manure / access passage	Recorded by CS Archaeology, no longer present during NAA survey. Photo by CS Archaeology 2018. There are two opposing doorways (101 and 102), which are centrally located within the west and east walls, suggesting a combined access and manuring passage or walkway. The floor appears to have been raised by the addition of a concrete screed and this has been used to define and demarcate the manure / access passage between the two doorways.	101 west door 102 east door 209 manure / access passage 306 manure / access passage	20th century	Moderate–low value as evidence for the use of the space but relate to final use of building.

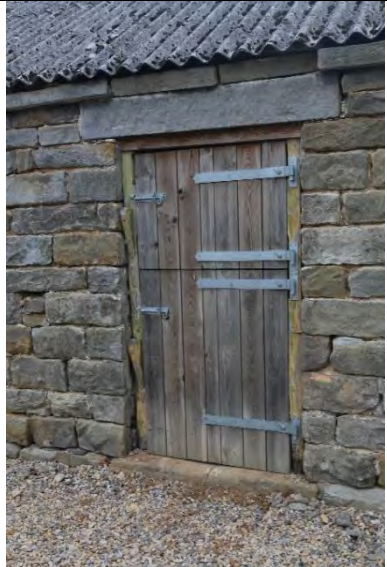
No.	Name	Description	Related Feature	Date	Significance	Photo
202	East door	This door opens onto the foldyard and has a large stone lintel and threshold stone.	101 west door 102 east door 201 west door 301 west door 302 east door 401 north loosebox door 501 south loosebox door	Early 19th century	High evidential value as an original feature of the building.

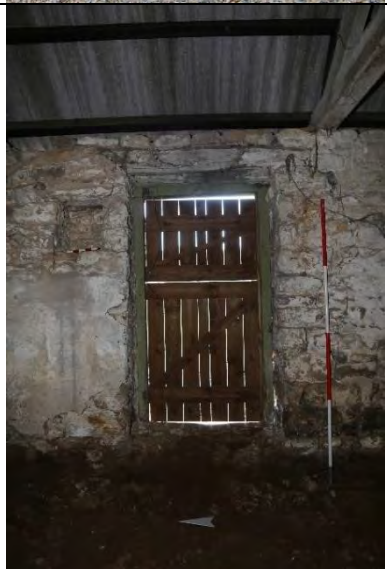
203	East niche	A square niche set to the north of door 202 used either for storage or to hold a lamp.	103 west niche 104 east niche	Early 19th century	High evidential value as part of the original fabric of the building.

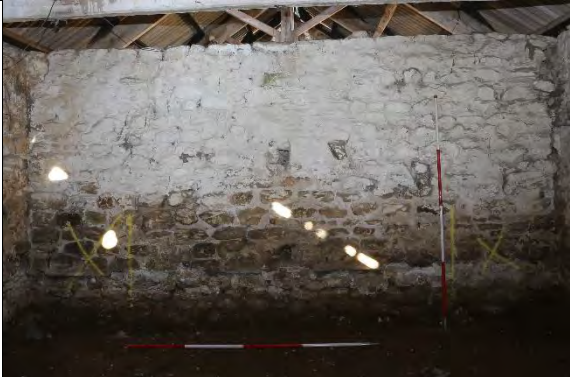
No.	Name	Description	Related Feature	Date	Significance	Photo
204	Joist holes	Two holes, one placed above the other, indicating the location of a stall partition, again for cattle. These holes are located along the north wall.	111 north byre joist holes 112 stall partitions 113 trough 206 stall partition scar 207 trough	20th century	Moderate-low evidential value as evidence of for the use of the space during the last phase of use.

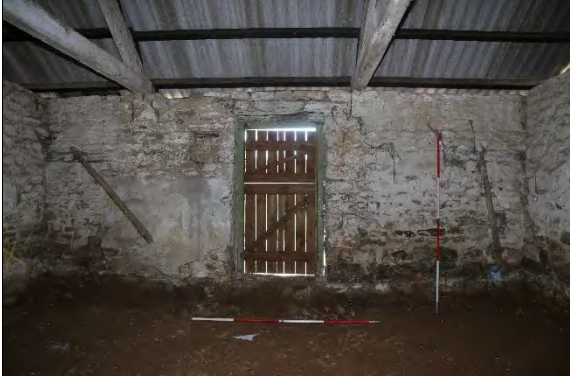
205	Timber uprights	Timber uprights associated with the structure of the feeding troughs. (Photo shows the east wall of room 200, the upright to the left has pivoted at its top end where it is attached to the wall, the upright to the right can be seen close to the vertical scale.)	109 north room tethering bar 105 horizontal timber 106 horizontal timber 107 horizontal timber 110 horizontal timbers 113 trough 114 trough 207 trough 208 trough scar	19th – 20th century	Moderate evidential value indicating location of feeding trough.

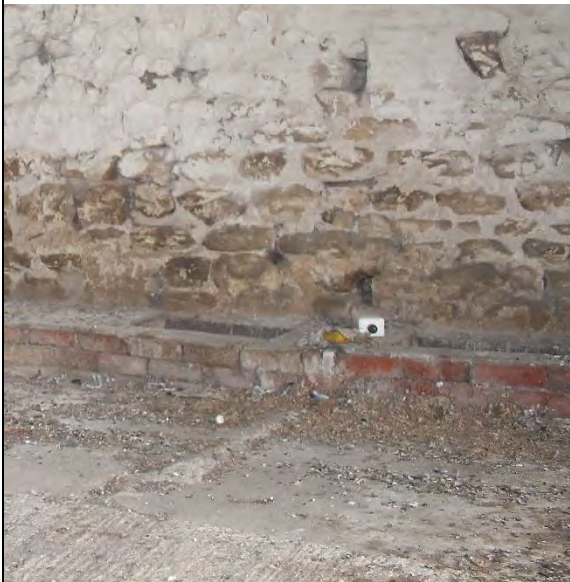
No.	Name	Description	Related Feature	Date	Significance	Photo
206	Stall partition scar	<p>Recorded by CS Archaeology, but no longer present during NAA survey</p> <p>Photo by CS Archaeology 2018.</p> <p>In line with the two joist holes (204) there is a gap between the feeding troughs (207) and a corresponding scar on the concrete floor. This indicates the location of a stall partition probably similar in design to (112).</p> <p>There would have only been two stalls in this room, accommodating two animals in each.</p>	<p>109 tethering bar</p> <p>111 joist holes</p> <p>112 stall partition</p> <p>113 trough</p> <p>204 joist holes</p> <p>207 trough</p>	19th – 20th century	Moderate–low value as evidence for the use of the space but related to the final use of building.

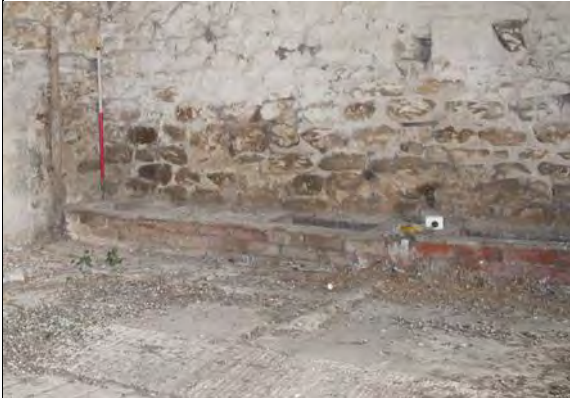
207	Trough	<p>Recorded by CS Archaeology, but no longer present during NAA survey</p> <p>Photo by CS Archaeology 2018.</p> <p>Two twin brick, concrete rendered troughs, allowing for four animals to be fed individually.</p> <p>Note the timber upright (205) at the end of the troughs to the right.</p>	<p>111 joist holes</p> <p>112 stall partitions</p> <p>113 trough</p> <p>204 joist holes</p> <p>205 timber uprights</p> <p>206 stall partition scar</p> <p>209 manure/access passage</p>	19th – 20th century	Moderate–low value as evidence for the use of the space but related to the final use of building.

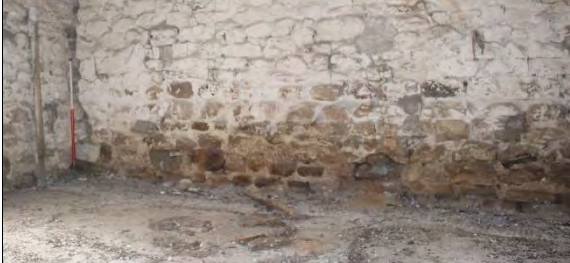
No.	Name	Description	Related Feature	Date	Significance	Photo
208	Trough scar	Recorded by CS Archaeology, but no longer present during NAA survey. Photo by CS Archaeology 2018. A scar can be seen on the floor in front of the south wall suggesting the location of an additional trough. A timber upright (205) can also be seen to the left of the photo.	114 trough	19th – 20th century	Moderate–low value as evidence for the use of the space but related to the final use of building.

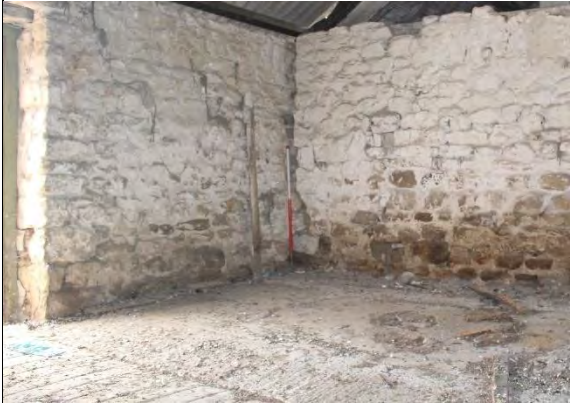
209	Manure/access passage	Recorded by CS Archaeology, no longer present during NAA survey. Photo by CS Archaeology 2018. There are two opposing doorways (201 and 202), which are centrally located within the west and east walls, suggesting a combined access and manuring passage or walkway. The floor appears to have been raised by the addition of a concrete screed and this has been used to define and demarcate the manure / access passage between the two doorways.	115 manure / access passage 201 west door 202 east door 306 manure / access passage	19th – 20th century	Moderate–low value as evidence for the use of the space but related to the final use of building.

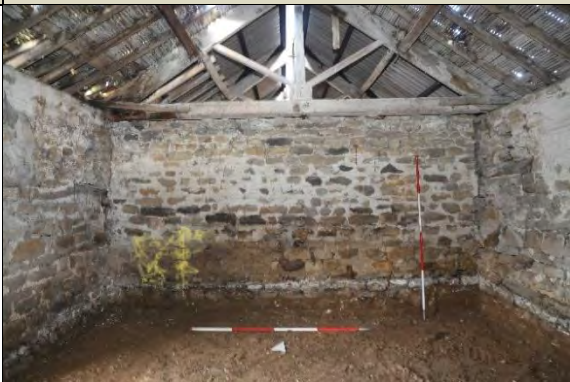
No.	Name	Description	Related Feature	Date	Significance	Photo
300	South-central room	South room - stabling. This room has been rendered with lime wash and lime plastering and still retains the original lath and plaster roof structure.	301 west door 302 east door 303 horizontal timber 304 trough remains 305 horizontal timber 310 north wall 320 east wall 330 south wall 340 west wall	Early 19th century	Moderate evidential value indicating former use.

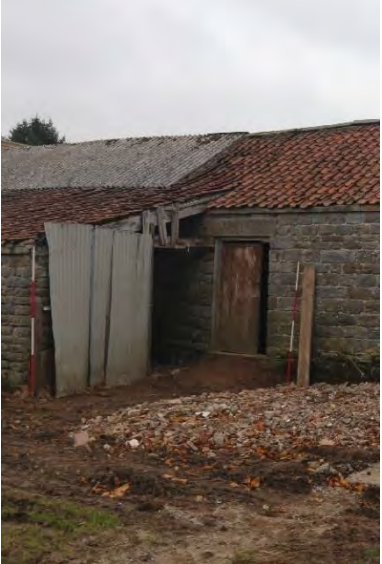
301	West door	The west door is the only other door to open directly to the fields to the west of the range. It has a large stone lintel and a single stone threshold.	101 west door 102 east door 201 west door 202 east door 302 east door 401 south loosebox door 501 north loosebox door	Early 19th century	High evidential value as an original feature of the building

6.3 The west range was used as a stable and byre during its final stage of use. Modern cattle stalls, low feeding troughs and tethering posts in the north rooms (100 and 200) indicate that this part of the building was used to house cattle, while the mid-height wooden troughs, hay racks, looseboxes and hay loft at the southern end of the building are more usually associated with horses (English Heritage 2006). The doors of the southern three rooms are also hinged to the south, while those at the northern end are hinged on the north side. Door 302 is also slightly larger, and the south side of the opening is splayed. A similar arrangement can be seen for door 301, which is splayed on the south side.

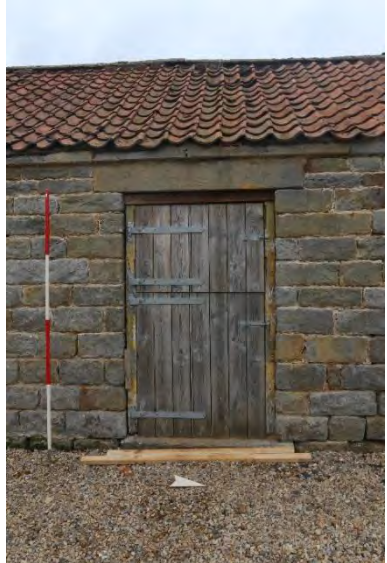
No.	Name	Description	Related Feature	Date	Significance	Photo
302	East door	The east door is wider than all other doors. It opens onto the foldyard and has a long stone lintel and threshold.	101 west door 102 east door 201 west door 202 east door 301 west door 401 north loosebox door 501 south loosebox door	Early 19th century	High evidential value as an original feature of the building.

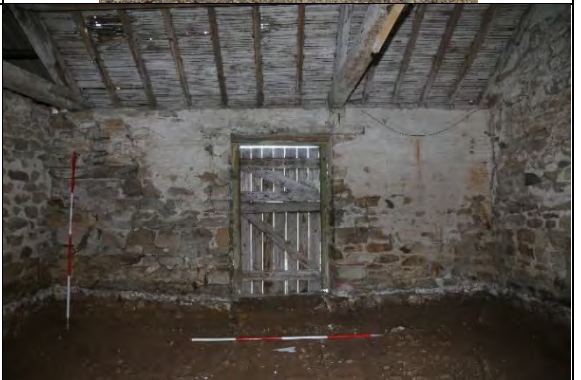
303 305	Horizontal timber	Similar to those in the north room (105, 106, and 107).	105 horizontal timber 106 horizontal timber 107 horizontal timber 110 horizontal timbers	19th century	Moderate evidential value indicating feeding trough.

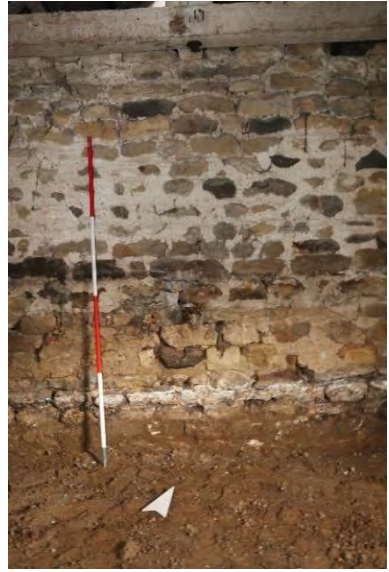
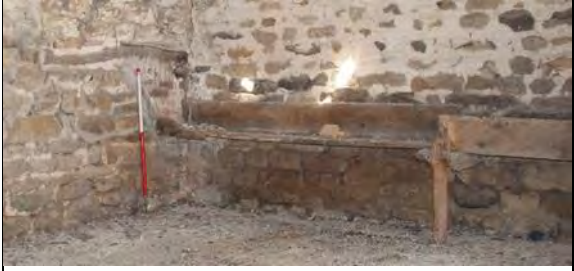
No.	Name	Description	Related Feature	Date	Significance	Photo
304	Trough remains	<p>Wooden remains of a trough set into the north wall. An upside-down, semi-trapezoid of wood is set into the north corner of both east and west walls indicating the original shape of the trough. It would have been centrally held by a wooden support set into the centre of the wall (top photo).</p> <p>Recorded by CS Archaeology, no longer present during NAA survey.</p> <p>Bottom photo by CS Archaeology 2018.</p> <p>A mid-height wooden feeding trough with a central supporting horizontal beam and leg.</p>	<p>403 trough remains 503 trough remains 2103 trough remains 2203 trough remains</p>	19th century	High-moderate evidential value as provides indication of original room function.

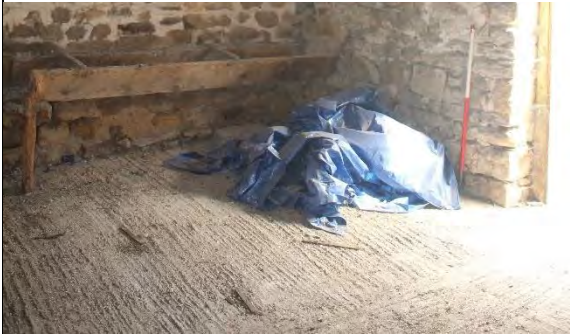
No.	Name	Description	Related Feature	Date	Significance	Photo
306	Manure / access passage	<p>Recorded by CS Archaeology, no longer present during NAA survey.</p> <p>Photo by CS Archaeology 2018.</p> <p>There are two opposing doorways (301 and 302), which are centrally located within the west and east walls, suggesting a combined access and manuring passage or walkway. The floor appears to have been raised by the addition of a concrete screed and this has been used to define and demarcate the manure / access passage between the two doorways.</p>	<p>115 manure / access passage</p> <p>209 manure / access passage</p> <p>301 west door</p> <p>302 east door</p>	19th – 20th century	Moderate–low value as evidence for the use of the space but related to the final use of building.

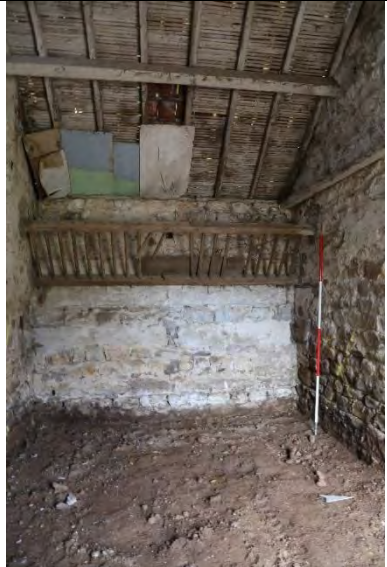
No.	Name	Description	Related Feature	Date	Significance	Photo
400	North loosebox	A narrow room accessed only from a single door onto the foldyard. It would have had two floors with a hay loft over. The hay rack and trough remains along the west wall provide proof of its use as stabling.	401 door 402 hay rack 403 trough 404 niche 405 hay loft window 406 floor beams 410 north wall 420 east wall 430 south wall 440 west wall 500 south loosebox	Early 19th century	High evidential value as it a very well-preserved example of a loosebox.

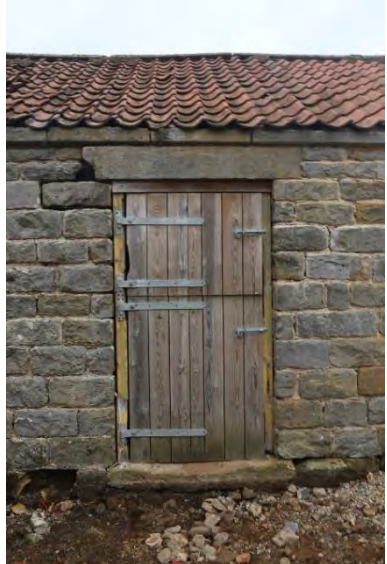
401	East door	The only access into the north loosebox, it opens onto the foldyard. It has a broken stone lintel and a large stone threshold.	101 west door 102 east door 201 west door 202 east door 301 west door 302 east door 501 south loosebox door	Early 19th century	High evidential value as an original feature of the building.

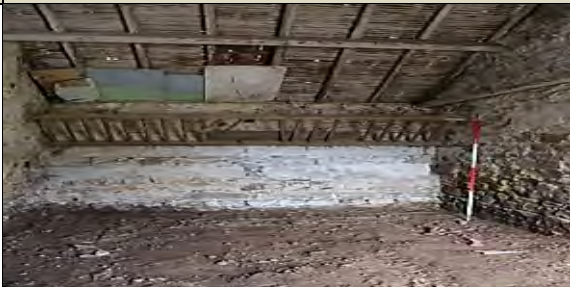
No.	Name	Description	Related Feature	Date	Significance	Photo
402	Hay rack	A large triangular wooden rack at the west end of the loosebox.	502 hay rack 601 hay rack	19th century	High-moderate evidential value as a clear indication of the use of room.

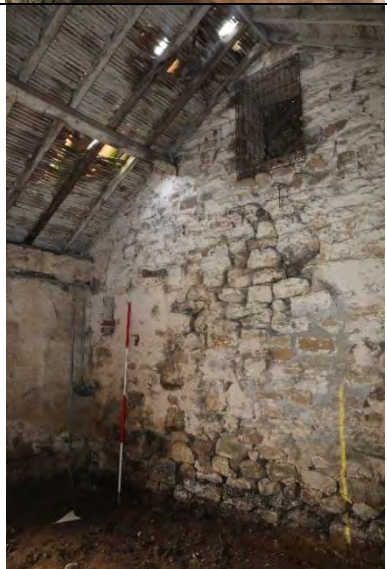
405	Hay loft window	Located on the wall at the top of the south wall, this window would have provided access between the hay lofts above both looseboxes.		Early 19th century	High evidential value as proof of the hay loft above the loosebox.

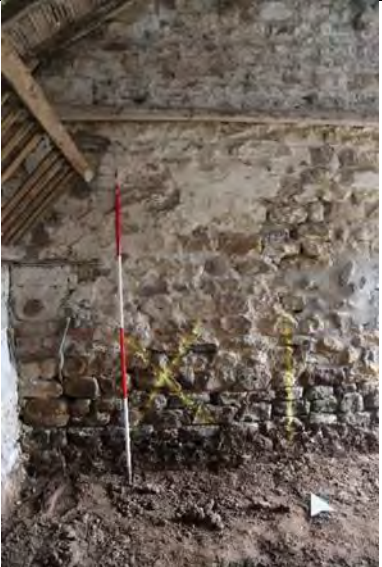
No.	Name	Description	Related Feature	Date	Significance	Photo
406	Floor support	Timber support located along the north wall used to hold the floor of the hay loft.	504 beams	Early 19th century	High-moderate evidential value as it indicates the presence of an upper floor.

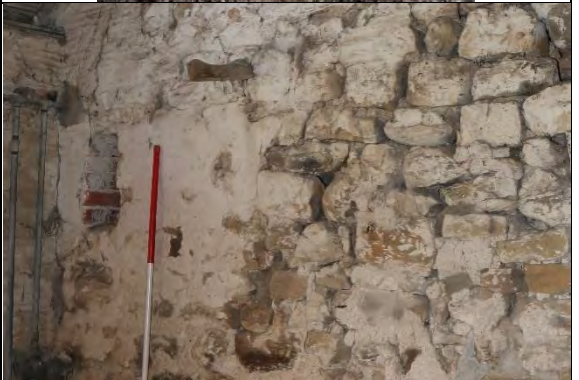
407	Floor support	Timber support projecting from the south wall used to hold the floor of the hay loft.	406 north loosebox beam	Early 19th century	High-moderate evidential value as it indicates the presence of an upper floor.

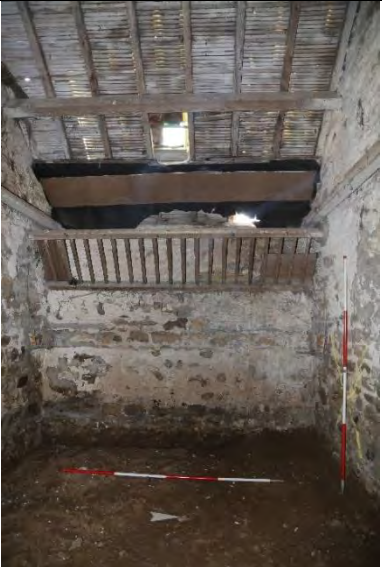
No.	Name	Description	Related Feature	Date	Significance	Photo
500	South loose box	A narrower room accessed only from a single door onto the foldyard. It would have had two floors including a hay loft. The hay rack and trough remains along the west wall.	501 south loose box door 502 hay rack 503 trough remains 504 beams 505 niche 510 north wall 520 east wall 530 south wall 540 west wall 400 north loosebox	Early 19th century	High evidential value as it a very well-preserved example of a loosebox.

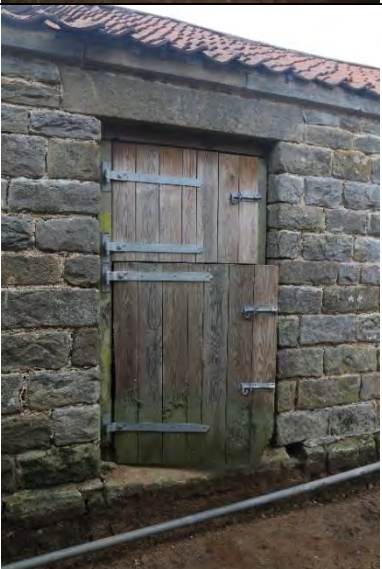
501	East door	The only access into the north loosebox, it opens onto the foldyard. It has a wide stone lintel and a large stone threshold.	101 west door 102 east door 201 west door 202 east door 301 west door 302 east door 401 north loosebox door	Early 19th century	High evidential value as an original feature of the building.

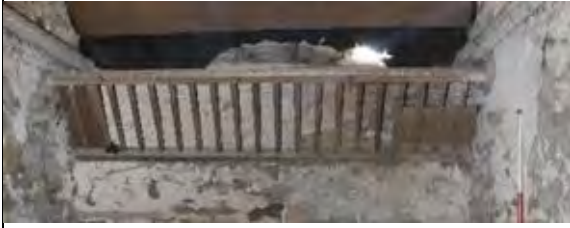
No.	Name	Description	Related Feature	Date	Significance	Photo
502	Hay rack	A large triangular wooden rack at the west end of the loosebox.	402 hay rack 601 hay rack	19th century	High-moderate evidential value.

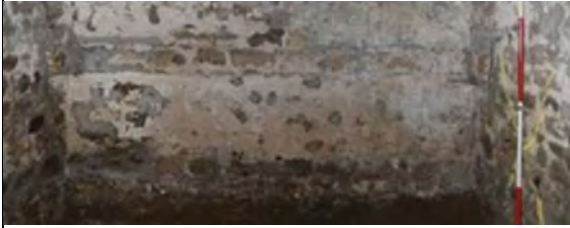
503	Trough remains	An upside-down semi-trapezoid of wood on the west corner of both the north and south wall indicating the location of the trough. There is also a scar along the west wall.	403 trough remains	19th century	High-moderate evidential value providing evidence for the use.

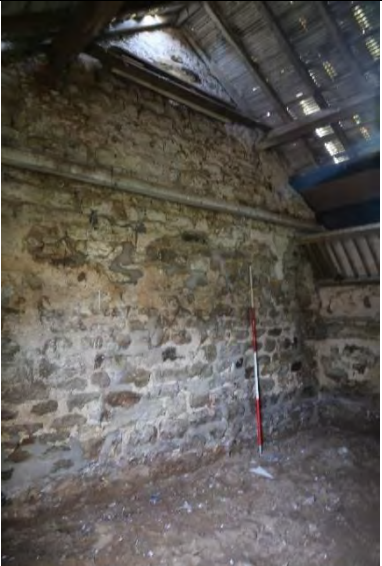
504	Beams	Projecting tie-beam located along the north and south wall used to hold the floor of the hay loft.	406 north loosebox beams	Early 19th century	High-moderate evidential value as it indicates the presence of an upper floor.

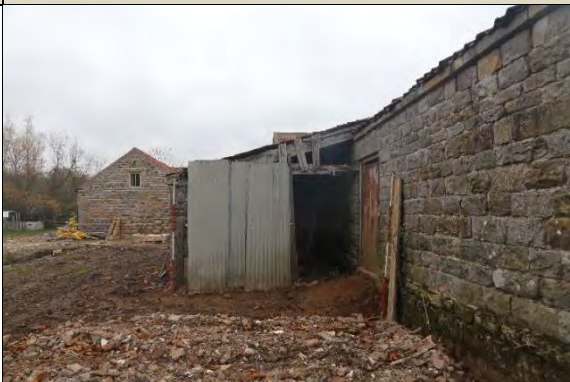
No.	Name	Description	Related Feature	Date	Significance	Photo
600	Outshot	A small outshot on the west side of the west range. Later addition, first shown on 1893 OS.	201 door 601 hay rack 602 truss 610 north wall 620 east wall 630 south wall 640 west wall	Late 19th century	High-moderate evidential value as late Victorian modification.

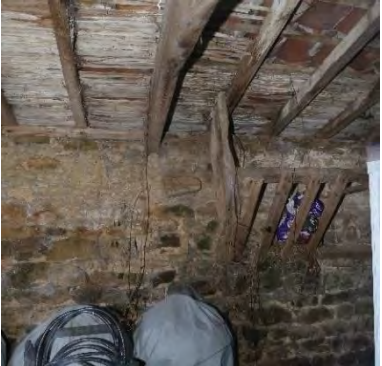
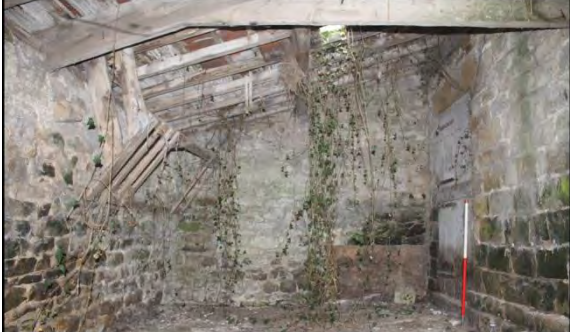
601	Hay rack	A partially dismantled hay rack located in the north-west corner of the outshot. It is tied into the wall and also hangs from the roof rafters. The hay rack was obscured during the NAA survey. Bottom photo by CS Archaeology 2018.	402 hay rack 502 hay rack	Late 19th century	High evidential value as indicates outshot was used for stabling.

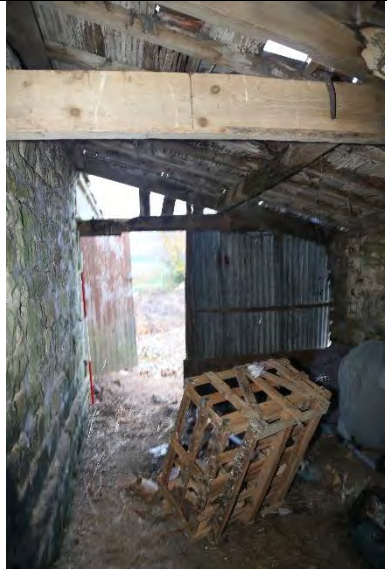
No.	Name	Description	Related Feature	Date	Significance	Photo
602	Tie beam truss	A half truss that supports the catslide roof of the outshot.		Late 19th century	High-moderate value as part of the original fabric.

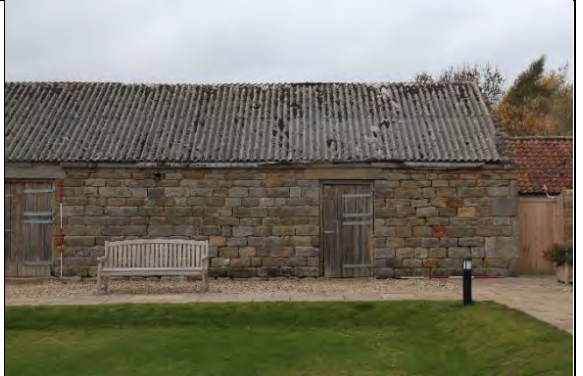
1010	East elevation	Front elevation of the west range facing onto the foldyard with primary access to all rooms of the range through five separate doors.	1011 blocked holes 1012 wooden remains 1013 ventilation slits	Early 19th century	High evidential value as primary access from foldyard and to looseboxes. Some aesthetic value.

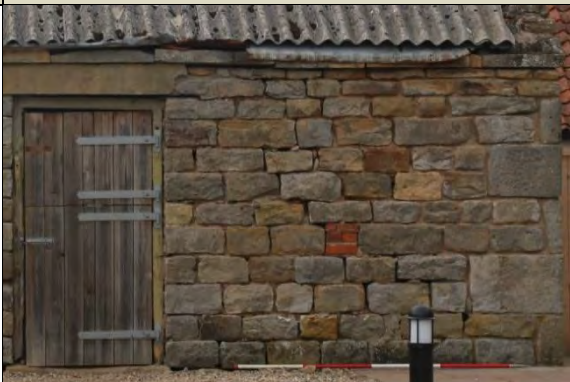
No.	Name	Description	Related Feature	Date	Significance	Photo
1011	Blocked holes	Square holes along the east elevation blocked either by stone or brick. Their use is unknown.		Early 19th century, later blocked	Moderate evidential value as indicative of specific use or structure at north end of building—exact function unknown.

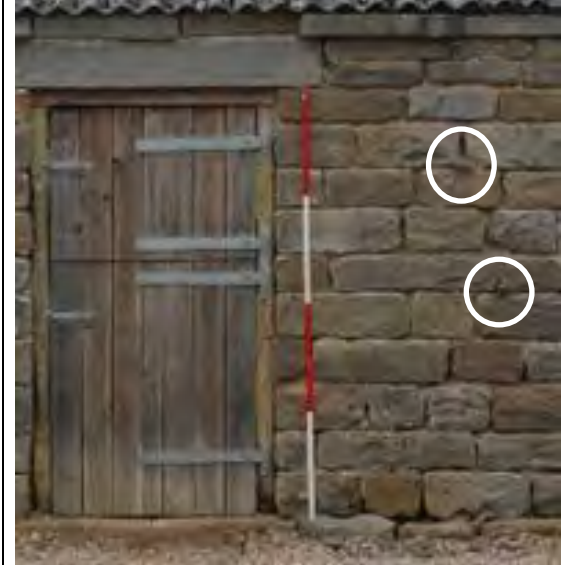
1012	Wooden fragments	Several wooden fragments protrude from the wall at various places along the elevation. Two examples are highlighted on the photo.	2302 wooden post 2303 wooden remains	19th century	Moderate evidential value although function is unclear.

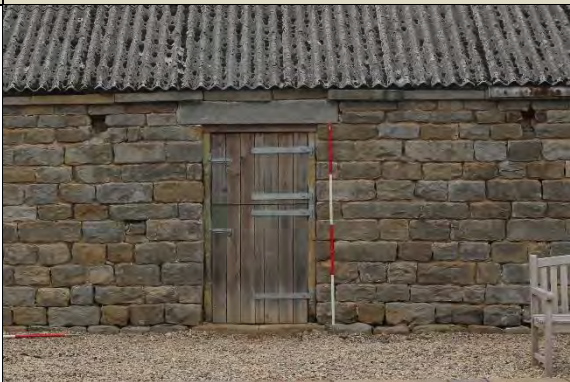
No.	Name	Description	Related Feature	Date	Significance	Photo
1013	Ventilation holes	On either side of door 302, two narrow ventilation niches flank the door. Could be putlogs for an external structure.		19th century	Moderate-low evidential value. Exact function is unknown but related to specific function at north end of building.

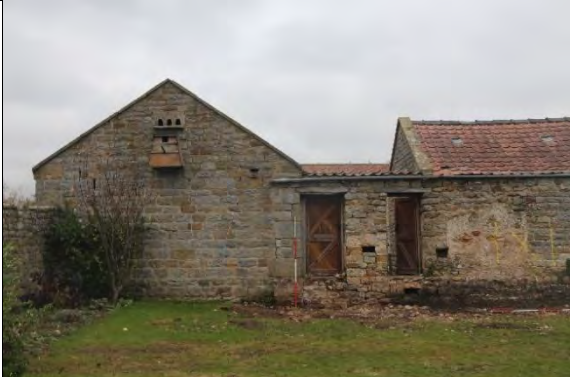
1200	South elevation	The wall is of plain stone with larger quoins. A dovecot is located near the top of the gable.	1201 dovecot 506 south loose box opening	Early 19th century	High evidential and moderate aesthetic value.

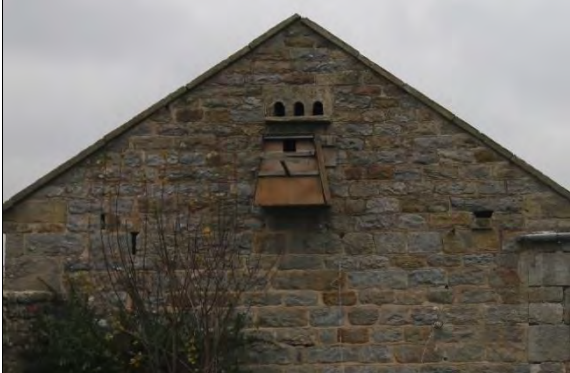
1201	Dovecot	The dovecot is composed of a single stone with three small arches over a stone ledge. Below it is placed a modern nesting box.	506 south loosebox opening	Early 19th century	High evidential and aesthetic value indicating the keeping of doves or pigeons.

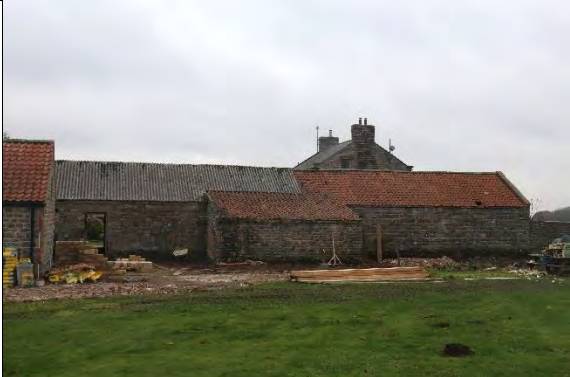
No.	Name	Description	Related Feature	Date	Significance	Photo
1300	West elevation	The west elevation includes two doors, one from 100 and another from 300. In the centre of the elevation is an outshot (600). Save the doors (101 and 301) the west elevation has few archaeological features.	101 west door 301 west door 600 outshot	Early 19th century	High evidential value as part of the original fabric.

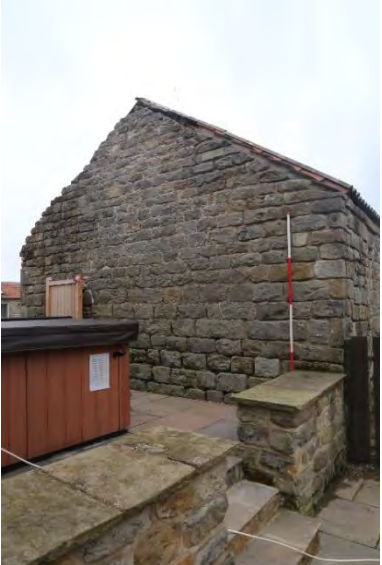
1400	North elevation	A plain elevation with no archaeologically significant features. The absence of defined quoins indicates that the gable was partially rebuilt.		Early 19th century	Moderate evidential value of change over time.

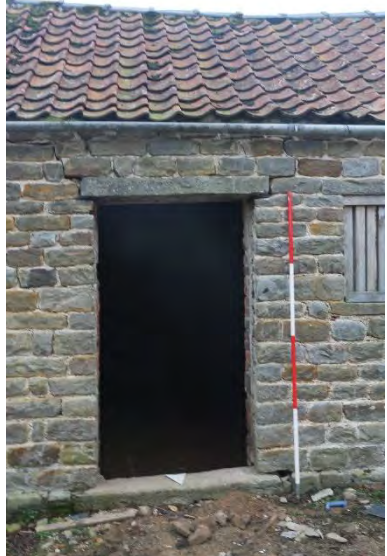
No.	Name	Description	Related Feature	Date	Significance	Photo
2101	West door	Door with a stone lintel and stone threshold. The interior lintel is of wood. The doorway currently has no frame or door.	2201 east door	Early 20th century	High evidential value as evidence of the original fabric of the building.

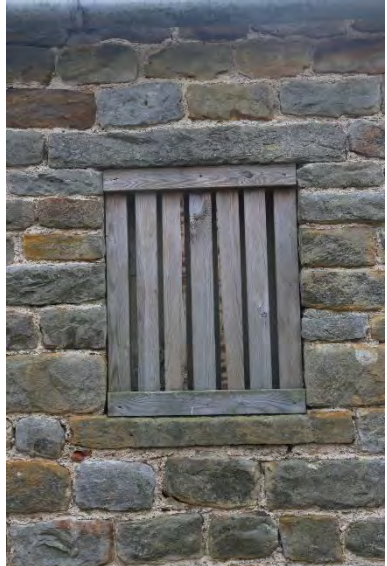
2102	West louvre window	A wooden louvre composed of seven vertical slats held by two horizontal slats on either end. This louvre is boarded up on the inside.	2202 east louvre window	Early 20th century	Moderate evidential value as evidence of the original use of the building for horses.

6.5 The south range also appear to have also been built as a stable. Whilst hay racks can be found in cattle housing (English Heritage 2006), the existence of louvred windows (2102 and 2202) and mid-height feeding troughs suggests the range was constructed for horses. Little survives of the former adjoining building to the east, but the surviving brick

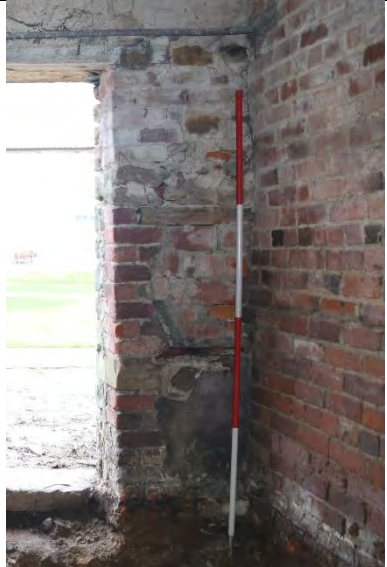
No.	Name	Description	Related Feature	Date	Significance	Photo
2103	Trough remains	An upside-down semi-trapezoid of wood fit into the bricks in the walls. It would have spanned the whole length of the wall with the help of a wooden support extending from the centre of the wall. A scar can be seen running along the length of the wall.	304 trough remains 403 trough remains 503 trough remains 2203 trough remains	Early 20th century	Moderate evidential value as evidence of use of the building.

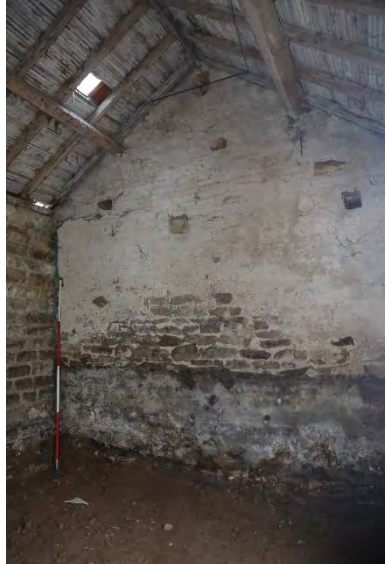
2104	Swallow holes	Small holes in the walls for birds.		Early 20th century	Moderate evidential value as it is not associated with historic use or phasing of building.

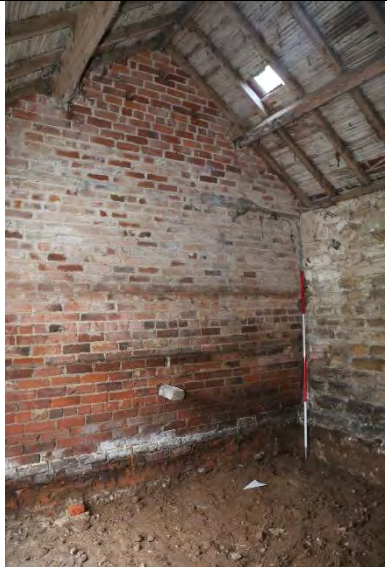
No.	Name	Description	Related Feature	Date	Significance	Photo
2105	Wall scar associated with hay rack	Two wall scars can be seen. The top one is associated with a hay rack.	2204 hay rack wall scar	Early 20th century	Moderate evidential value as provides evidence for the presence of a hay rack.

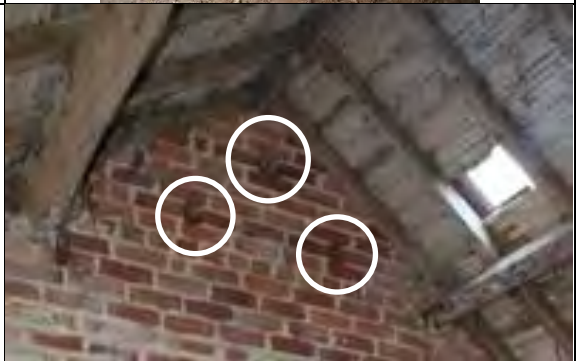
2106	Ventilation holes	Three square ventilation holes at the apex of the gable of the dividing wall to facilitate airflow.		Early 20th century	Moderate evidential value

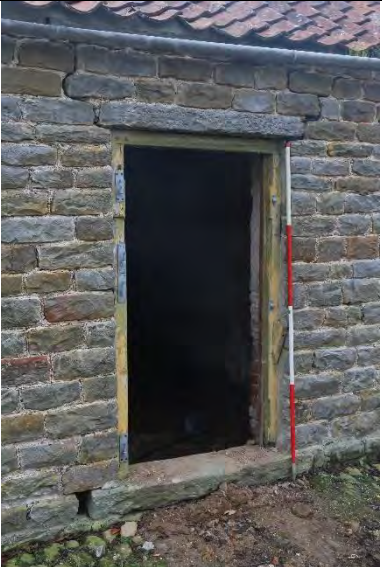
No.	Name	Description	Related Feature	Date	Significance	Photo
2201	East door	Door with a stone lintel and stone threshold. The interior lintel is of wood. The doorway currently has a wooden frame but no door.	2101 west door	Early 20th century	High evidential value as evidence of the original fabric of the building.

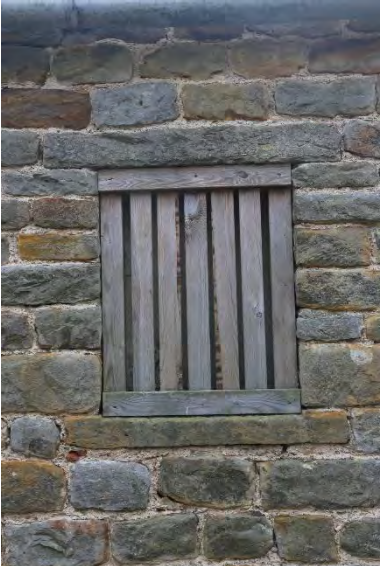
2202	East louvre window	A wooden louvre composed of seven vertical slats held by two horizontal slats on either end.	2202 east louvre window	Early 20th century	Moderate evidential value as evidence of the original use of the building for horses.

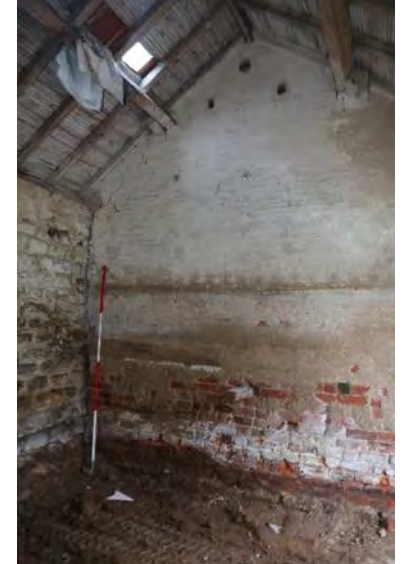
2204	Hay rack wall scar	Two wall scars can be seen. The top one is associated with a hay rack.	2105 hay rack scar	Early 20th century	Moderate evidential value as provides evidence for the presence of a hay rack.

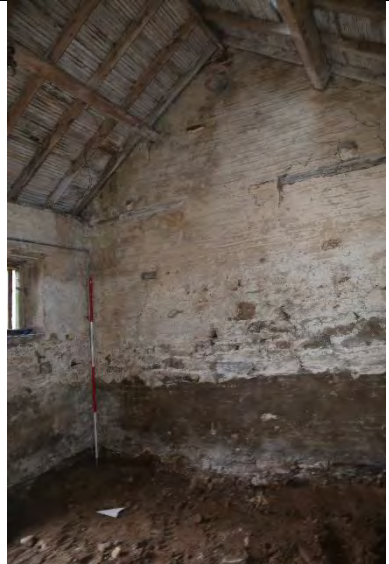
No.	Name	Description	Related Feature	Date	Significance	Photo
2205	Horizontal timbers	Horizontal timbers within the east wall of room aligned with the top of the north and south walls. Extending into the east wall.	2107 horizontal timbers	Early 20th century	Moderate evidential value as part of the original fabric of the building.

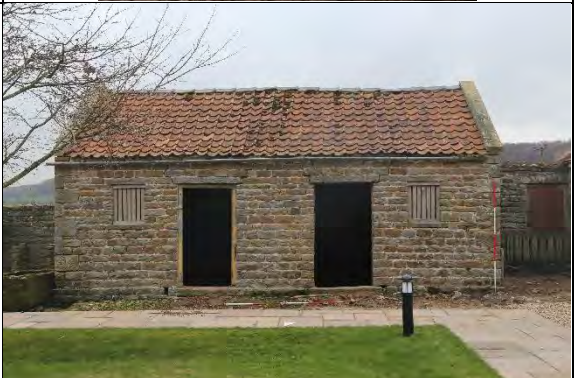
2300	North elevation	The front of the building overlooks the central foldyard Two doors (2101 and 2201) and two louvre windows (2102 and 2202).	2101 west door 2102 west louvre window 2201 east door 2202 east louvre window 2301 cobbles 2302 post	Early 20th century	High evidential and aesthetic value as the front, and original, façade of the building.

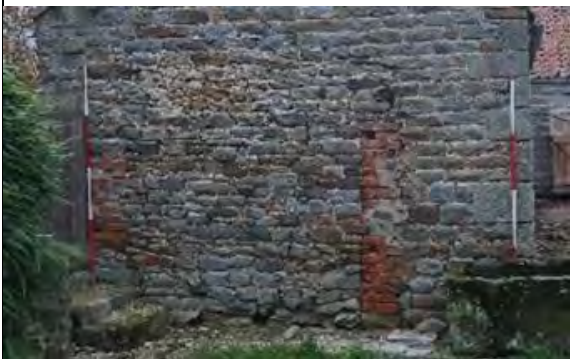
2403	Rubble infill	The rubble infill highlights an inclined roof scar.	2400 west elevation 2401 wall scars	Late 20th century	High evidential value associated with former layout of the south range.

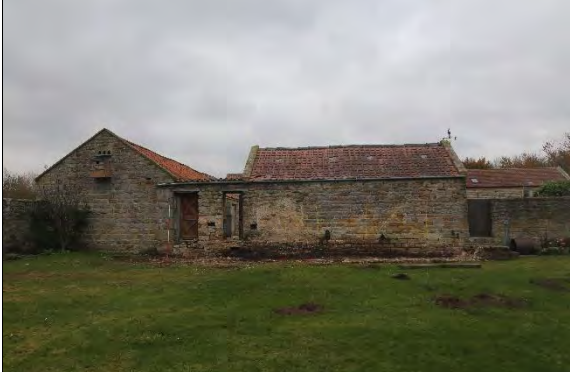
2500	South elevation	The south elevation would originally have formed the north wall of the greenhouse (2700). Most of the features on this wall are therefore discussed as part of the greenhouse remains (see below).	2501 roof lights	Early 20th century	High evidential as part of the original building and in relation to the now demolished 'greenhouse' range.

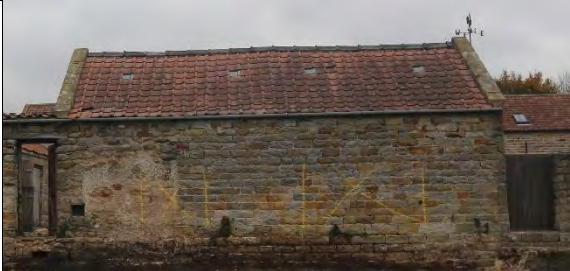
No.	Name	Description	Related Feature	Date	Significance	Photo
2501	Roof lights	Four small roof lights across the roof of the south elevation. Provide some of the only lighting in the building.		Early 20th century	Moderate: appear to part of the original design.

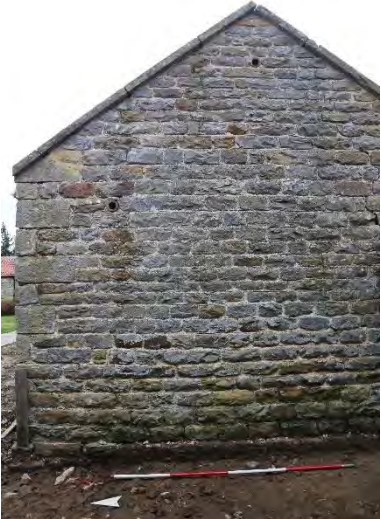
2600	West elevation	A plain coursed stone wall with quoins on the north side. Two vents, one at the top of the gable and one on the north side, provide airflow into the building.	2601 ventilation holes	Early 20th century	Moderate-low evidential value as part of the original fabric of the building.

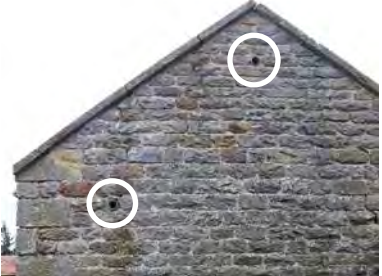
2601	Ventilation holes	There are two ventilation holes which can be clearly seen in the western gable wall.	2402 ventilation holes	Early 20th century	Moderate-low evidential value as part of the original fabric of the building.

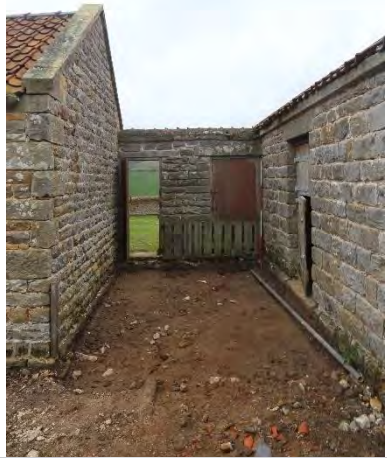
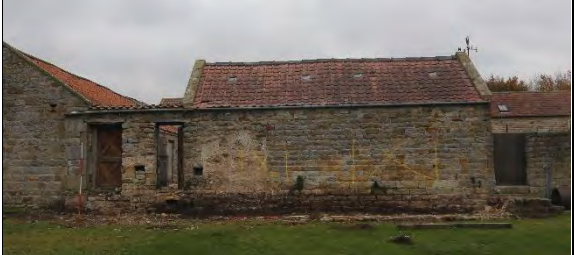
No.	Name	Description	Related Feature	Date	Significance	Photo
2700	Greenhouse remains	To the rear of the south elevation are the footings of a building that abutted the south range. The only standing wall of this building is its north elevation which connects the south and west ranges and has two doors and the remains of a pantile roof. Google Earth imagery shows a glass roof structure in this location by the late 20th century. A wall scar on the south elevation indicates that it may have originally been shorter.	2701 east door 2702 west door 2703 niches 2704 footings 2705 ventilation hole	Late 19th – Early 20th century	High evidential value as an indication of the location of the former linear range shown to the south of the existing south range on historic OS maps.

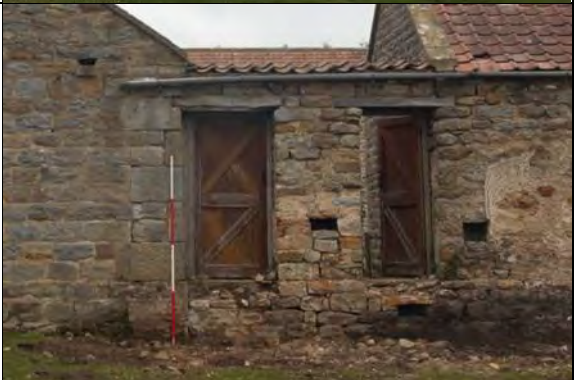
2701 2702	Doors	Two doors within the remaining wall of the greenhouse. The west door is the wider of the two with a thicker stone lintel. The east door has a thinner stone lintel and opens onto what is now the field to the south of the farm.	2703 niches 2704 footings 2705 ventilation hole	19th or Early 20th century	High evidential value as the only standing remains of the greenhouse.

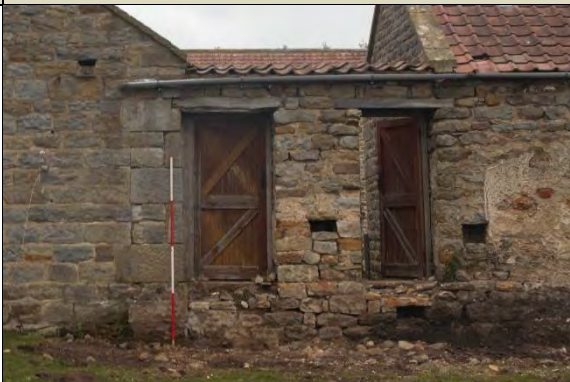
No.	Name	Description	Related Feature	Date	Significance	Photo
2703	Niches	Two niches built on either side of the east door. The west niche is partially blocked. These niches were probably used as storage.	2701 east door 2702 west door 2704 footings 2705 ventilation hole	19th or Early 20th century	Moderate evidential value as part of the original building fabric and the only remains of the demolished linear range (greenhouse).

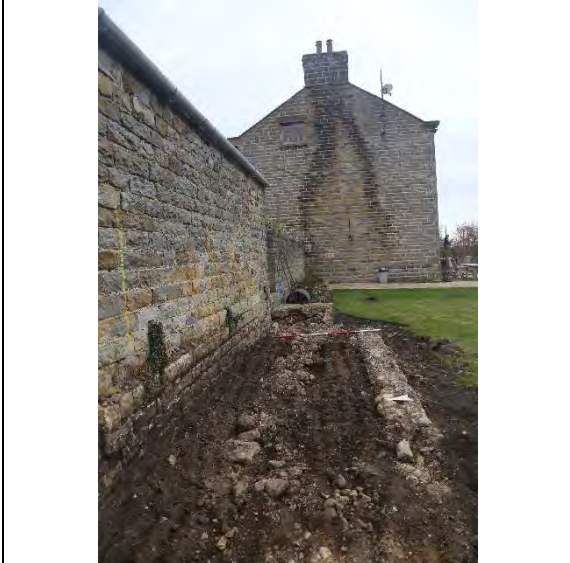
2704	Footings	The footings of the greenhouse extend along the whole length of the south elevation of the south range. The walls are approximately 50cm thick. The building was approximately 2m wide.	2701 east door 2702 west door 2703 niches 2705 ventilation hole	19th or Early 20th century	Moderate evidential value as indicative of the dimensions of the demolished range.
