6.0 PHASING AND DISCUSSION

West range elevations and cross-section

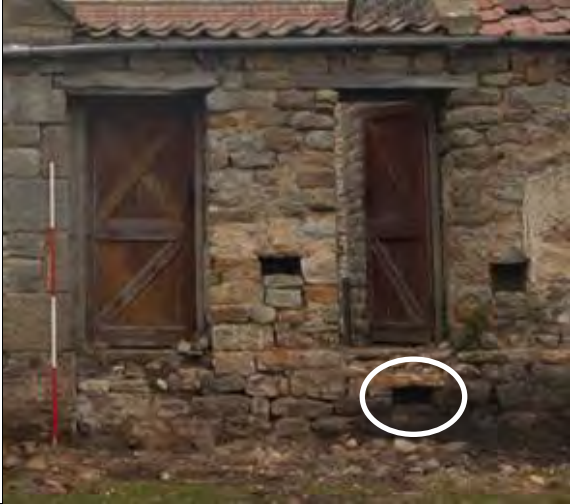
No.	Name	Description	Related Feature	Date	Significance	Photo
2705	Ventilation hole	Below the east door is a rectangular hole. It would probably have been beneath the floor level. This may have been used to provide ventilation or later heating to the greenhouse.	2701 east door 2702 west door 2703 niches 2704 footings	19th or Early 20th century	Moderate evidential value as an indication of the use and structure of the building.

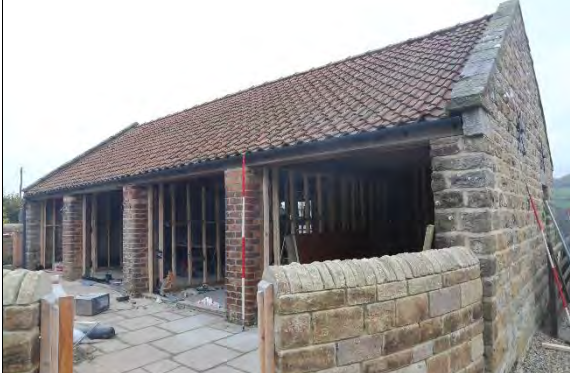
3000	Cart shed	A four-bay structure the interior was devoid of any features at the time or survey except for the roof trusses. The building is mostly of stone with three brick piers on the north elevation.	3101 tie-beam trusses 3102 ties-rods 3200 north elevation 3300 east elevation 3400 west elevation 3500 south elevation	Late 19th - Early 20th century	High evidential value as a later farmstead development.

- 6.8 The cart shed is a single-phase building constructed between 1893 and 1912. It is typical of many cart sheds of this period. It was the second to be built at Thirley Cotes, the first being located at the east end of the main barn. A third shed was built at the same time at the west end of the barn range. The bullnose brick on the corners of the cart shed piers were intended to reduce the risk of damage when machinery in and out of the building. Pedestrian access to the shed was via the door on the west elevation (3502).

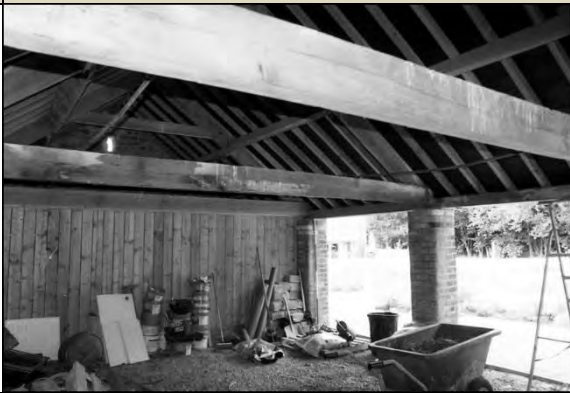
No.	Name	Description	Related Feature	Date	Significance	Photo
3101	Tie-beam trusses	Three tie-beam trusses with upper collars. Photo by CS Archaeology 2018.	3102 tie-rods	Late 19th - Early 20th century	High evidential value as part of the original fabric of the building.

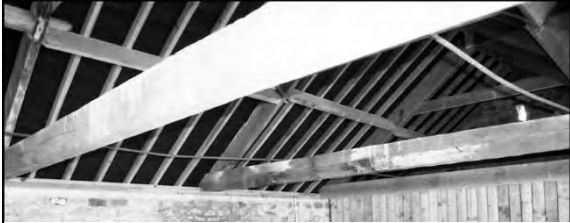
3102	Tie-rods	Two tie-rods run through the building from gable to gable just above the level of the wooden roof tie-beams. Photo by CS Archaeology 2018.	3303 Cross-shaped anchor plates	Late 19th - Early 20th century	High evidential value as part of the original fabric of the building.

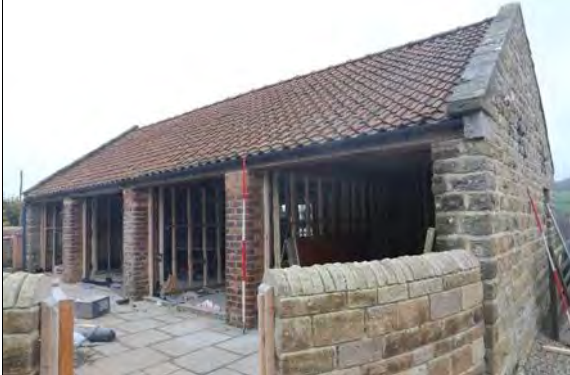
3200	North elevation	The north elevation is the front of the building. It has four bays, each separated by a square bullnose brick pier.	3201 brick piers	Late 19th - Early 20th century	High evidential value as the front elevation and main access to the building. Some aesthetic value.

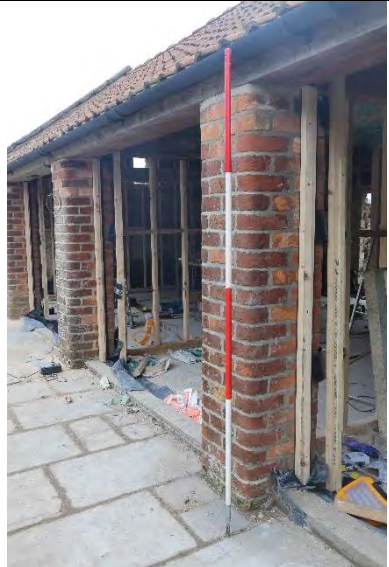
No.	Name	Description	Related Feature	Date	Significance	Photo
3201	Brick piers	Three bullnose brick piers. The corners of the piers were rounded so as not to scratch machinery coming in and out of the building.		Late 19th - Early 20th century	High evidential value as the main distinguishing feature of the north elevation.

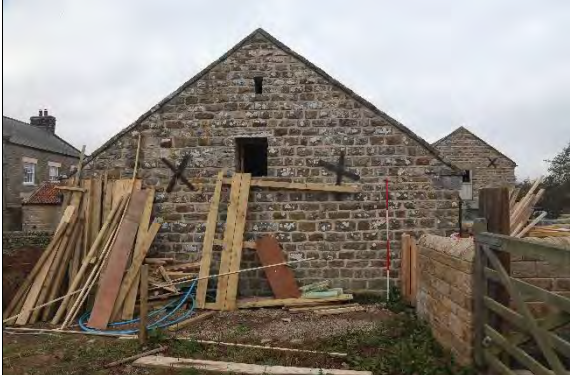
3300	East elevation	The east elevation consists of a square window (3301) and a rectangular owl hole (3302). The wall is of roughly cut and regularly coursed stone.	3102 tie-rods 3301 window 3302 owl hole 3303 cross-shaped anchor-plates 3503 cross-shaped anchor-plates	Late 19th - Early 20th century	High evidential value as part of the original fabric of the building.

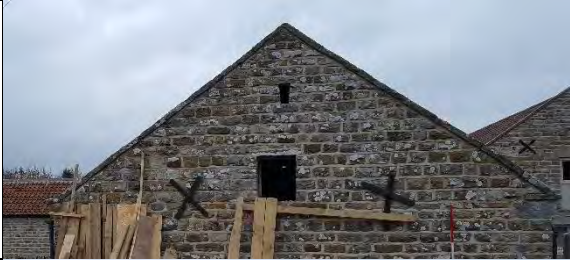
No.	Name	Description	Related Feature	Date	Significance	Photo
3301	Window	The east end gable features a single window centrally located.	3302 owl hole 3303 cross-shaped anchor-plates	Late 19th - Early 20th century	High evidential value as part of the original fabric of the building.

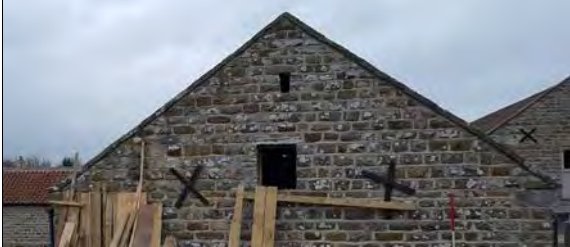
3302	Owl hole	Above the window (3301), and below the apex of the gable there is a narrow owl hole or ventilation slit.	3301 window 3303 cross-shaped anchor-plates	Late 19th - Early 20th century	High evidential value as part of the original fabric of the building.

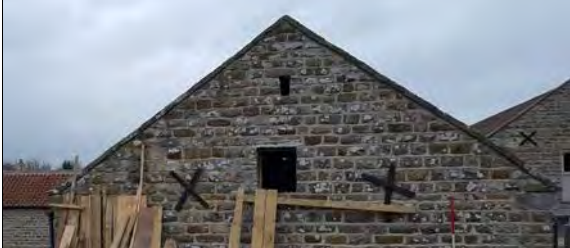
3303	Cross-shaped anchor-plates	There are two cross-shaped anchor-plates located either side of the window and at the height of the base of the window. These secure either end of two metal tie-rods (3102).	3301 window 3302 owl hole 3503 cross-shaped anchor-plates	Late 19th - Early 20th century	High evidential value as part of the original fabric of the building.

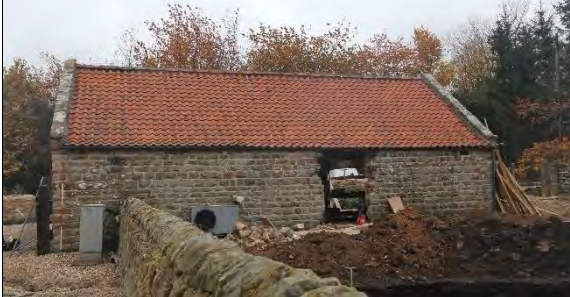
3400	South elevation	The south elevation is of regular coursed sandstone with no archaeological features of note. At the time of survey there was a modern opening (3401).	3401 modern intervention	Late 19th - Early 20th century	High evidential value as part of the original fabric of the building.

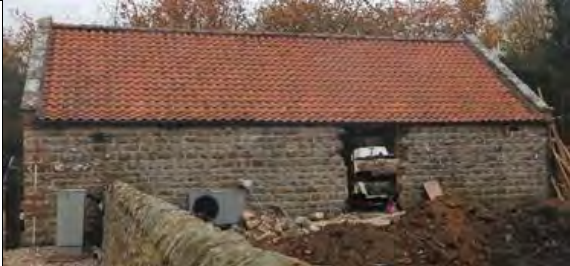
No.	Name	Description	Related Feature	Date	Significance	Photo
3401	Modern intervention	At the time of survey an opening measuring approximately 1.20m wide, had been inserted without planning permission at the eastern end of the building. This will be restored to an approved standard.	3400 south elevation	Modern	Of no significance as it is a modern intervention.

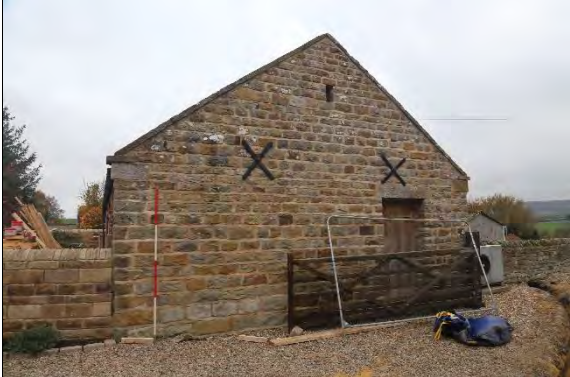
3500	West elevation	As 3300. Contains a rectangular owl hole (3502) at the top of the gable with a door (3501) on the south end of the elevation. The door has a stone lintel.	3102 tie-rods 3303 cross-shaped anchor-plates 3501 door 3502 owl hole 3503 cross-shaped anchor-plates	Late 19th - Early 20th century	High evidential value as part of the original fabric of the building.

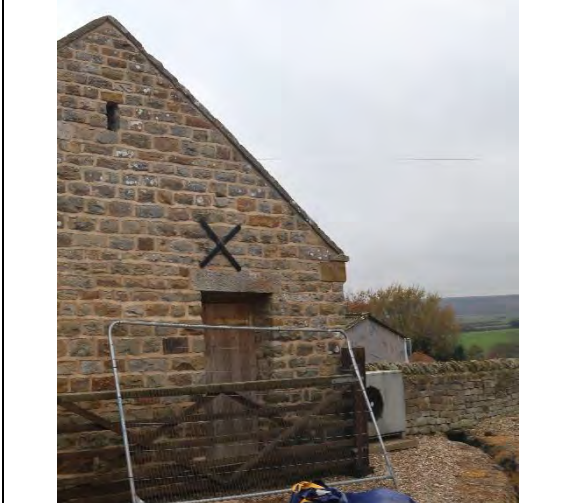
3501	Door	Door to the south providing access into the interior, set with a thick stone lintel.	3502 owl hole 3503 cross-shaped anchor-plates	Late 19th - early 20th century	High evidential value as part of the original fabric of the building.

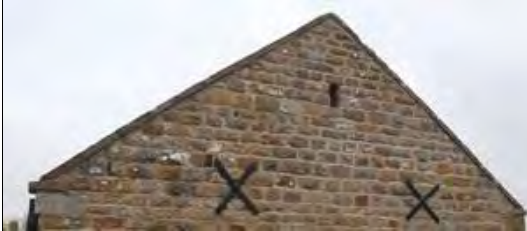
No.	Name	Description	Related Feature	Date	Significance	Photo
3502	Owl hole	The location of the owl hole mirrors that of the east gable. It is centrally positioned below the apex of the gable.	3501 door 3503 cross-shaped anchor-plates	Late 19th - Early 20th century	High evidential value as part of the original fabric of the building

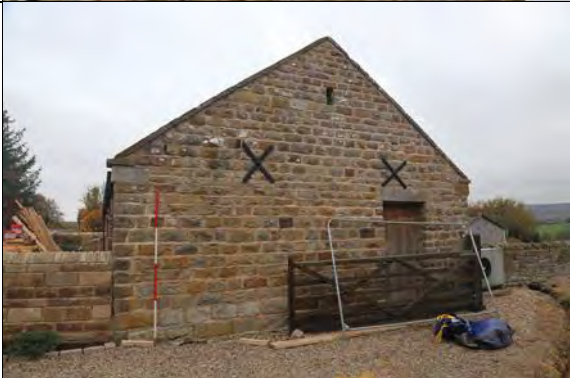
3503	Cross-shaped anchor-plates	There are two cross-shaped anchor-plates, mirroring the location of the anchor-plates (3303) on the east elevation. These secure either end of two metal tie-rods (3102).	3102 tie-rods 3303 cross-shaped anchor-plates 3501 door 3502 owl hole	Late 19th - Early 20th century	High evidential value as part of the original fabric of the building.
