# NYMNPA

## PLANNING ISSUE

## Initial Drawings for Client and Planning consideration only

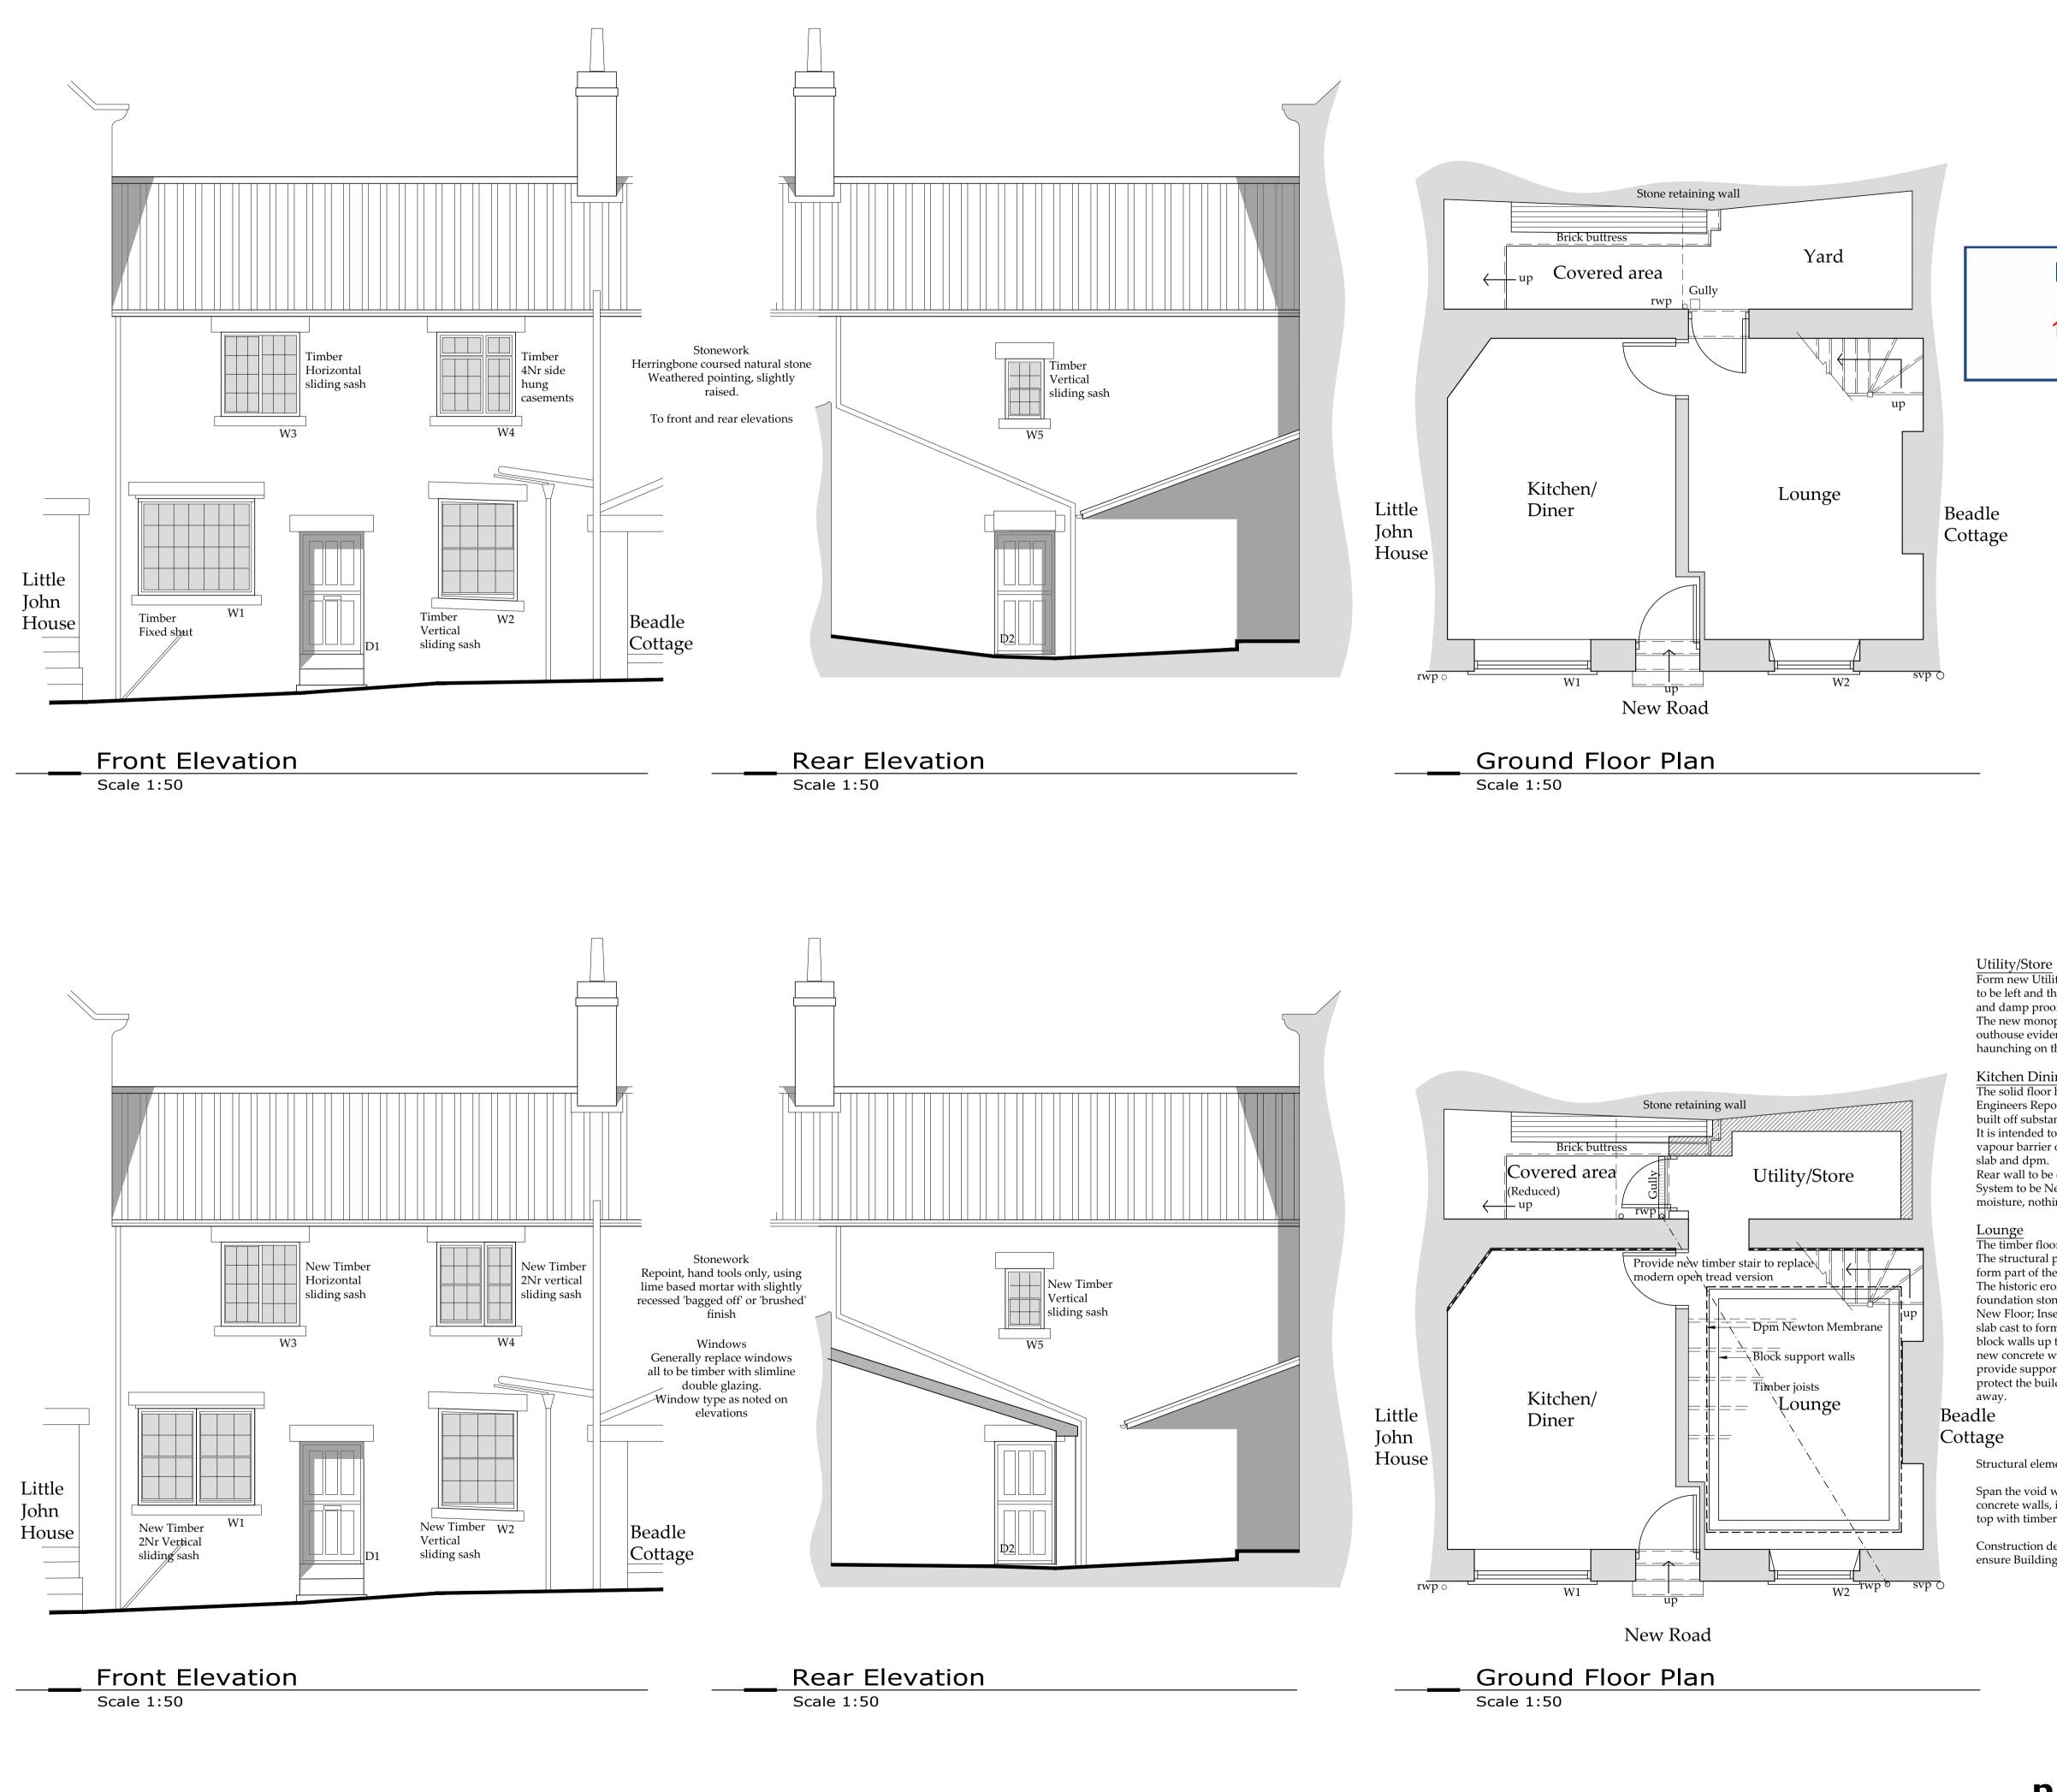
- Form new Utility/Store Room within the rear Yard. Existing walls to be left and the room is to be formed using an inner insulated and damp proofed skin.
- The new monopitched roof is to follow the line of a former outhouse evidence of which is provided by the remains of cement haunching on the stone wall.

- Kitchen Dining Room The solid floor has been removed due to serious defects-See Engineers Report. It appeared to have been a modern replacement built off substandard fill.
- It is intended to provide a new floor. Floating timber boards, vapour barrier onto Flooring grade insulation onto concrete floor
- Rear wall to be drylined with dpm behind lapped into floor dpm. System to be Newton Membrane allowing perculation on moisture, nothing applied to the wall.

- Lounge The timber floor has been removed leaving a large sub floor void. The structural problems are noted on the Engineers reports which form part of the application. Photographs will also be provided. The historic erosion has left areas where the original wall

- foundation stones are left exposed. New Floor; Inset from the existing walls provide a foundation slab cast to form a structural base. From this construct concrete block walls up to the underside of floor level, backfill between the new concrete walls and the lower levels of the house walls to provide support, include a newton membrane dpm as above to protect the building from damp but allow it to naturally percolate

- Structural elements must be to a structural engineers design.
- Span the void with a timber joist floor supported on the new concrete walls, infill between joists with insulation and line the top with timber floor boarding.
