From:**Sent:** 02 December 2021 14:10**To:** Kelsey Blain**Cc:****Subject:** Your ref NYM/2021 / 0862/ CLLB

- Cross Sectional details of the windows are attached as requested.
- Because the application is for “ like-for-like ” replacement windows then the existing and proposed cross sectional details are the same and for this reason only one drawing is provided which applies .

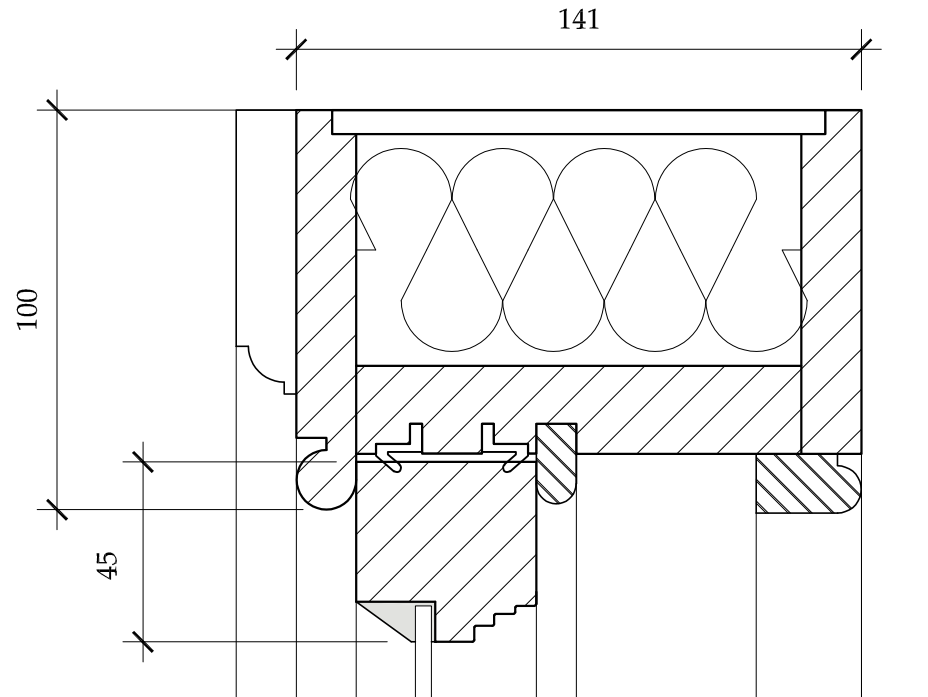
Head

Cross-Sectional detail

- Single glazed windows using 4mm float glass and putty pointed externally using traditional linseed oil putty

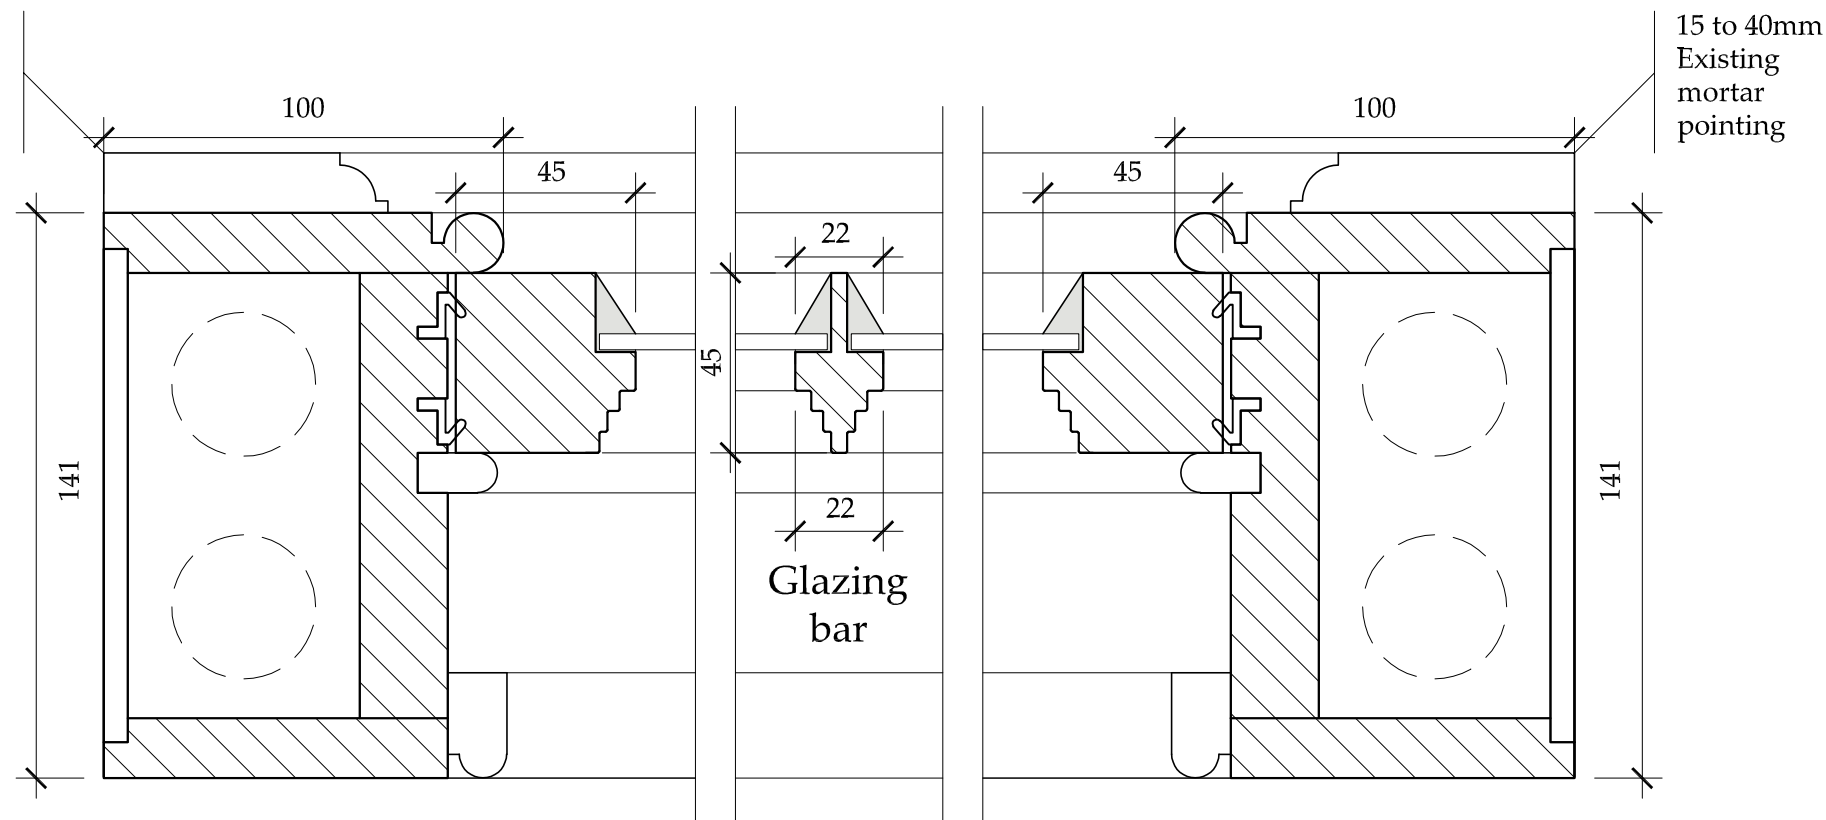
Plan detail

○ Vertical sliding sash window
Scale 1:2
