PROJECT
PROPOSED REPAIRS AND WORKS TO OUTBUILDING AT HILDA COTTAGE SHELL HILL, ROBIN HOODS BAY

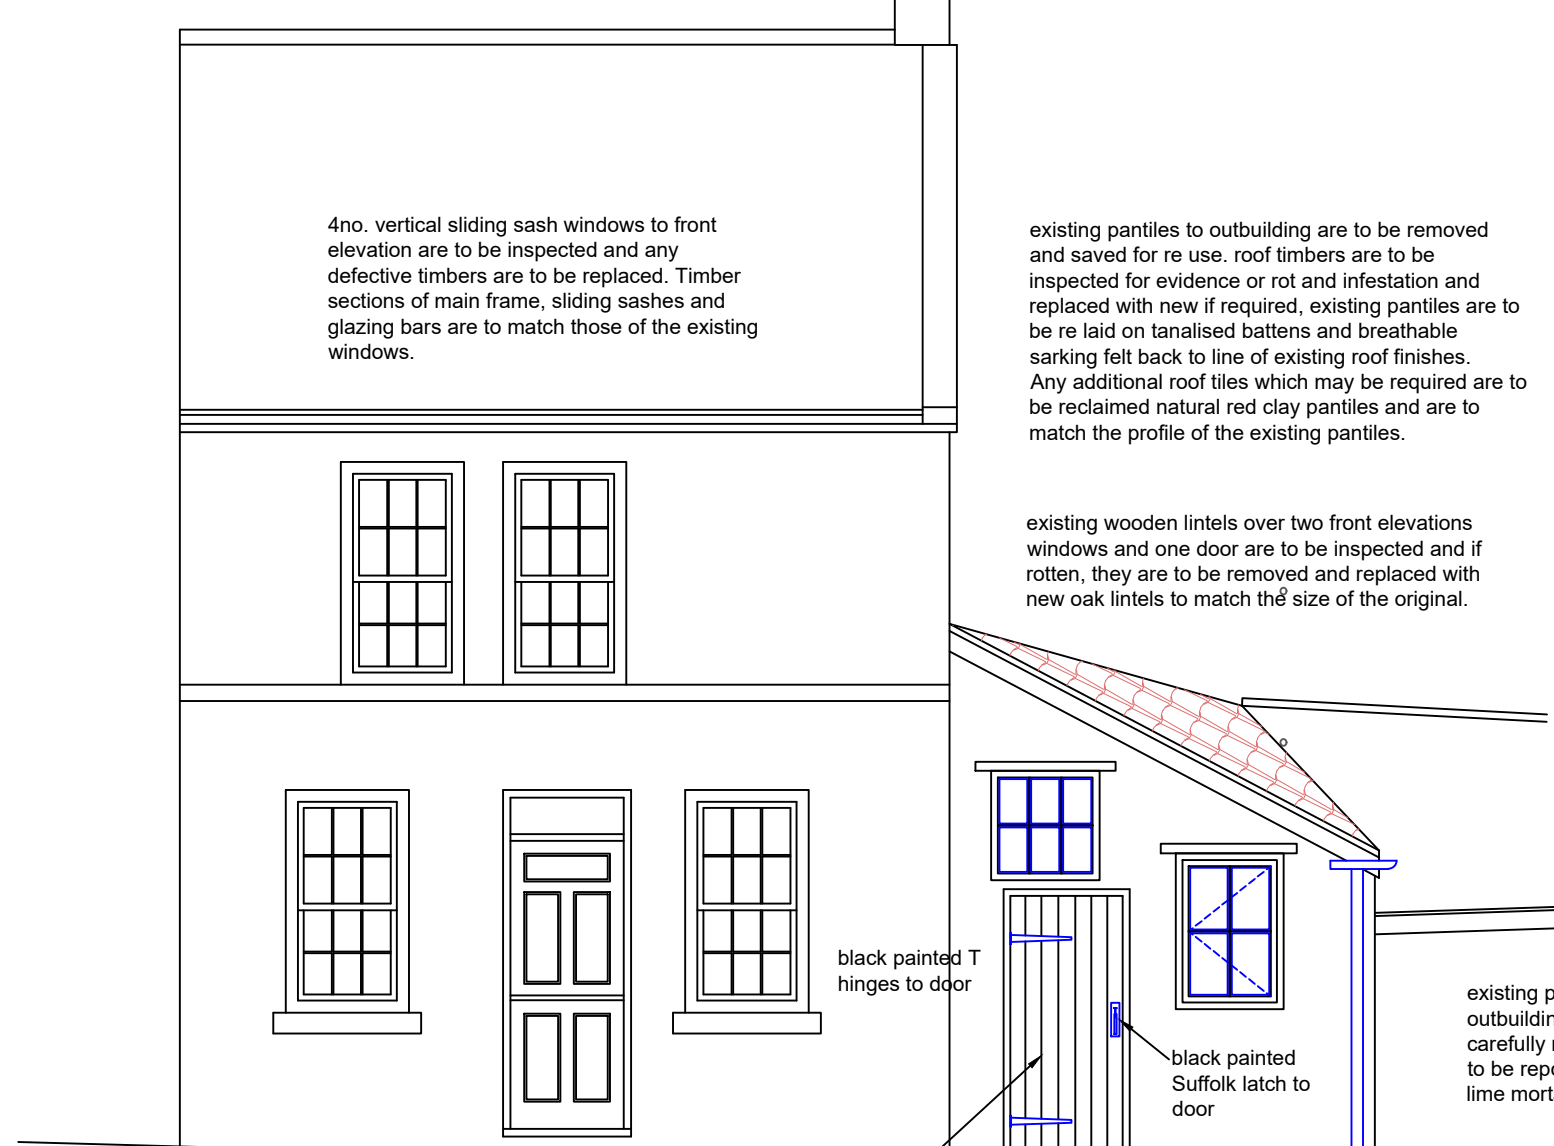
Proposed Front Elevation

existing wooden lintels over two front elevations windows and one door are to be inspected and if rotten, they are to be removed and replaced with new oak lintels to match the size of the original.

2no. timber windows to front elevation are to be repaired as necessary, all new timber sections of main frame, opening sashes and glazing bars are to match those of the existing windows. Glazing is to be single glazed to maintain appearance of original windows.

existing paint to stonework of outbuilding to front elevation to be carefully removed and stonework is to be repointed with non hydraulic lime mortar.

existing rotten door and frame to front elevation of outbuilding is to be removed, new door and frame is to be manufactured and inserted into existing opening but secured in the closed position as a false door. details of door and frame to match those of the original door

8. It is proposed to remove the existing paint finish from the front elevation of the store and to allow the stonework to dry out, whereupon it's condition is to be evaluated and repointing with a non hydraulic lime based mortar.

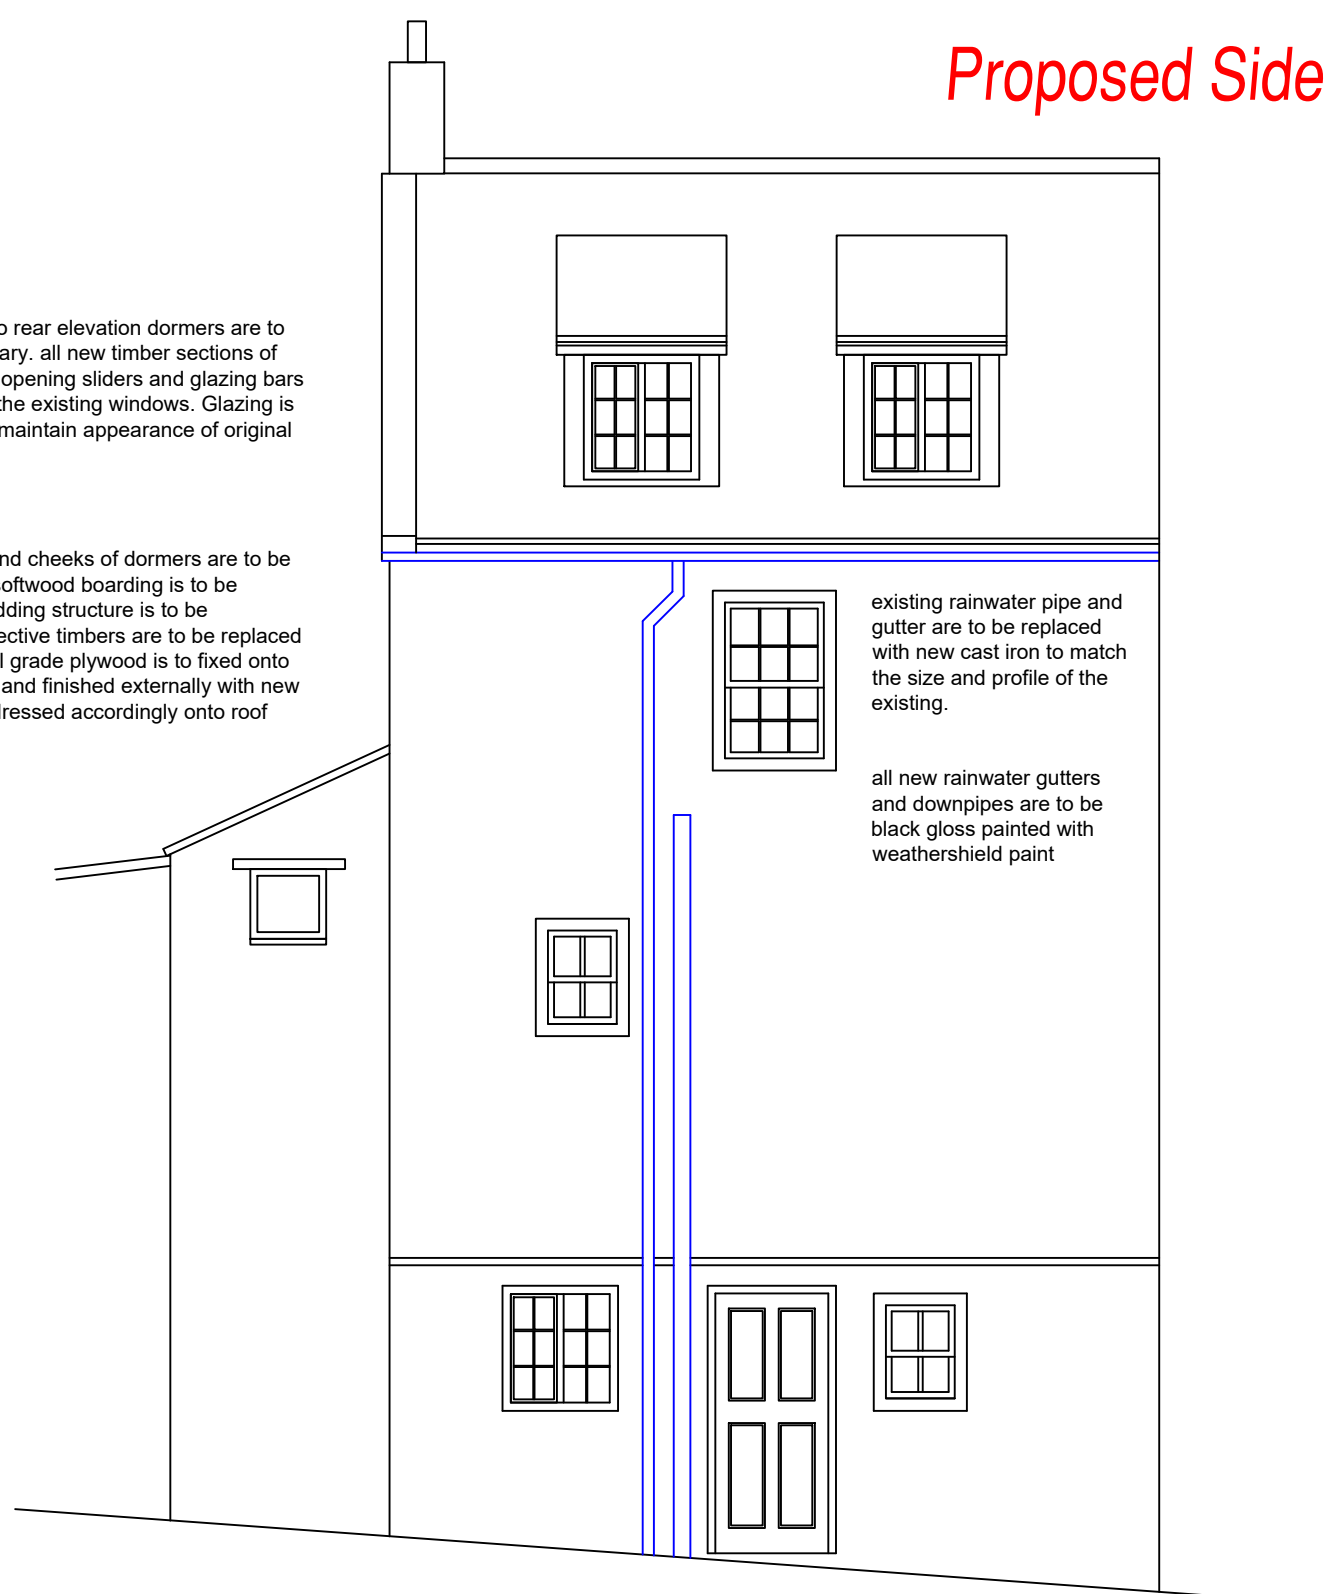
Proposed Rear Elevation

2no. timber windows to rear elevation dormers are to be repaired as necessary, all new timber sections of main frame, sideways opening sliders and glazing bars are to match those of the existing windows. Glazing is to be single glazed to maintain appearance of original windows.

all leadwork to faces and cheeks of dormers are to be removed, plywood or softwood boarding is to be inspected and any defective timbers are to be replaced with new. new external grade plywood is to be fixed onto breathable membrane and finished externally with new code 4 leadwork and dressed accordingly onto roof finishes

existing rainwater pipe and gutter are to be replaced with new cast iron to match the size and profile of the existing.

all new rainwater gutters and downpipes are to be black gloss painted with weathershield paint

6. the proposed roof insulation has been revised to be sheeps wool insulation.
7. the rainwater goods to the rear elevation have been noted as being removed and replaced with new cast iron and to receive a black gloss painted finish.
