ALTERATIONS to YORK HOUSE KING STREET ROBIN HOODS BAY

Drawing: EXISTING ELEVATIONS I

Drawing No. 193/03 Date: DECEMBER 2017 Scale: 1/50

MICHAEL MILLER BA(Hons) ARCH. CIAT Architectural Consultant.

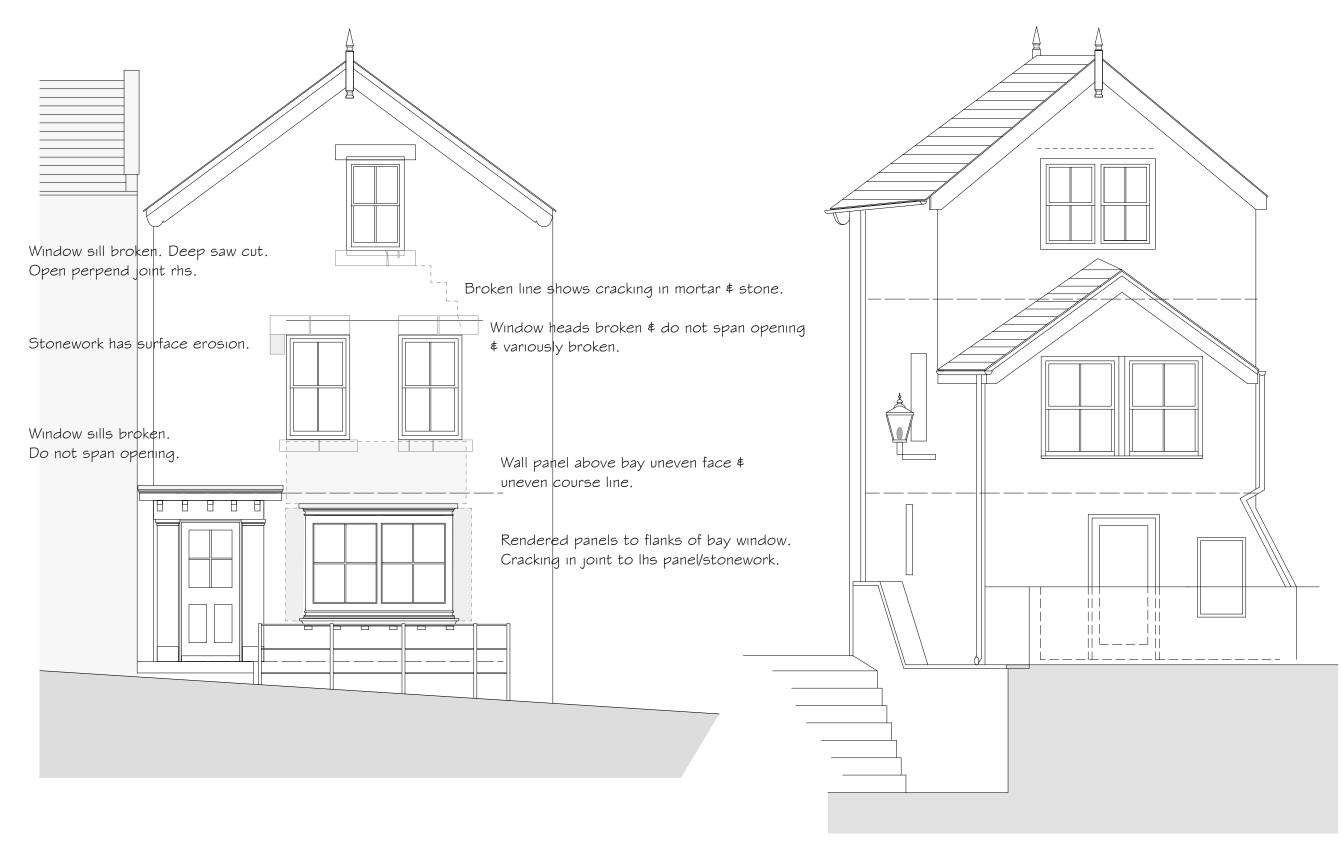
SOUTH ELEVATION

N O R T H E L E V A T I O N

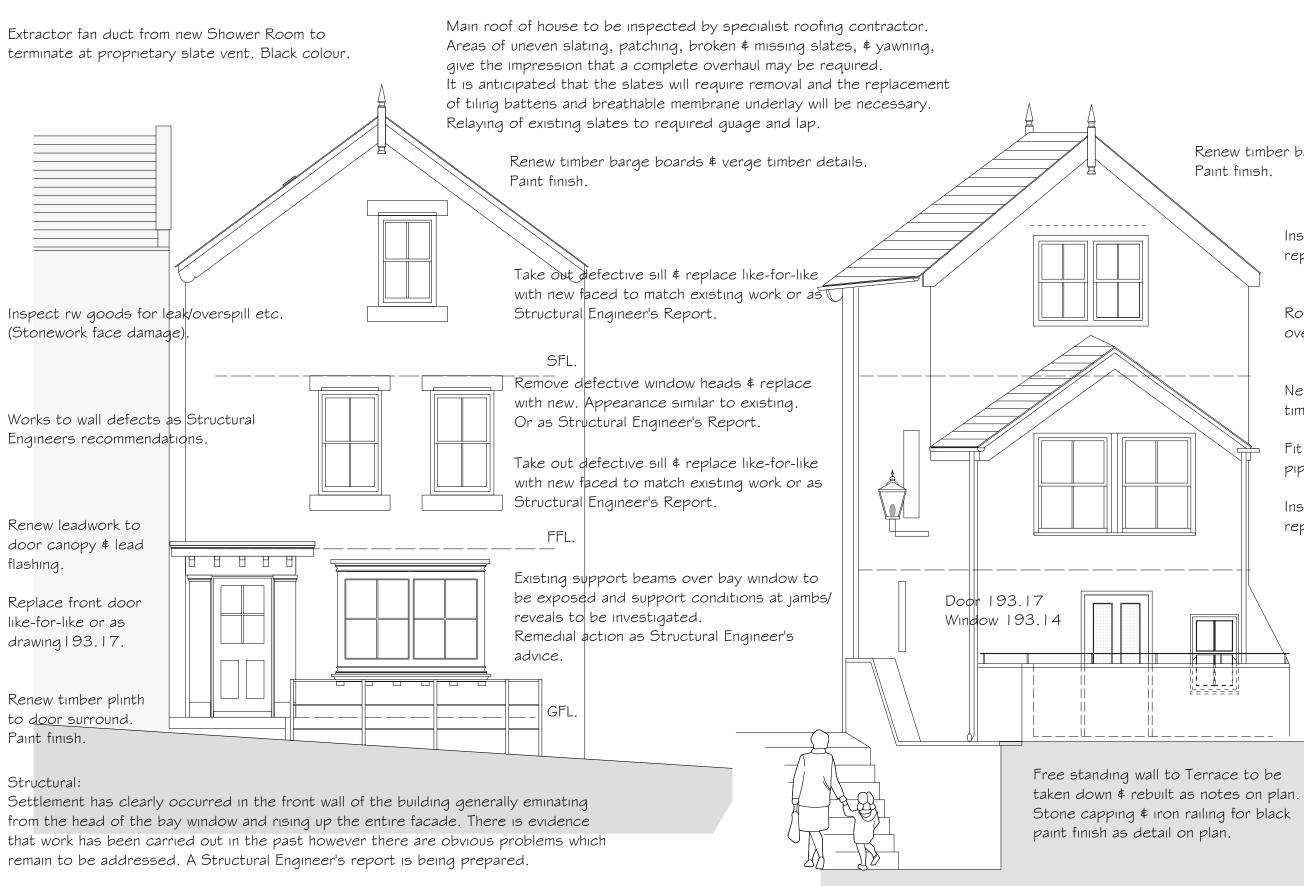
Drawing: EXISTING ELEVATIONS I

OUTH ELEVATION S

ELEVATION ORTH Ν

Renew timber barge boards \$ verge timber details. Paint finish.

Inspect timber to window frame \$ repair as required. Paint finish.

Roof to first floor extension to be overhauled as notes on plan drawing.

New timber barge boards & verge timber details. Paint finish.

Fit return to rw gutter \$ 50mm fall pipe. Discharge to current location.

Inspect timber to window frame \$ repair as neccesary. Paint finish.

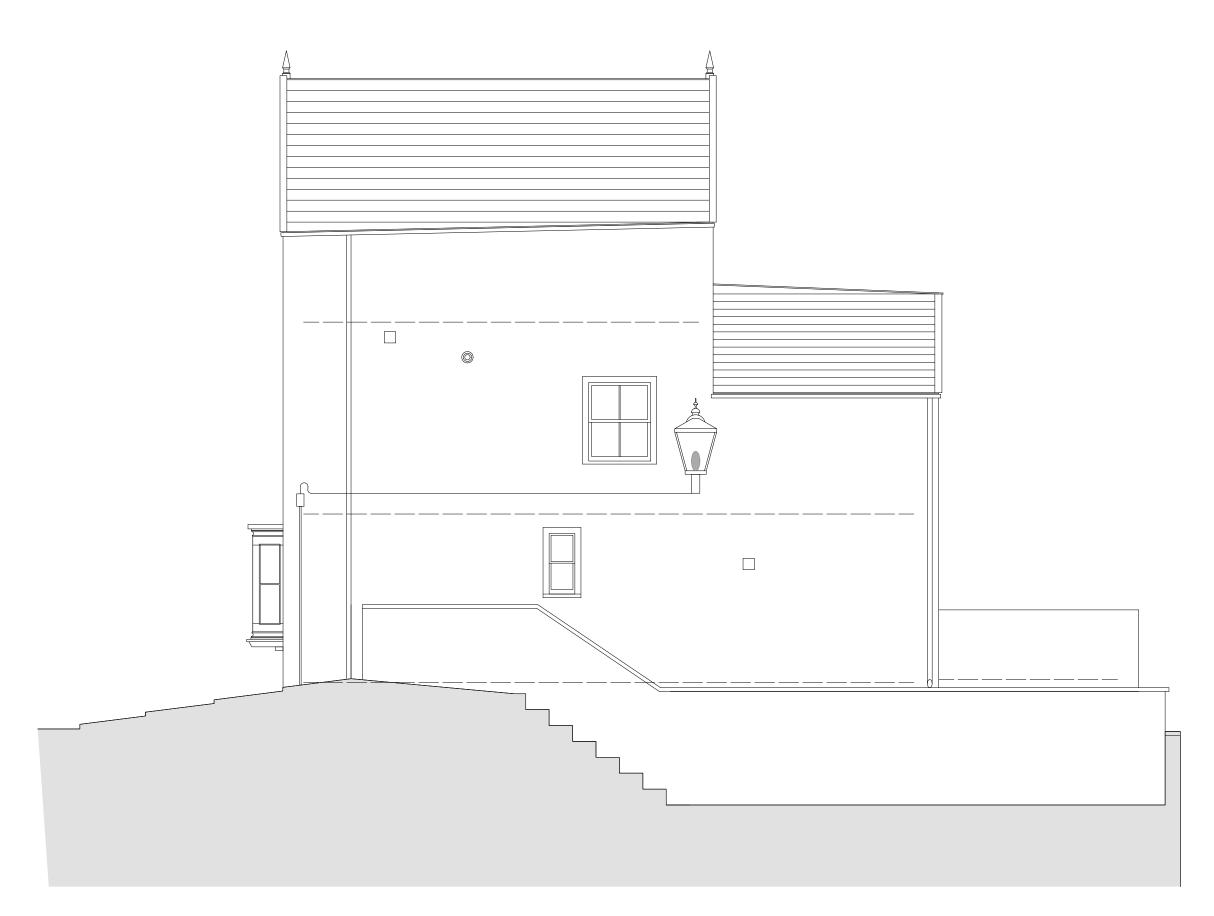
Drawing: EXISTING SIDE (EAST) ELEVATION

EAST ELEVATION

Main roof of house to be inspected by specialist roofing contractor. Areas of uneven slating, patching, broken \$ missing slates, \$ yawning, give the impression that a complete overhaul may be required. It is anticipated that the slates will require removal and the replacement of tiling battens and breathable membrane underlay will be necessary. Relaying of existing slates to required guage and lap.

Renew timber barge boards \$ verge timber details. Paint finish.

Roof abutment with Second Floor Level wall: remove timber batten detail \$ reinstate using lead flashing \$ soakers to slating. Adjust/reinstate render

Lay breathable membrane. New treated sw battens. Re-lay slates to correct gauge \$ lap for size \$ location. Fix with copper nails. Renew timber barge boards/plates \$ slate cover battens to match existing.

Take down rainwater goods. clean & repaint.

Take down extg wall to terrace \$ reconstruct in reclaimed stonework coursing and bonding to match better construction elsewhere. Finish top with sawn stone capping to match adjacent work. Wrought iron railing to wall top to form total ht of structure to 1.10m

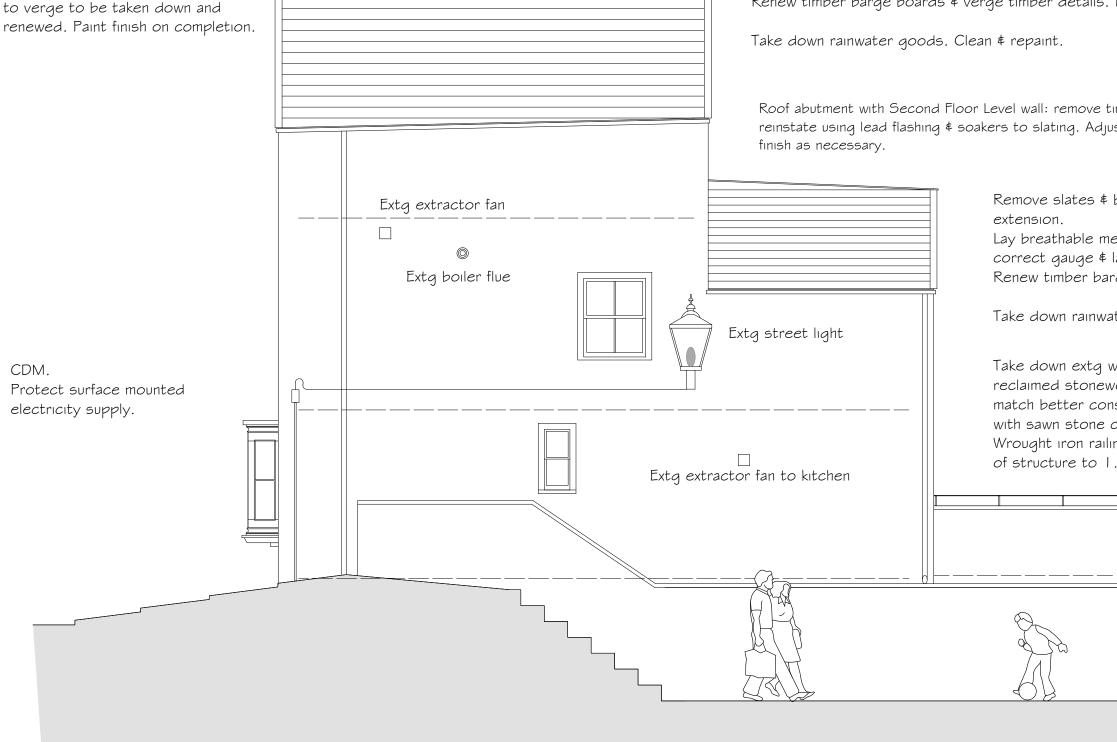
Drawing: PROPOSED SIDE (EAST) ELEVATION

EAST ELEVATION

Barge boards \$ other timber trims

Remove slates \$ battens from existing roof over First Floor level

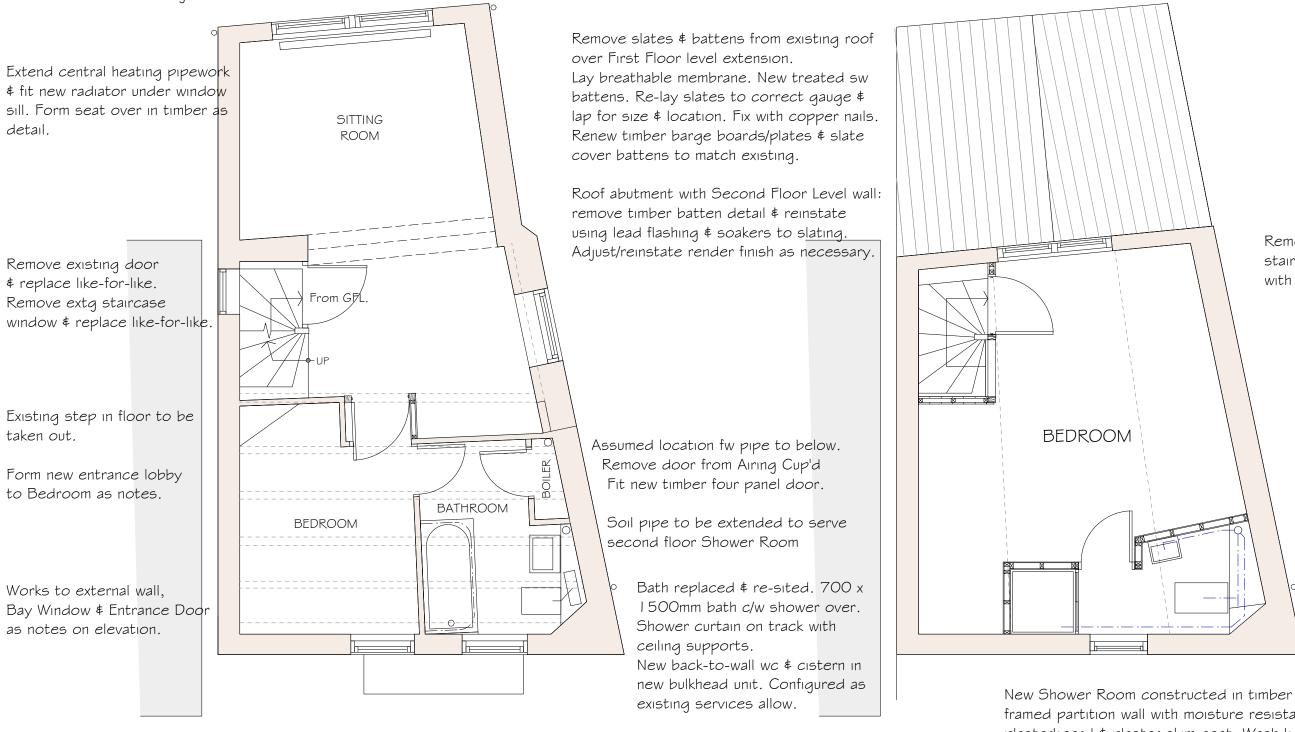
framed partition wall with moisture resistant plasterboard & plaster skim coat. Wash basin, wc \$ shower unit (tray/screen/wall panels/mixer \$ spray) as client directs. Floor finish as client. Layout assumes that tray is on riser kit \$ waste in duct to s/vp \$ drop to connection in boiler cupboard below.

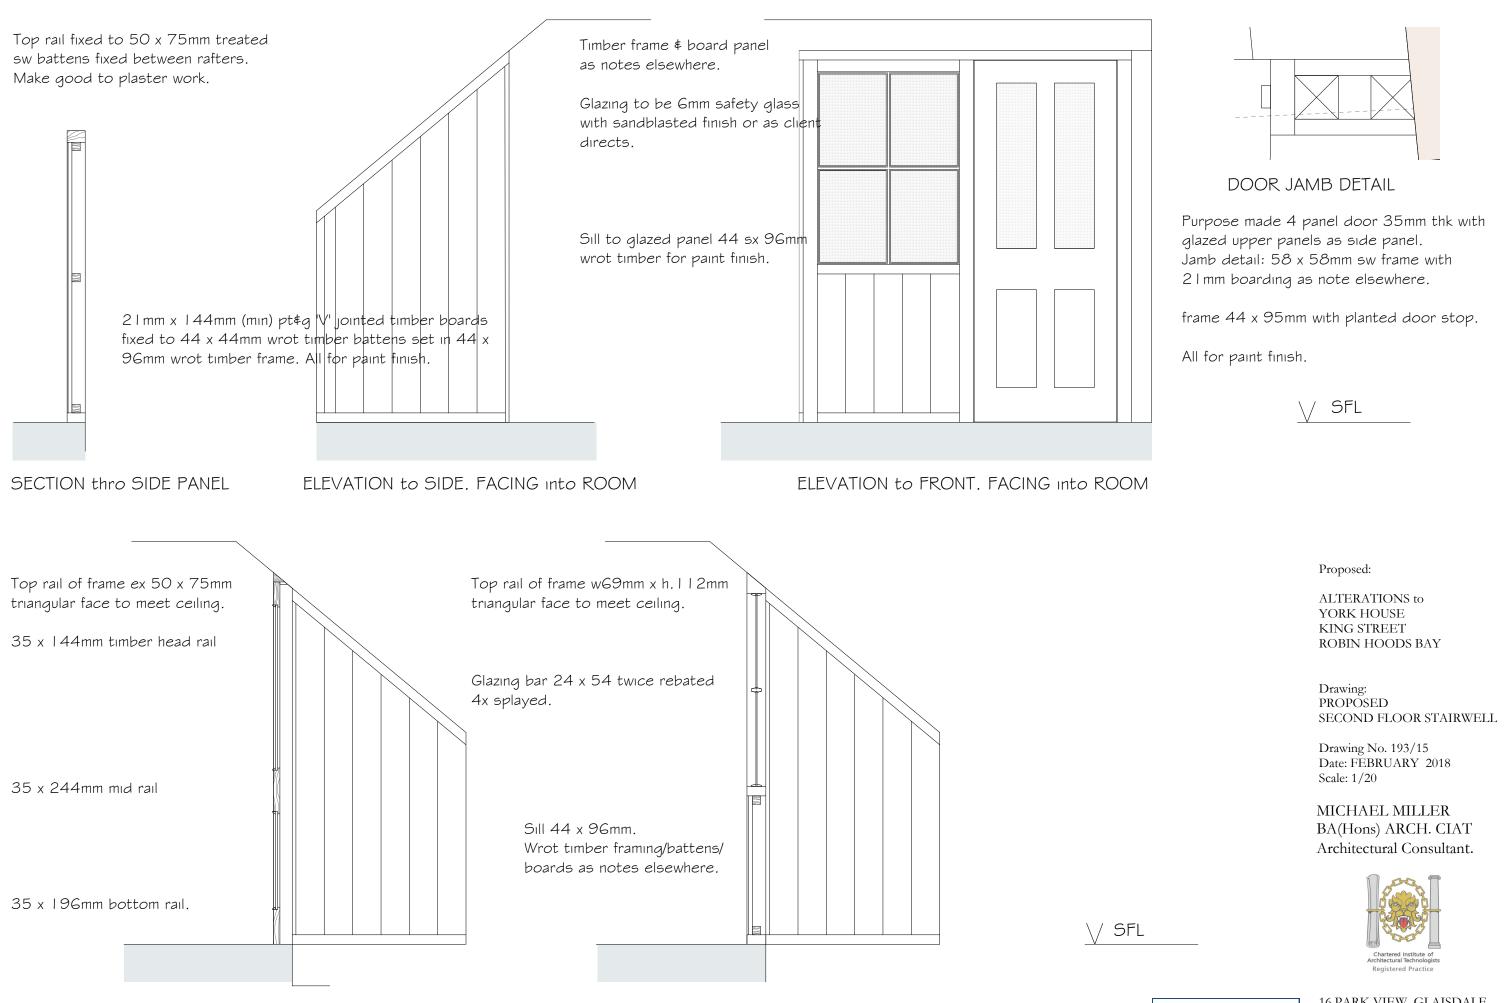
ELEVATION to SIDE. FACING into STAIRWELL **♯** GLAZED SECTION.

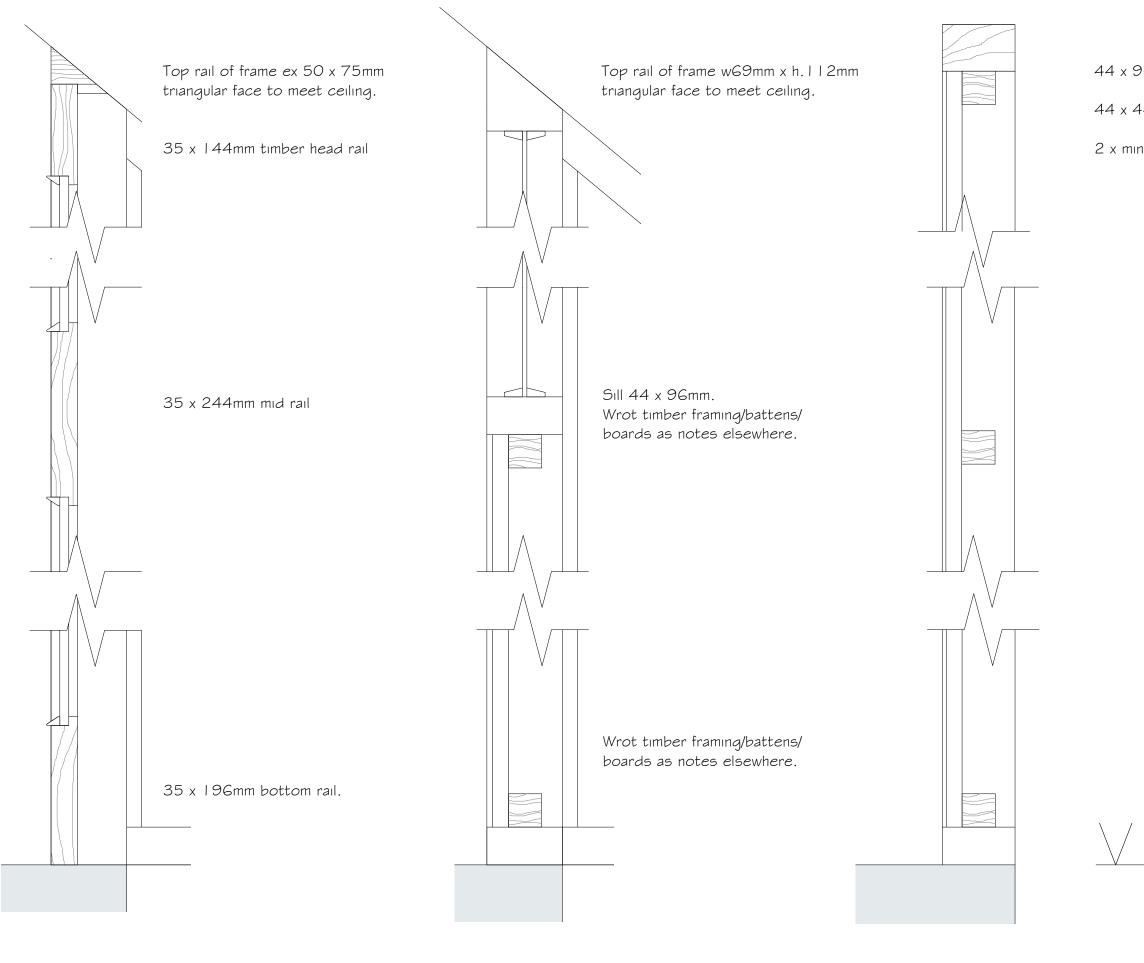
DOOR SECTION

slimlite glazed with putty & butyl

slimlite glazed with beads & butyl

GLAZED SECTION

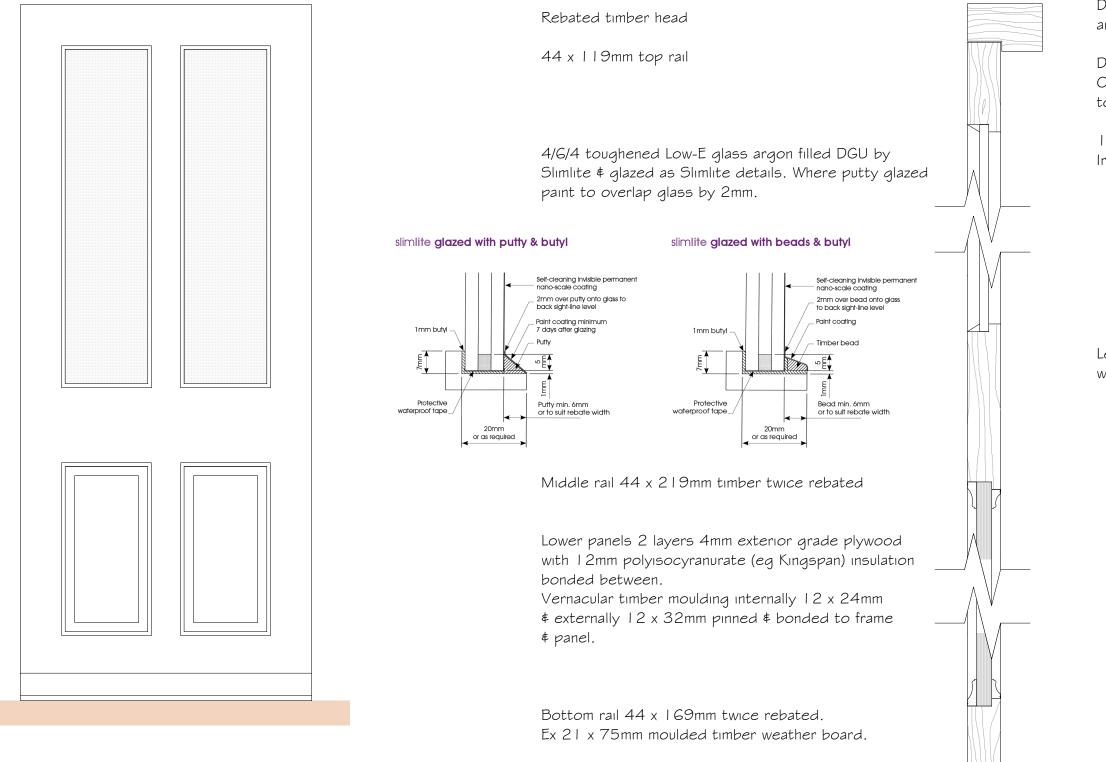
EXTERNAL ELEVATION

Proprietary low sill threshold eg Stormguard Slimline rain & draught excluder.

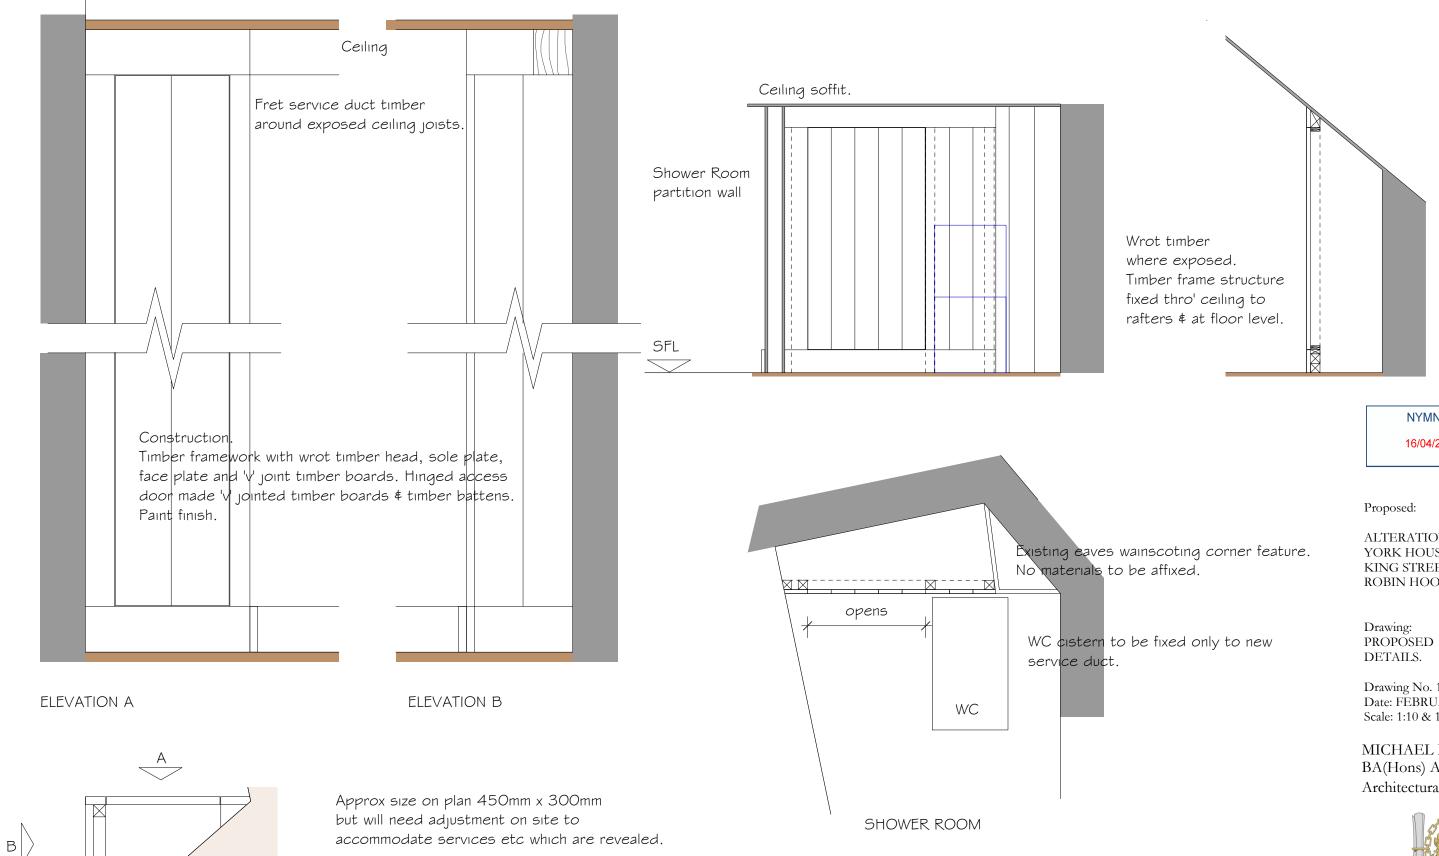
GFL FRONT BEDROOM SERVICE DUCT

SFL ATTIC WC SERVICE DUCT
