YORK HOUSE, KING STREET, ROBIN HOODS BAY.
2018/0204/LB & 0232/FL

Proposed:
ALTERATIONS to
YORK HOUSE
KING STREET
ROBIN HOODS BAY

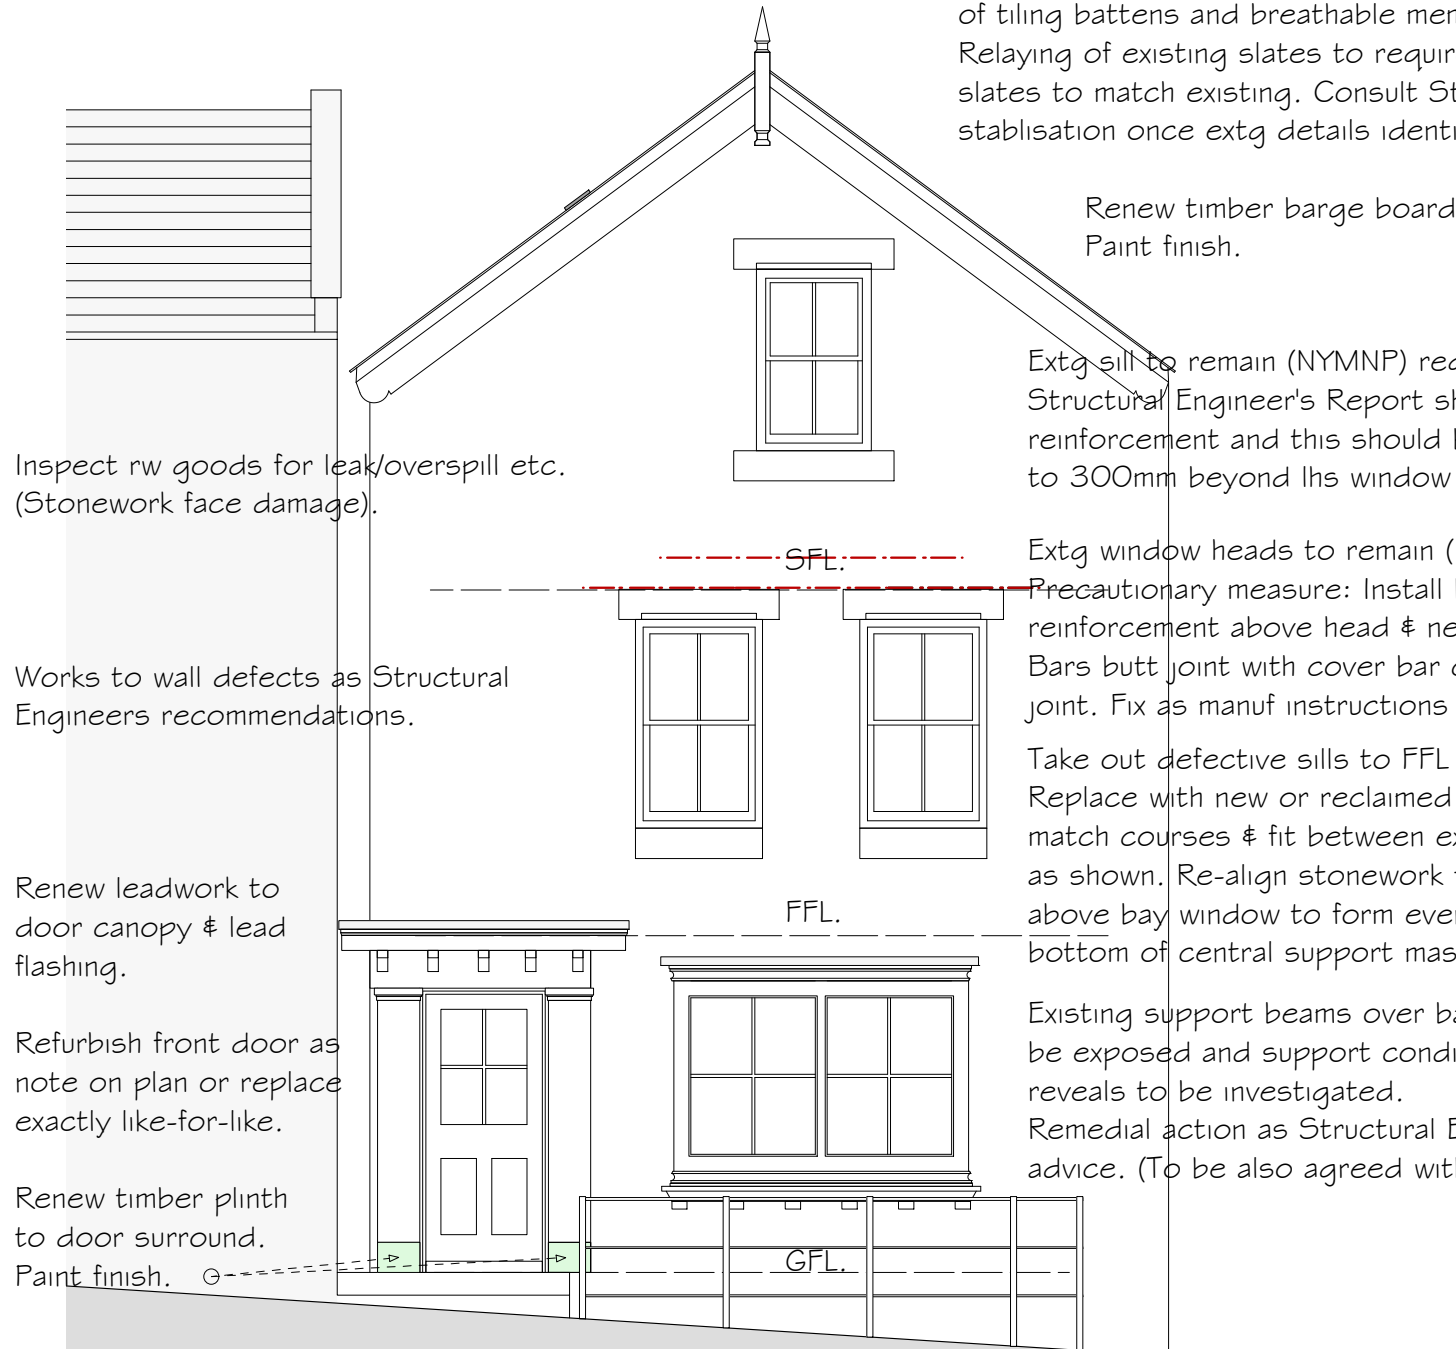
Revision A. 4.6.2018.
Notes re: extg slates to be re-laid. Need to consult Structural Engineer. SFL sill to remain + Helifix bars reinf. FFL window heads to remain Helifix bars reinf. FFL window sills.

Structural:
Settlement has clearly occurred in the front wall of the building generally emanating from the head of the bay window and rising up the entire facade. There is evidence that work has been carried out in the past however there are obvious problems which remain to be addressed. Refer to Structural Engineer's report.

Extg sill to remain (NYMNP) requirement. Structural Engineer's Report shows crack reinforcement and this should be extended to 300mm beyond lhs window opening.

Extg window heads to remain (NYMNP).
Precautionary measure: Install Helifix joint reinforcement above head & next course over. Bars butt joint with cover bar centrally over joint. Fix as manuf instructions in 50 mm groove.
Take out defective sills to FFL window openings. Replace with new or reclaimed sills section to match courses & fit between extg historic masonry as shown. Re-align stonework to 3no courses above bay window to form even panel incl. quirk bottom of central support masonry.

Existing support beams over bay window to be exposed and support conditions at jambs/ reveals to be investigated. Remedial action as Structural Engineer's advice. (To be also agreed with NYMNP).

- 2.14 Front FFL window openings. Window head: I discussed this with Richard Agar Associates, Structural Engineers; the thinking was that;
 - a). An unequal ms angle would not work very well under the existing heads as there is not really a level course for insertion and;

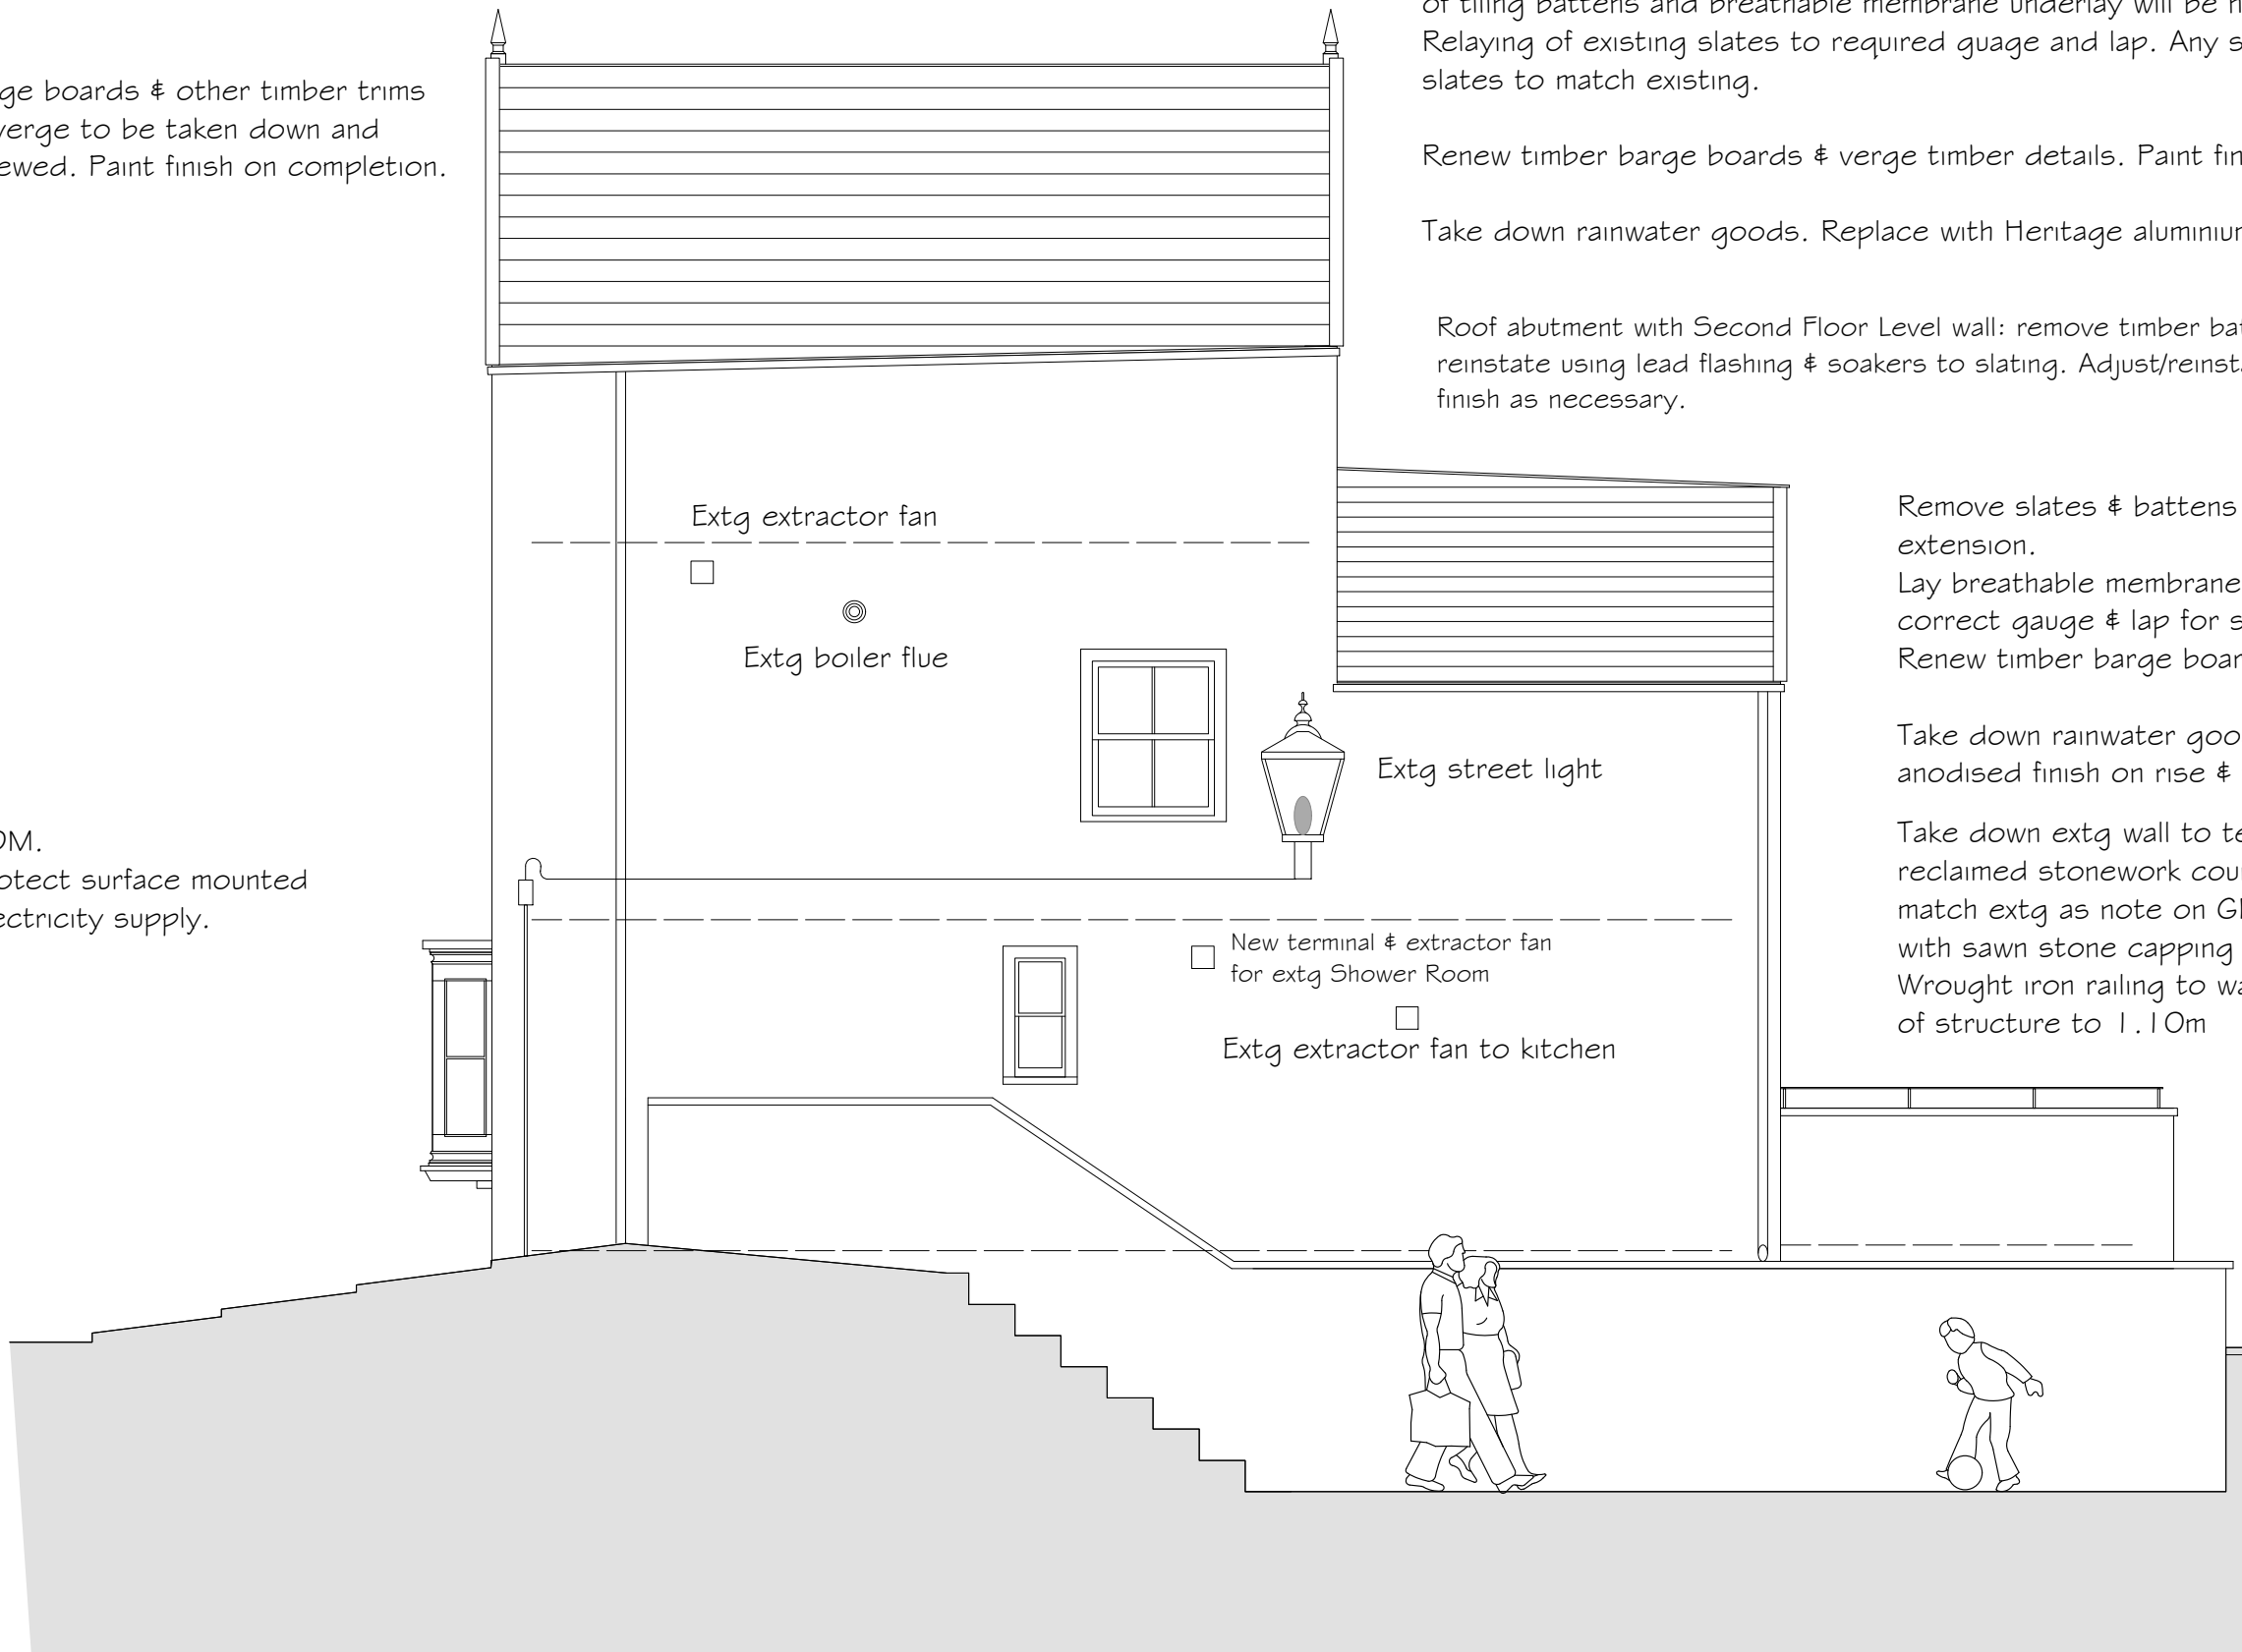
E A S T E L E V A T I O N

Barge boards & other timber trims
to verge to be taken down and
renewed. Paint finish on completion.

Main roof of house to be inspected by specialist roofing contractor.
Areas of uneven slating, patching, broken & missing slates, & yawning,
give the impression that a complete overhaul may be required.
It is anticipated that the slates will require removal and the replacement
of tiling battens and breathable membrane underlay will be necessary.
Relaying of existing slates to required gauge and lap. Any supplementary
slates to match existing.

Roof abutment with Second Floor Level wall: remove timber batten detail &
reinstale using lead flashing & soakers to slating. Adjust/reinstale render
finish as necessary.

Remove slates & battens from existing roof over First Floor level
extension.

Lay breathable membrane. New treated sw battens. Re-lay extg slates to
correct gauge & lap for size & location. Fix with copper nails.
Renew timber barge boards/plates & slate cover battens to match existing.

Take down rainwater goods. Replace with Heritage aluminum sections black
anodised finish on rise & fall brackets.

Take down extg wall to terrace & reconstruct in
reclaimed stonework coursing and bonding to
match extg as note on GFL Plan. Finish top
with sawn stone capping to match adjacent work.
Wrought iron railing to wall top to form total ht
of structure to 1.10m

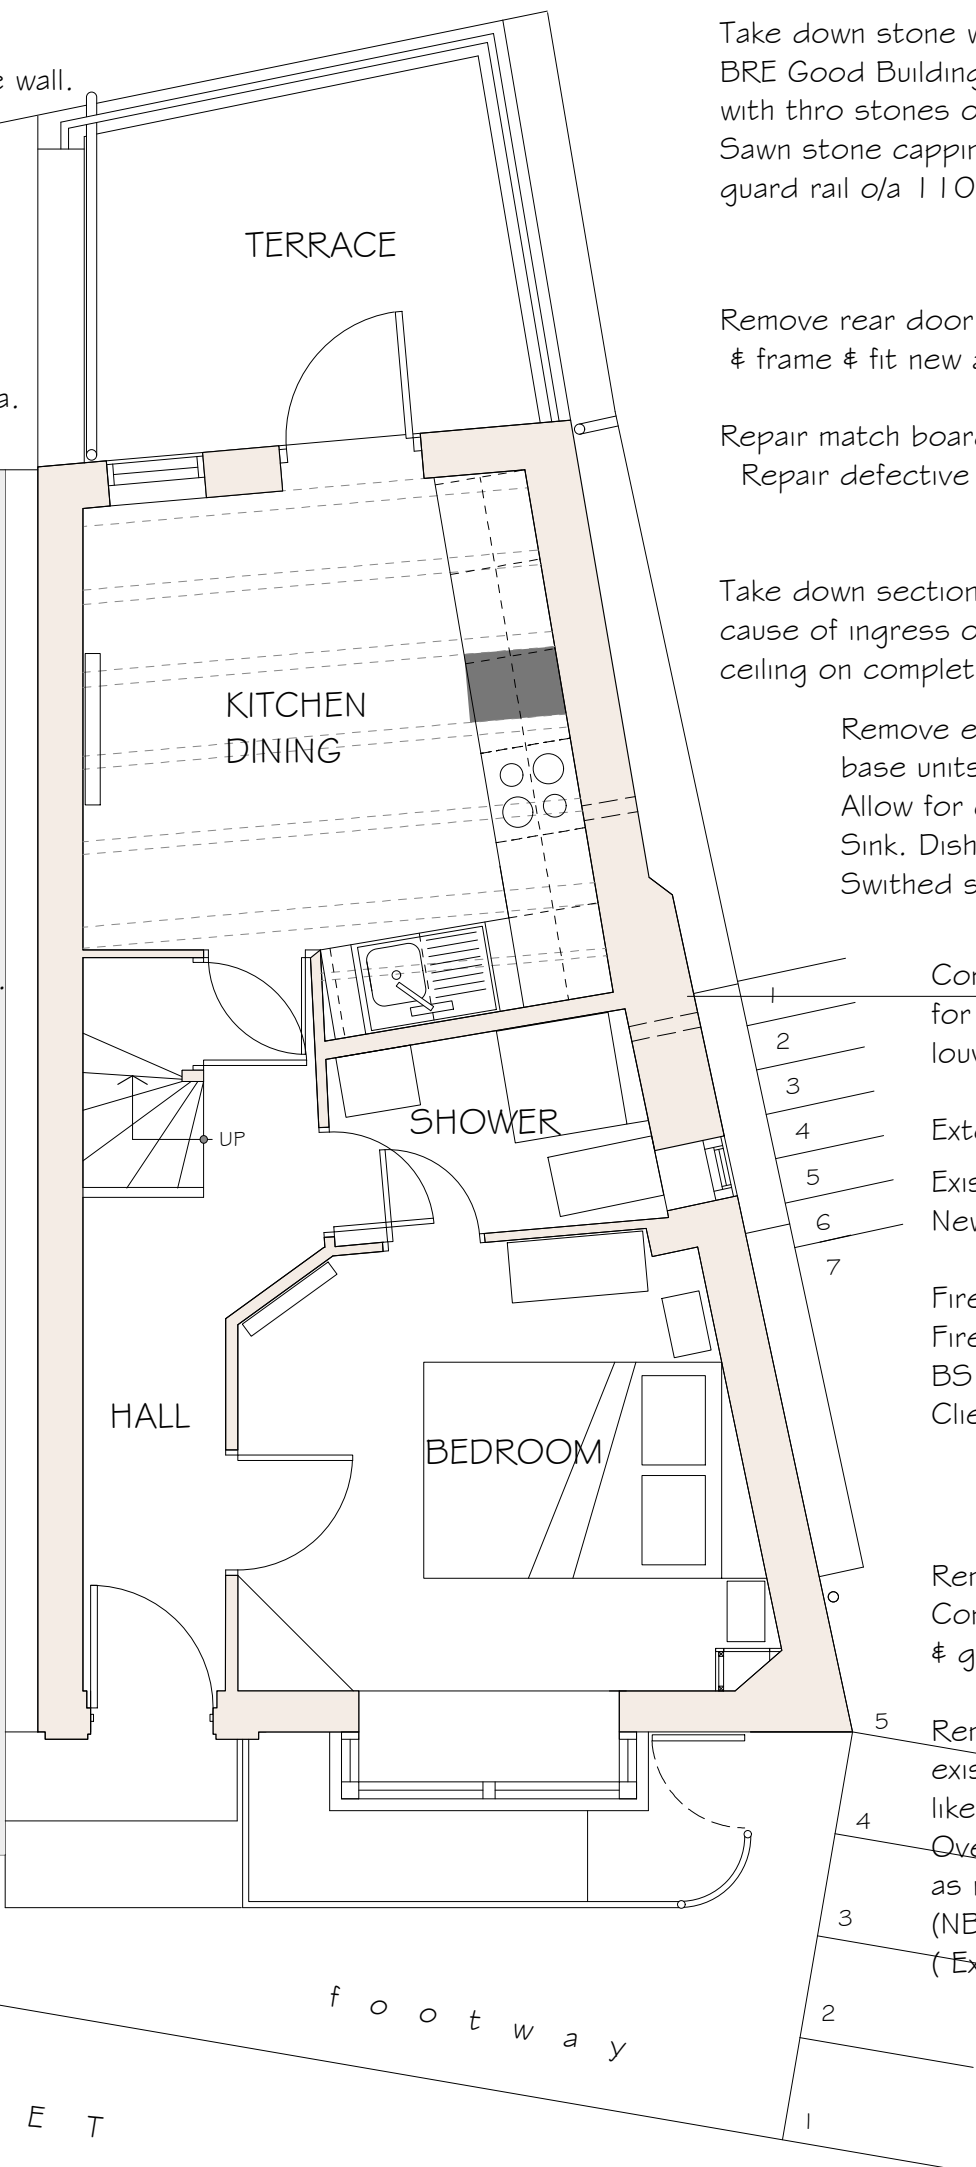
Wrought iron railing approx 200mm height on sawn stone coping on stone wall. O/a height from deck 1100mm. See Section opposite.

Take out existing standsheet window frame & replace with vertical sliding timber sash window as detail 193.14a.

Front door to be refurbished by fitting draught seals to frame. Sections to suit gaps. Adjust door to allow for fitting low sill threshold seal. Alternatively replace exactly like-for-like.

Take down stone wall to terrace & rebuild in two skins fair face both sides min 215mm thick o/a. BRE Good Building Guide No. 14. Max height 1075mm. Coursing & faces to match existing & tied with thro stones or stainless steel ties @ 600mm centres horizontally & 450mm centres vertically. Sawn stone capping as neighbouring property & wrought iron railing approx 200mm height to form guard rail o/a 1100mm. CDM Working at height.

Remove modern matchboard lining to head of bay window to expose existing structural support. Inspect and carryout remedial work on a like-for-like replacement basis.

Overhaul lead sheet covering to Bay Window & fit new lead flashing as necessary. (NB. Presently ingress of water at head location) (External wall variously cracked/settled above this location).

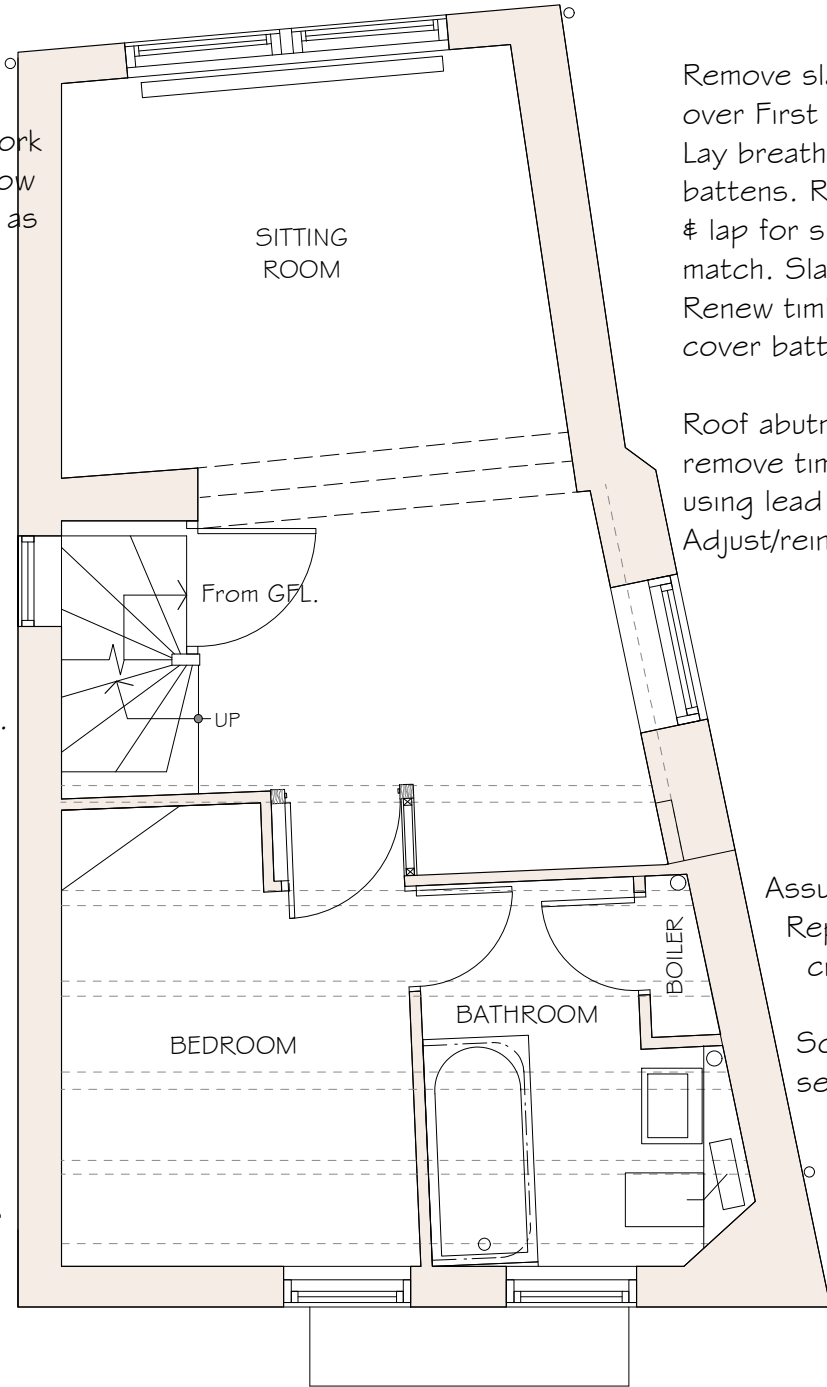
Remove slates & battens from existing roof over First Floor level extension. Lay breathable membrane. New treated sw battens. Re-lay existing slates to correct gauge & lap for size & location. Any additional slates to match. Slates fixed with copper nails. Renew timber barge boards/plates & slate cover battens to match existing.

Roof abutment with Second Floor Level wall: remove timber batten detail & reinstate using lead flashing & soakers to slating. Adjust/reinstate render finish as necessary.

Bath replaced & re-sited. 700 x 1500mm bath c/w shower over. Shower curtain on track with ceiling supports. New back-to-wall wc & cistern in new bulkhead unit. Configured as existing services allow.

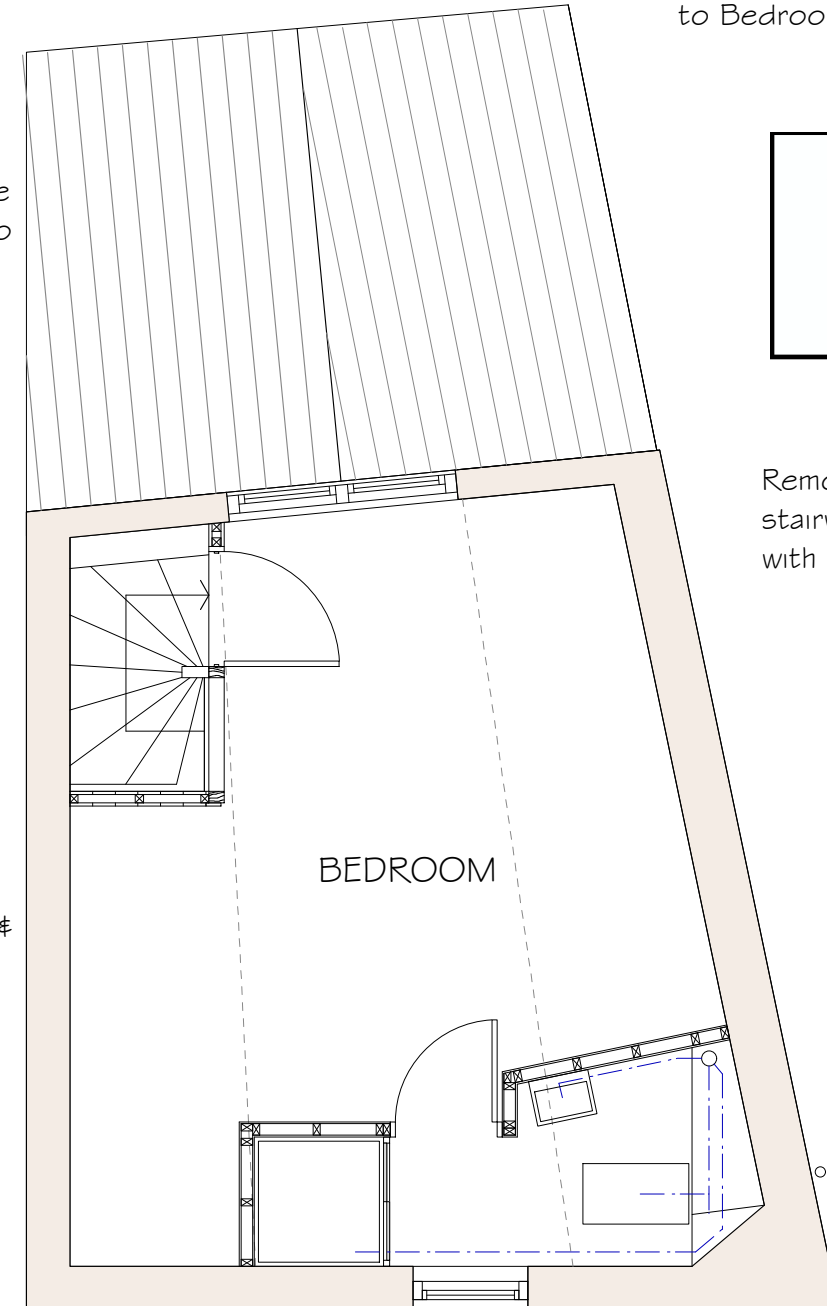
Remove wrought iron guard rail to stairwell & construct new partition with four panel door as detail 193.16

New Shower Room constructed in timber framed partition wall with moisture resistant plasterboard & plaster skim coat internally. Partition wall to Bedroom face finished with wide timber boards to match elsewhere. Wash basin,wc & shower unit (tray/screen/wall panels /mixer & spray) as client directs. Floor finish as client directs. Layout assumes that tray is on riser kit & waste in duct to s/vp & drop to connection in boiler cupboard below.

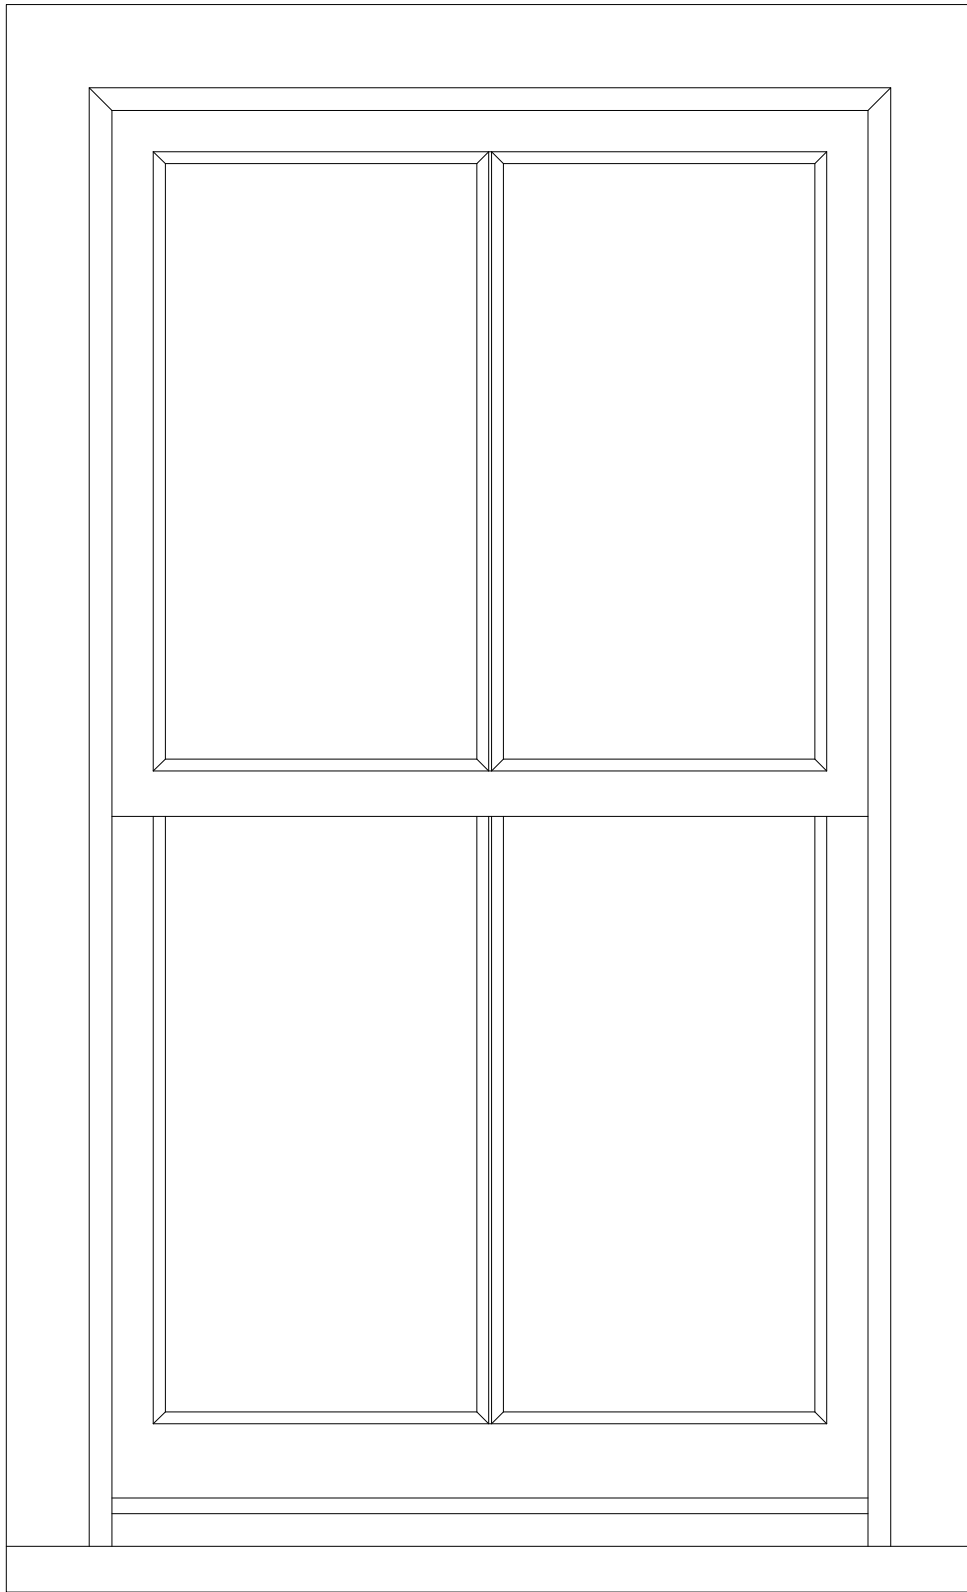
EXTERNAL ELEVATION

Revision A. 4.6.2018
 Altered to lead weight balanced.
 Frame & box sections/details altered.

Vertical sliding sash window frame to be constructed in accoya for white paint finish. Timber sections as traditional standard sections and lead weight balance in sash box. (Traditional to mean as BS 644 Pt.2).
 12mm Slimlite double glazed unit. Toughened glass both panes. Inner pane Low-E. Argon filled cavity.
 Glazing as Slimlite details

- 2.01. Boundary wall – amended as your proposal.
- 2.02 Drawing amended to lead weight balanced sash. Sections altered.
- 2.03. Ok.
- 2.11 Front door, notes amended as you propose.

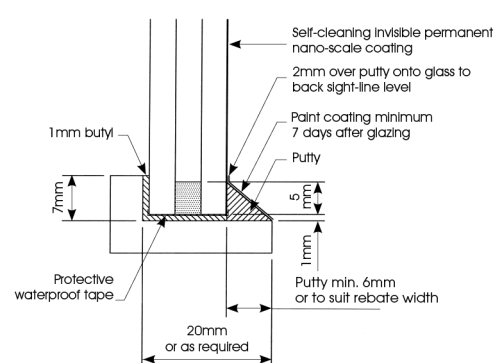
slimlite glazed with putty & butyl

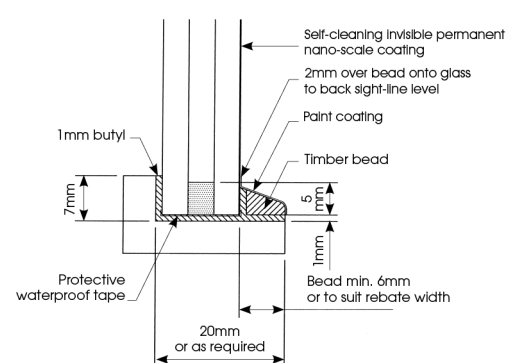
slimlite glazed with beads & butyl
