Proposed:
ALTERATIONS to
YORK HOUSE
KING STREET
ROBIN HOODS BAY

Drawing:
EXISTING
ELEVATIONS I

Drawing No. 193/12a
Date: DECEMBER 2017
Scale: 1/50

Drawing:
BUILDING REGULATIONS
NOTATION SHEET I.

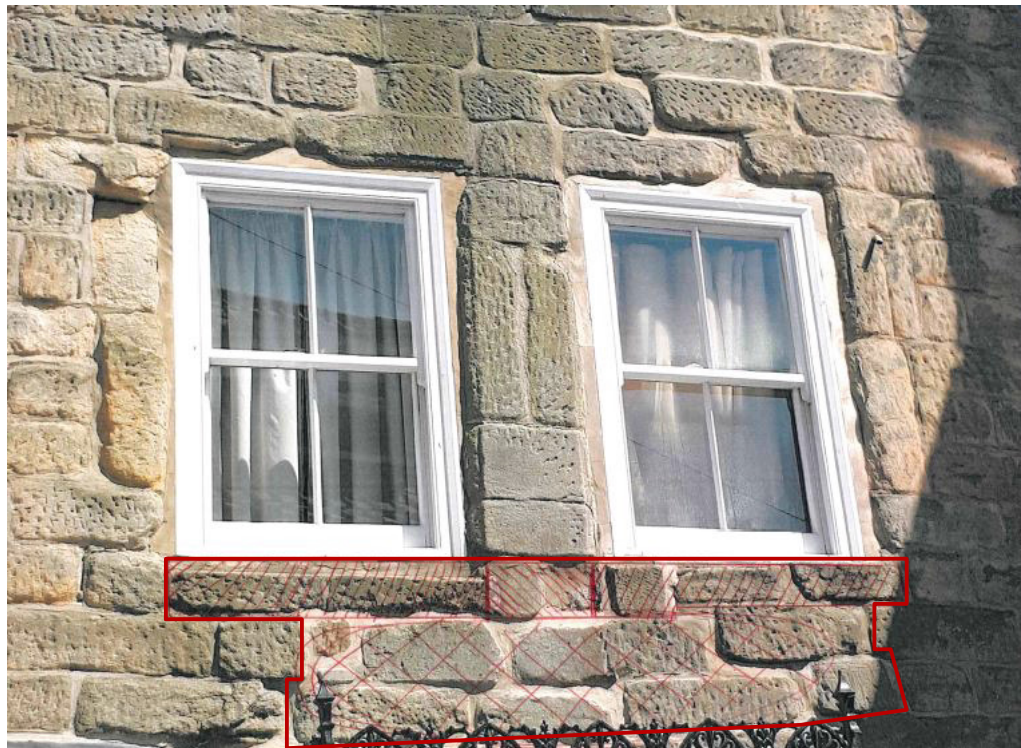
Where existing stonework is displaced the opportunity arises for the panel of wall above the Bay Window to be re-aligned. The extent of this work is shown in the photograph below.

It is considered that the bulk of the existing material (stone) can be reused however supplementary stone shall be from a source identified by a stone mason as being of a geological match which is likely to be of a sandstone sourced locally. The tooling shall be picked face to match existing work and bedding, jointing & pointing shall be mortar mix 1:2½ lime sand (50% sieved sharp sand + 50% builders sand) for bedding, jointing & pointing as NYMNP requirements. Joints to be slightly recessed with bag rubbed finish.

Existing support beams over bay window to be exposed and support conditions at jambs/ reveals to be investigated. Remedial action as Structural Engineer's advice. (To be also agreed with NYMNP).

Bay window head to be replaced like-for-like if found to be timber. Dry straight grained Oak to be minimum standard.
