Subject: NYM/20108/0653/FL St Athanasius Monastery Langdale End E62 NYMNP details 31-01-19

Location: **St Athanasius Monastery**

Report Type: **Arboricultural Impact Assessment**

Ref: ARB/CP/2005

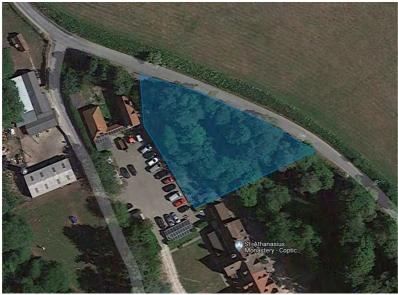
Figure 1: Area Surveyed Highlighted

2.1 The area surveyed is located to the east of the entrance driveway for the St Athanasius Monastery in Langdale End. Figure 1 shows the extent of the site.

- Map data ©Google Imagery
- 2.2 The survey area is primarily situated upon a wooded bank that rises from the driveway up to the level of the road. A small section to the west of the driveway was also included.
- 2.3 On the day the site was surveyed the sky was clear which presented good levels of light. Any visibility issues encountered are noted within Appendix 1).

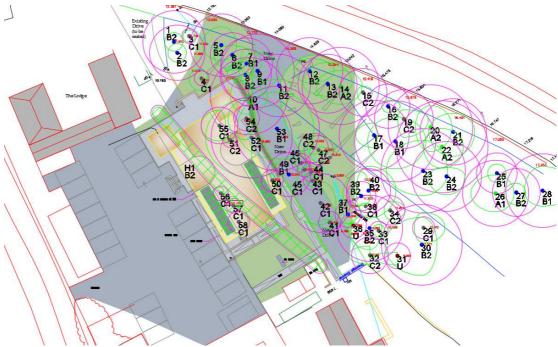
Figure 2: Proposed Layout

- 5.1 This section concentrates on the proposed development and how it relates to the current tree population within the site. Any conflict issues between the proposed layout and existing trees are discussed and remedial options, where possible, suggested.
- 5.2 It is proposed that a church will be constructed within the site with a new access driveway and car parking, as displayed in figure 2 and in greater detail within the Arboricultural Impact Plan (Appendix 3).

As shown within Figure 2 the construction of the proposed church and driveway will necessitate the removal of thirty-one trees and one hedge.

Mitigation / Countermeasure: Of those that require removal to enable the layout, one tree, number 10, was classified as Category A. Ten were classified as Category B, sixteen as Category C and one as Category U. In addition we would recommend the removal of Tree 36 due to poor condition. The majority of the trees that will need to be removed are positioned upon the bank rising up to the roadside and as such there will be a visual impact but one that will be softened by the larger number

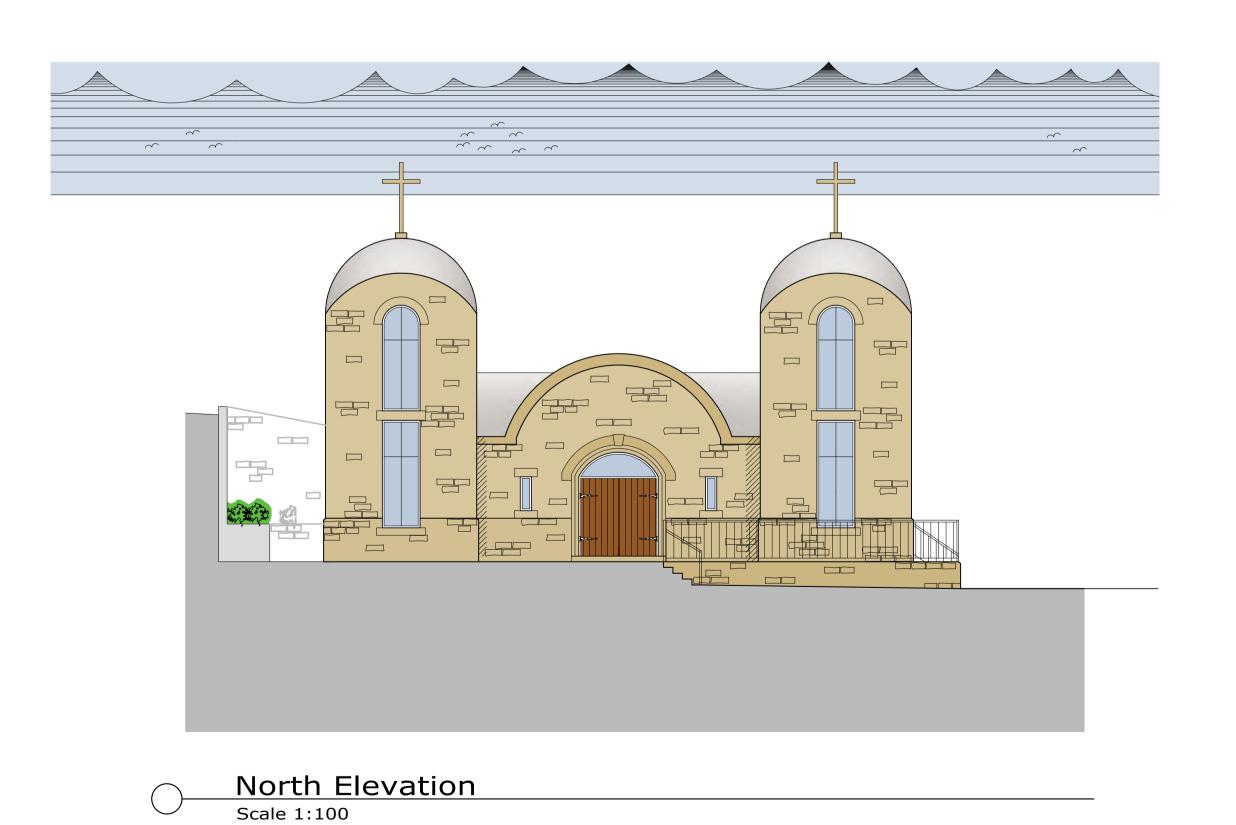
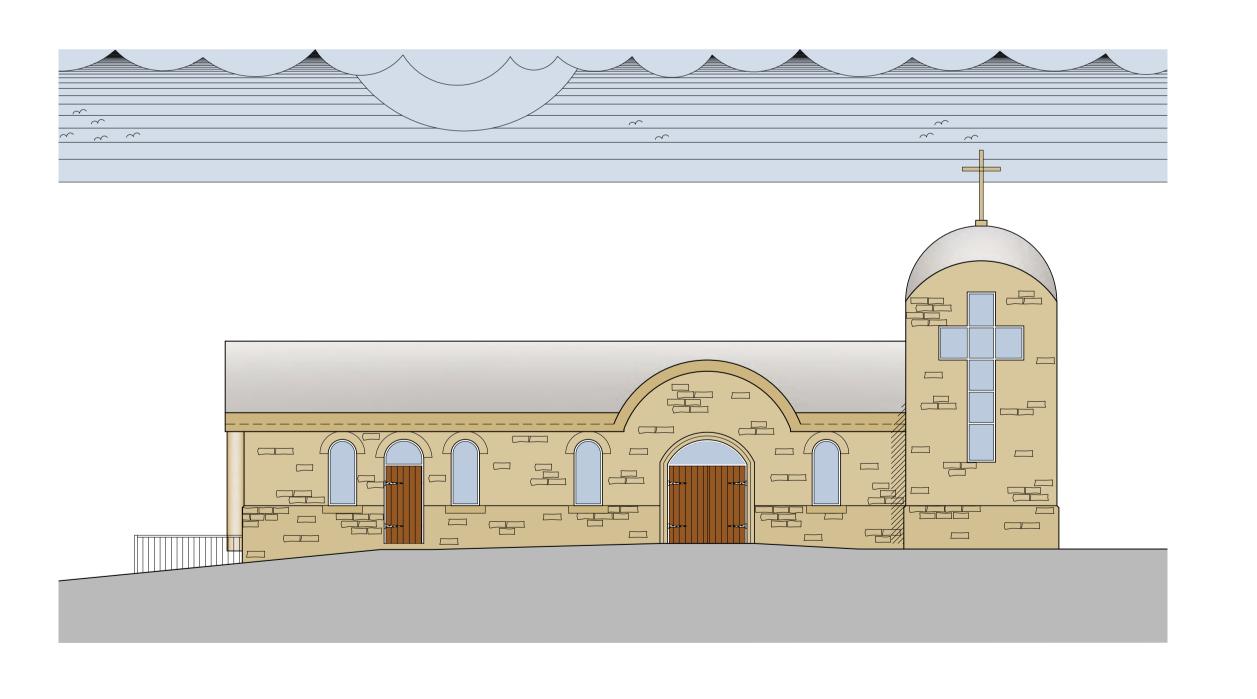
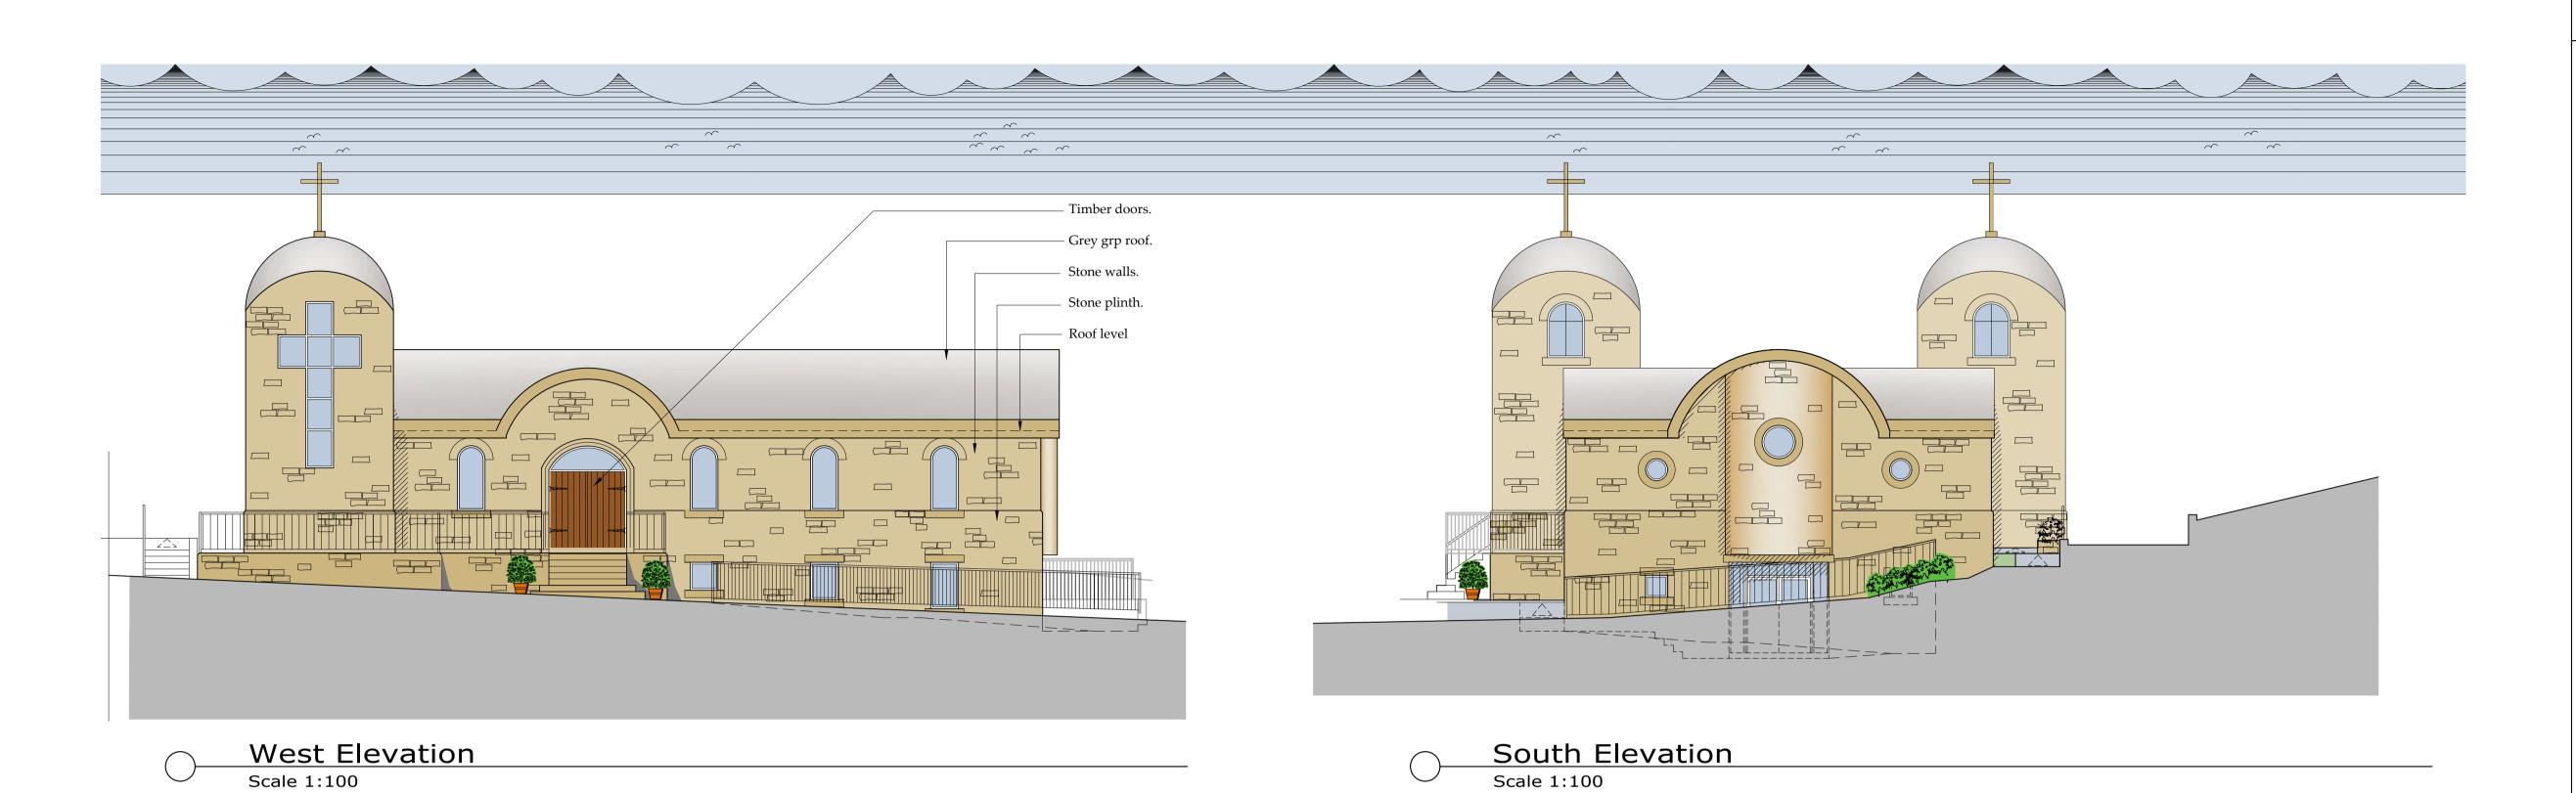
D11161-03

Scale 1:100

- Elliot Consultancy Arboricultural report using new topographical survey showing full extent of trees
- D11161-02F, Floor Plans showing minor design alteration, windows to Lower ground
- D11161-03H, Elevations, added windows also materials to externals altered.
- D11161-04B, Revised existing topographical survey produced to show further trees as noted in Astute Ecology Report
- D11161-05E, Proposed Block Plan/Topo, building moved to prevent encroachment on Car Park
- D11161-06B, Amended site sections following building position change
- D11161-07A, Car Parking drawing

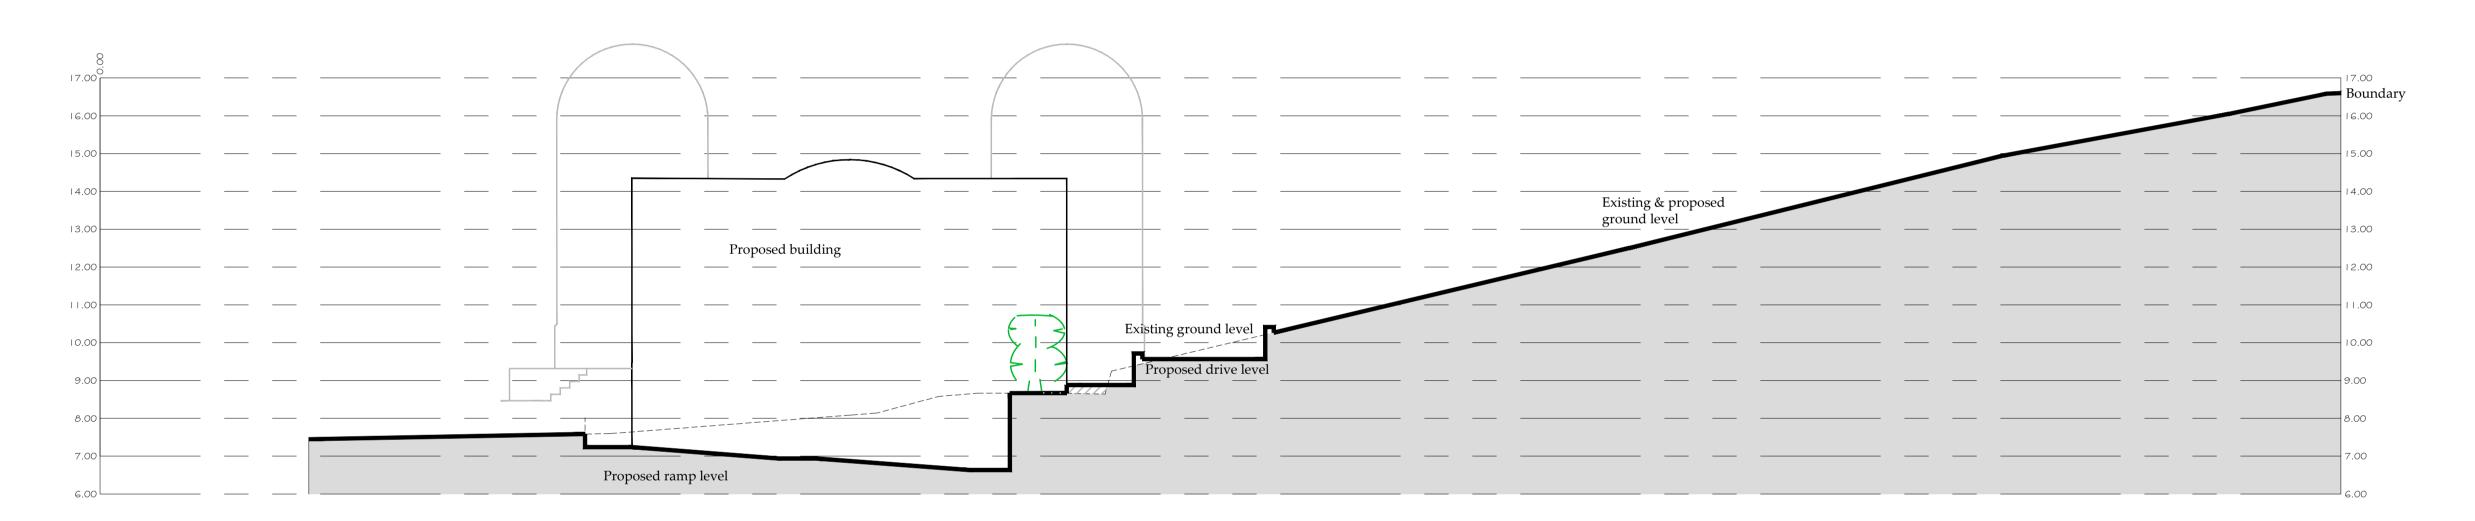
Section C-C Scale 1:100

Existing & proposed ground level Proposed building Existing ground level
