REPORT ON A
STRUCTURAL INSPECTION AND APPRAISAL
OUTBUILDING/FORMER BARN - STOUPE BROW FARM

26 August 2010

Our Reference: 10 C 173 vp

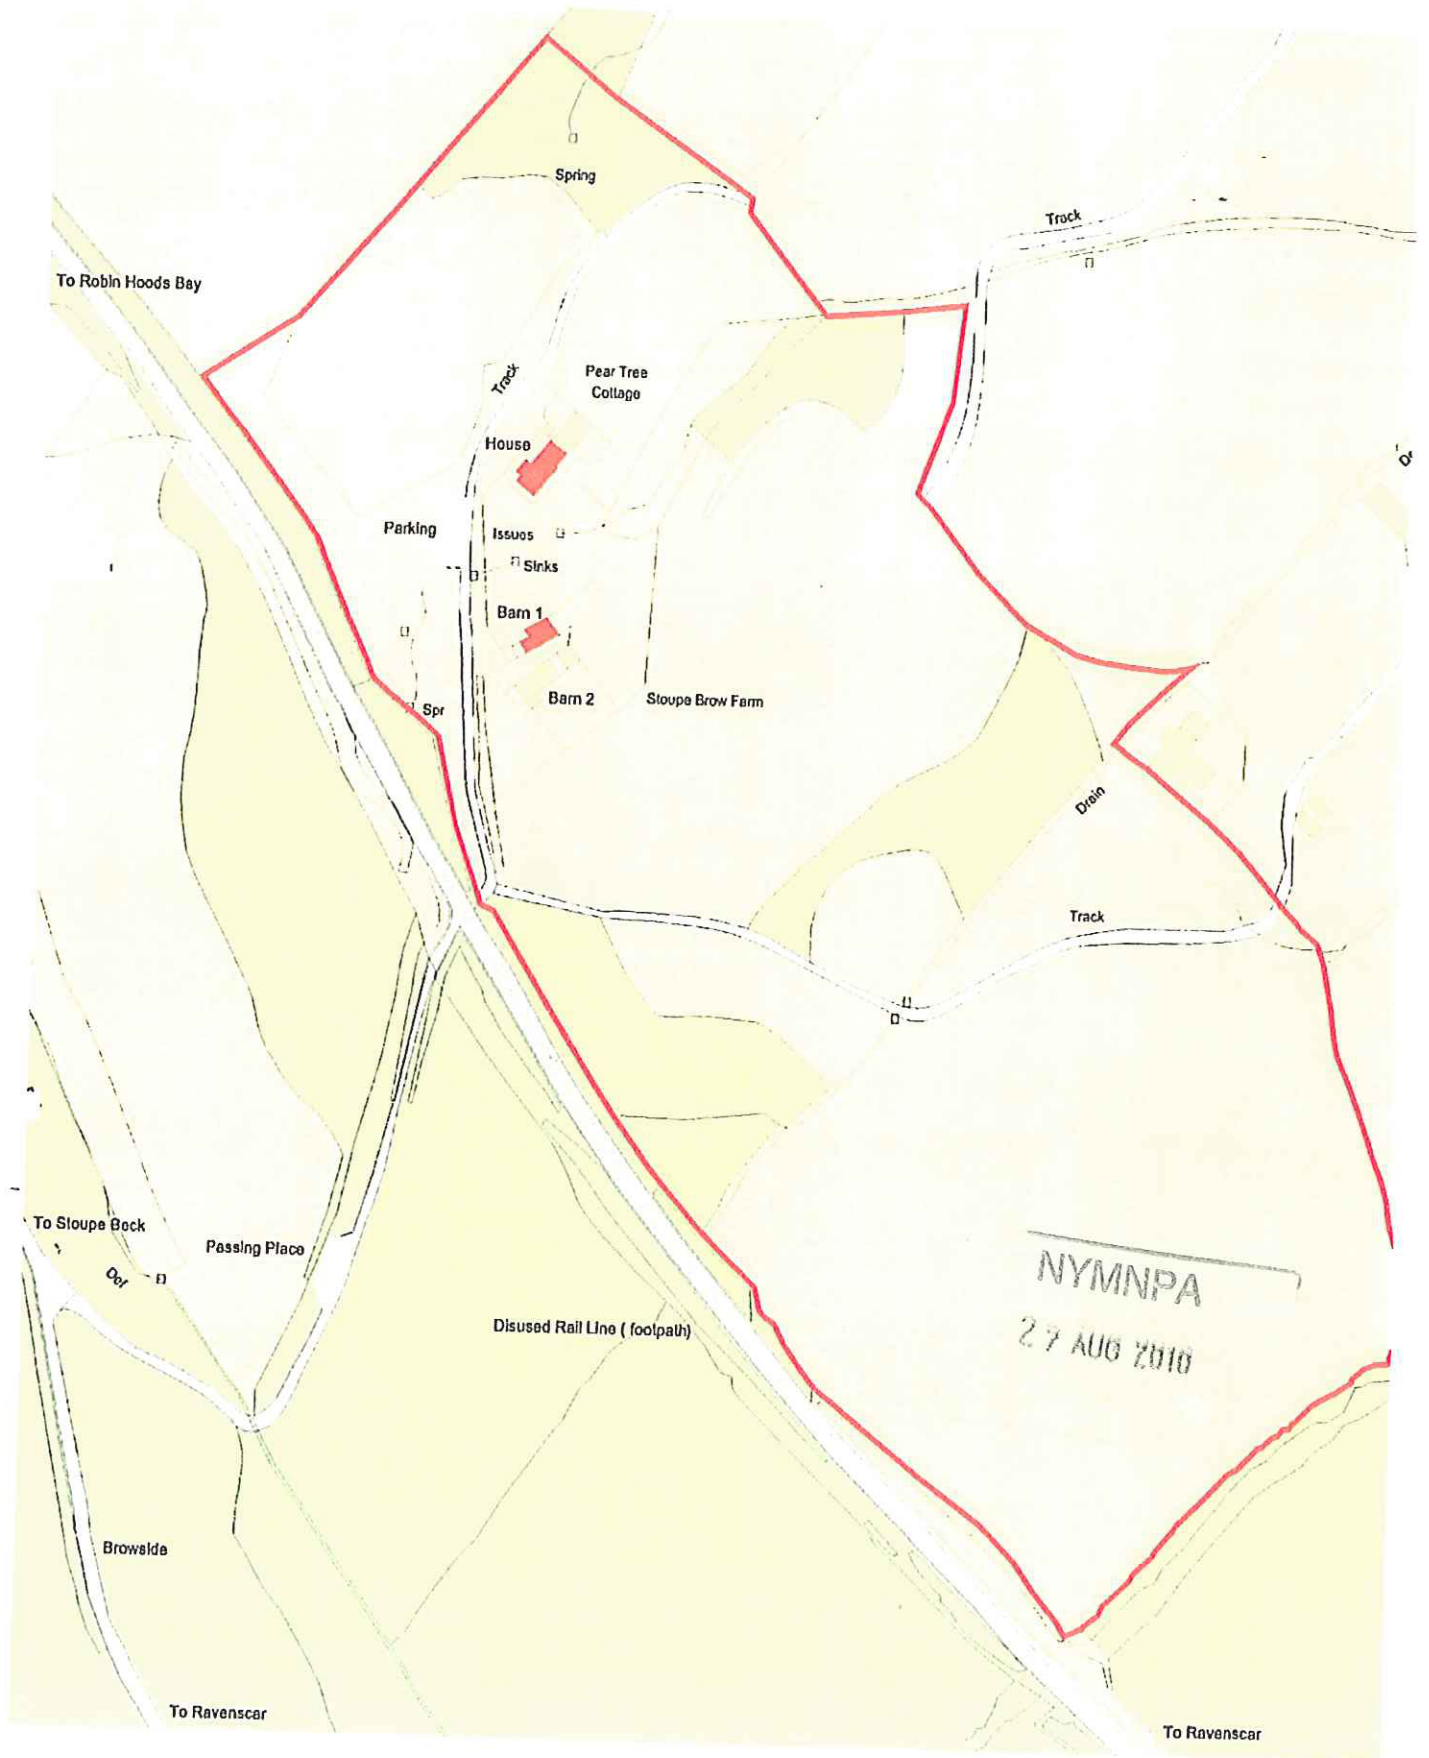
- 1.2. The outbuilding is marked in red as part of 'Barn 1' on the attached copy of the architect's location plan, drawing 01, attached to this report. For convenience the subject building will be described as Barn 1, although it is an independent 2-storey stone built structure adjoining the roofless stone walls of what was formerly a larger barn.
