ALTERATIONS at 13 BARTONS ROW EGTON WHITBY

Drawing: PROPOSED ELEVATIONS.

Drawing No. 198/11 Date: JANUARY 2018 Scale: 1/50

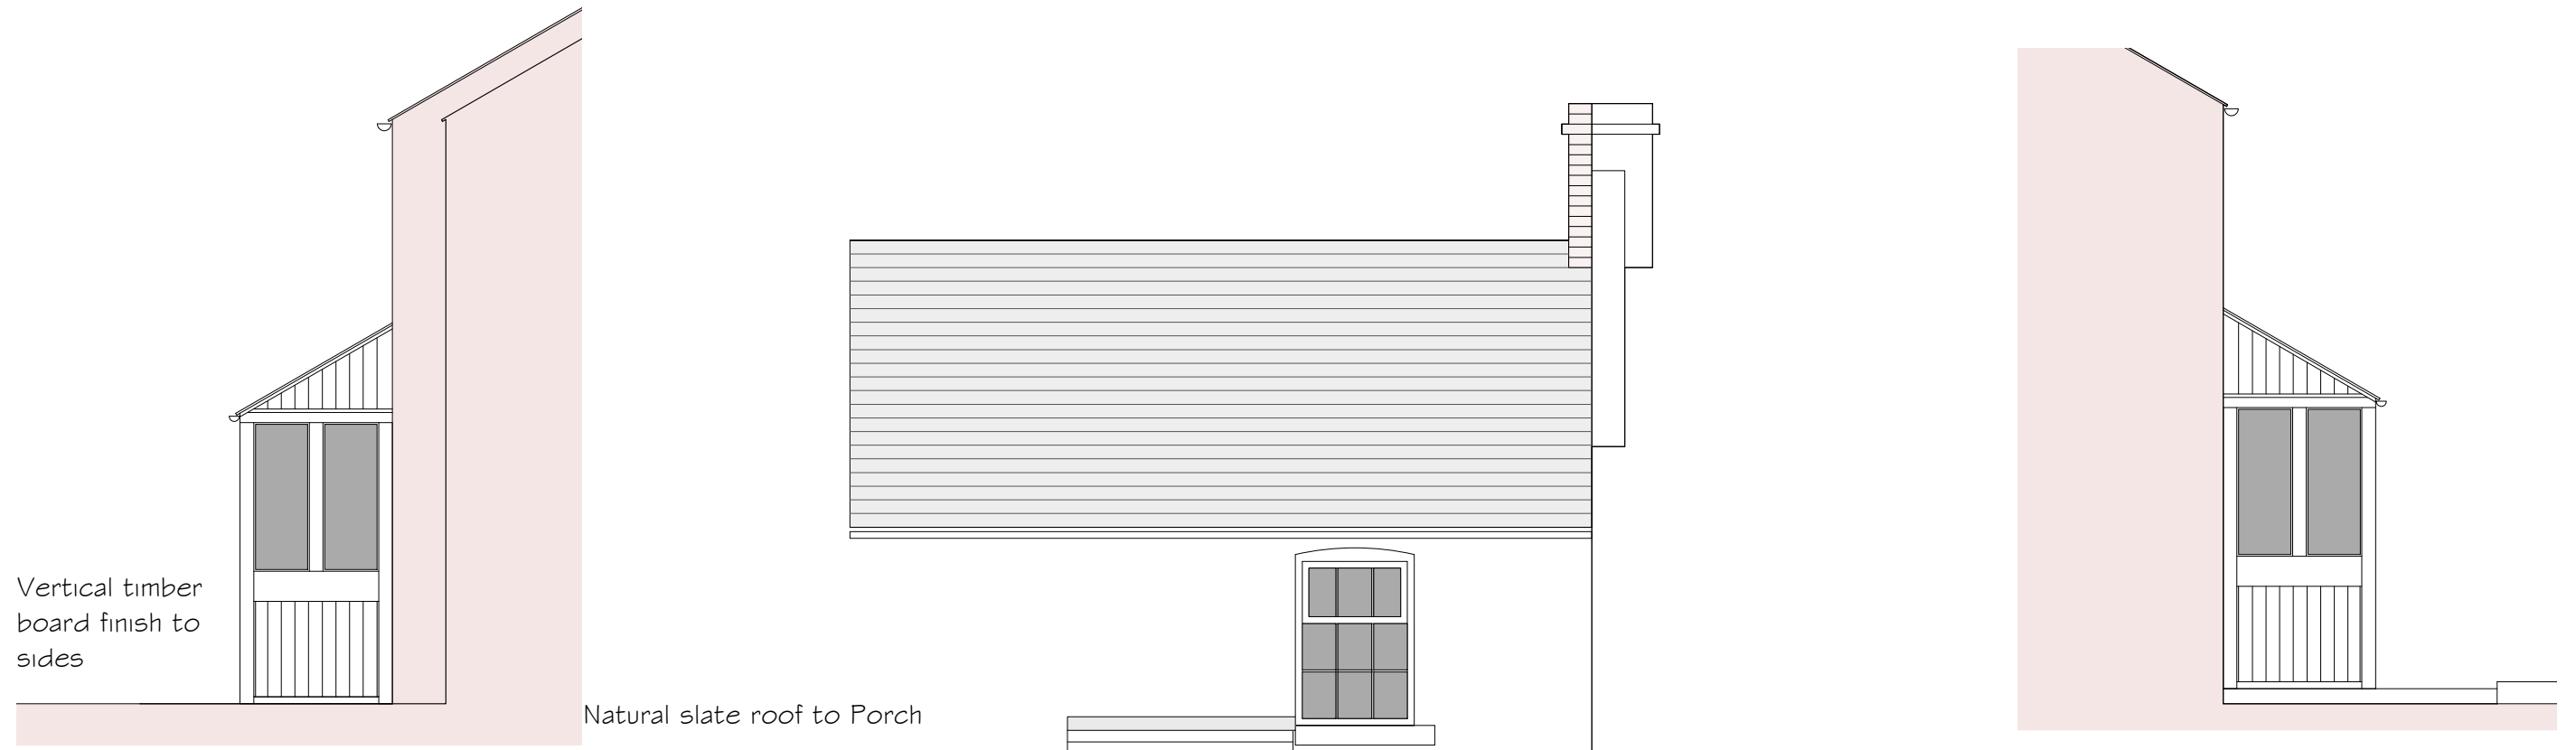
Natural slate roof to Porch

75mm diameter half round uPVC rainwater gutter. 50mm diameter uPVC fall pipe. Discharge to gravel.

Timber framed structure to form new Porch. Glazed panels using safety glass. Composite door with timber grain finish.

Where levels reduced: rebuild retaining boundary wall or construct independant stone structure to match existing.

Existing wrought iron gate to remain. New gate opening to be created in stone wall as shown. Timber gate posts to match existing & timber gate.
