## DESIGN & ACCESS STATEMENT

#### TOFTA FARM, STAINTONDALE

# Bat, Breeding Bird and Barn Owl Scoping Survey Tofta Farm, Staintondale

# Structural Condition Report on Existing Barn

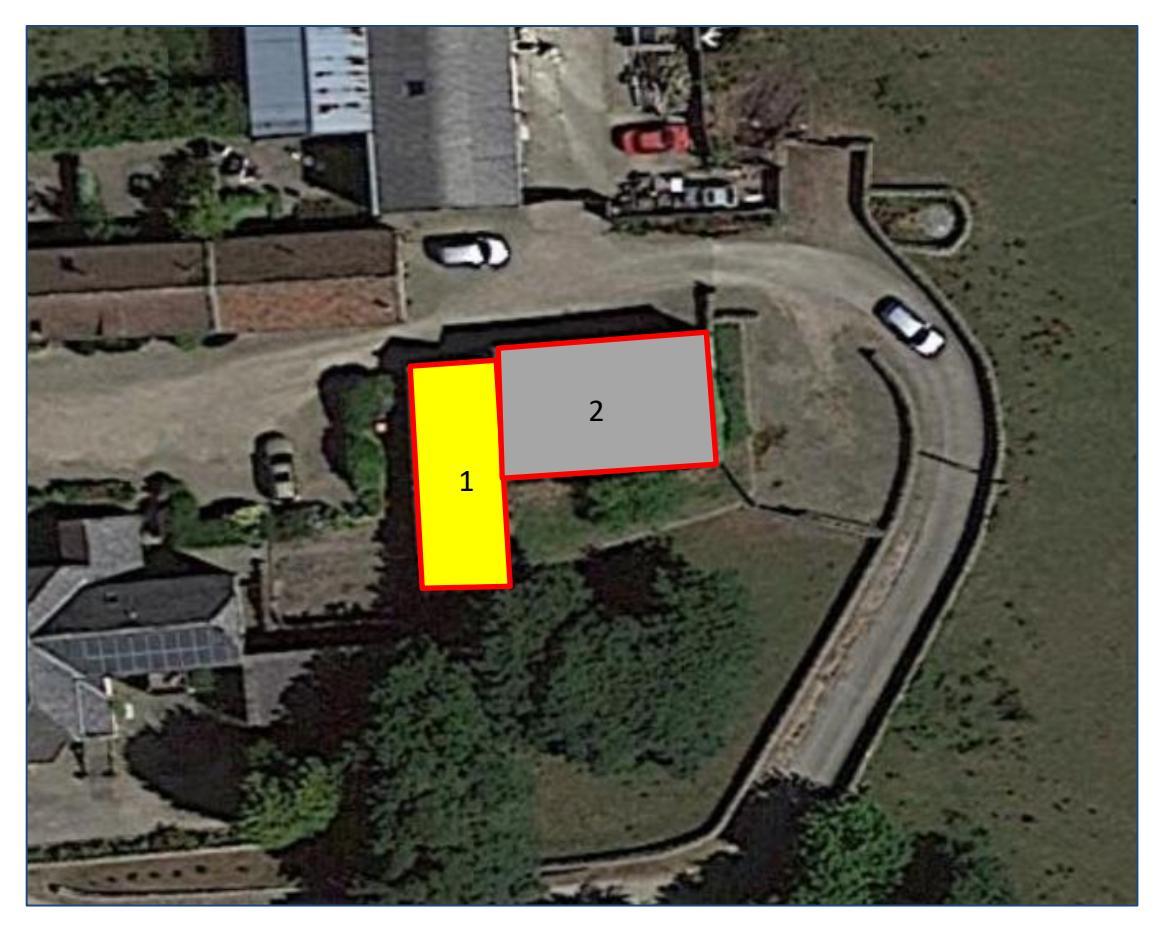
Figure 3: Visual inspection results

Building ref.	Description	Features with potential bat roost habitat (PBRH).
1 – Very	One-storey stone-built building, with a relatively	Small area of
low	new roof. Tiles are generally well-sealed, and only	access under
potential	potential access between tiles and liner is at	lowest course of
risk of	lowest course of tiles on western aspect of	tiles.
supporting	building. No evidence of bats identified in this	
bats	location, and no evidence found internally. No	
	evidence of breeding birds.	
2 -	Modern constructed building, which is very well-	No PBRH.
Negligible	sealed. All potential crevices have been sealed	
risk of	with expanding foam. No evidence of bats	
supporting	identified, and no evidence of breeding birds.	
bats.

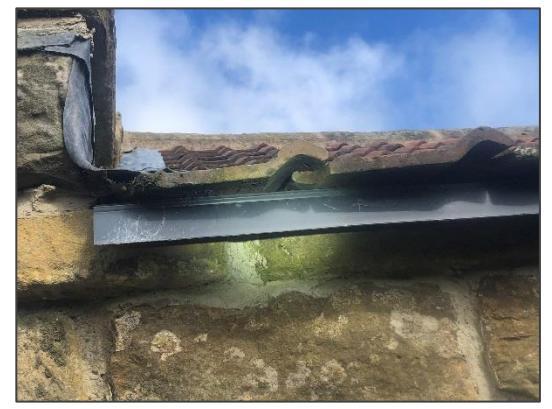
Photo 3: Potential access on Building 1.

The current proposals will have a negligible impact on any potential bat roosting habitat. Therefore, no further surveys are necessary. However, should proposals change, and the roof, the roof liner or the potential access noted on western aspect be altered in any way, further survey effort would be required to determine presence/absence of bats.

9.2.2 Should the plans change, and should any alterations be required to the roof, the roof liner, and the potential access noted on western aspect under lowest course of tiles, then bat activity surveys in line with current Bat Conservation Trust Good Practice Guidelines will be carried at the appropriate time of year (May-September) and in suitable weather conditions.

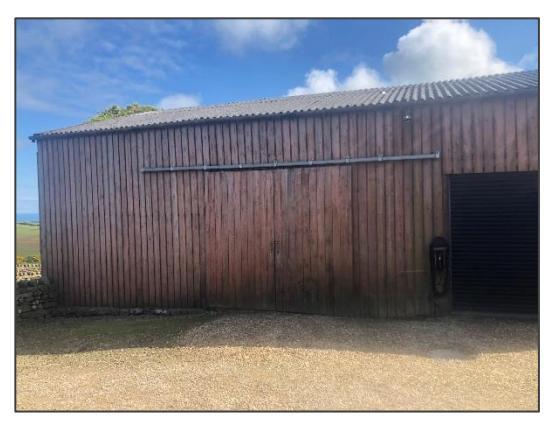
Building 2 is of negligible value for roosting bats, generally due to the construction materials used, and lack of suitable crevices.

Photo 5: External view of Building 2.

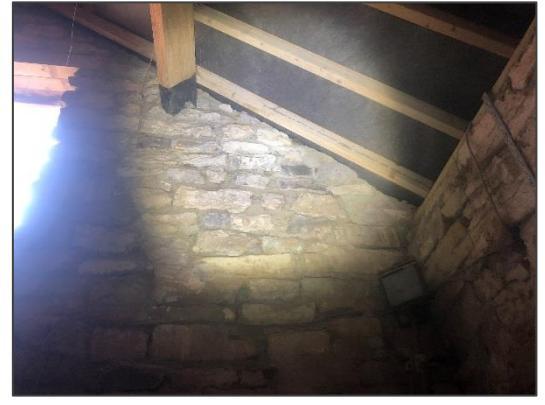
Photo 4: Internal view of Building 1, and well-sealed wall tops.

We can rule out any use of the buildings by bat species which require a covered void to fly in, including by maternity use. Internal conditions were undisturbed and dry, and there was dense cobwebbing within the internal roofs which are optimal for the preservation of bat droppings and feeding remains. We would expect to find bat droppings within the voids should a maternity roost be present on site.

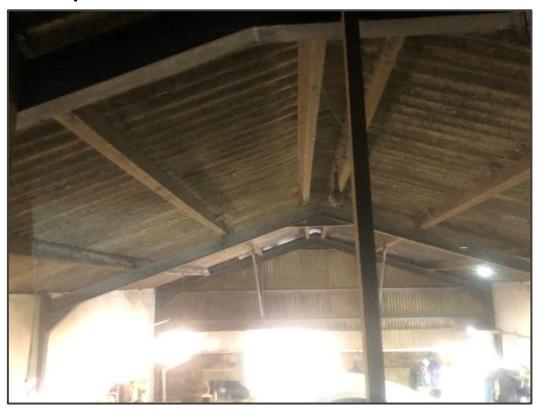
Photo 6: Internal view of Building 2.

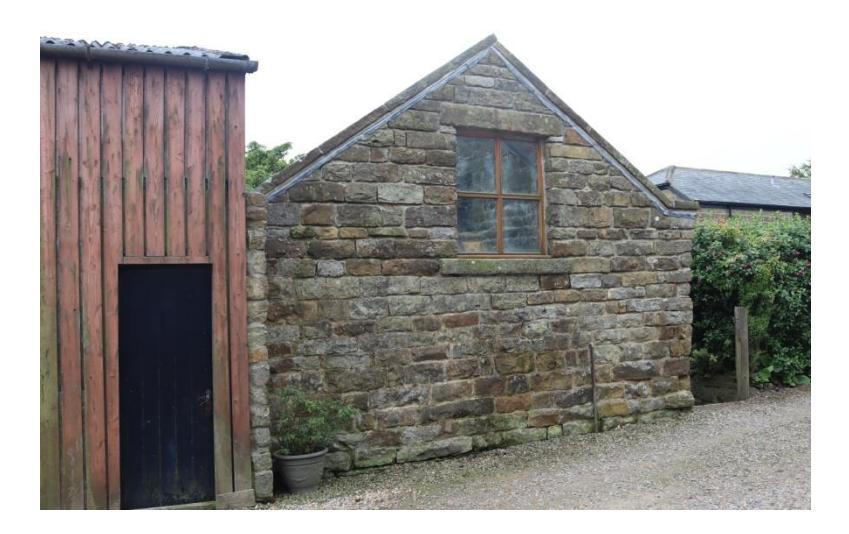
(a) A short length of the existing west wall, towards the front, exhibits outward bulging at eaves level. This could have been caused by spreading of a former roof truss at this point. It is not considered serious structurally.

(b) Whilst overall the current external stonework is well pointed there is a small section , in the area of the wall 'bulge' mentioned above that requires pointing attention. Also ,the east side wall will require renovation and pointing when the workshop building is removed together with new lintels to proposed windows.

Front, North Elevation Shed along side to be removed

Eaves level bulge / missing pointing in west wall

- Repoint small area of external joints to stonework in the vicinity of the wall 'bulge'
- Provide metal corner straps say 40mm x 4mm, minimum leg lengths of say 1m each way. Say 4 no vertically at internal corners, plugged and screwed (heavy duty) or resin anchored into strong points in the existing walls.
- The conversion will need to comply with current Building Regulation requirements and ass such the following will be needed ;
  - Provide insulation and topping screed to ground floors
  - Add additional timbers to the underside of existing rafters to create sufficient depth for the required roof insulation /air gap
