Supplied by: Stanfords 21 Nov 2019 Licence: © Crown Copyright and database rights 2019 OS100035409 Order Licence Reference: OI1363861 Centre coordinates: 495211 505068 3, Bloomswell, Robin Hoods Bay, Whitby YO22 4RT

NYMNPA 09/10/2019			Sill
Totali Solutions Ltd		Drg Ref; TW-SD1	External Frame Tolerances to BS 644:2003
147 Traditional Weights	Section Details	Drawn; GC Scale 1:2 A3 Date; 23rd Sept 2019

Alterations

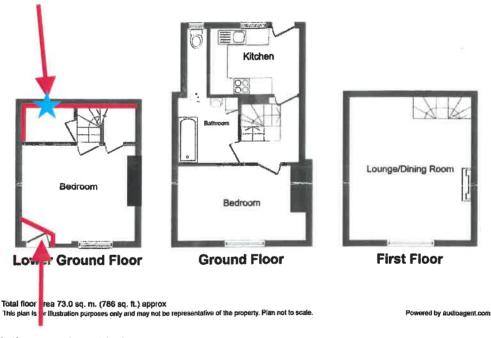
FLOOR PLAN

Existing Damp proofed stud wall with gypsum plaster board and skim

Existing porch put in by previous owners to change ground floor lounge to become a bedroom and not open directly onto the street as the property was for holiday rental.

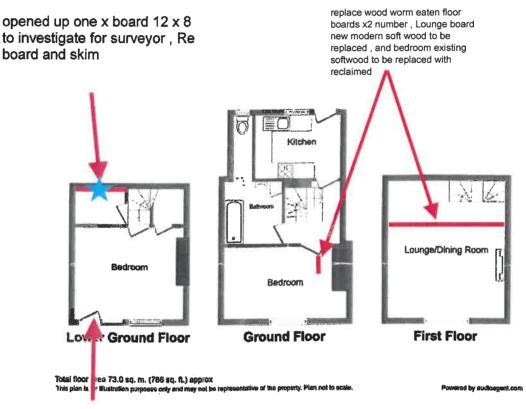
FLOOR PLAN

Remove porch which has been screwed to existing substrate and make good
