**From:** [Building](#)  
**To:** [Planning](#); [Kelsey Blain](#)  
**Subject:** Comments on Mount Misery, Hackness - NYM/2019/0842/LB & 0841/FL  
**Date:** 27 January 2020 16:31:16

Mount Misery is a Grade II Listed Building dating from the late 18th century and constructed of dressed sandstone under a pantile roof with traditional single glazed 12-pane Yorkshire sliding sashes to the principal elevation. Externally the building appears to be relatively unaltered, except for the insertion of 2 modern windows (evidence of openings being enlarged) and a small dormer to the rear (all single glazed). Whilst these modern insertions are not mentioned in the list description, they have certainly been in situ since before 1995 and along with the date of listing of 1987 it is considered that these changes could have been carried out prior to listing. Outside there are several small stone and pantile outbuildings as well as more modern timber structures. Overall this building is considered to be an attractive farmhouse retaining both architectural and historic interest and the character of the site as a whole reflects the simple vernacular style of architecture and small scale form of deve

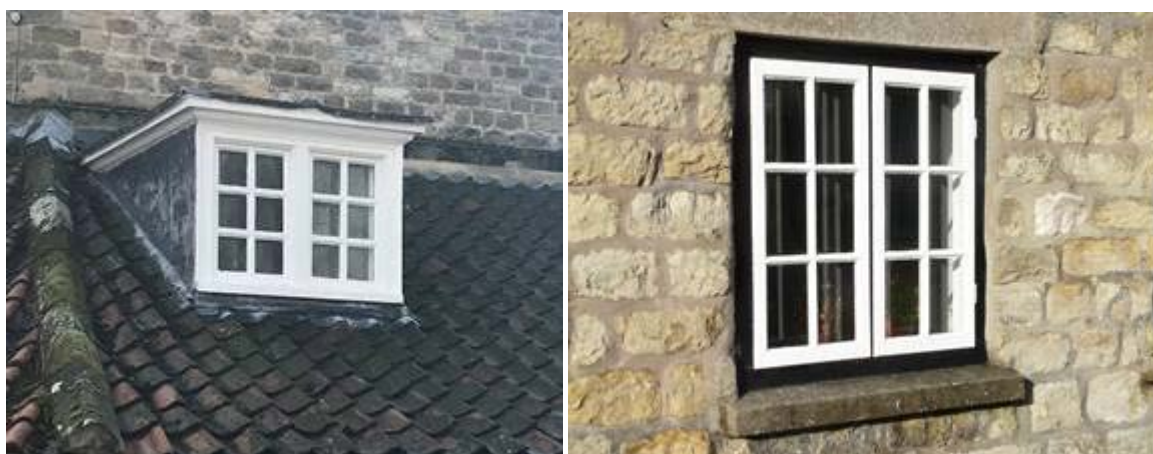
Below are examples of a well detailed casement which could be replicated:

All replacement windows should be of traditional construction incorporating weight bearing glazing bars. The use of slim d/g units will be necessary in order to achieve this and should be of 4:4:4 or 4:6:4 profile as a maximum. While the sectional details can be conditioned as part of an approval, we will require confirmation of this approach and amended plans prior to determination.
