DESIGN AND HERITAGE STATEMENT
PROPOSED ROOF ALTERATIONS
BALMORAL HOUSE, CHURCH STREET, STAITHES. TS13 5DB
FOR MR & MRS EVERARD.

DESIGN AND HERITAGE STATEMENT

BALMORAL HOUSE, CHURCH STREET, STAITHES

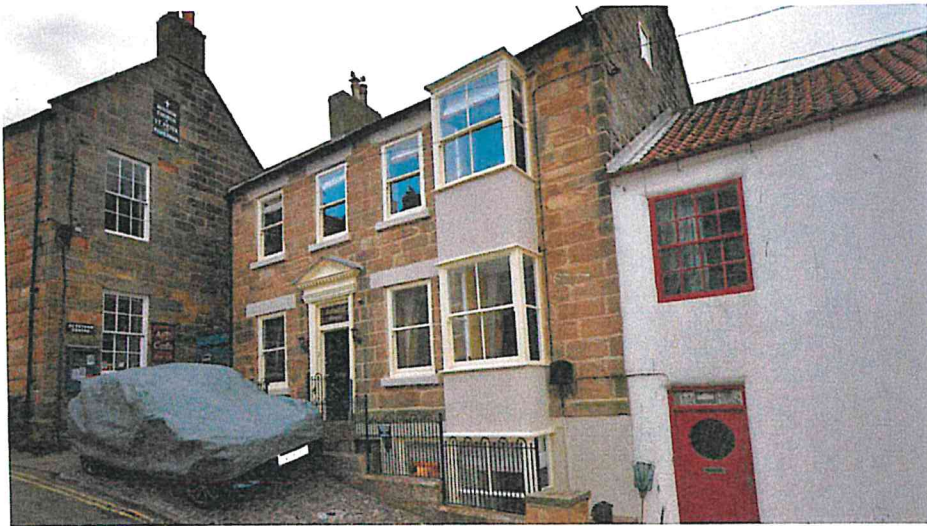
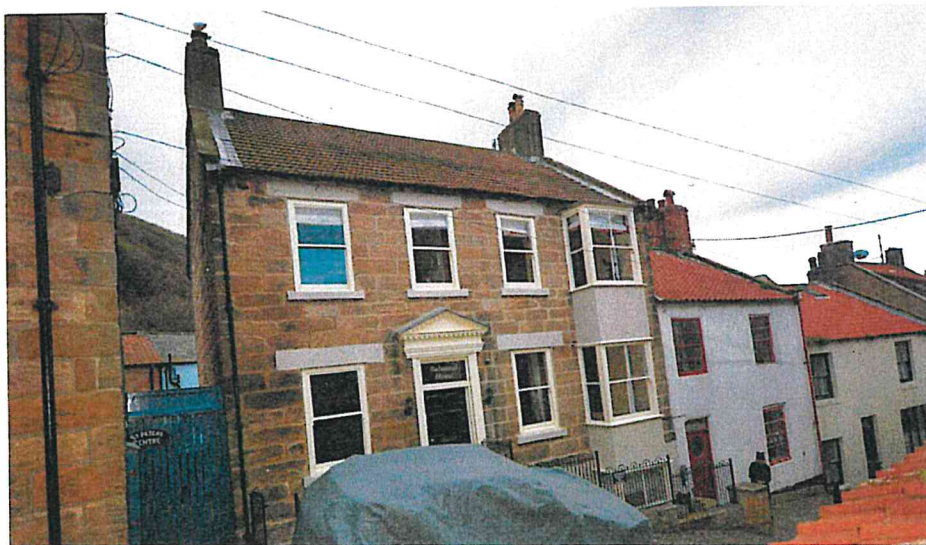
East – Front elevations of Balmoral House onto Church Street.

- Externally the roof finish was replaced with concrete tiles probably in the 1960's. The house retains stone copings to the roof and the chimneys are rendered probably onto brick. The windows are generally traditional sliding sashes and look original. Most rooms have sash windows with a single division but the arched stair window and two basement windows are small paned which may suggest that the original sashes were small paned and these were changed in Victorian times. Window openings to the front have simple stone heads and weathered sills – there are no separate sills at the rear. The entrance door has a timber surround and pediment with dentil mould which will be modern but may replace an earlier surround. Strangely there is one Yorkshire horizontal sash window at basement level on the front elevation.

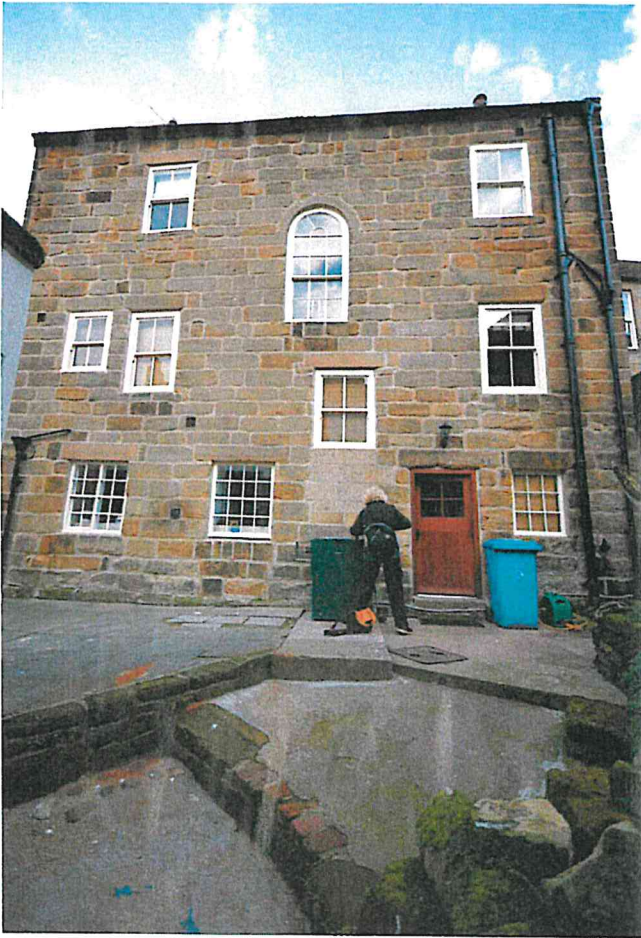
Rear – West Elevation onto private yard.

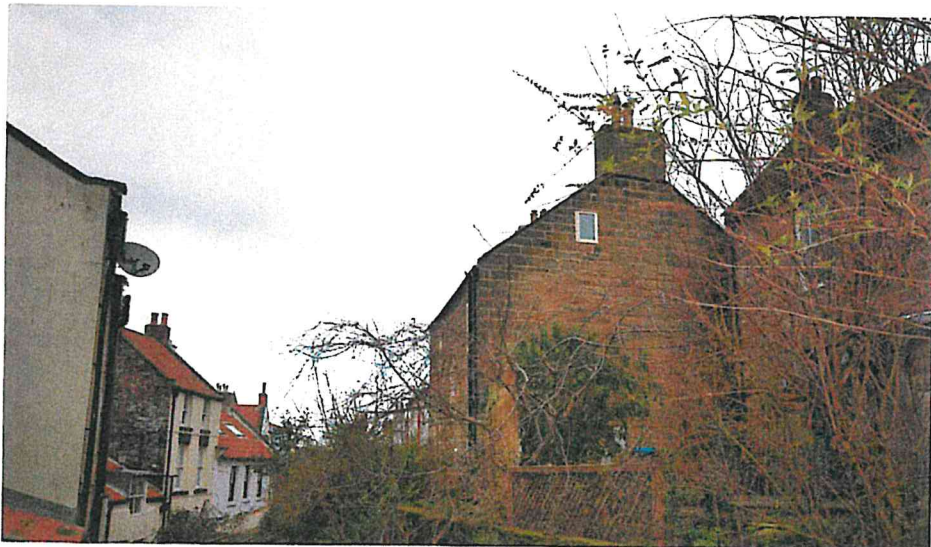
South Gable Elevation.
