example of proposed finishes

proposed summer house - scale 1:100@A3

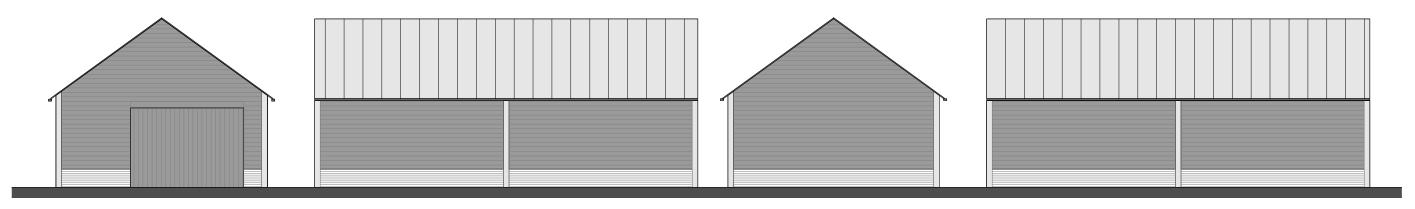
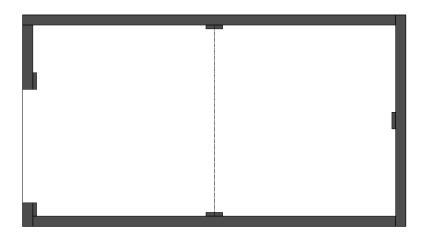
horizontal shiplap boarding to have black stain

example of oak corner post with specialist brick dwarf wall on brickwork to match the existing dwelling

treated oak posts - 150 x 150

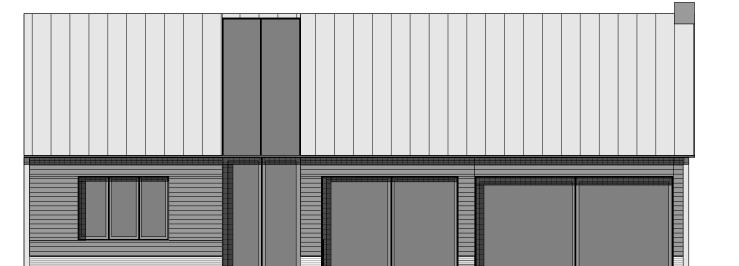
roof glazing and vertical wall glazing to be on powder coated aluminium frame RAL ????
