Heritage Statement

First floor Refurbishment and sauna

Downhill Cottage, New Road, Robin Hoods Bay, YO22 4SF

Design and Access Statement

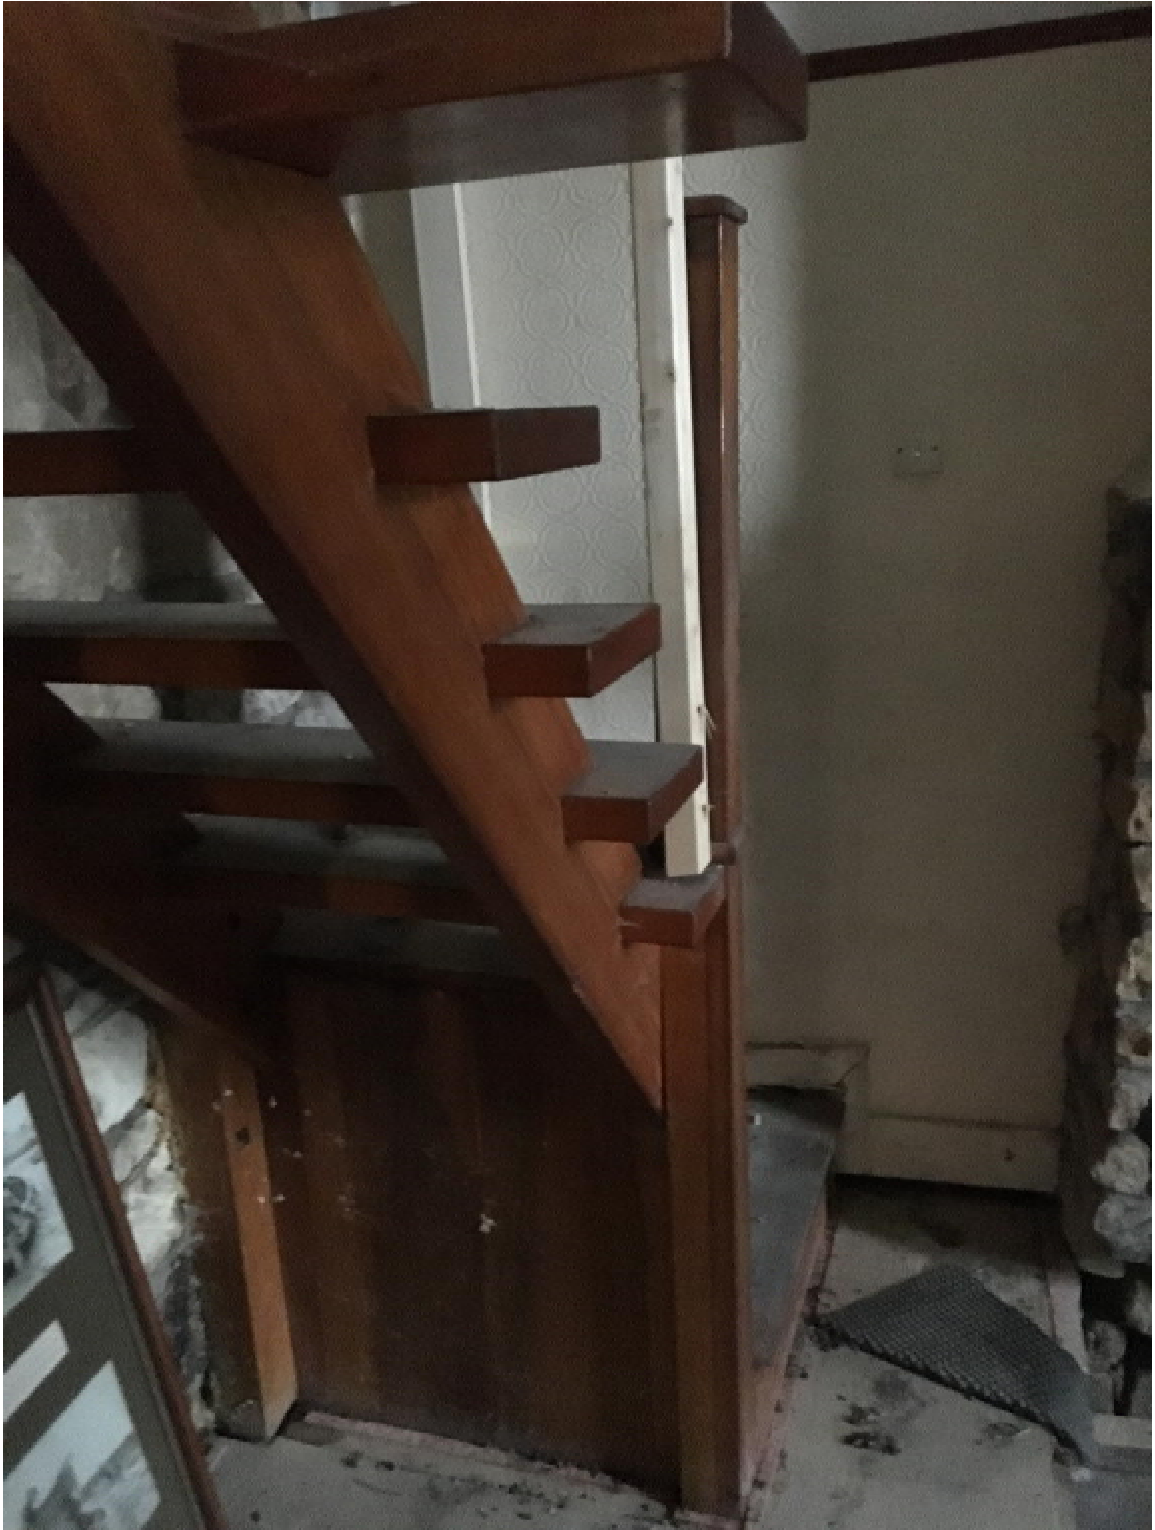
The ground floor is split into 2 rooms. A former kitchen and an adjacent living room. The living room has a modern (C20) open tread timber stair. The First floor is split into two bedrooms and a bathroom. Bedroom 2 and bathroom share window W4.

Photograph 1
Open plan stair to lounge

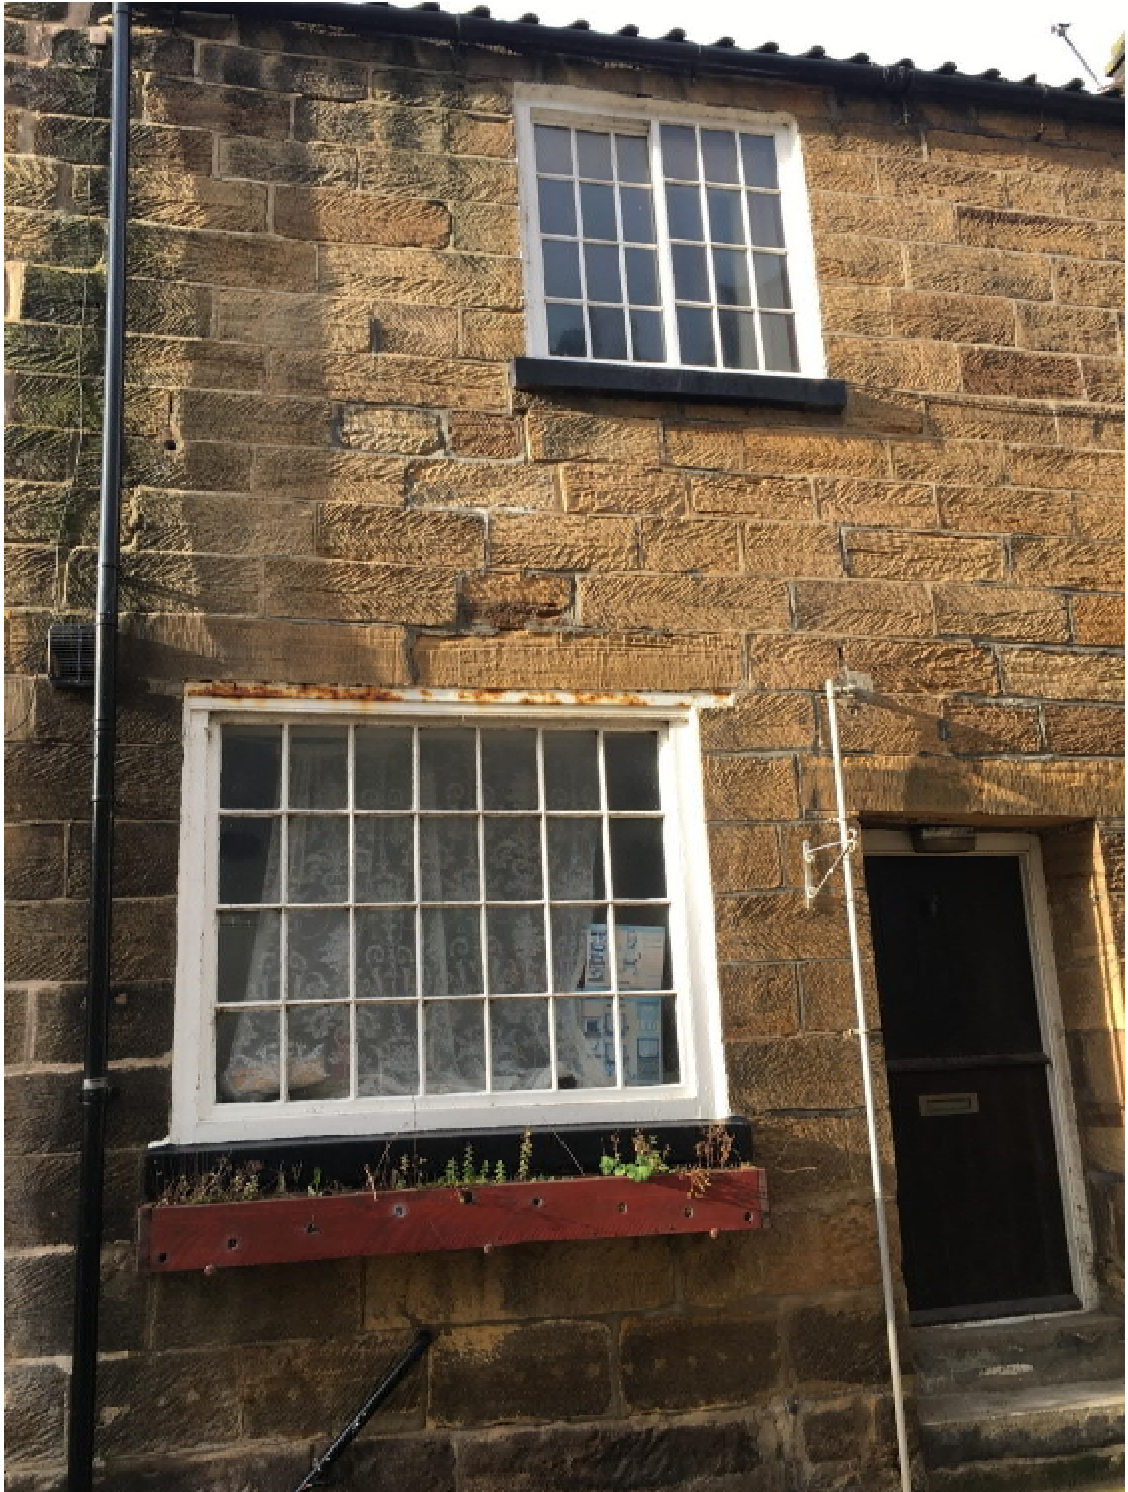
The kitchen window W1, has been amended at some point, although quite historic. It appears that due to a failure of the stone lintel above, a steel support was inserted below the stone lintel and cut into the coursed stone on either side. Possibly at the same point in time a fixed sash was inserted.

Photograph 5
Part Front Elevation, W1 and W3

The improvements to windows W1, W2, W3 and W5 have been approved under application NYM/2019/0794/FL.

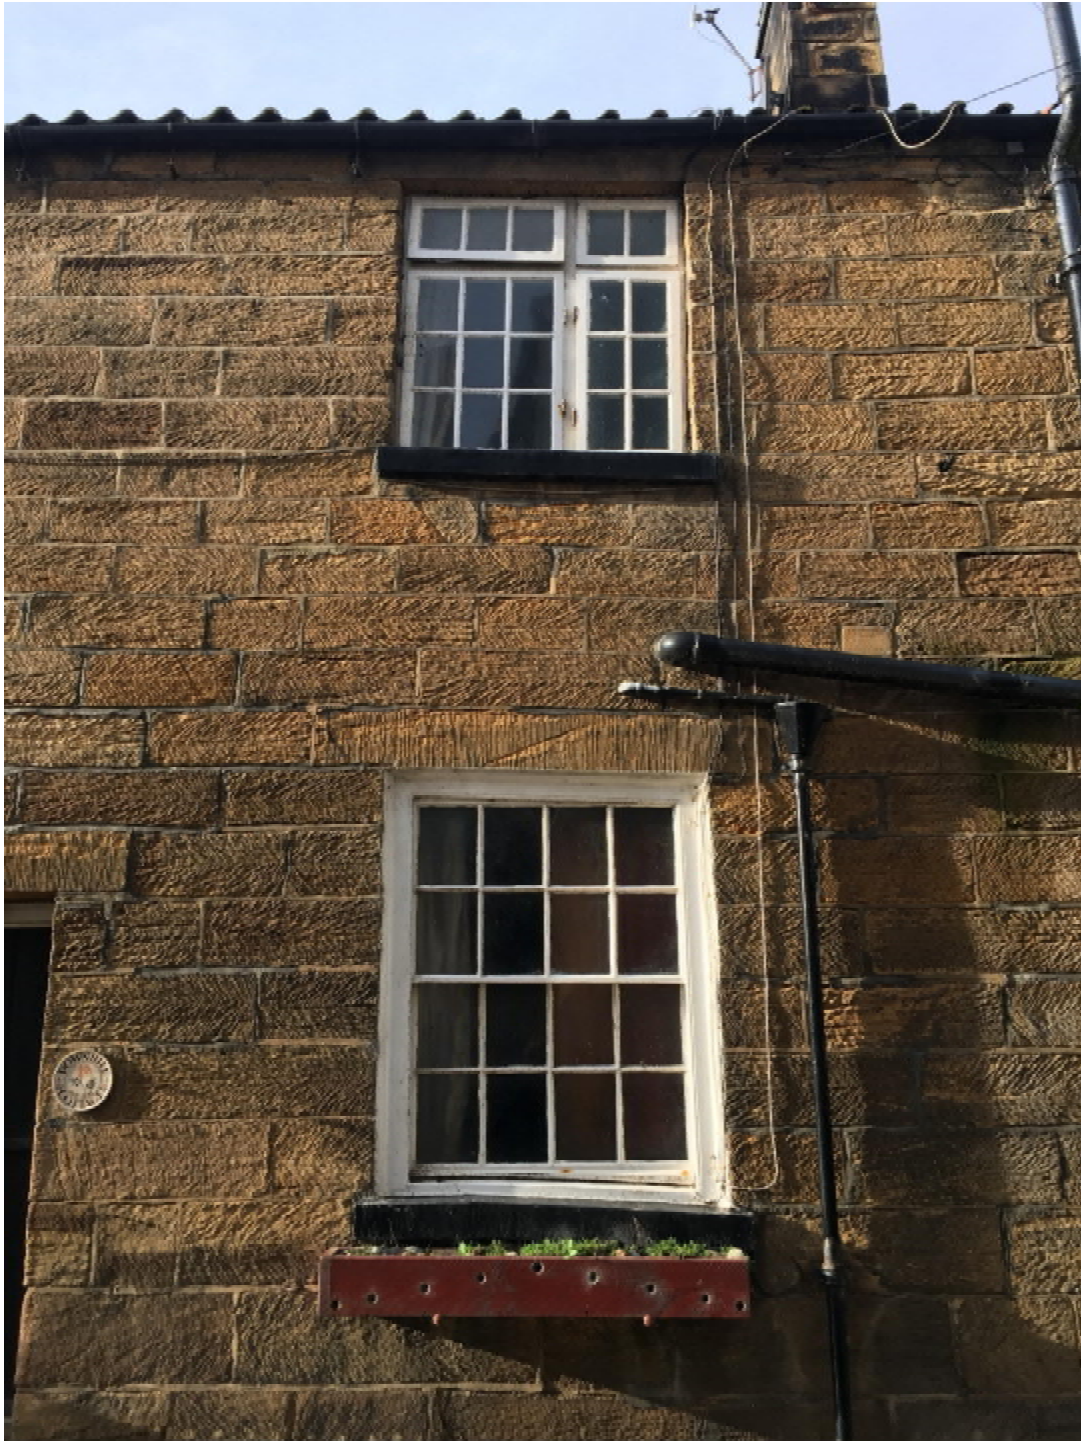
The front elevation contains 4 windows and the entrance door. The windows have undergone some alteration, in particular W4, which is a relatively modern casement window, presumably altered and replaced to allow the historic subdivision of a first-floor bedroom to create a bathroom.

Photograph 6
Part Front Elevation, W2 and W4

W4; The side hung casements will be replaced by a vertical sliding sash window. To match the new window W3

The window will all be timber painted construction and glazing is to be slimline double-glazed units. Separate panes for each subdivision.

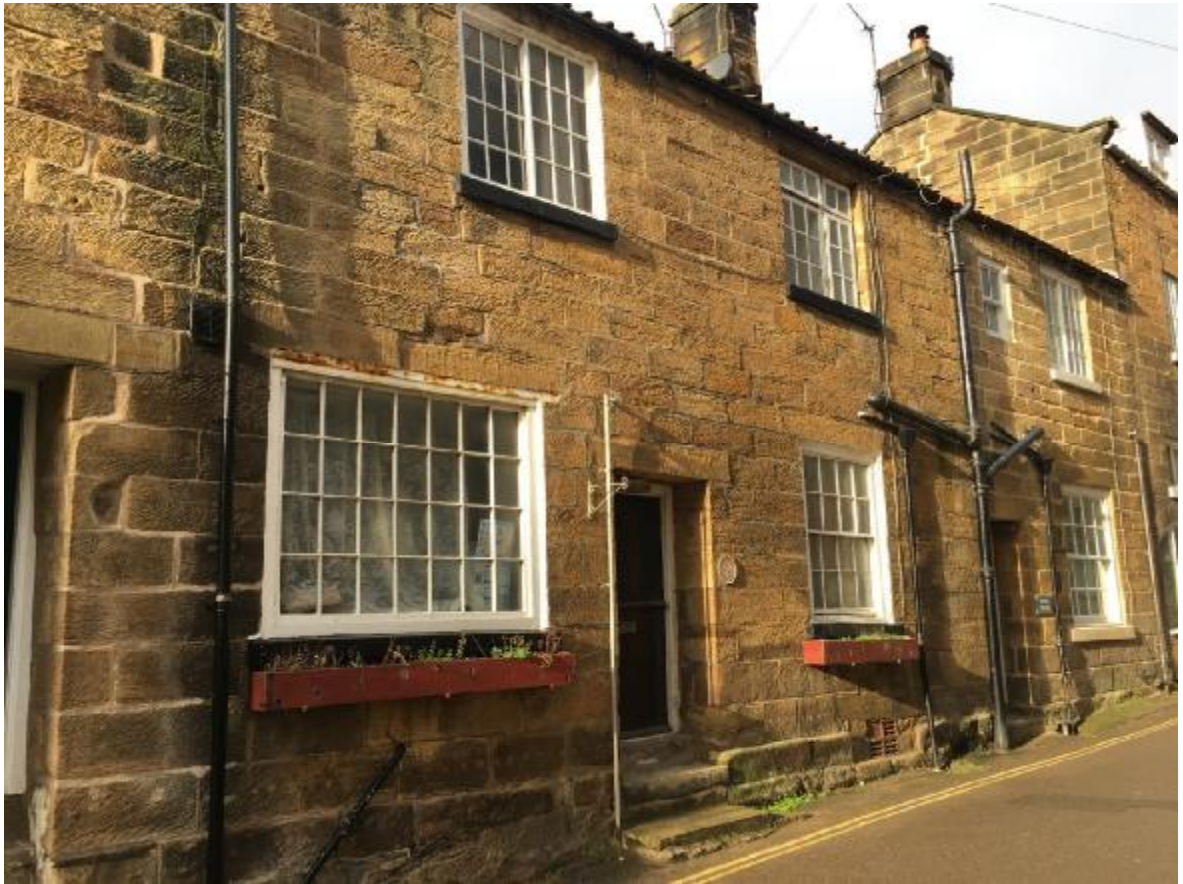
Photograph 7
Front elevation with Beadle Cottage beyond

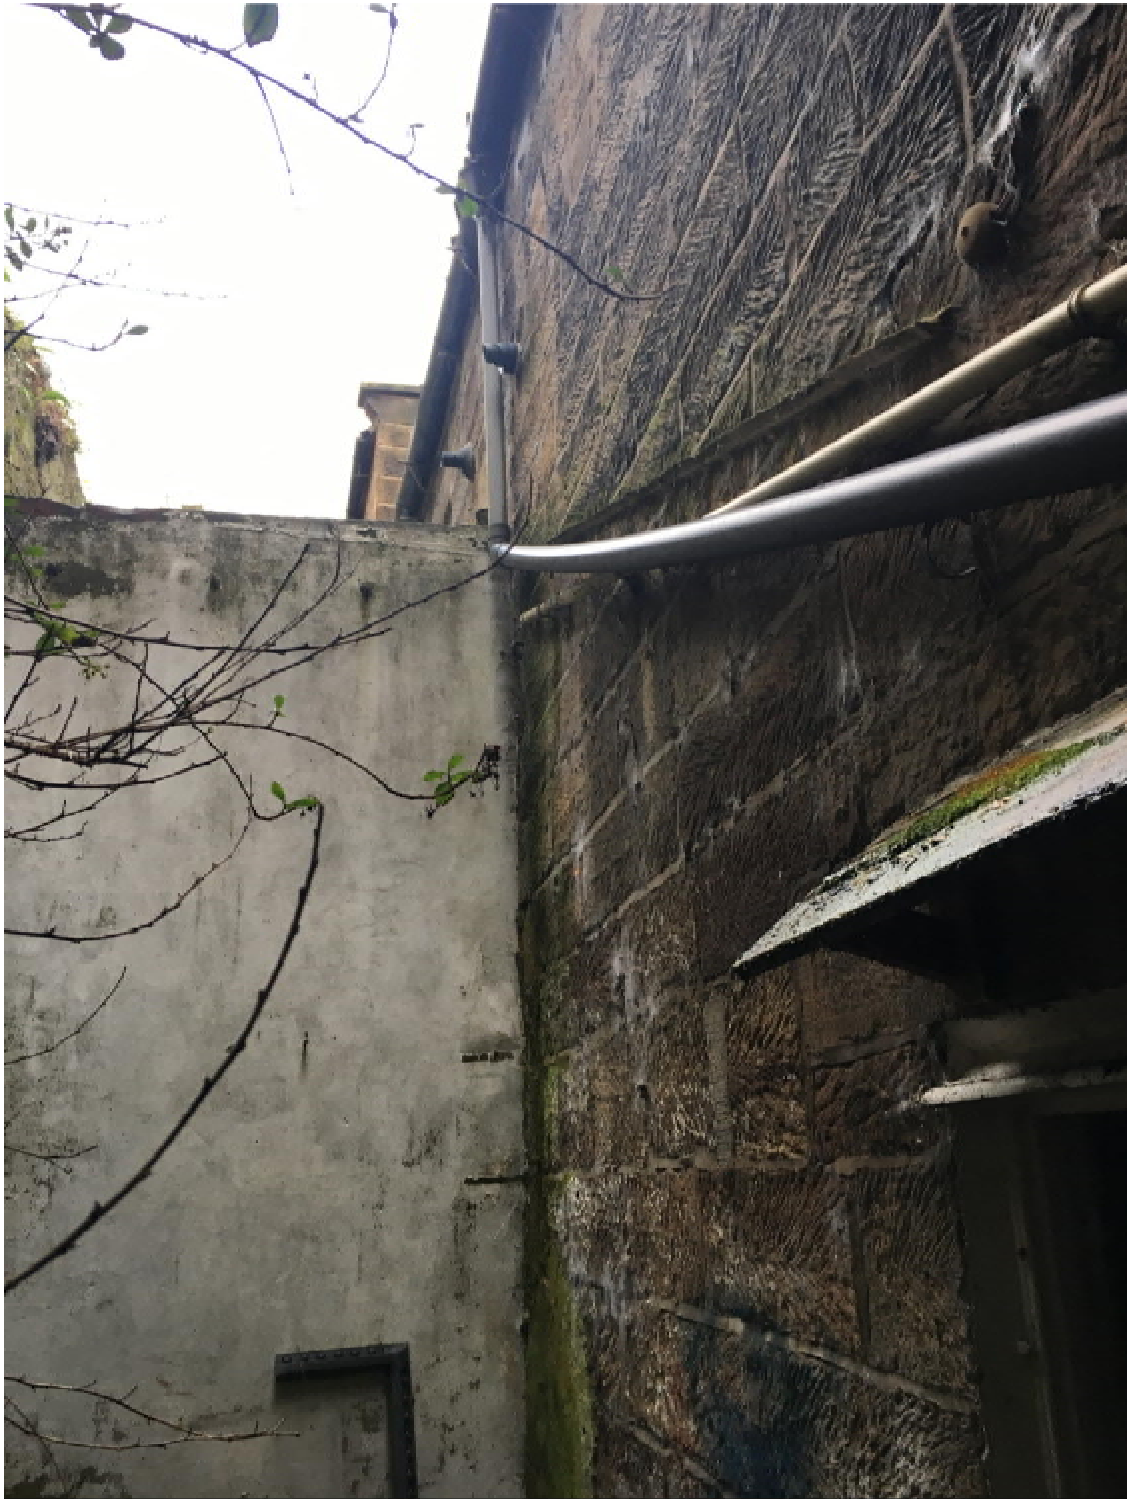
The Yard is bounded by 2/3 storey high Party Walls to either side and a very high (5m +) stone retaining wall to the rear. Due to its relative low position, the Yard will appear dark and damp for most of the time.

Photograph 8
Rear Yard looking at Party Wall of Beadle Cottage

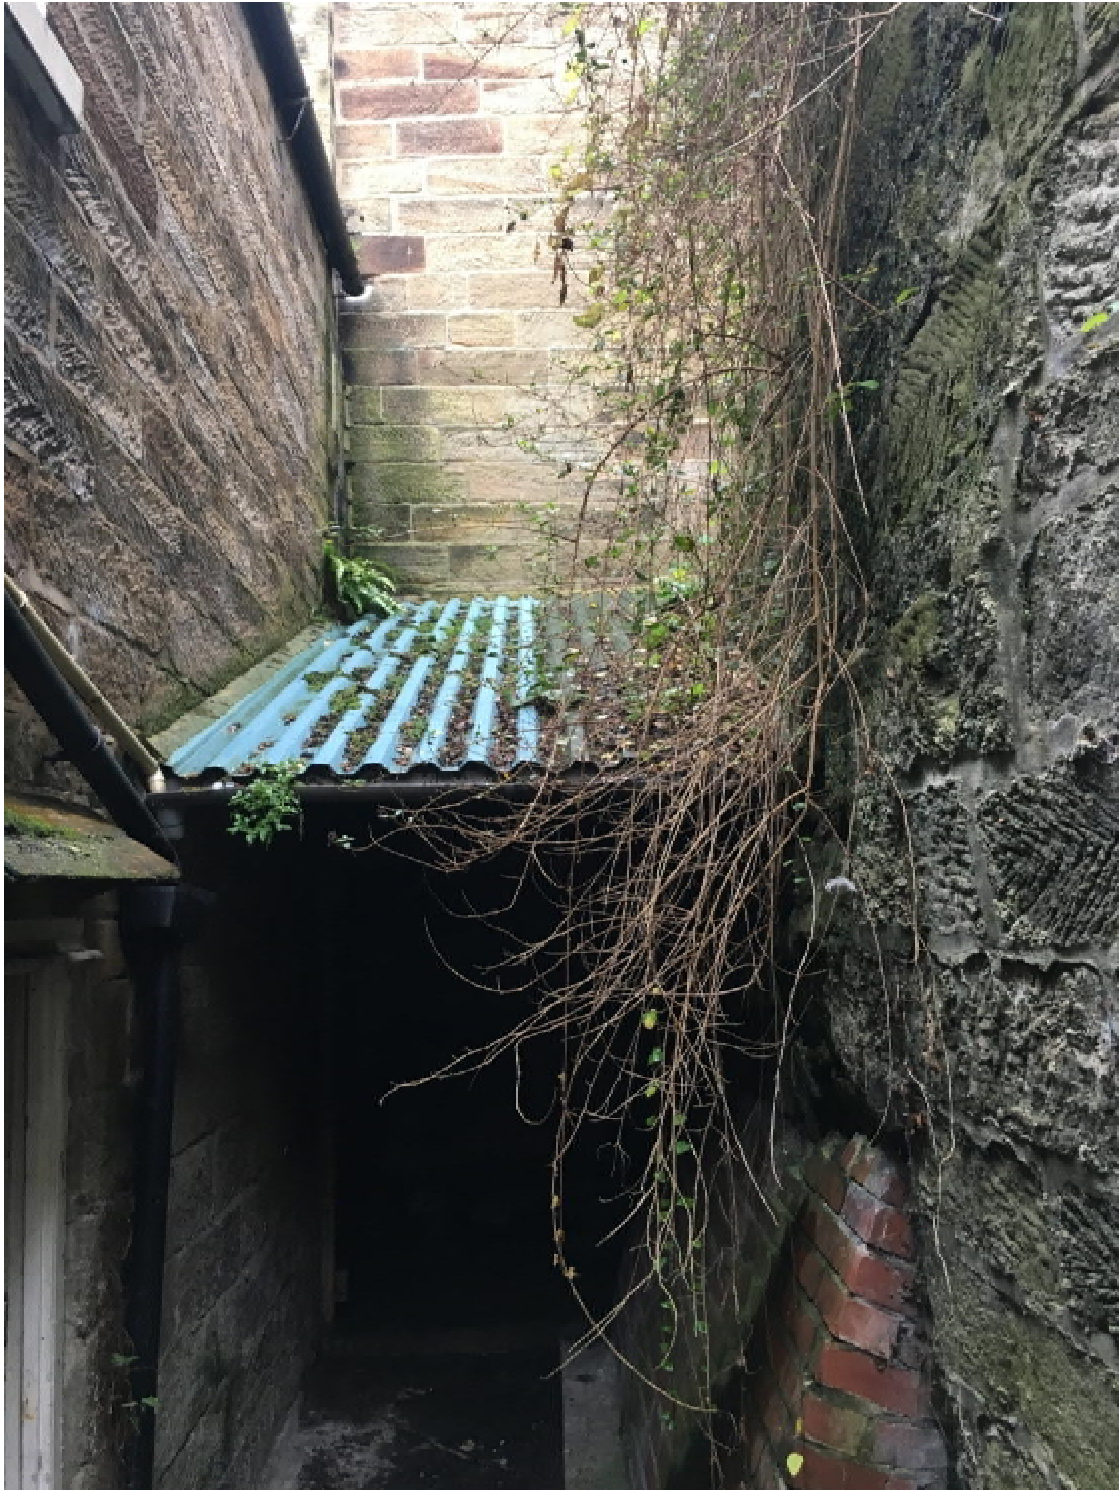
The rear retaining wall has a significant bulge in the centre and a relatively modern brick buttress has been constructed.

Part of the Yard has a modern steel sheet cover. Also apparent are the remnants of haunching, presumably from a previous roof attached to the rear house wall.

Photograph 9
Rear Yard looking at Party Wall to the south
Note; covered area and brick buttress

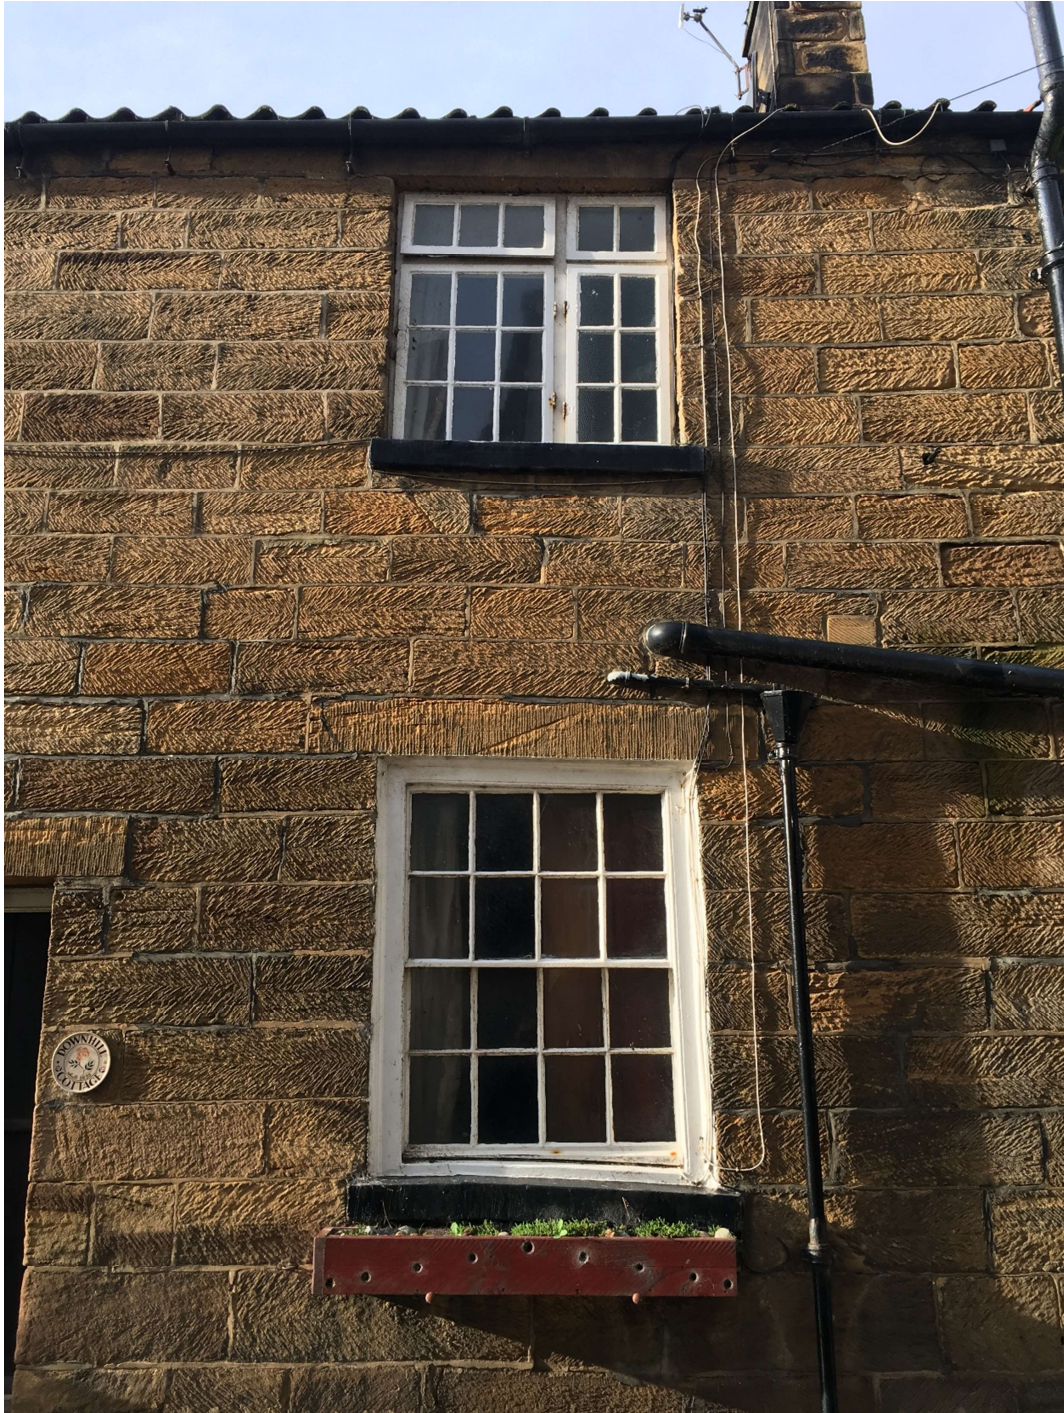
This application includes the replacement of W4. Currently this is a non-original window which appears to have been amended to suit a relatively modern room separation. The window now serves both rooms.

Photograph 1
W4, First floor window

W4; The side hung casements will be replaced by a vertical sliding sash window. To match the new window W3.

The window will all be timber painted construction and glazing is to be slimline double-glazed units. Separate panes for each subdivision.

W4, the current window, has been specifically created to suit ad-hoc sub-division of the first floor. The new window will reflect the historic and original design matching those approved recently.

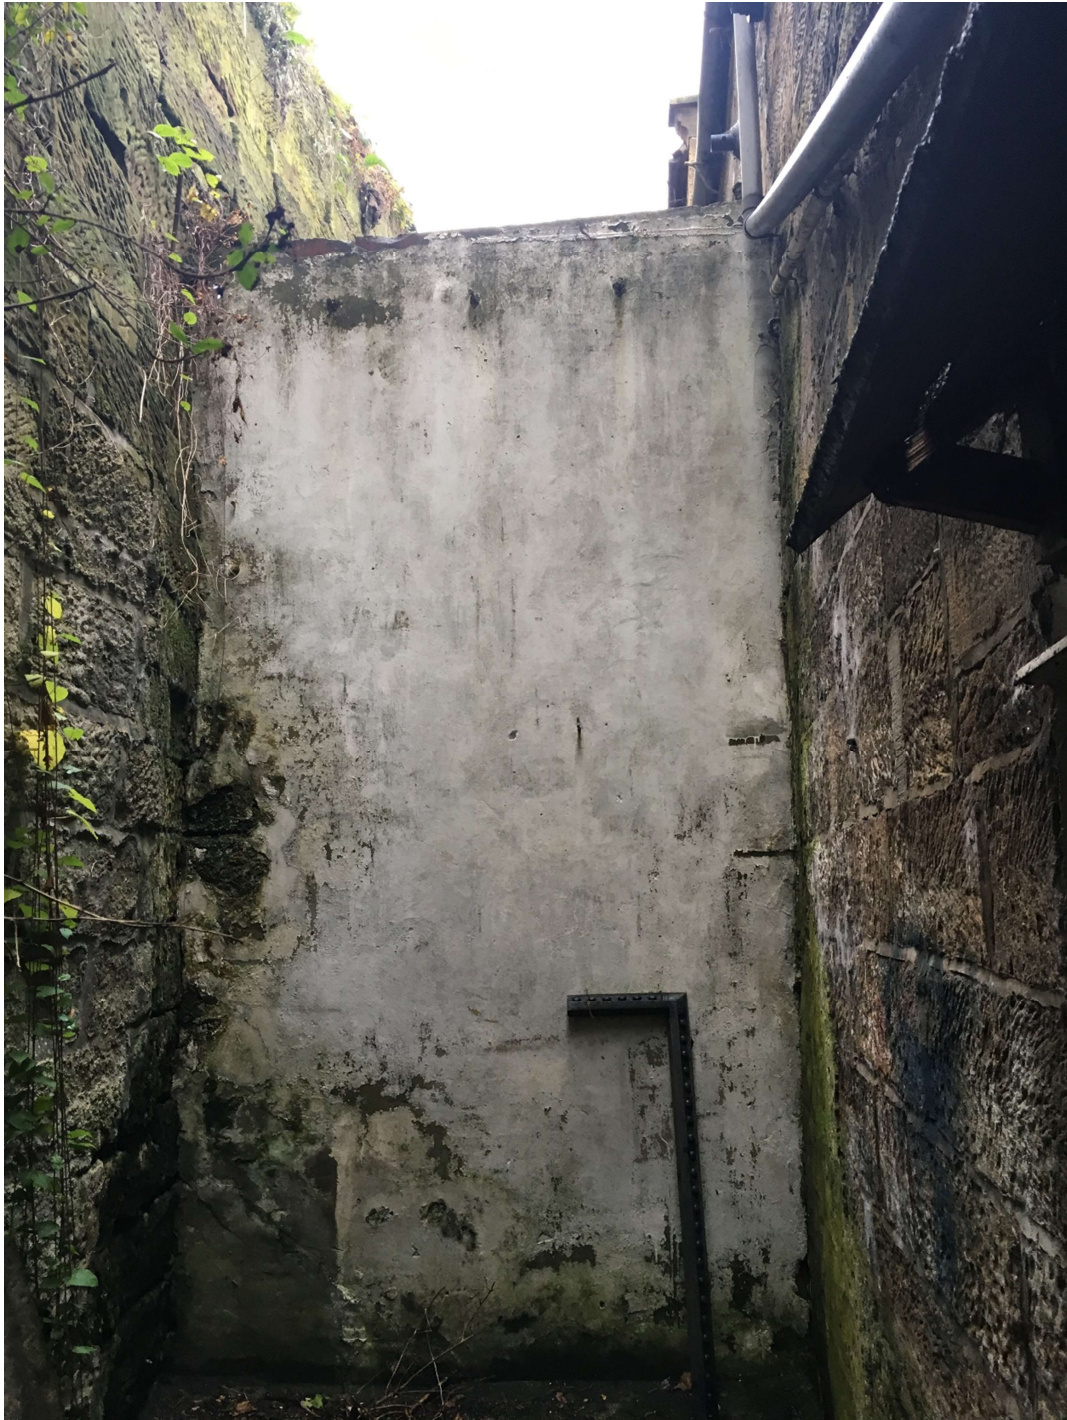
To the rear of the property is a small yard area. It runs across the full extent of the rear of the property and varies in depth between 1500 and 1800mm.

The floor has, at some point, been re-concreted to falls into a drain gully close to the rear door.

The yard is bounded by 2/3 storey high Party Walls to either side and a very high (5m +) stone retaining wall to the rear. Due to its relative low position, the yard will appear dark and damp for most of the time.

The rear retaining wall has a significant bulge in the centre and a relatively modern brick buttress has been constructed.

Part of the yard has a modern steel sheet cover. Also apparent are the remnants of haunching, presumably from a previous roof attached to the rear house wall.

Photograph 2
Rear yard, area to accommodate Sauna

In the rear yard area it is proposed to place a small free-standing Sauna building.

Sauna; The requirement is driven to improve the amenity of occupants. It is placed in an area that has very limited use and not viewed from the street.

The Sauna will only occupy a small area of the yard, leaving the remainder for storage and utility space.
