**TITLE** DESIGN & ACCESS & HERITAGE STATEMENT  
**PROJECT** REPLACEMENT WINDOWS, REMOVAL OF FENCE AND  
ERECTION OF GARDEN WALL  
**CLIENT** Mr & Mrs Rajab

**VERSION** 1.0      **DATE** 05.12.2020      **JOB No**      **2036**

This statement accompanies a planning application for the replacement of existing timber windows and the removal of garden fence with the erection of a new boundary wall and entrance gate.

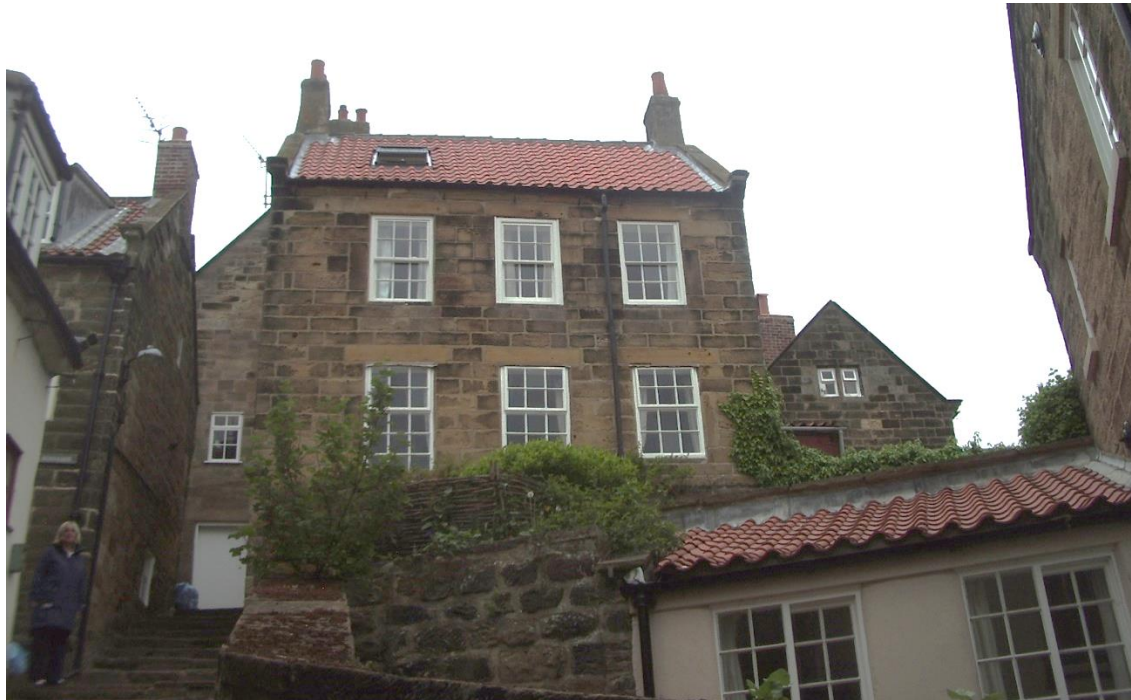
Image 3: Southern elevation showing the first and second floor

The principal, southern elevation, can be identified by its 3 vertical bays. The ground floor has a central entrance door with small flanking windows to either side. The first floor has large modern storm proof mock sash windows. The second floor has smaller window openings. These are made up of one vertical sash window and two mock sash windows with top hung opening sashes. The working vertical sash window is a modern replacement sash with horns. The third floor is served by two Velux rooflights and a small modern storm-proof window to the eastern elevation.

Whilst not being in keeping with the character of the property the windows are now dilapidated and are in need of replacement.

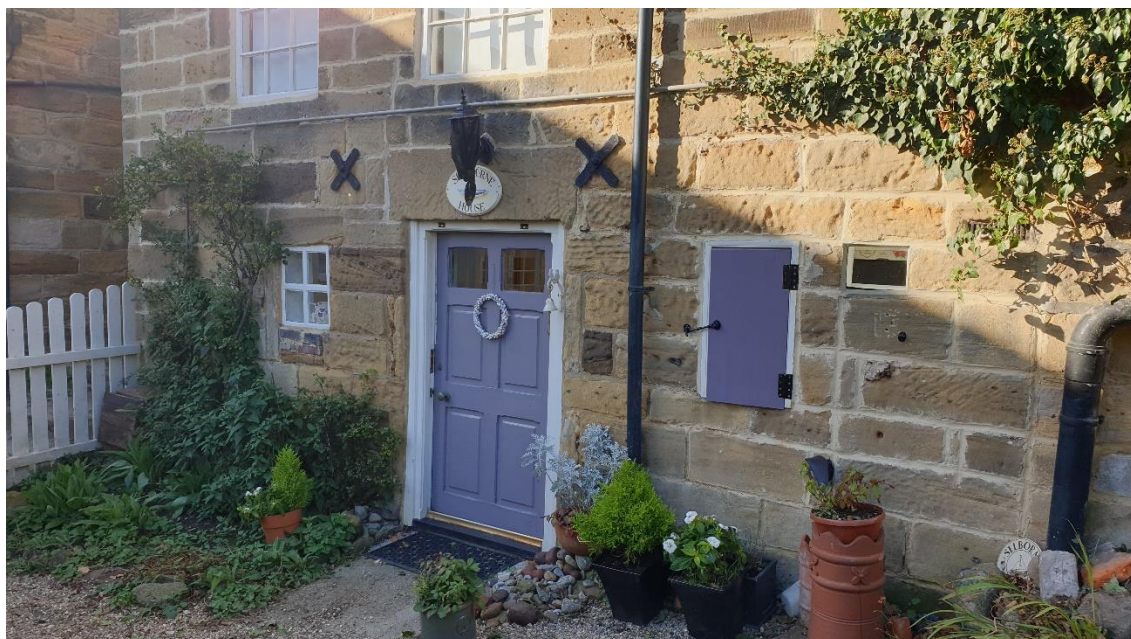
Image 4: Southern elevation ground floor

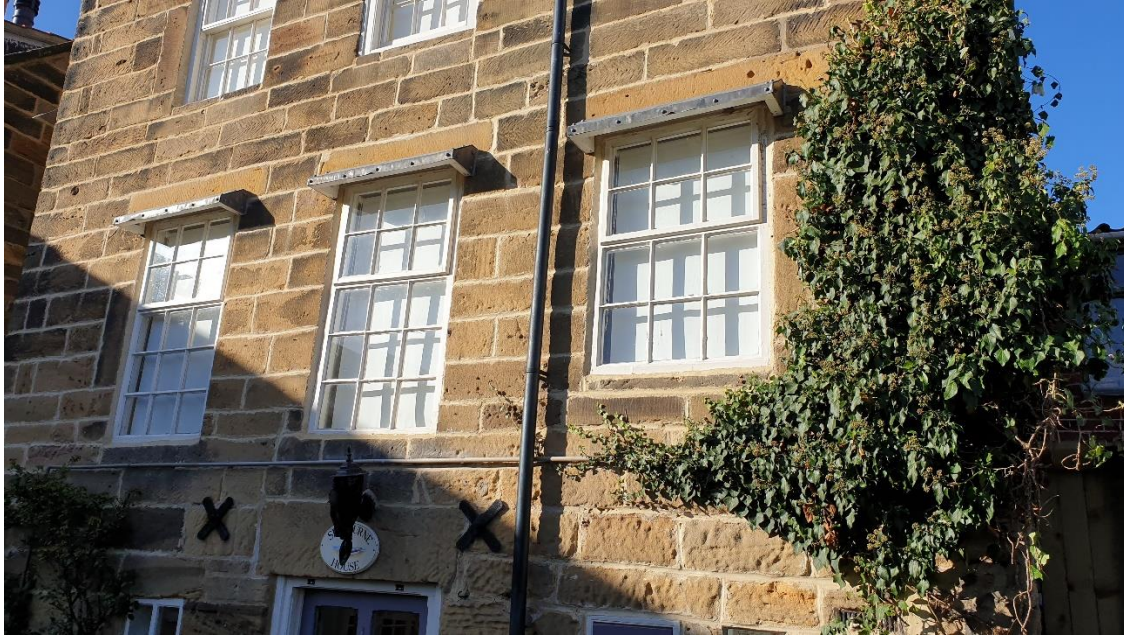
**Image 5: first floor windows**

The first-floor windows currently have lead canopies fitted to prevent water ingress, due to the condition of the window.

All the windows are single glazed and are putty pointed and painted in standard white.

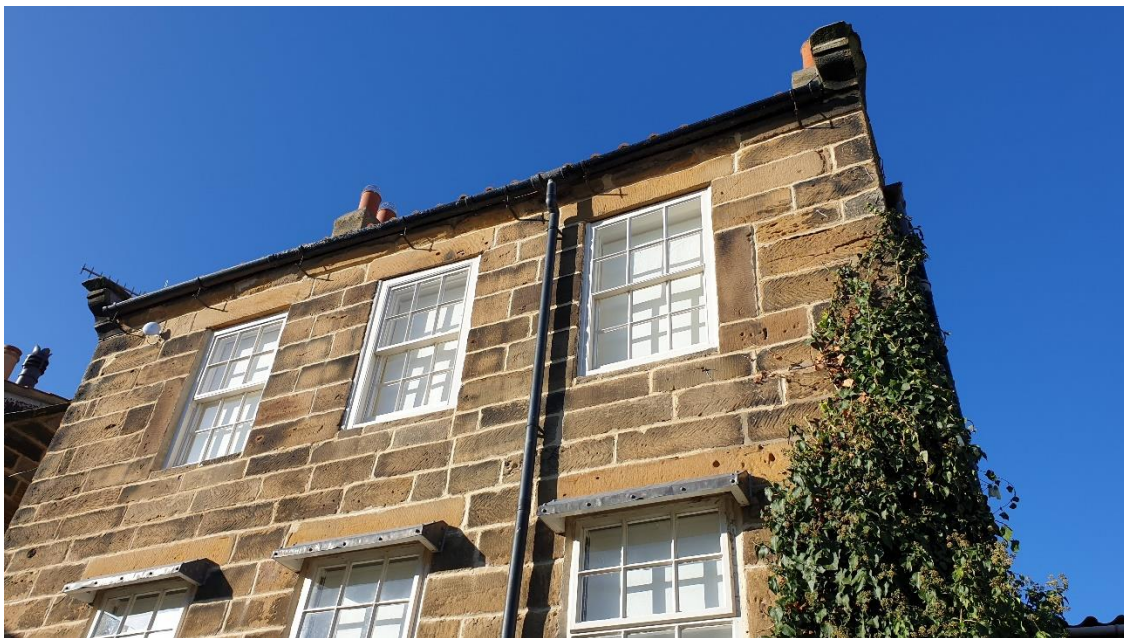
**Image 6: first floor windows**

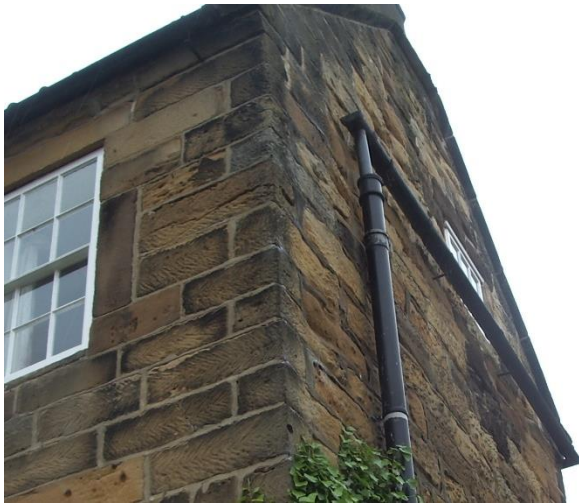
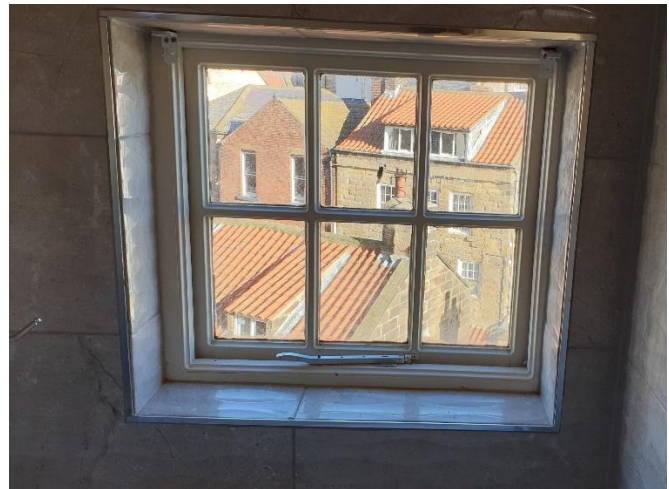
Image 7: second floor gable window

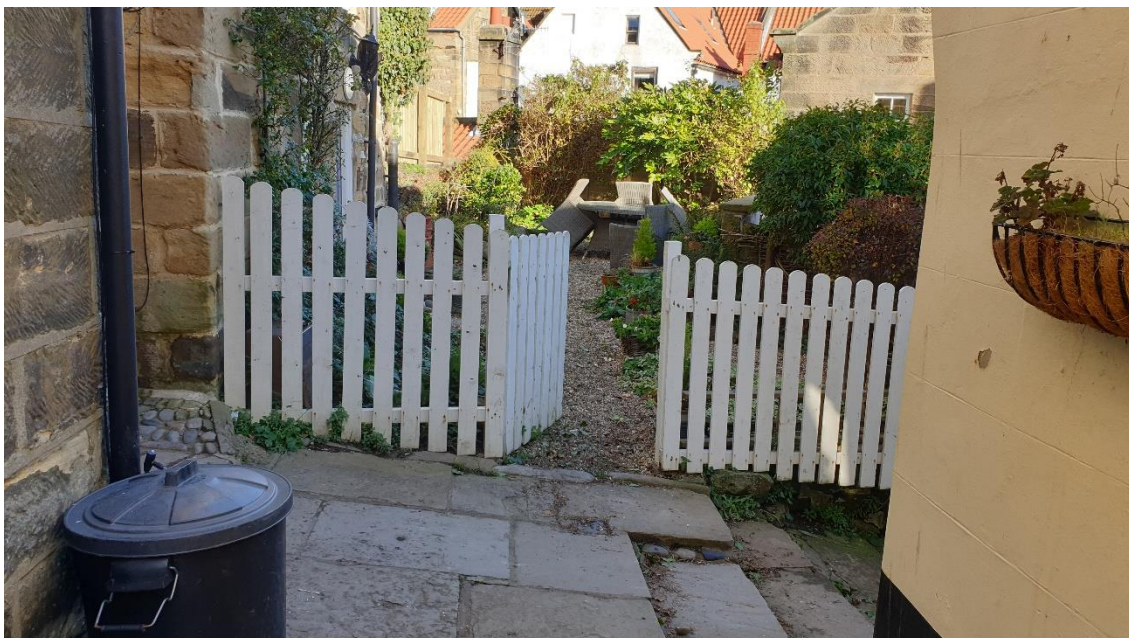
Image 8: picket fence to west boundary

There is a small amenity space to the south of the house that has access to Tyson's Row and is enclosed behind a modern timber picket fence, stone walling and neighbouring buildings.

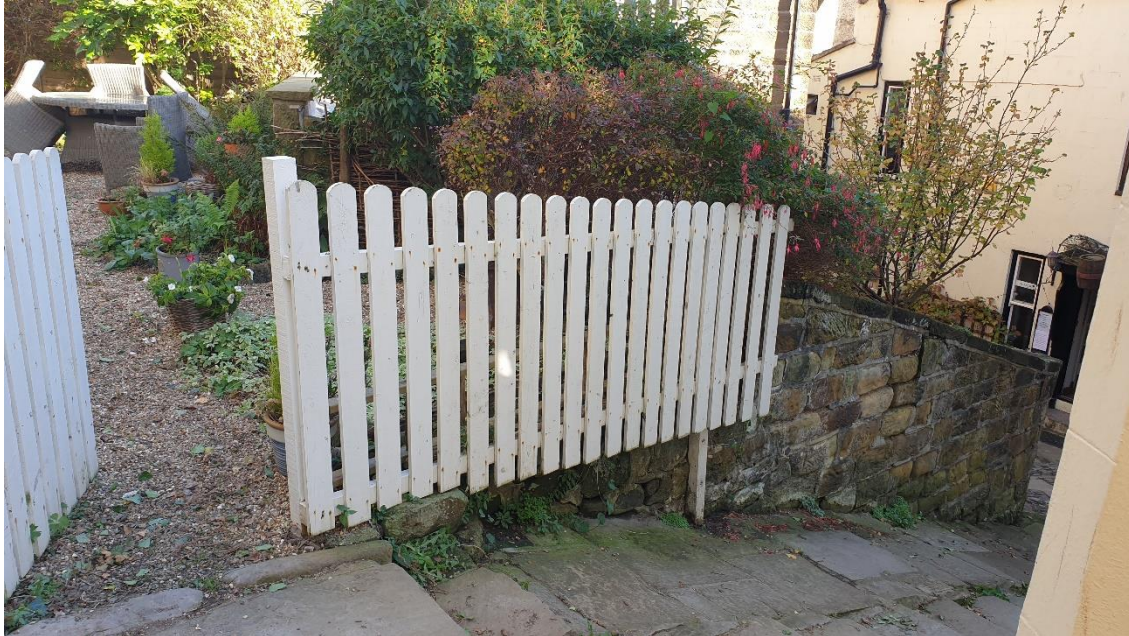
**Image 9: fence to be replaced with wall to match**

The white picket fence is to be replaced with a stone that matches in scale, form and detail that of the wall shown in image 9.

It is proposed to use locally sourced reclaimed stone and copings. The new wall will form a continuation of the existing wall, with a proposed height similar to the current fence line.
