Design and Access Statement 3 Arncliffe View, Egton

HERITAGE STATEMENT FOR PLANNING APPLICATION REFERENCE NYM/2020/1002/NEW

FOR 3 ARNCLIFFE VIEW

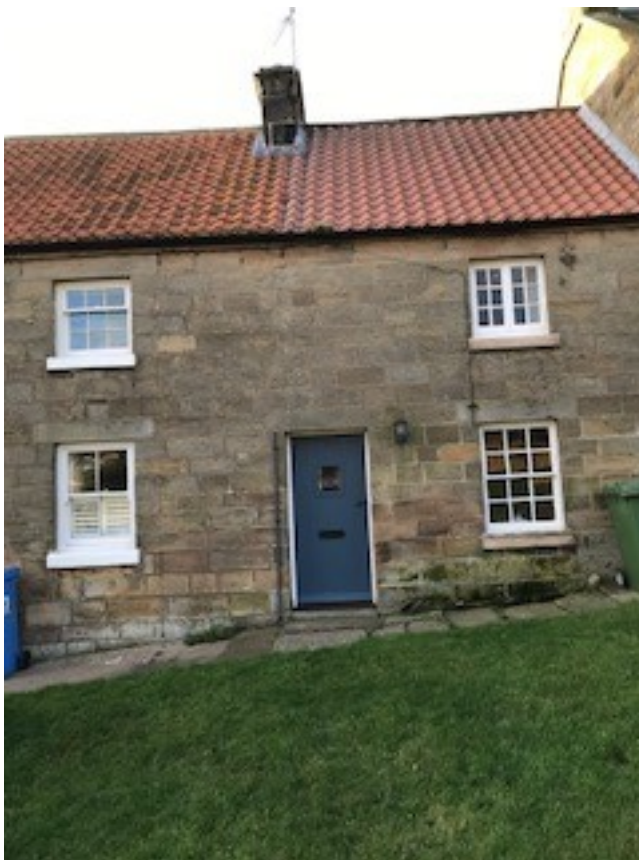
FRONT FACADE

To the front aspect there is one ground floor window and one first- floor window. The first-floor window is currently a different style both to the ground floor and the house next door. We would like to ensure both the historical aspect is correct by replacing the first-floor window with a more appropriate style, rather than a direct replacement. This will help to ensure that the appearance of the row of cottages which make up Arncliffe View is not compromised.

See below the front of the 3 Arncliffe View – the windows to the right of the blue front door (facing the cottage) are the ones referred to above. The first-floor window to the left is that of no 2 Arncliffe View and this would be the preferred style for the first-floor replacement.

However, what it be possible would be to replace the first-floor window to the front façade with a sash window, which would be more in keeping with the period in which the cottage was built. This could be styled to match the first-floor windows of no2 Arncliffe View.

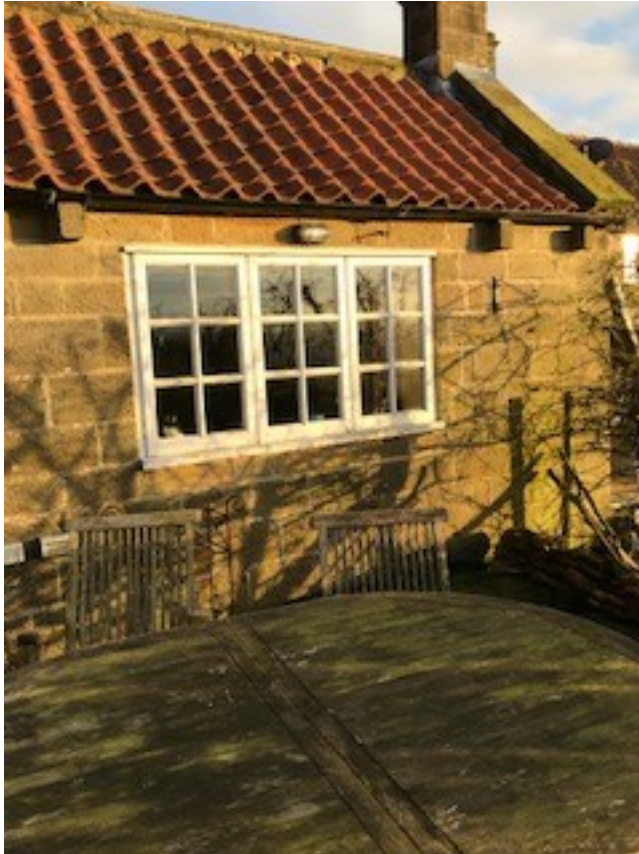
KITCHEN WINDOW

To the rear of the cottage there are three windows. On the ground floor there is a small cloakroom window and a larger kitchen window. The kitchen window is a double-glazed unit and was installed by the previous owners as part of the kitchen extension. See photo below.

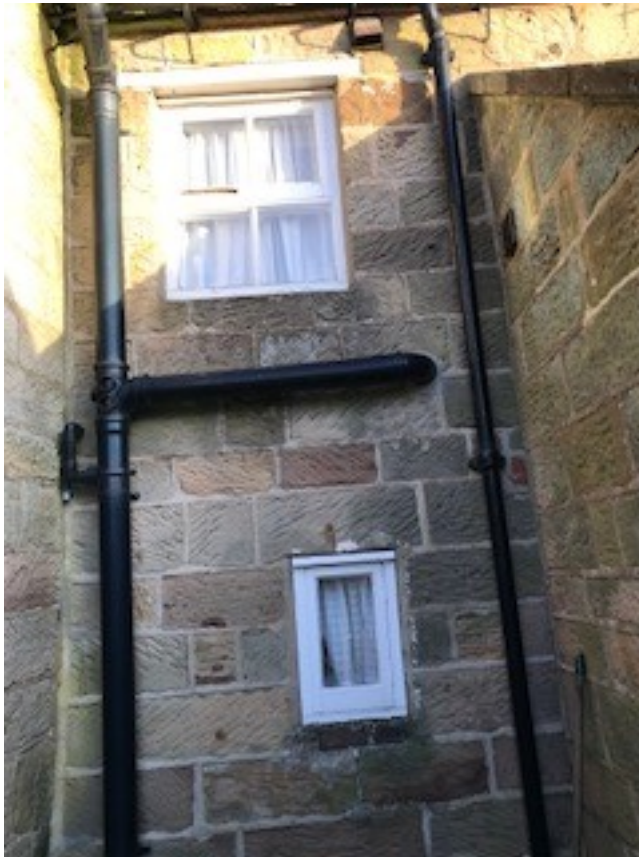
CLOAKROOM WINDOW (ground floor) and BATHROOM WINDOW (first floor)

To the first floor is the bathroom window. This is extremely rotten and in grave danger of falling apart, as can be seen by the photo below of both it and the cloakroom window:

The new windows would all be made of US Scandinavian redwood with traditional ovolu mouldings. They would then be treated with a preservative and painted with TEKNOS long life semi-gloss paint in white.

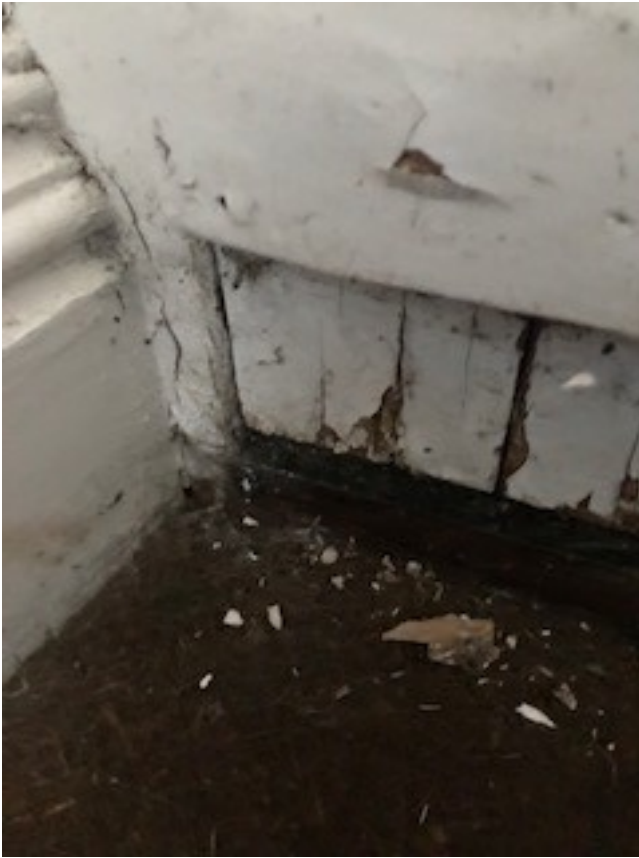
FRONT DOOR, BOTTOM SECTION

We would like to replace both the navy painted front door (see picture of front house façade) and white back door (photo below) with double boarded FLB doors in the same style as the existing doors. Currently both doors swell with the damp in the winter becoming difficult to open and shut. This is particularly problematic with the front door, which is now splitting at the bottom and leaking when it rains, causing a damp patch.

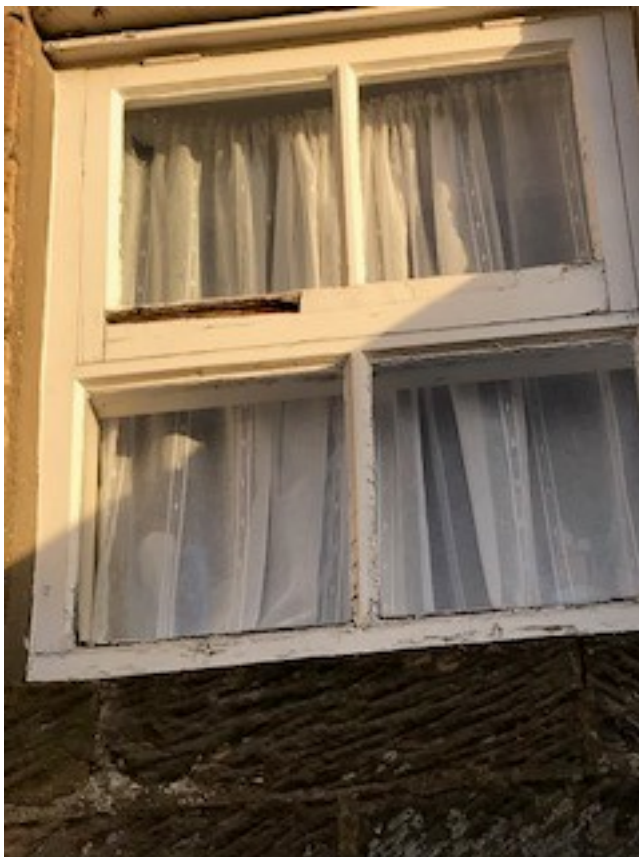
The existing windows are rotting and falling apart. The single glazing allows for moisture to adversely affect the poor-quality wood, reducing the life of the windows considerably and allowing the damp and cold into the building.

Existing white painted wooden single glazed external windows to be replaced with double glazed units made of US Scandinavian Redwood, treated with a preservative to extend their life, and then painted with TEKNOS long life semi glazed paint in white.

The impact of the replacement windows will be positive. It will help to preserve the life of the building but at the same time it will be impossible for anyone passing through Egton and viewing the house from the road to know that the windows have been replaced as the external façade will appear unchanged.

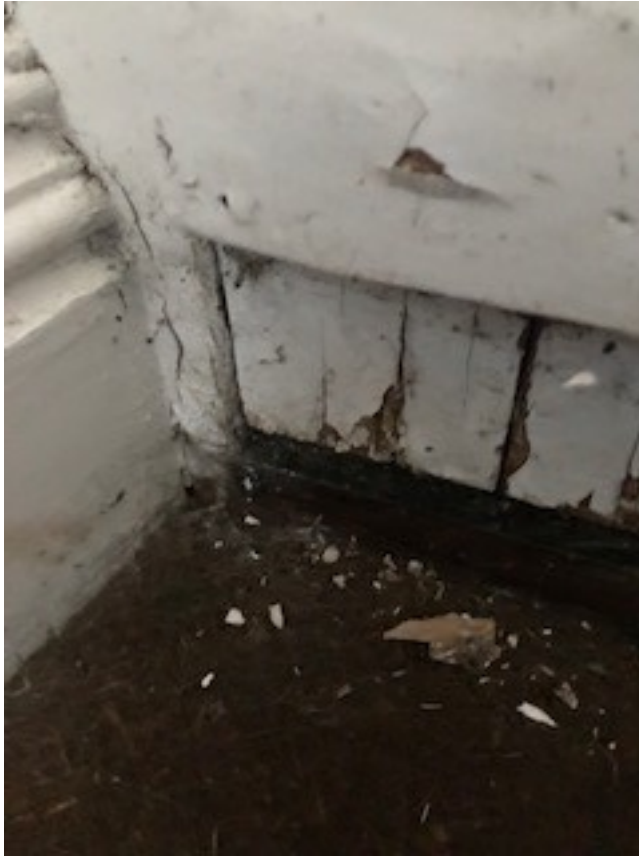
FRONT DOOR

The existing door is severely cracked at the bottom. The wood expands and contracts with the damp and cold and then the warmth of summer. The result of this is that the door is extremely hard to close and lock. The force needed to close the door has resulted in it splitting. The rain seeps in at the bottom and is causing damp patches in the entrance.

The existing navy blue painted wood front door with one square pane with an unusual circular pattern to be replaced with an identical styled double boarded FLB door made of US Scandinavian redwood, treated with a preservative, and painted with TEKNOS long life semi glazed paint in navy blue.

The impact of the new door will be positive. Again, the external façade will be unchanged but the effect of a watertight door on preserving the structure of the building and preventing the need for any significant building repairs in the future will be great.

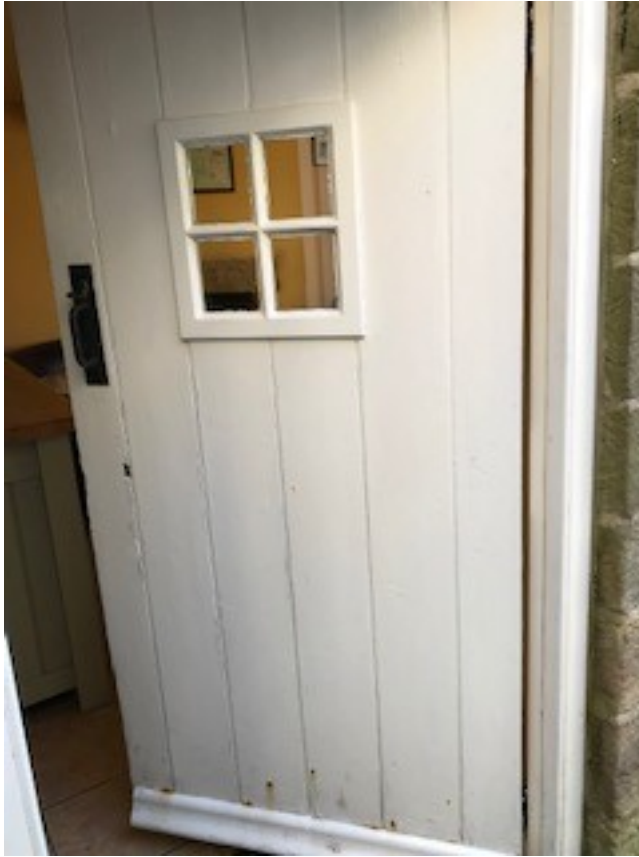
BACK DOOR

The existing door is a white painted wooden door with a four-pane window. This would replace a double boarded FLB door made of US Scandinavian redwood, treated with a preservative, and painted with TEKNOS long life semi glazed paint in white in the exact same style.

The existing door is made of a wood which expands and contracts with the damp and cold and then the warmth of summer. The door is less exposed than the front door but does allow the rain to seep in at the bottom and onto the kitchen floor.

The impact of the new door will be positive. Again, the external façade will be unchanged, but the result will be to have a watertight door, stopping damp from coming into the house. This will have a long-term effect of reducing the chances of damp and damage to the structure and integrity of the building.
