Design and Access Statement Householder – Repair (in a Conservation Area)

This application is for the repair and make good the roof area around on the south facing aspect of the property (Glenhowen, Chapel Street, Robin Hoods Bay). The current roof is allowing water ingress into the top floor attic room especially around the chimney stack and dormer window.

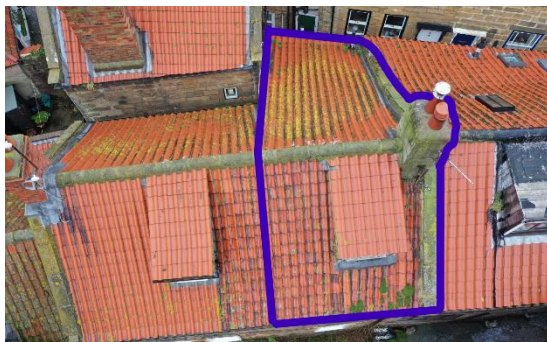
Image of existing roof

The blue outline on the image below shows the extent of the roof of Glenhowen (the property) within Chapel Street.

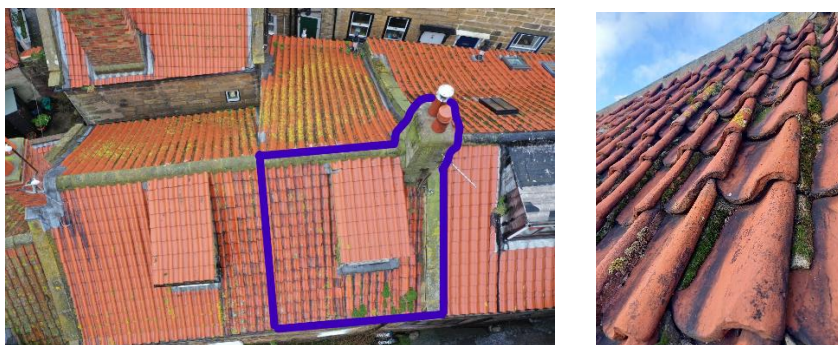
The area of roof to be repaired is shown in the image below highlighted by the blue boarder. Also shown is another image detailing the current conditions of the roof tiles.

The planned work required will include, new lead flashing to the chimney stack and adjoining coping stones and both sides of the existing dormer window, re rendering of the chimney stack, existing timbers to be treated for wood worm and rot, new roofing felt as required, natural wool insulation to be added where space allows and replacement handmade William Blyth Barco old English pantiles in natural red.

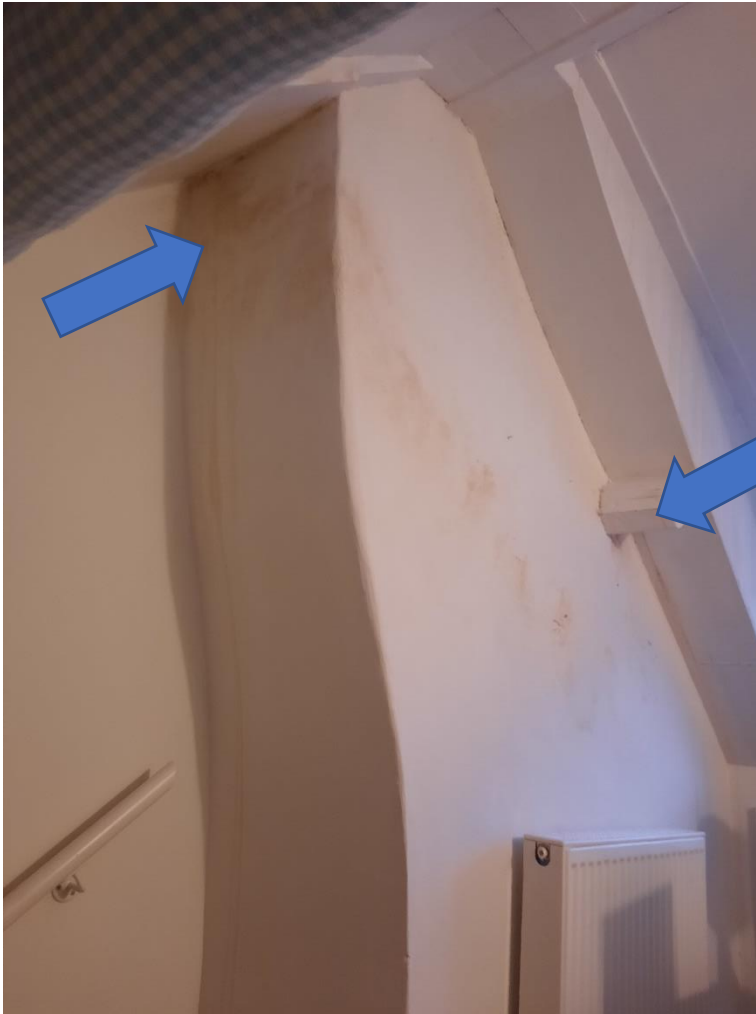
Image of water damage seen over the winter in the Attic room.
