Beeston Cottage
Tommy Baxter St
Robin Hood's Bay
YO22 4RZ

This is situated in Robin Hood's Bay Conservation Area and is a Grade II Listed Building.

Proposed replacement of dormer window unit

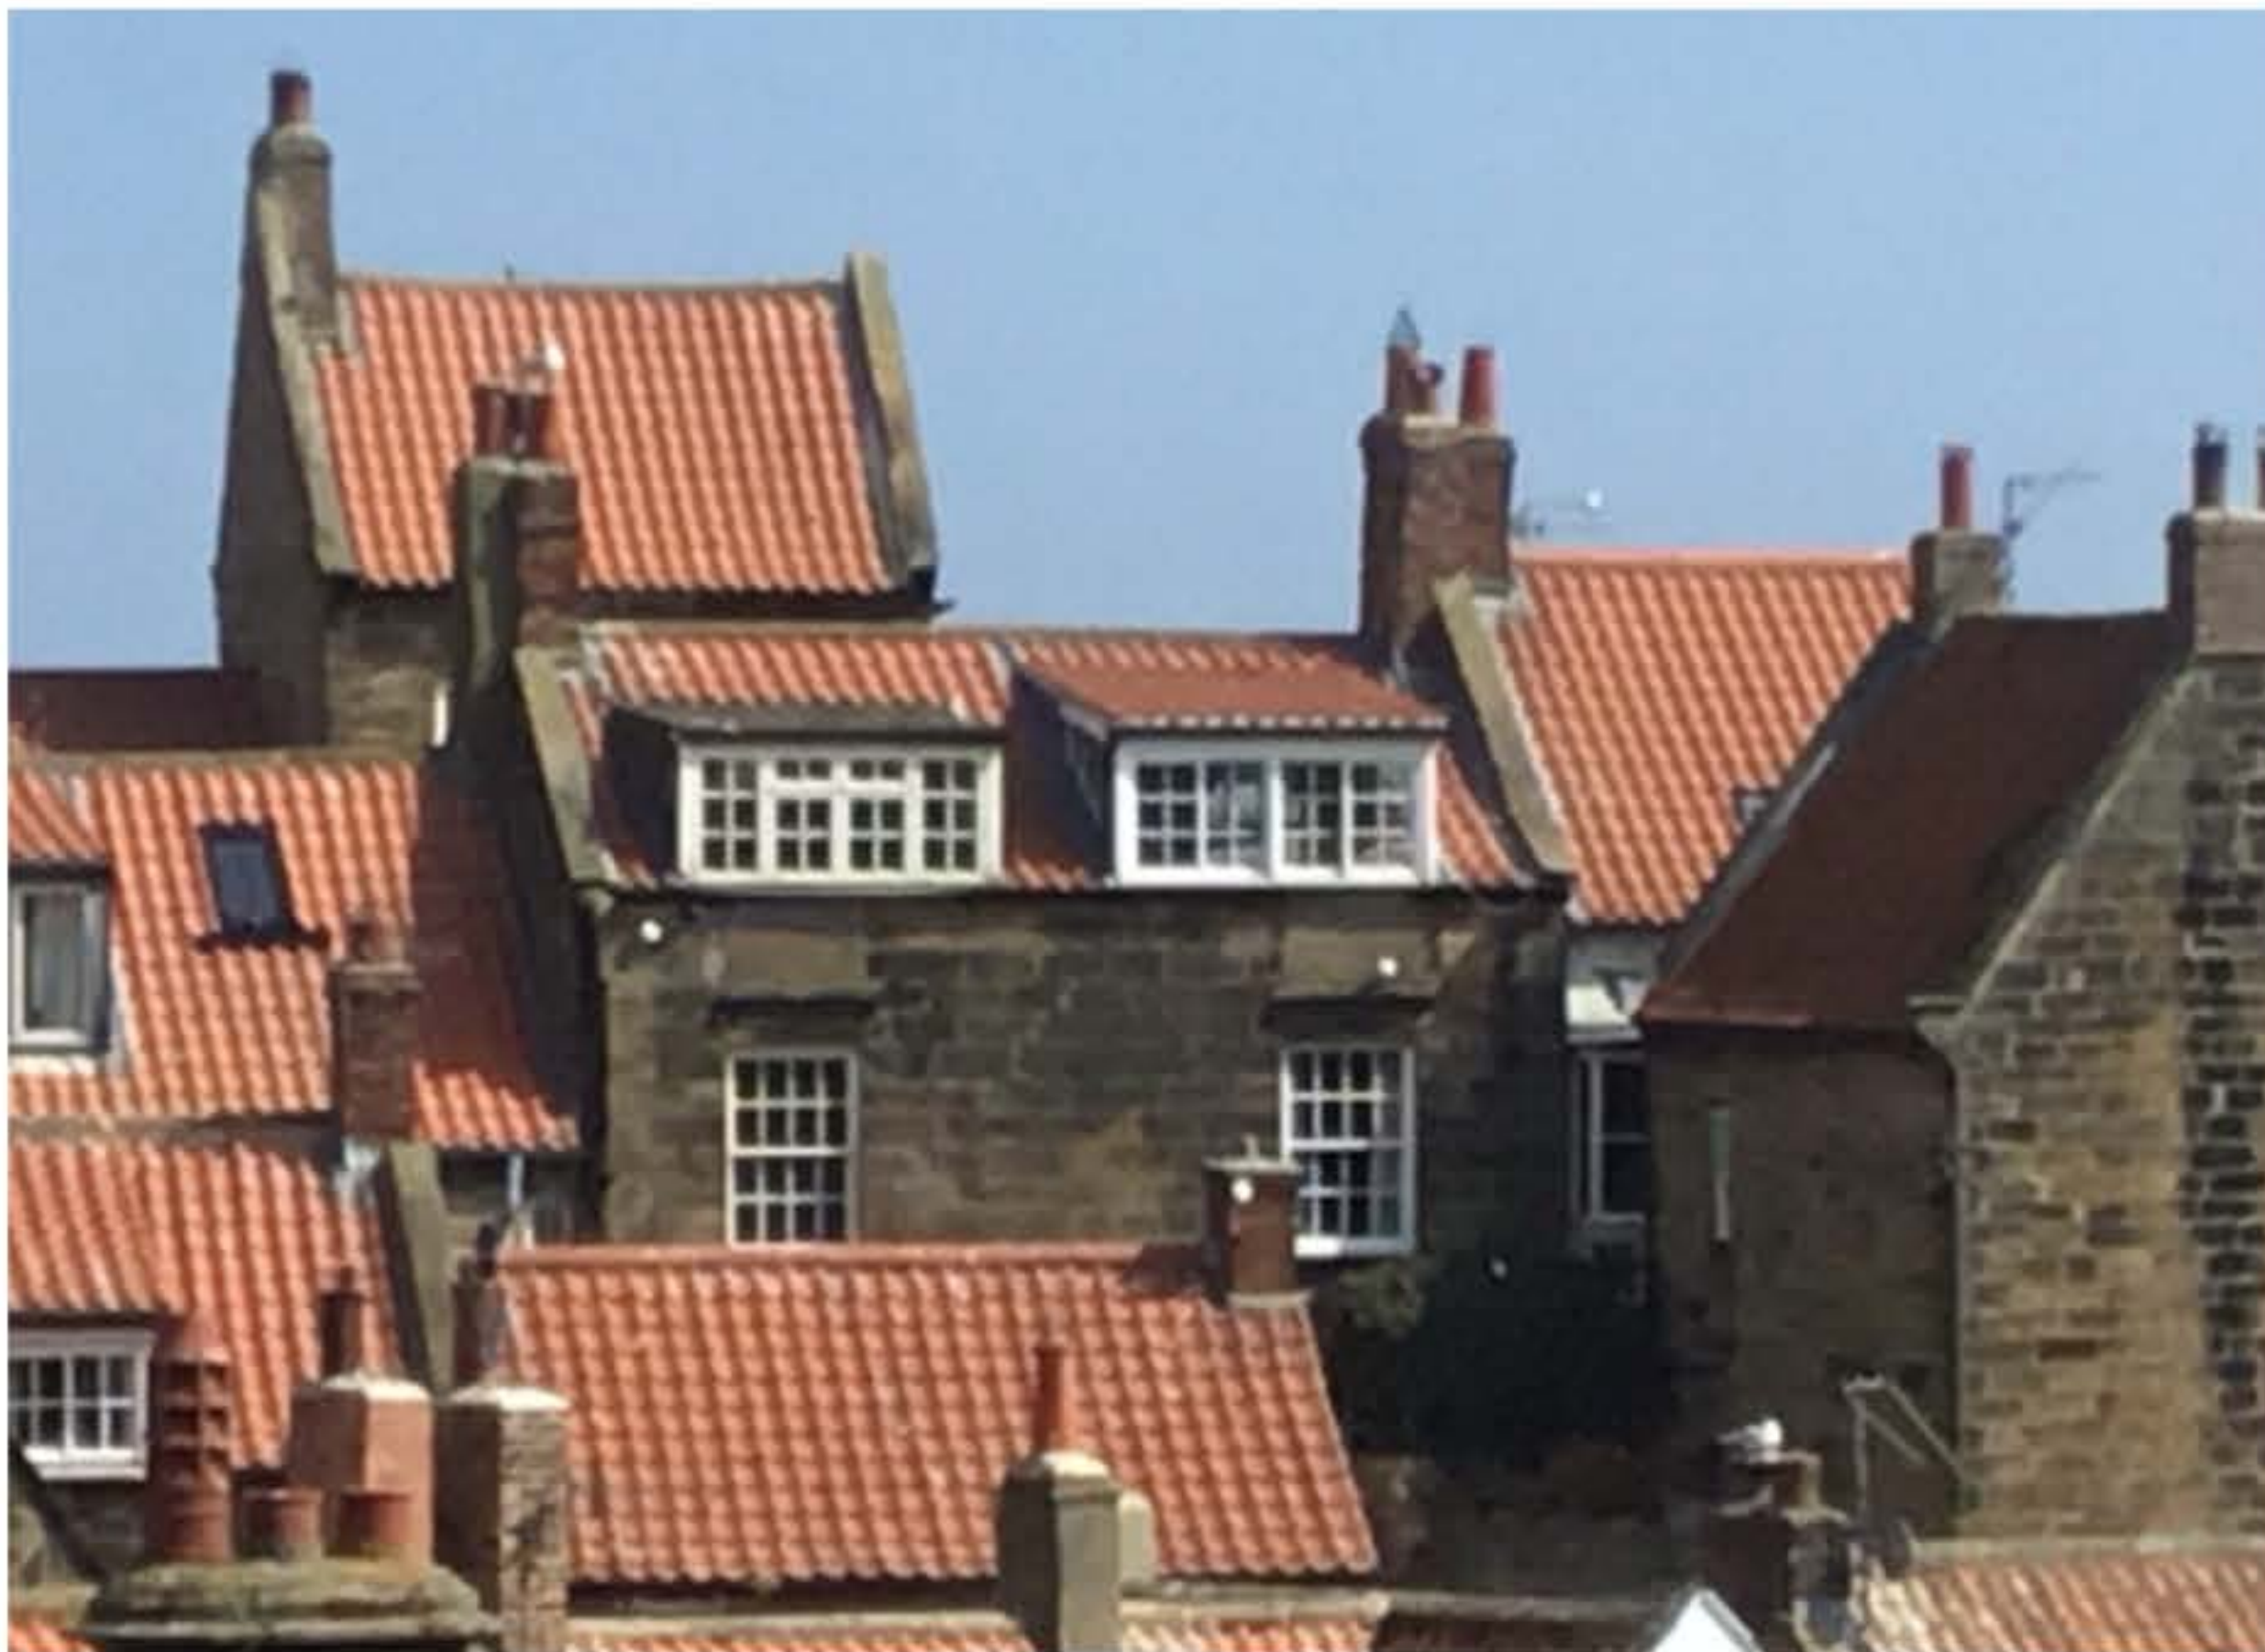
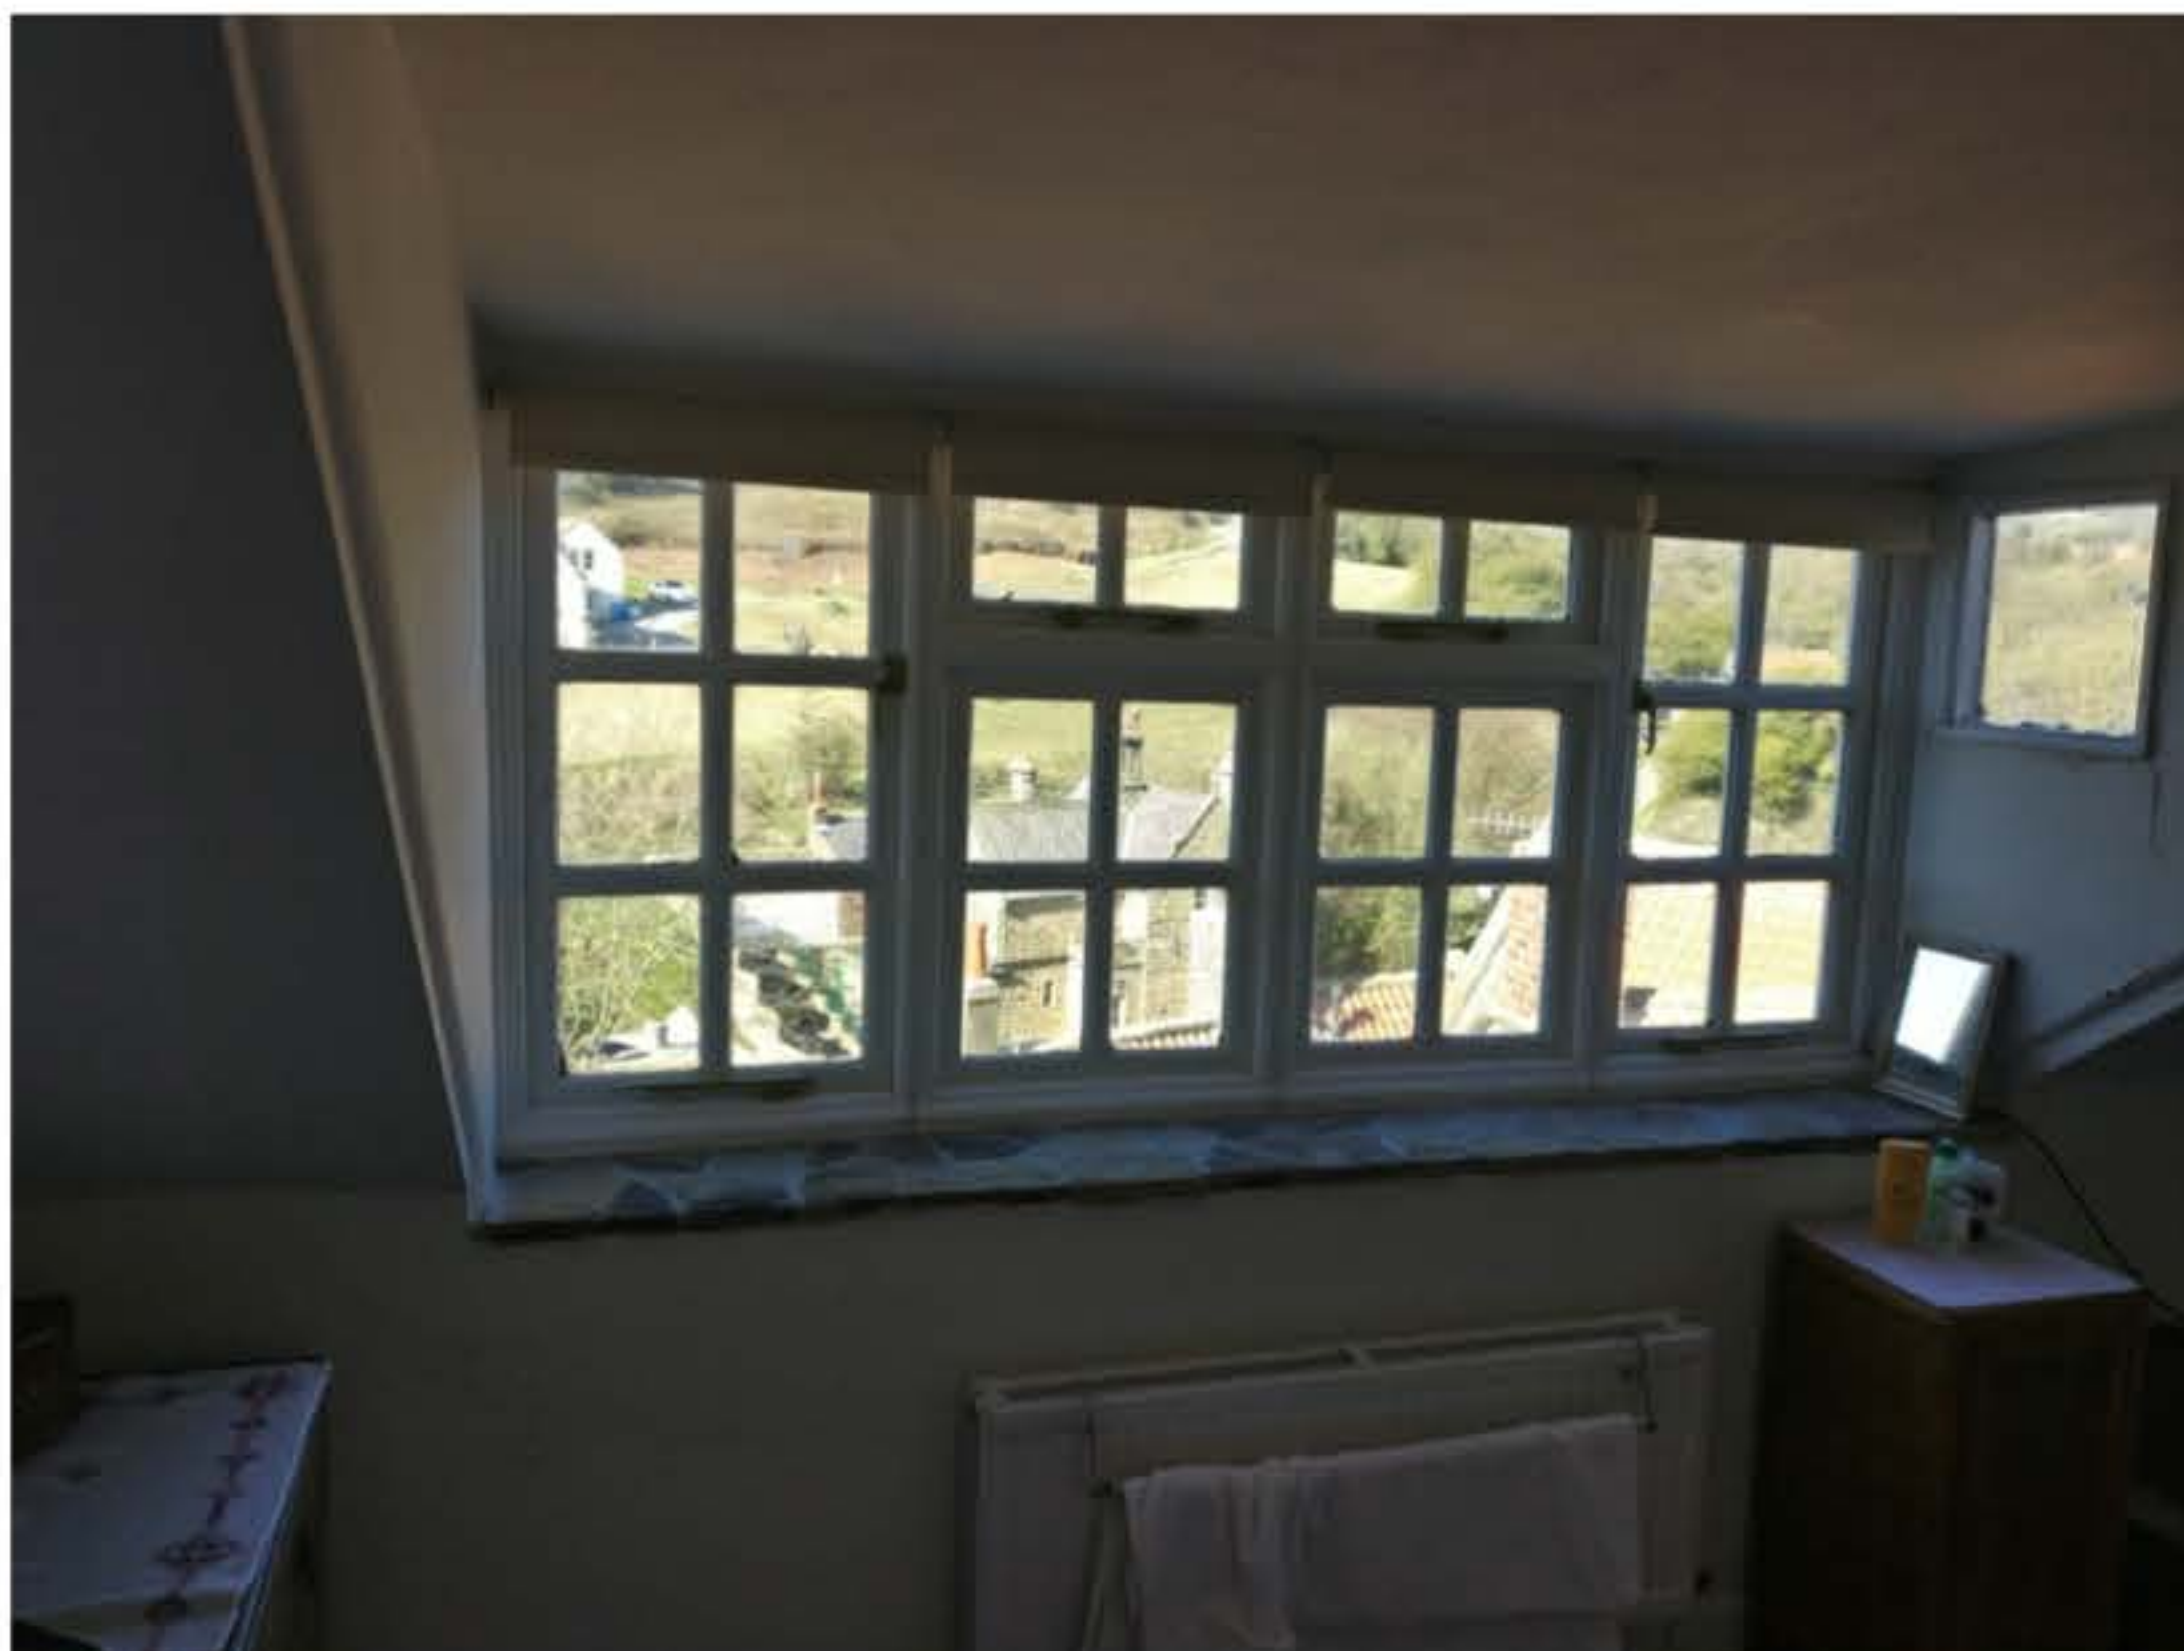
The existing window (left on the photograph) is too rotten to repair so a complete replacement unit will have to be made by a local joiner. This will be made up in hardwood to match as closely as possible the next door unit which it adjoins on the right hand on the photograph. This creates the opportunity to improve the energy efficiency of Beeston's cottage so 10mm double glazing with 4 mm glass will be incorporated into the new frames.

- a) Replacement of rotten wooden dormer windows with like for like unit, with double glazing and narrower glazing bars. This will match the neighbouring property's dormer window. It will also relate better to the other windows of Beeston and Auburn Cottages.
- b) Existing softwood single glazed white painted windows will be replaced by hardwood double glazed units with narrower glazing bars and mullions. They will also be painted white.

- a) The proposed work is replacement nearly "like for like" and as such there is very little change to the heritage asset.
- b) It will however prevent further weather damage to the window frames which have deteriorated significantly.
- c) Double glazing will have environmental advantages, improving insulation of the property and therefore the energy efficiency.
- d) Narrower glazing bars will match the windows with its "pair" as shown in the photo submitted previously with the application via the Planning Portal.
The existing dormer window appears slightly heavy compared with its neighbour. As it needs replacing I am requesting the opportunity to reduce the glazing bar width which will reduce any adverse impact on the heritage asset.

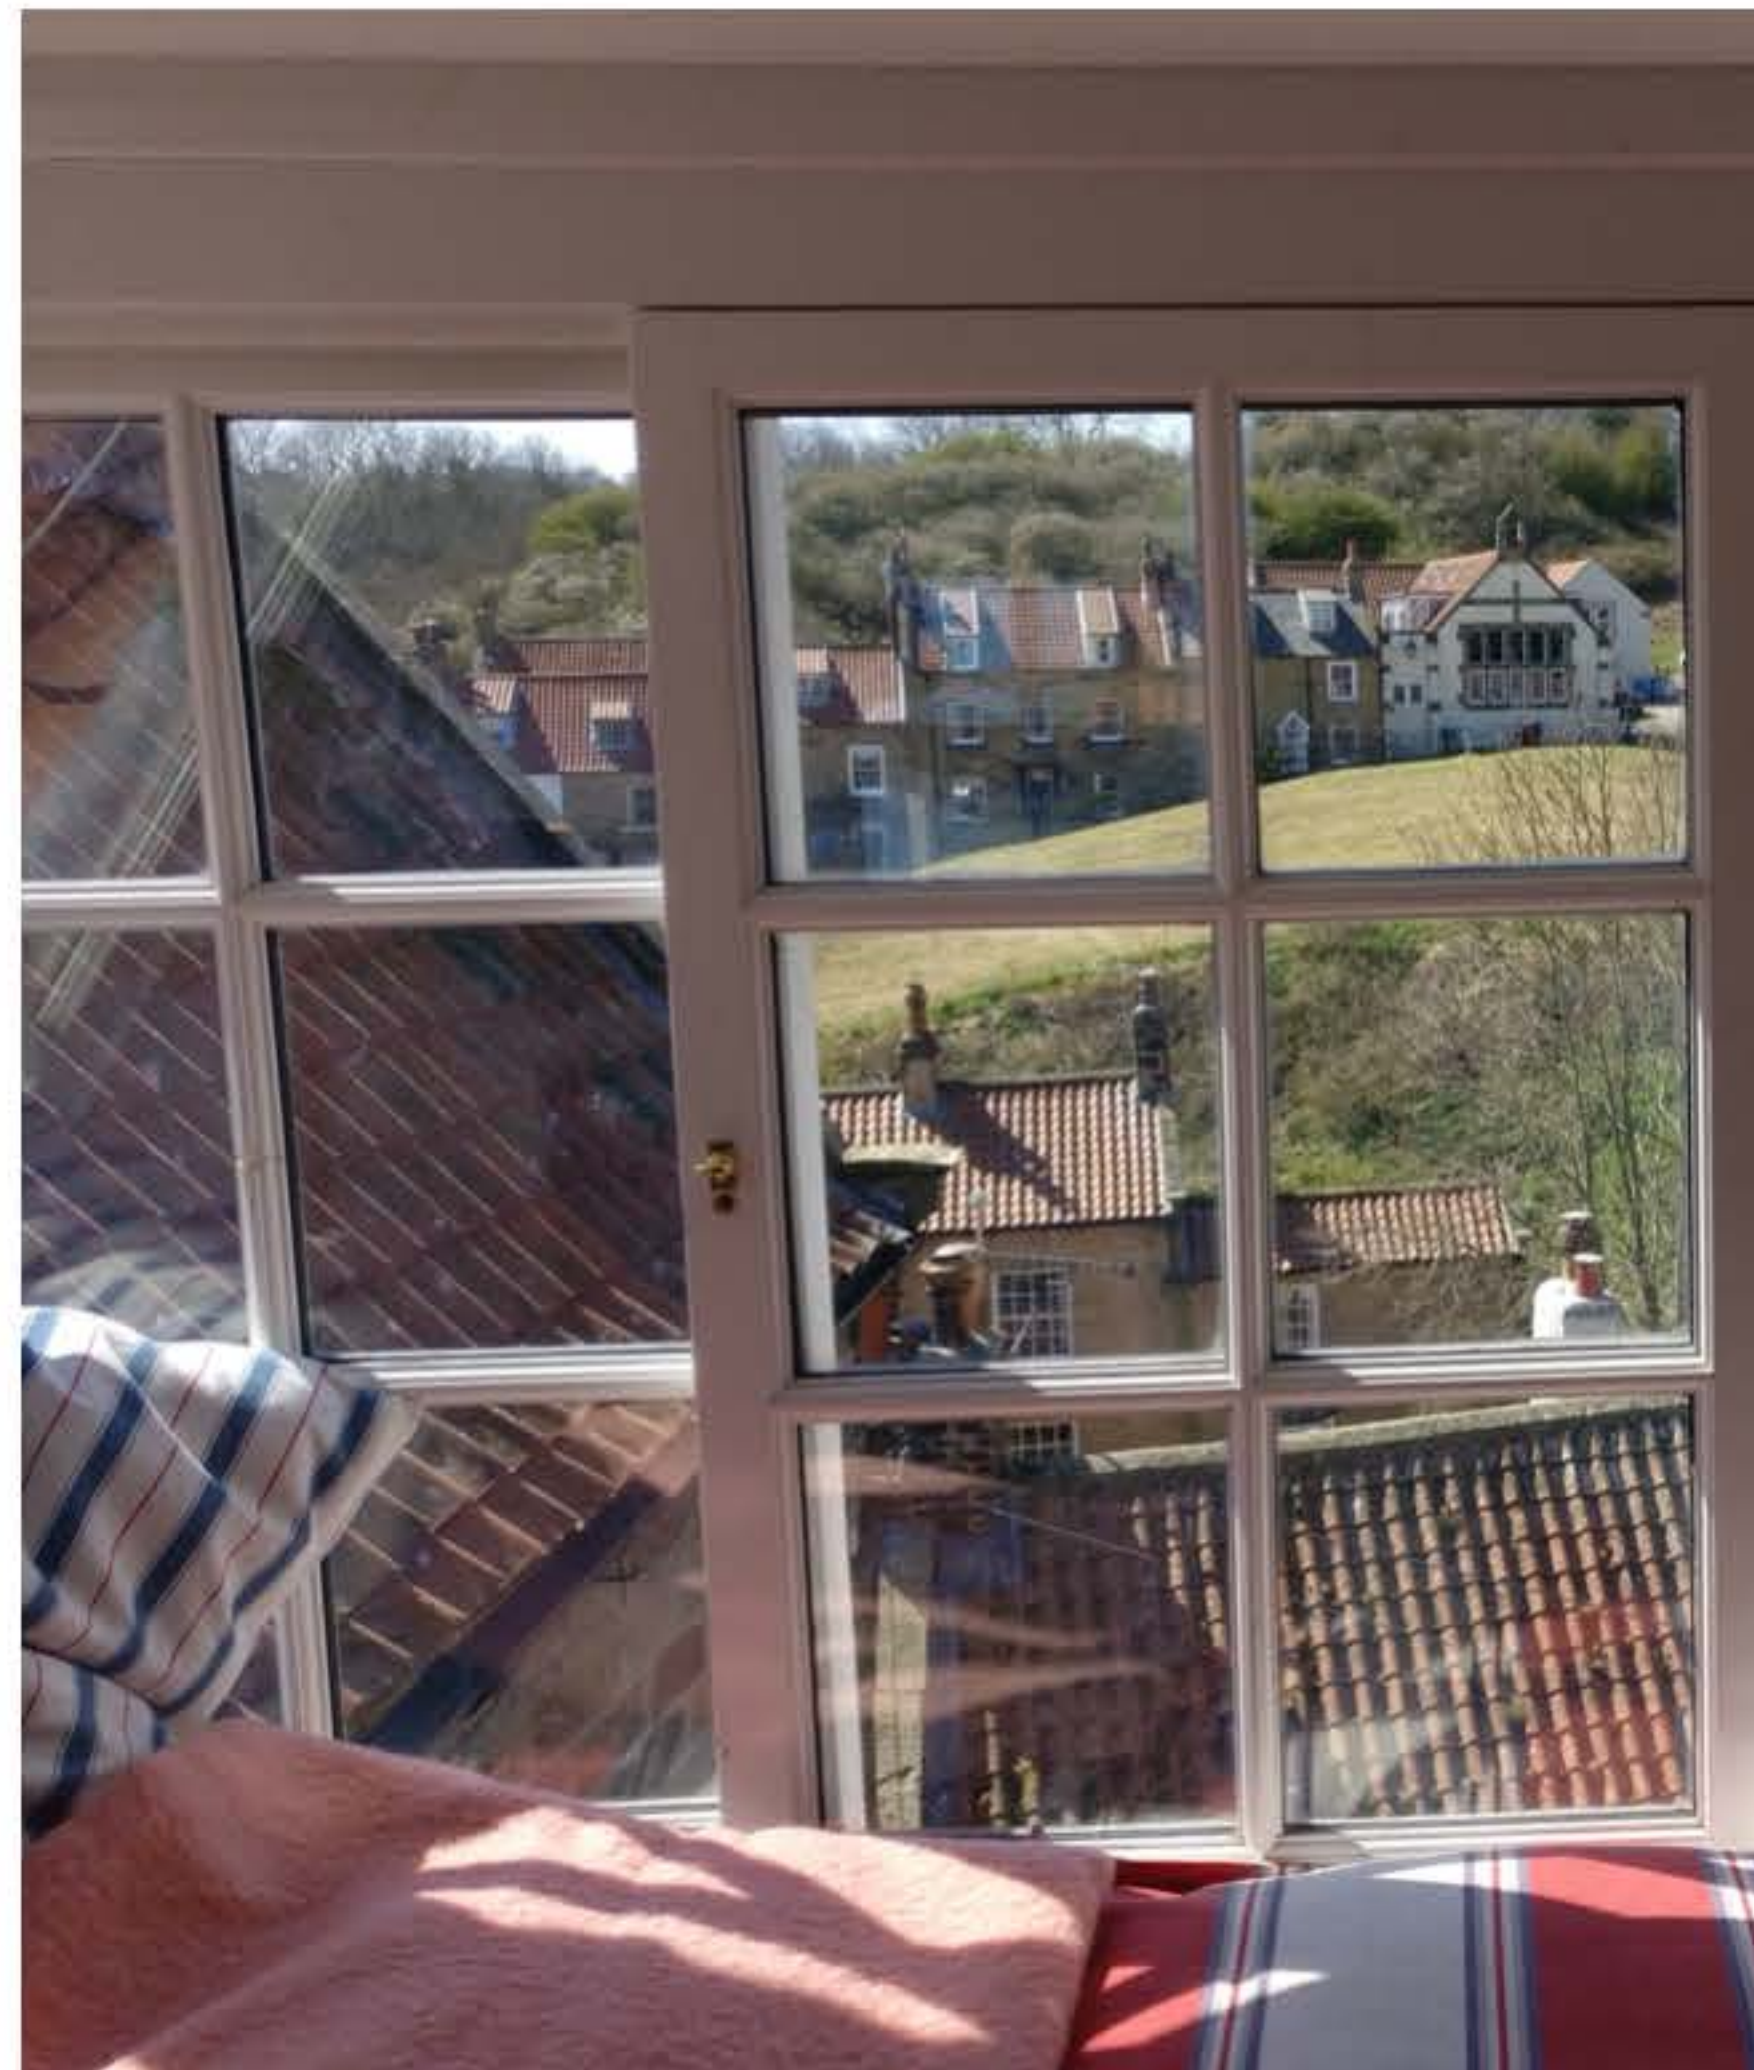
Proposed replacement window unit
Beeston Cottage Robin Hoods Bay

This is a detail of adjoining dormer in Tommy Baxter street.
We will be using opening casement windows as at present not sliding sashes as shown on this image.
