Design & Access Statement

Proposed consent for alterations & extension to; Cliff Cote, Prospect Field, Robin Hoods Bay, YO22 4RH

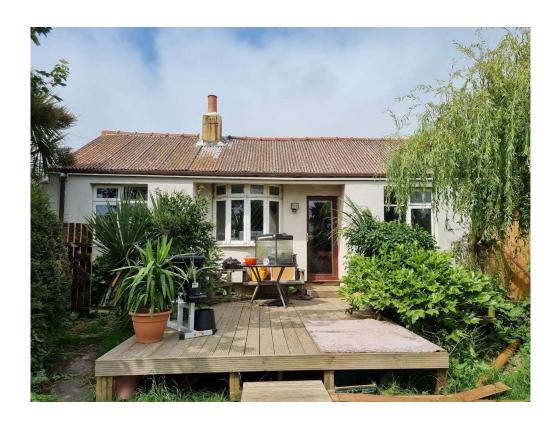
The current state of Cliff Cote has been down to amalgamations of previous 'weekend' projects since the structure was erected, although no definite date, but probably first started in the 1920/30's. The building consists of a single storey, open plan space topped with a pitched corrugated roof, capped with clay ridge tiles.

The existing building is in a desperate state of disrepair. Water penetration from both above and below has rotted the majority of internal and external woodwork. The existing roof was clad in asbestos of which is currently being professionally removed. The lean-to against the rear of the property has been removed due to it not being structurally sound.

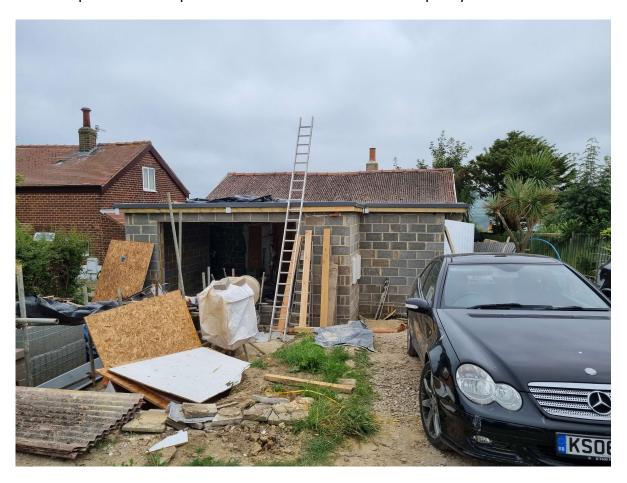
The current owners have added a single storey extension to the rear of the property, replacing the lean-to under a permitted development in order to have somewhere to temporally live.
