## Foxhill Pasture

Throxenby  
Scarborough  
YO12 5TD

Application for Stable Conversion to Annex  
Heritage Statement and  
Design & Access Statement

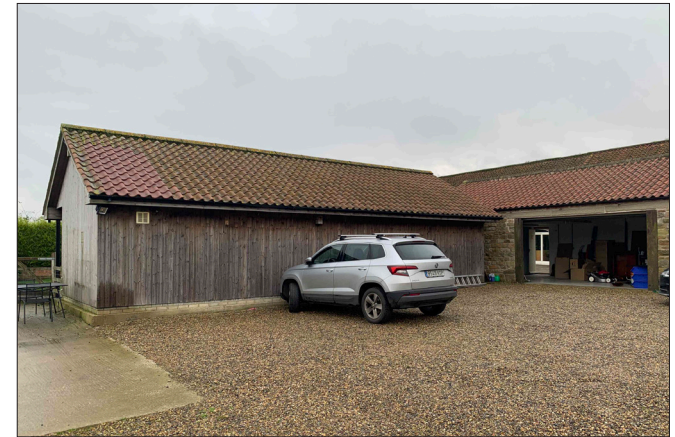
Stable from west

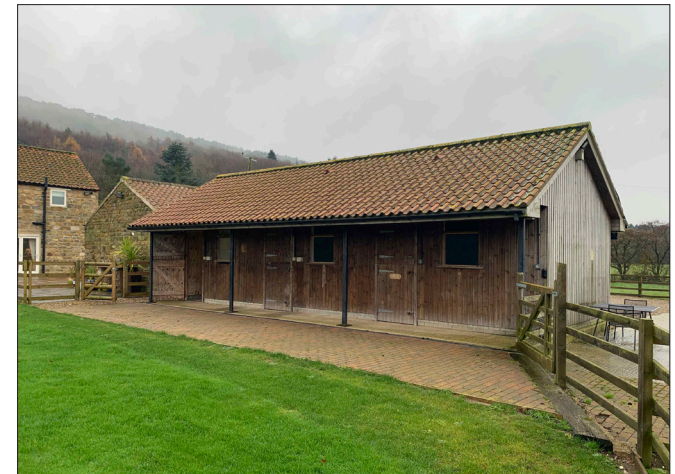
Stable from east

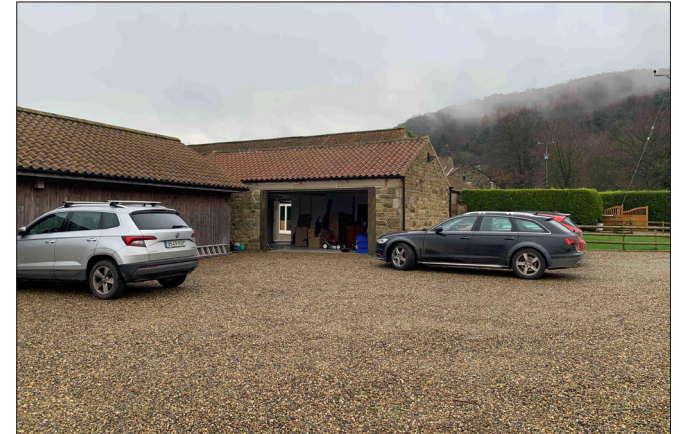
Garage and rear of stables

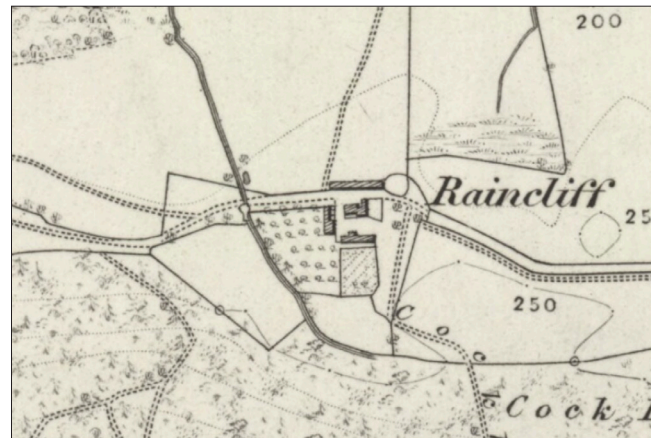
Extracts from historic OS maps show that the buildings were all in evidence before the first edition Ordnance Survey of 1854. With the road running through the farm yard. There is significant development between 1850 and the second edition 1891 map where the fold yard is formed and a new wing extends to the north where the garage presently stands

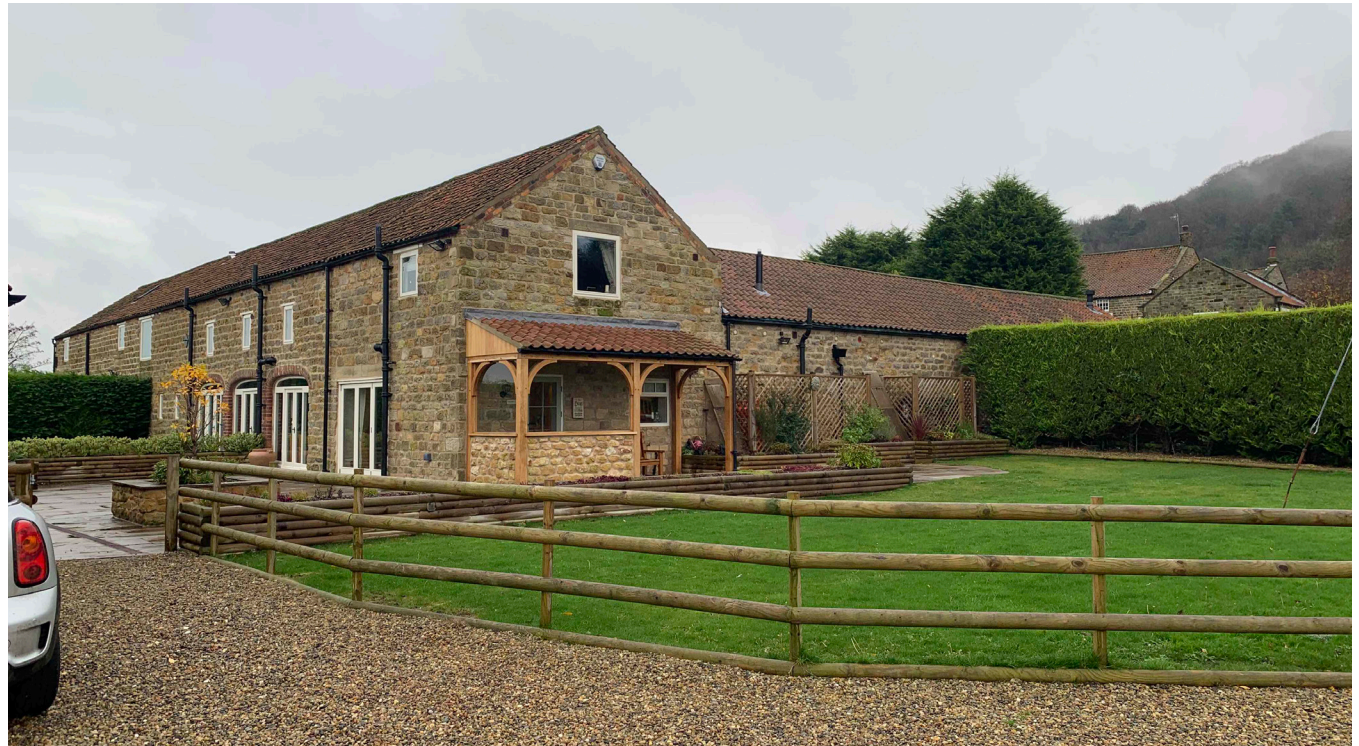
The farm buildings were listed in 1986 and date from the mid 18th century. In coursed rubble sandstone with a pantile roof they surround a central courtyard to the south and have a number of features typical of the area including stone steps, brick piers and segment arches to the rear (which now are infilled as windows to the principal living area).

Arrival and north east side of barn
