# York House, King Street, YO22 4SH

York House  
King Street,  
Robin Hoods Bay,  
Whitby,  
North Yorkshire  
YO22 4SH

Proposed:  
WINDOW REPLACEMENTS  
at  
YORK HOUSE  
KING STREET  
ROBIN HOODS BAY

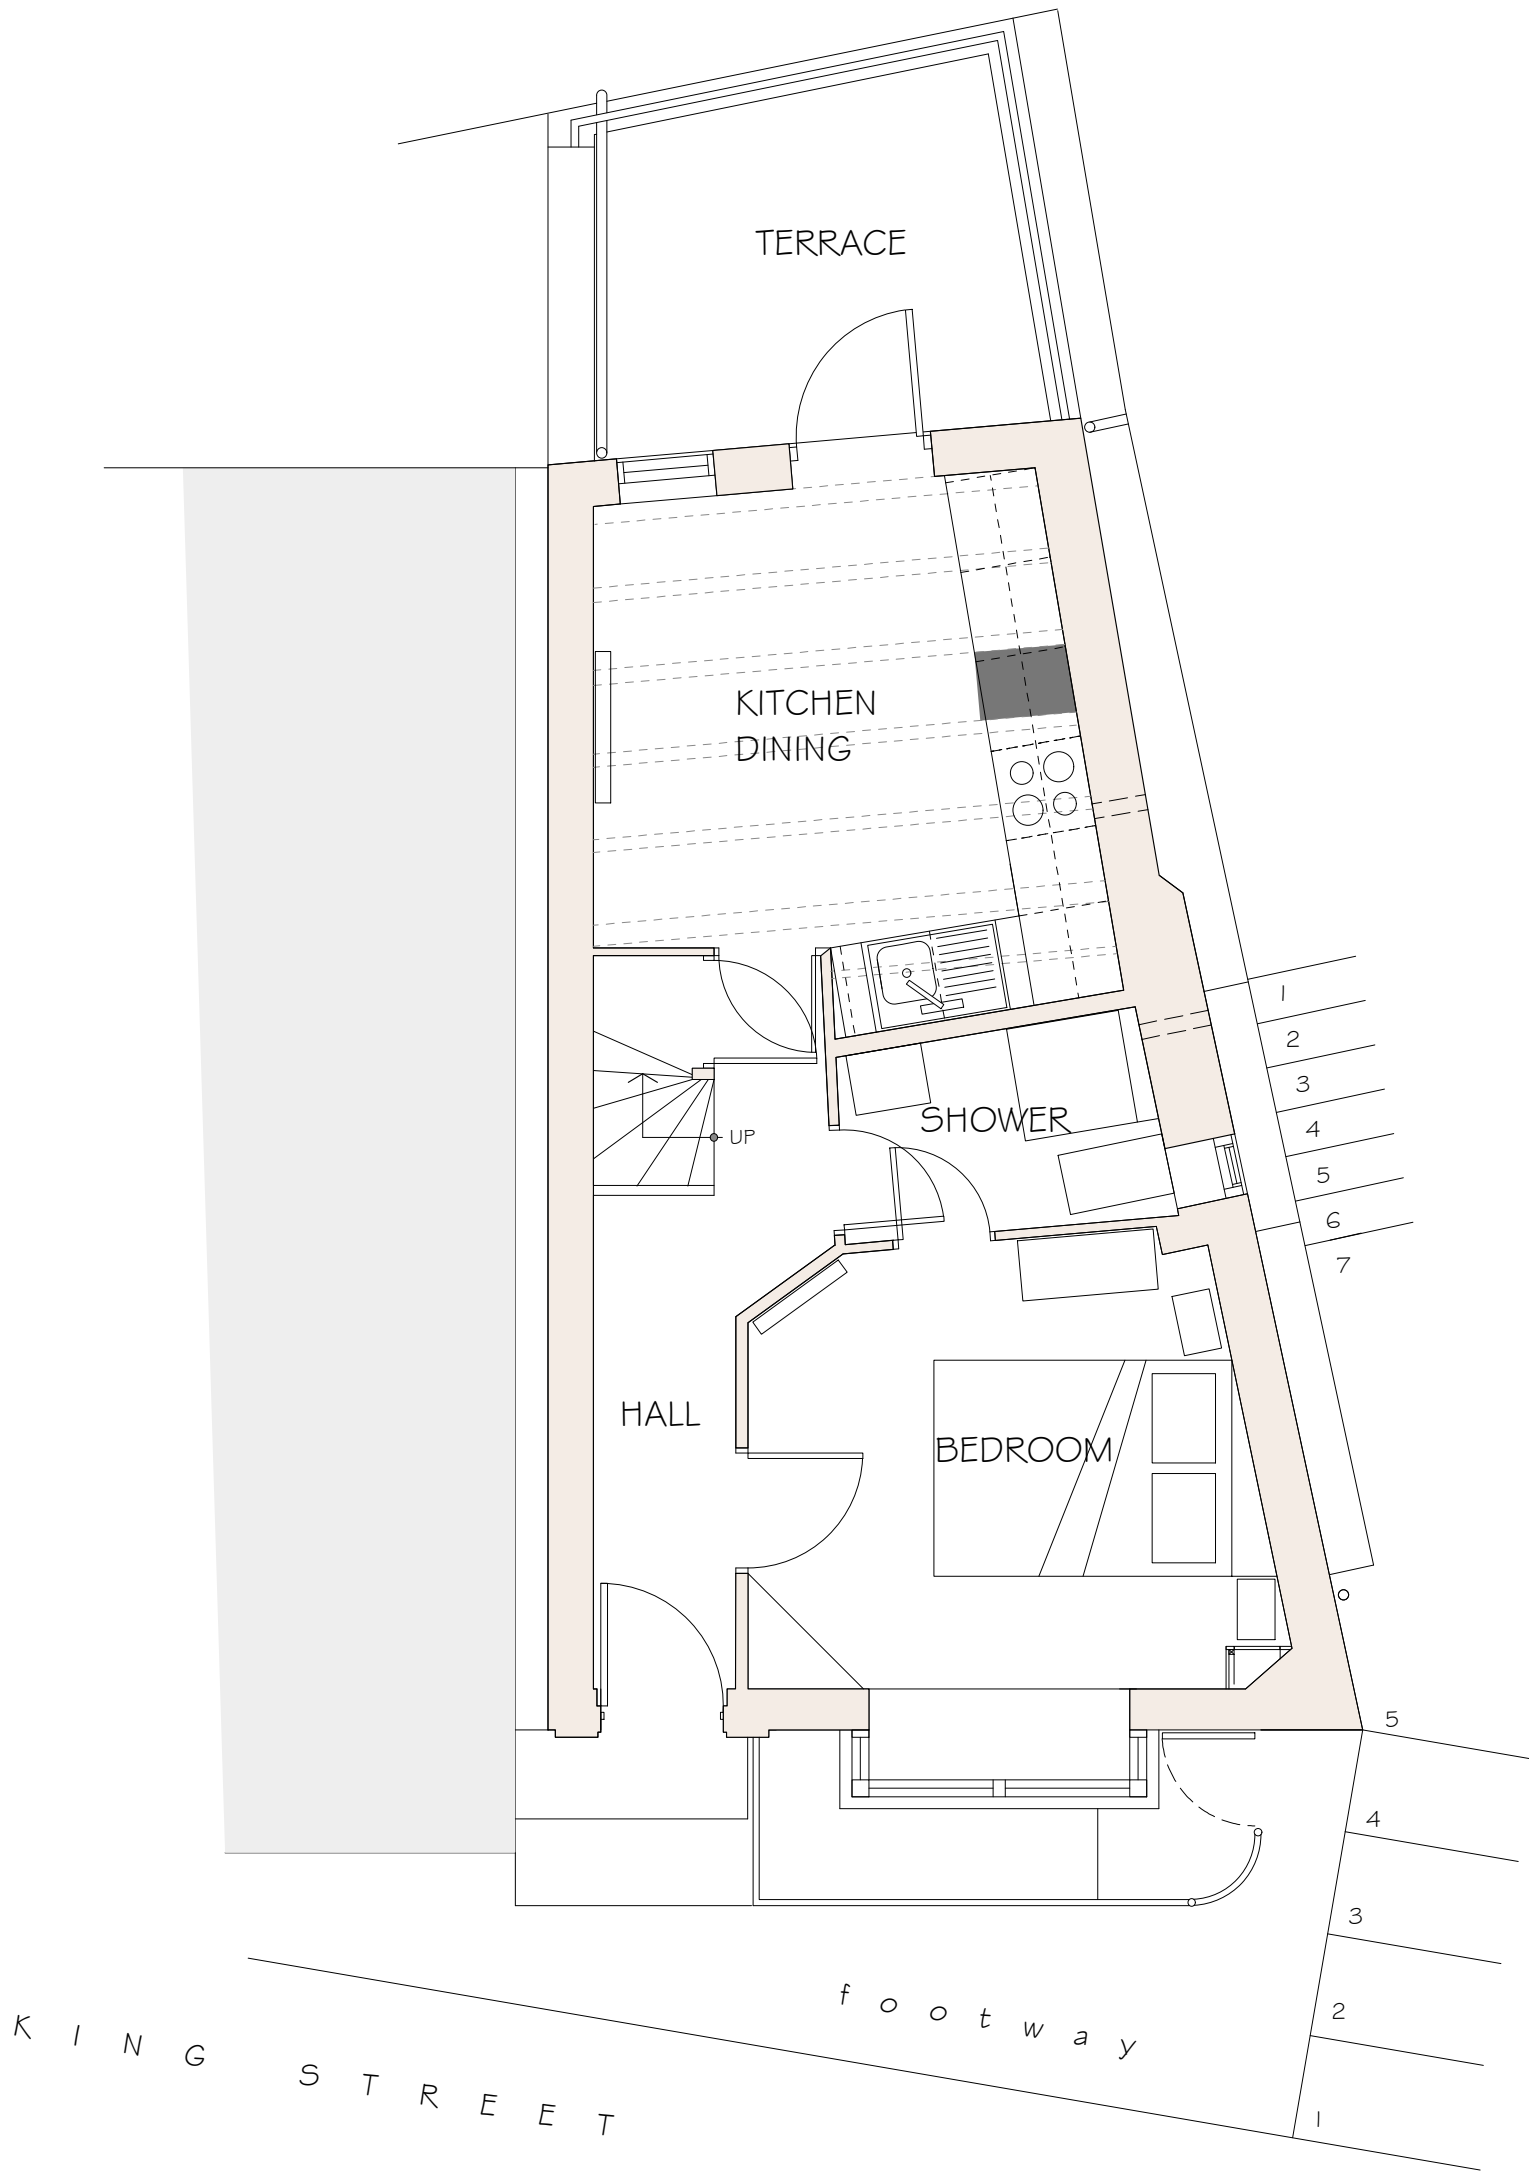
Drawing No. 432/01  
Date: JULY 2023  
Scale: 1/50

Drawing:  
EXISTING  
GROUND FLOOR PLAN

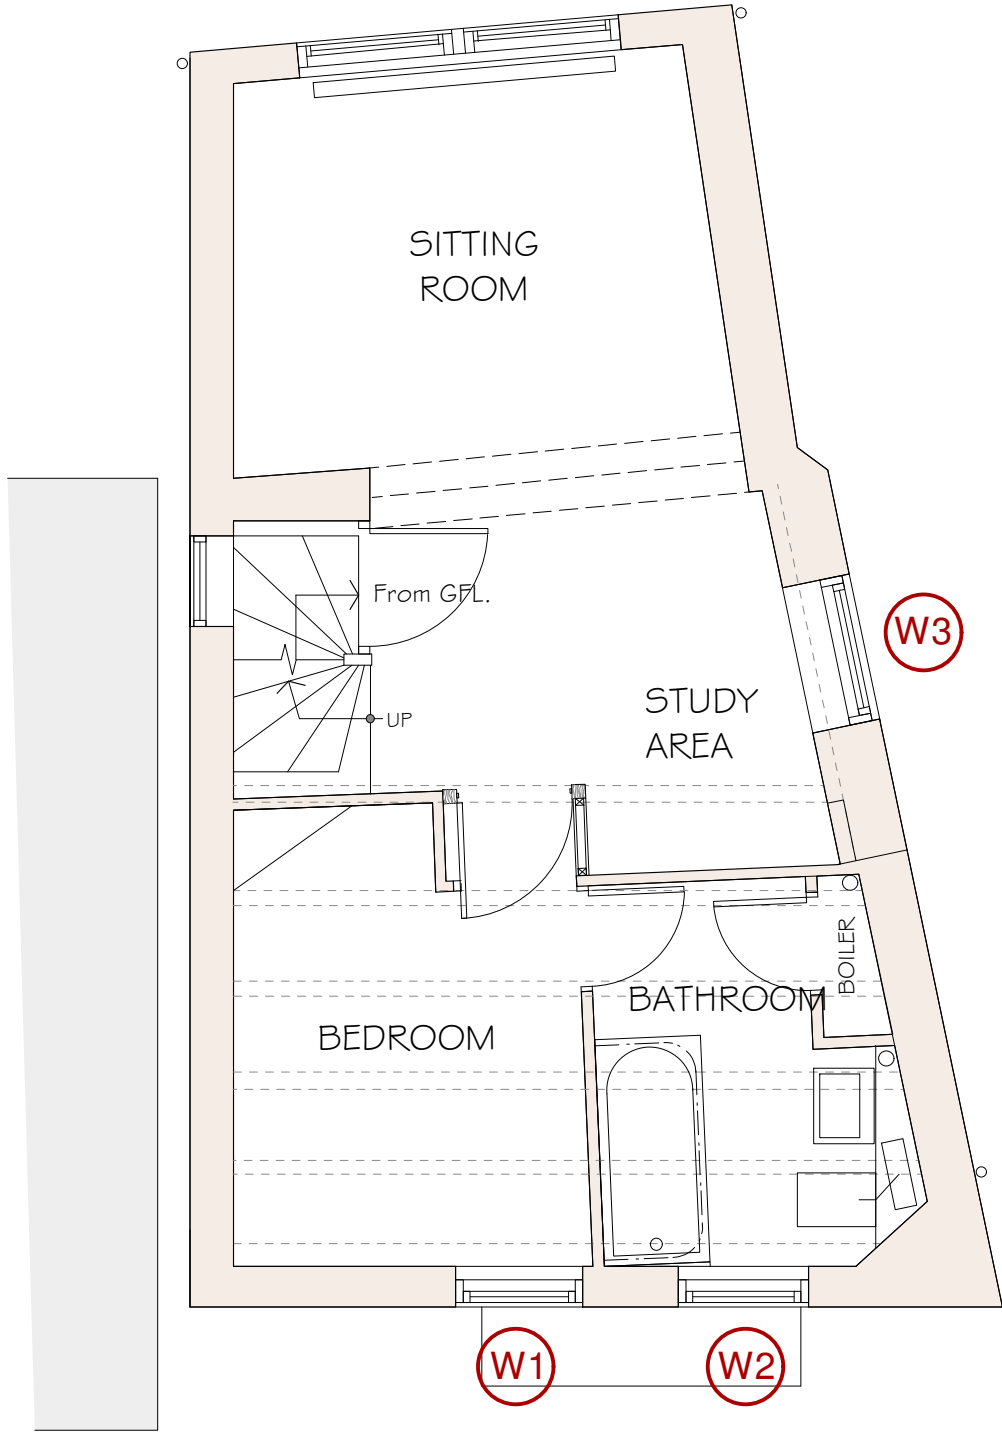
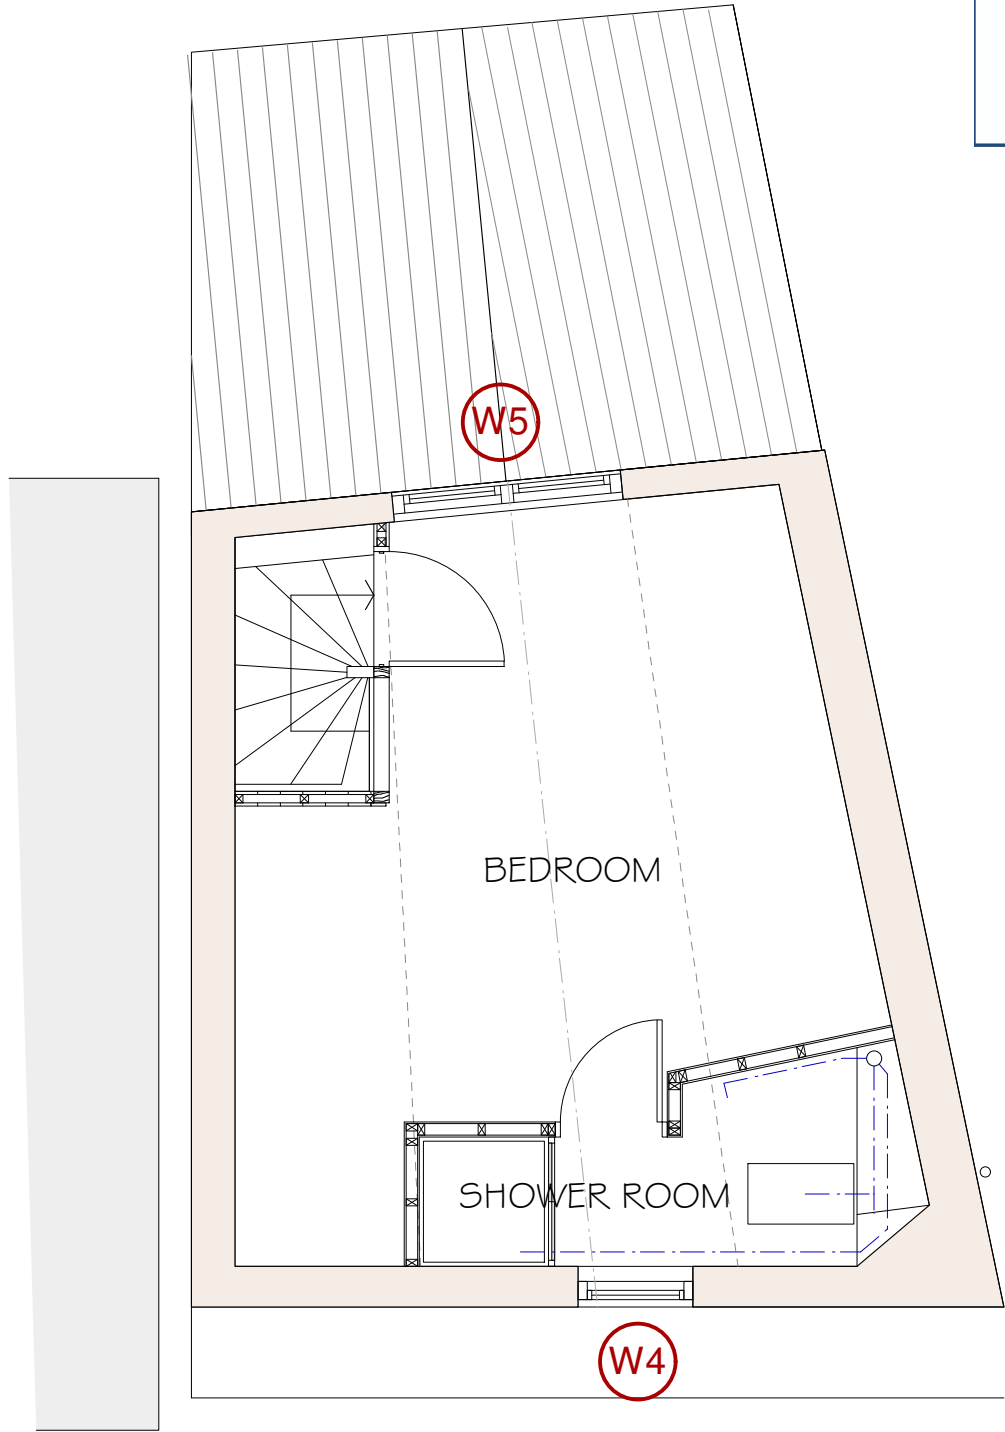
Drawing No. 432/02  
Date: JULY 2023  
Scale: 1/50

Drawing:  
EXISTING FIRST FLOOR &  
SECOND FLOOR PLANS

F I R S T F L O O R

S E C O N D F L O O R

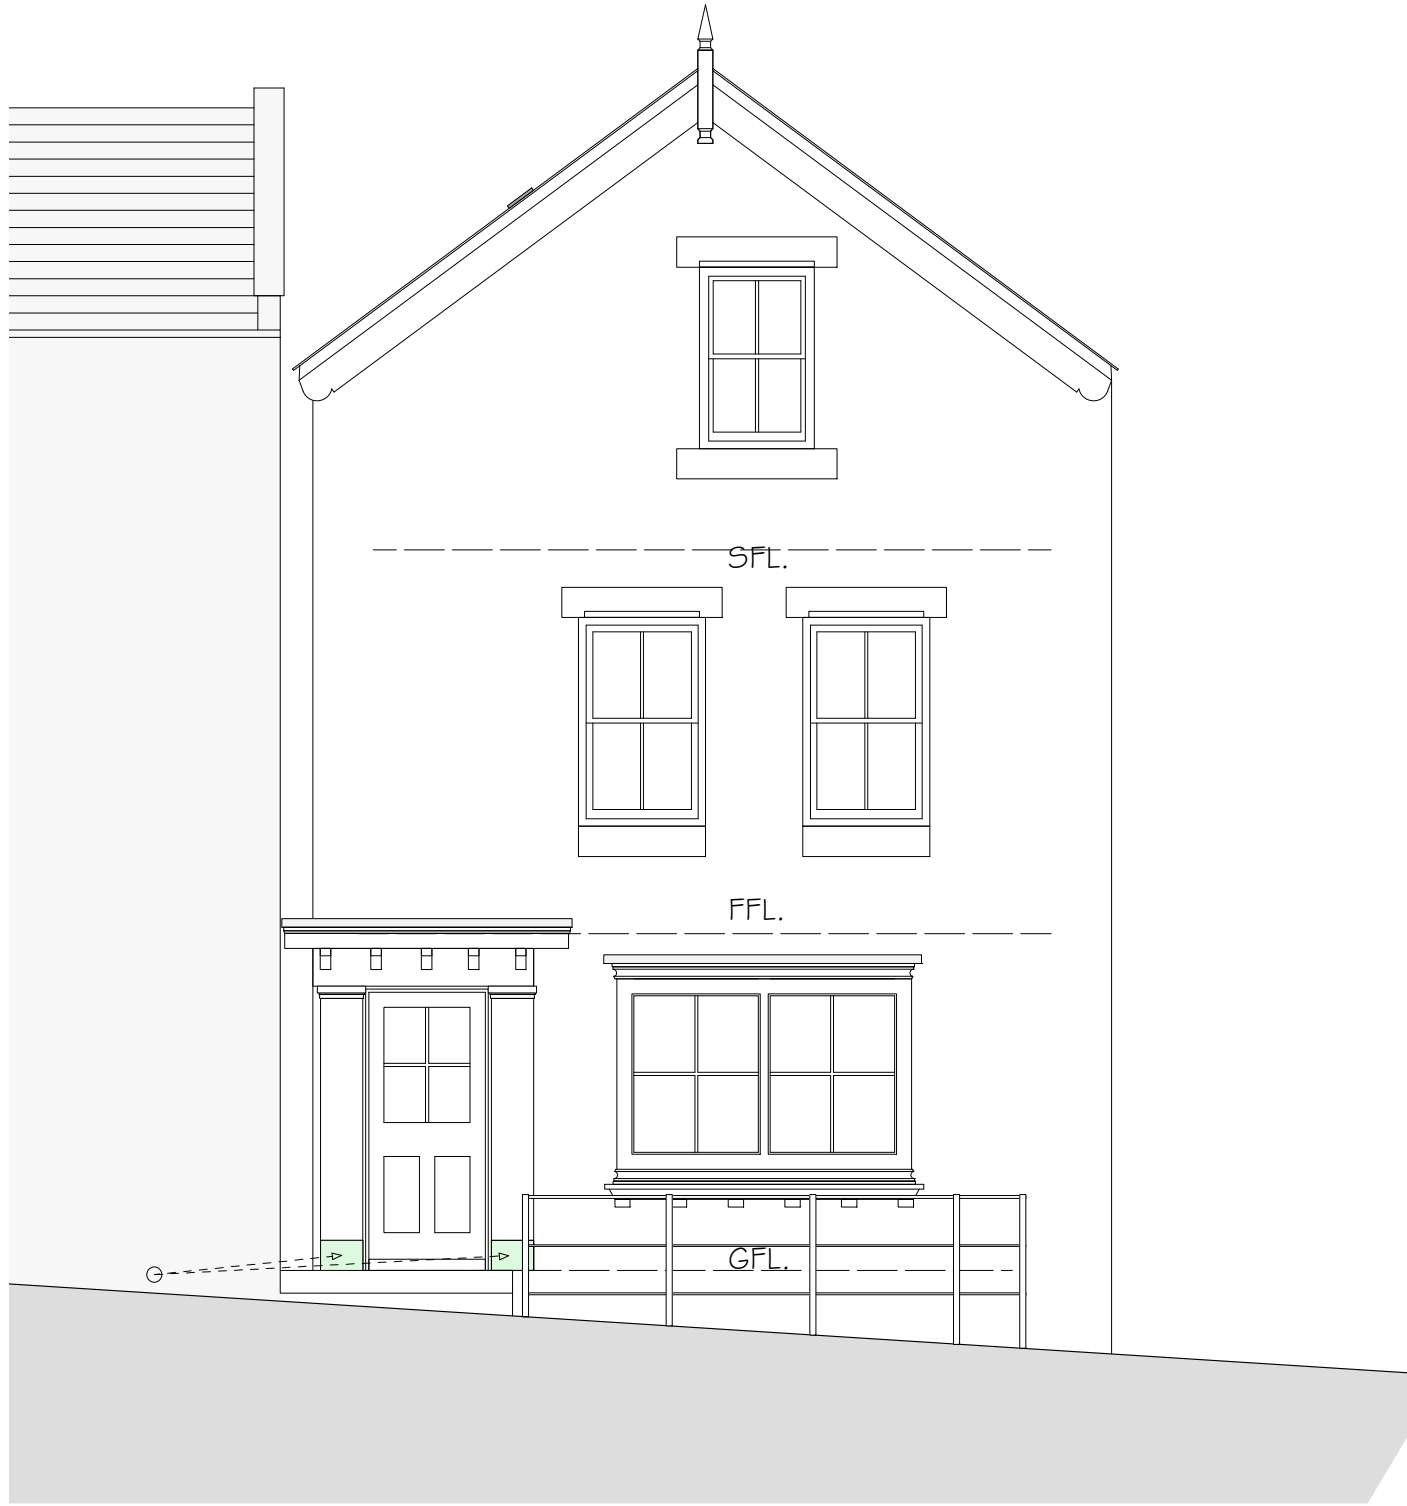
S O U T H E L E V A T I O N

Drawing:  
 EXISTING  
 ELEVATIONS I

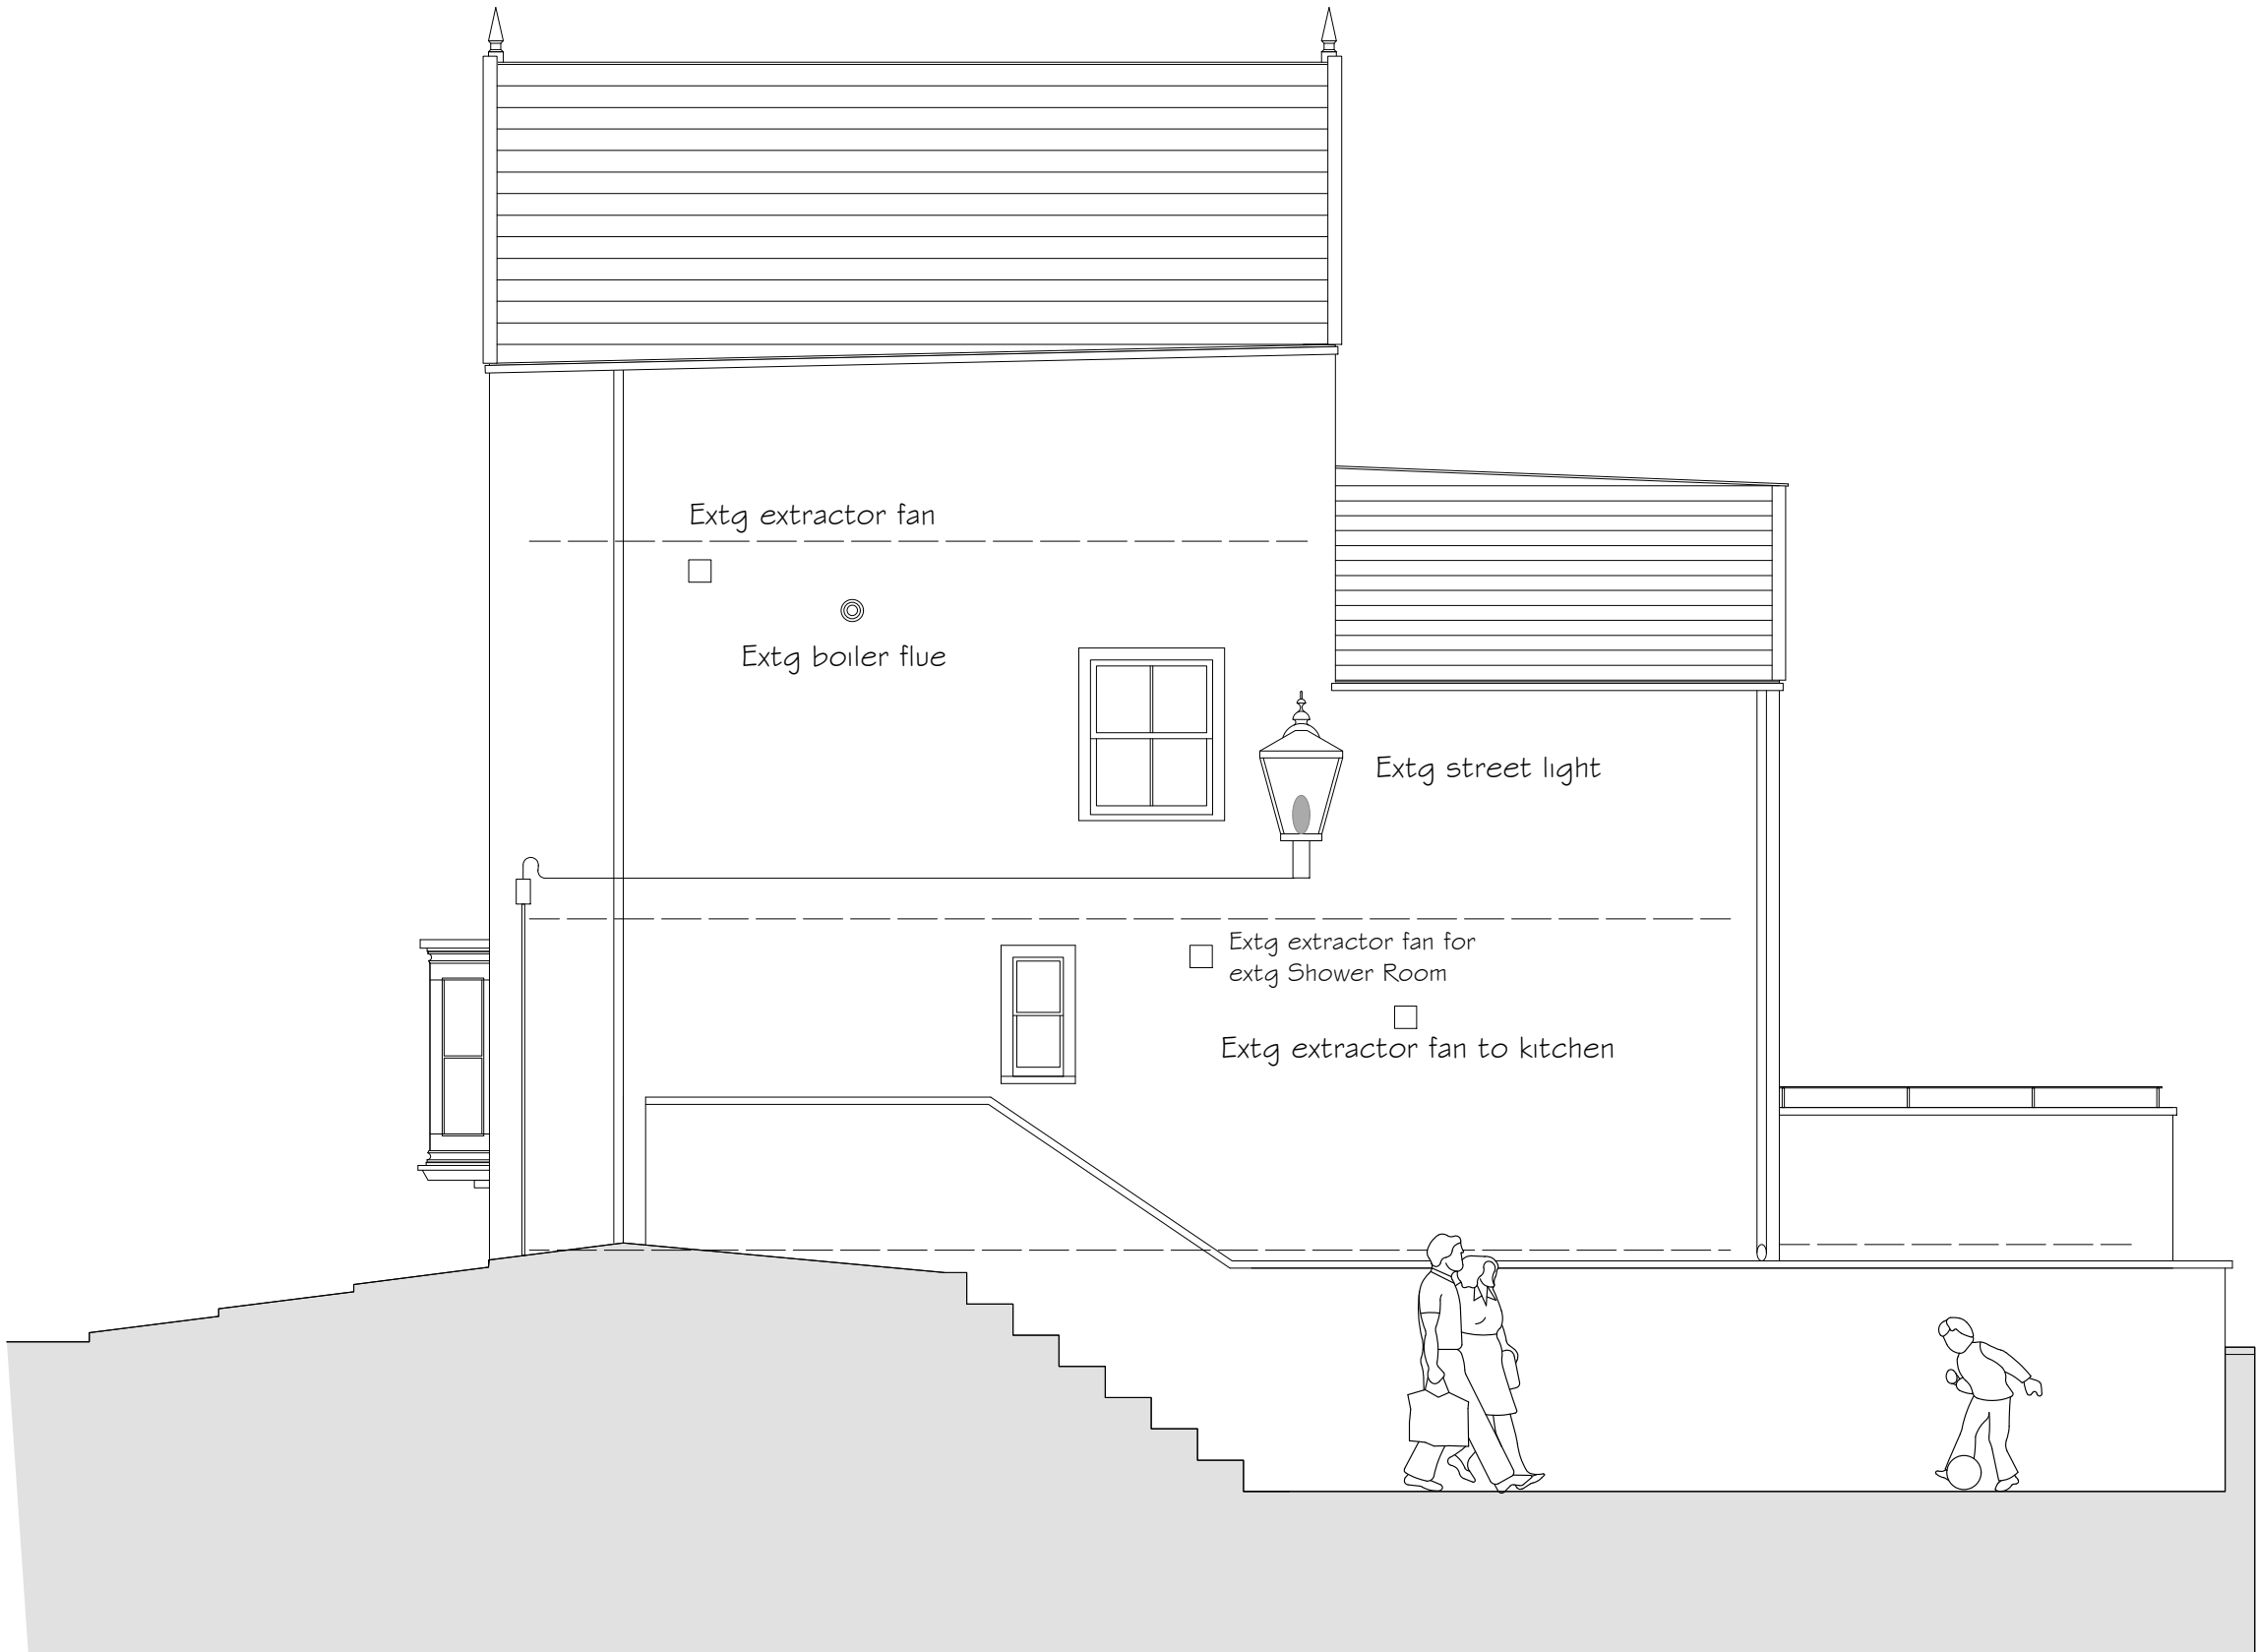
Drawing No. 423/04  
Date: JULY 2023  
Scale: 1/50

Drawing:  
EXISTING  
SIDE ELEVATION

E A S T E L E V A T I O N

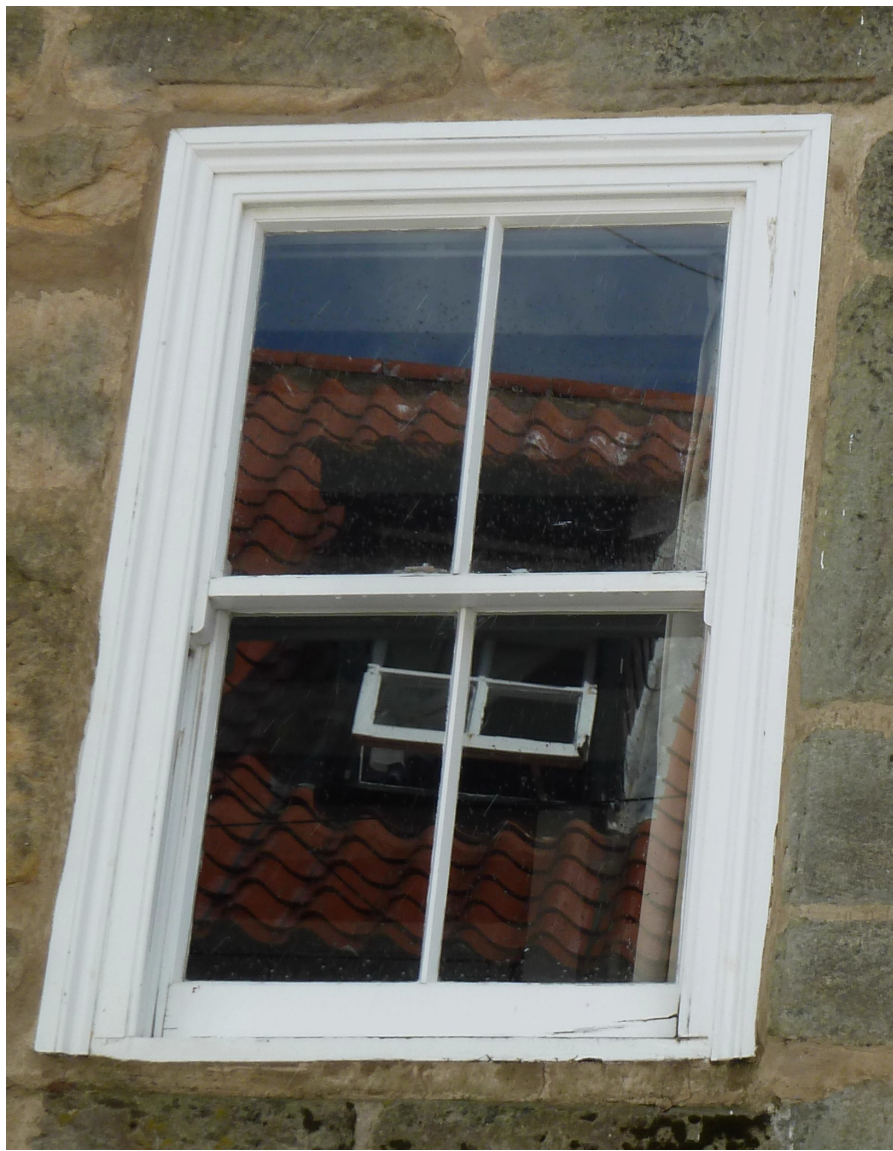
W1

Main visible defects:  
Sill, bottom rail and meeting rail rotted.  
Staining to rhs upper sash jamb.

Window frame manufacture circa  
1980's to 1990's

REPLACEMENT WINDOW FRAMES TO BE TIMBER FOR WHITE PAINT FINISH.

INSTALLATION DETAILS TO MATCH EXISTING FOR ALL LOCATIONS.

MODIFY INSTALLATION AS NECESSARY FOR DEEPER BOX FRAME.

FRAME SECTIONS AS J.HALLAM JOINERY 'EGTON' HERITAGE RANGE.

WHERE REQUIRED EXTEND SILL TO PROJECT BEYOND STRUCTURE USING REBATED AND GLUED SECTION.

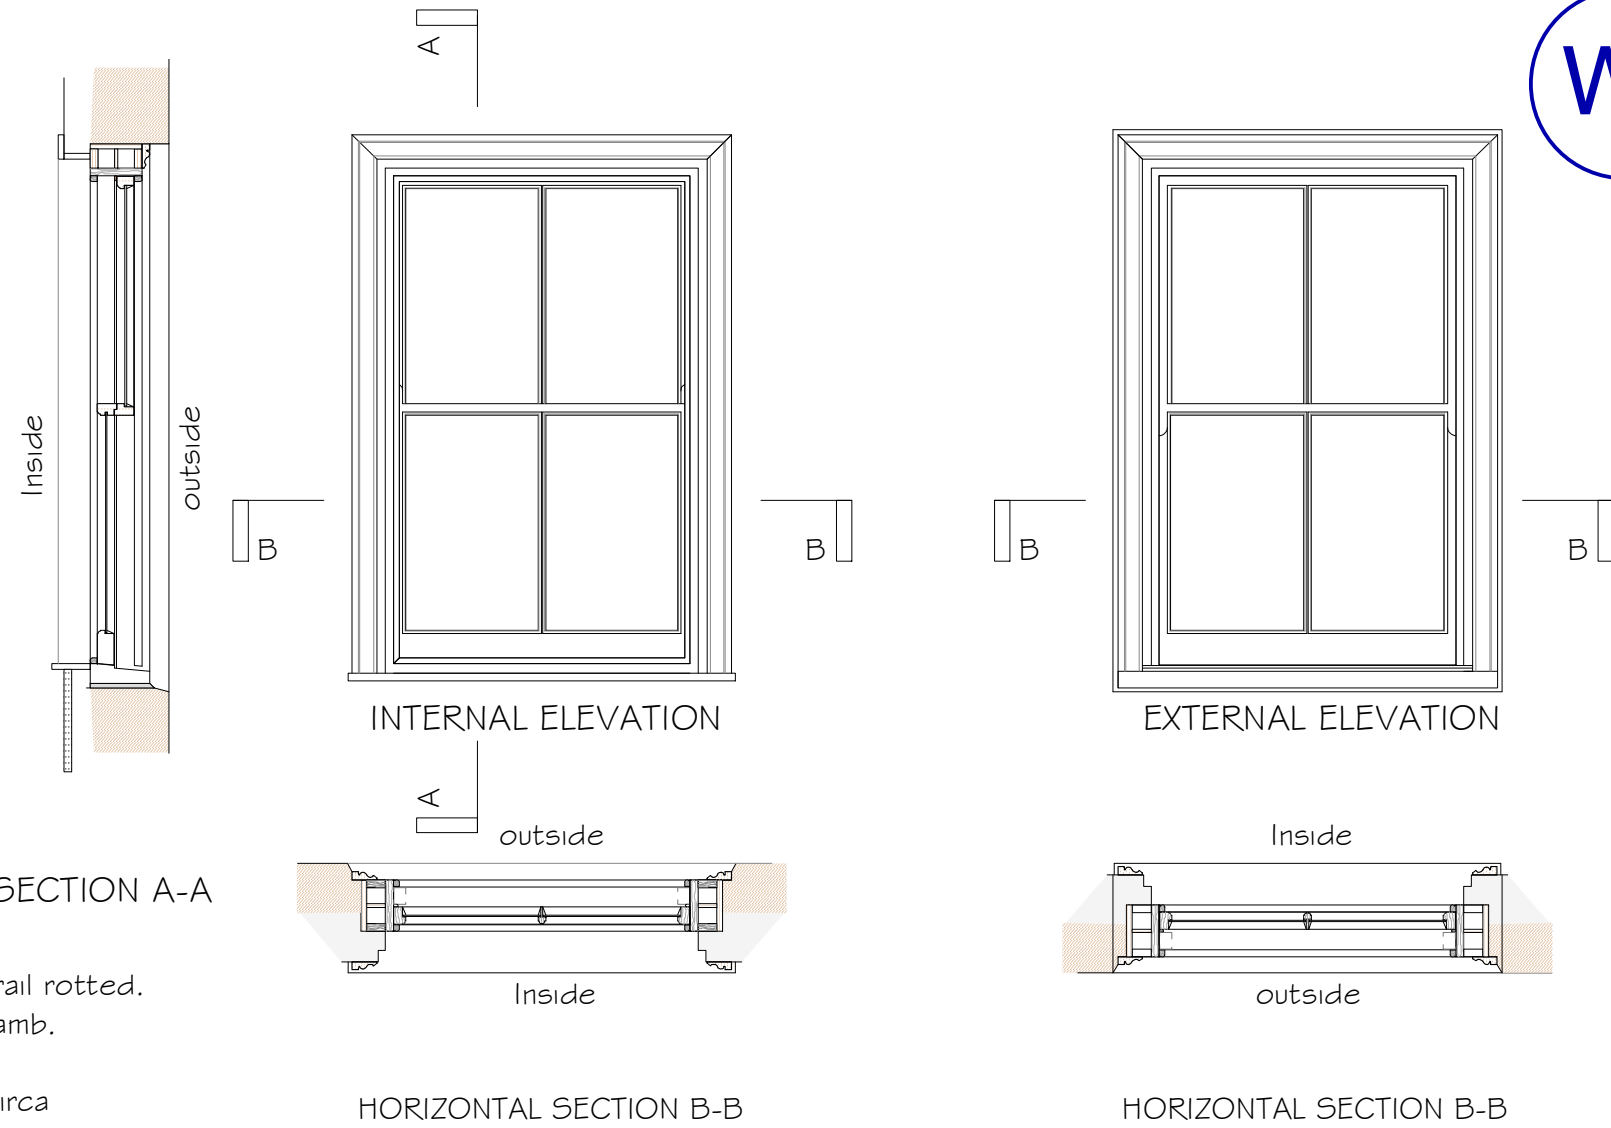
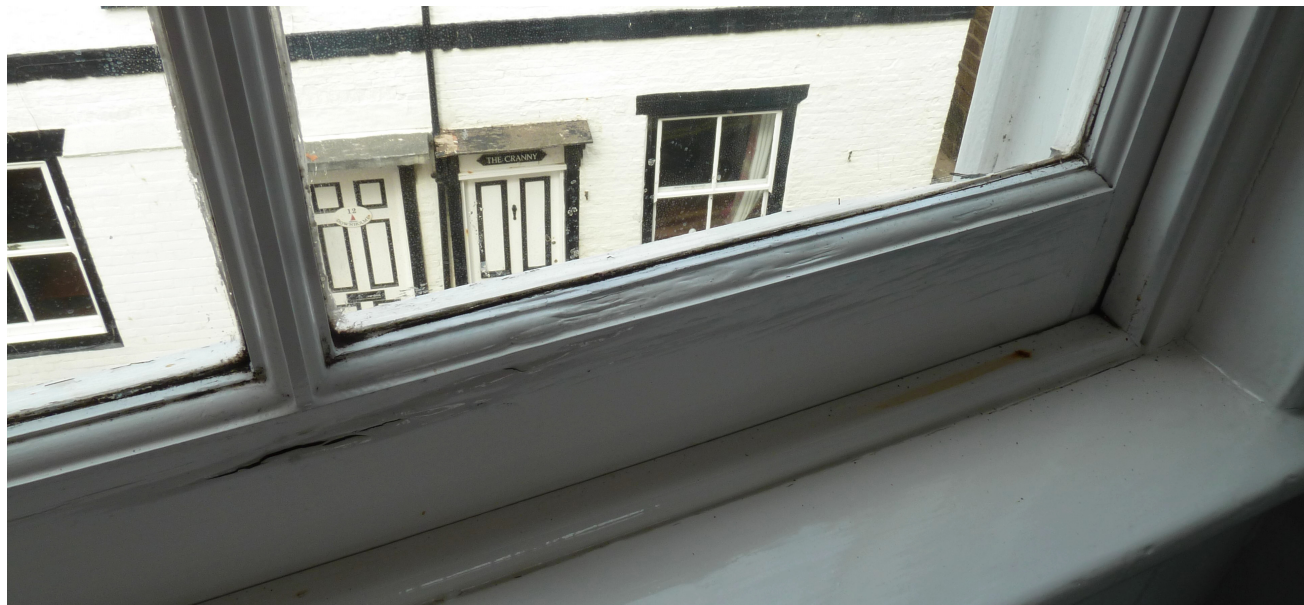
FIRST FLOOR LEVEL BEDROOM (LHS Viewed Externally).

Cracked paint and surface mould indicates general state of decay throughout the frame components internally & externally. Details of the sash and meeting rails as for W2.

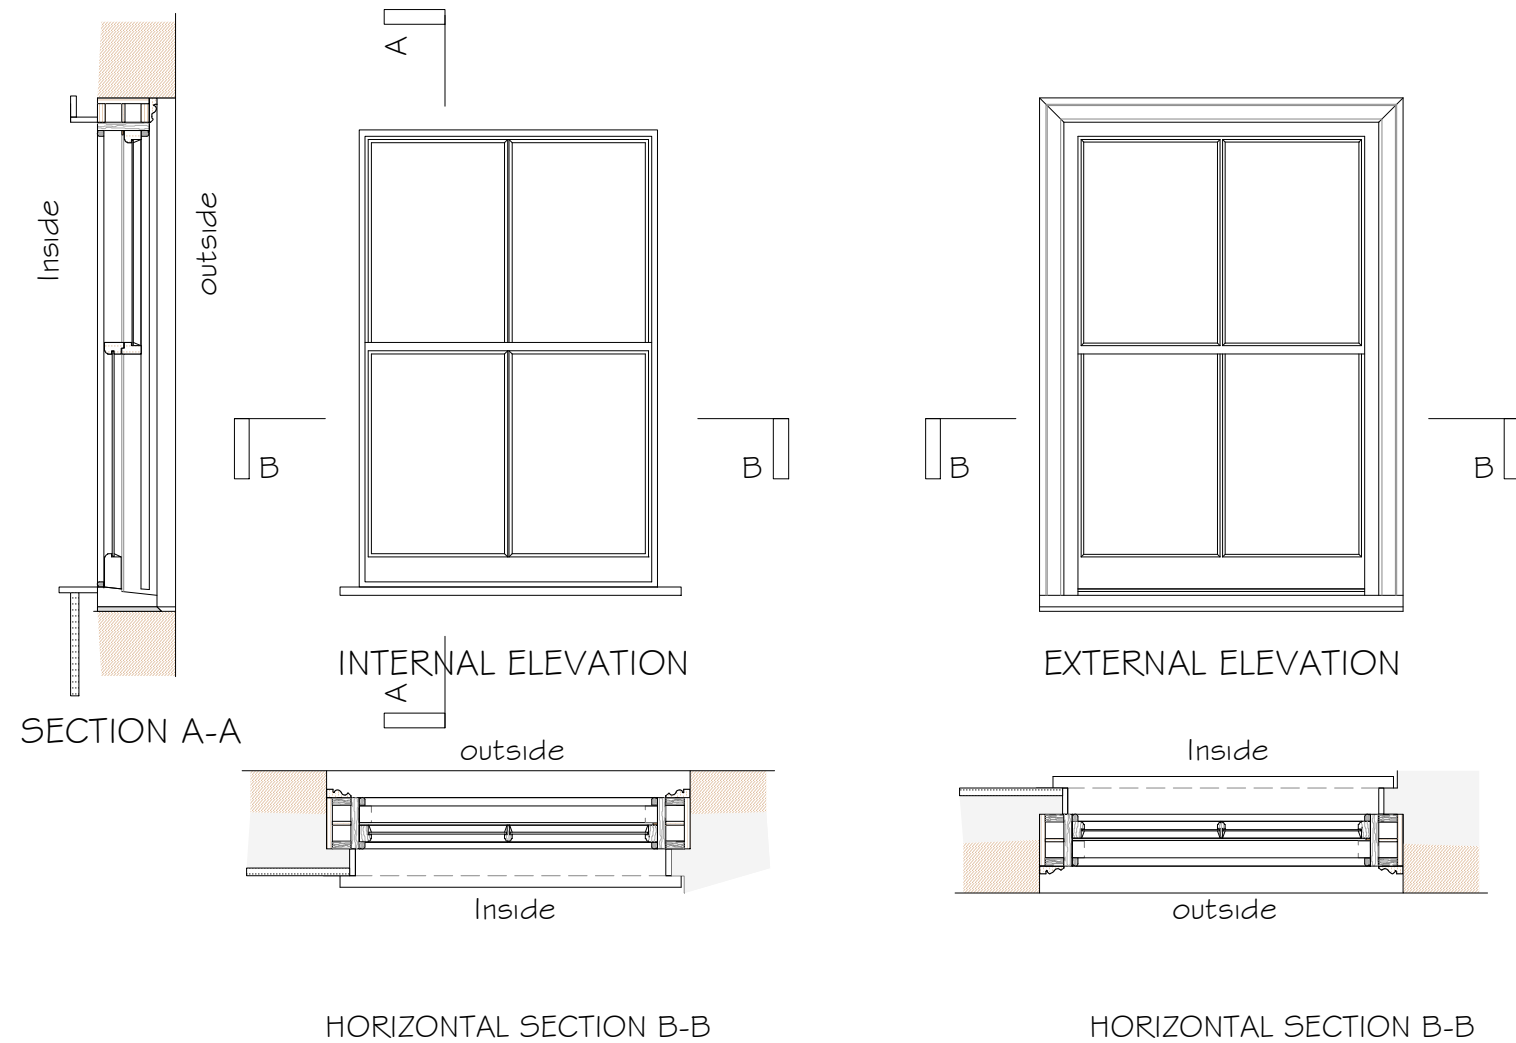
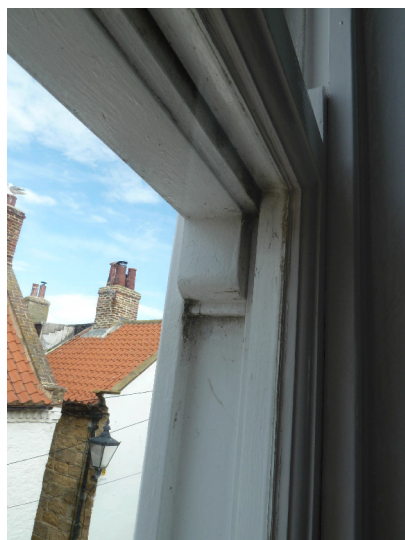
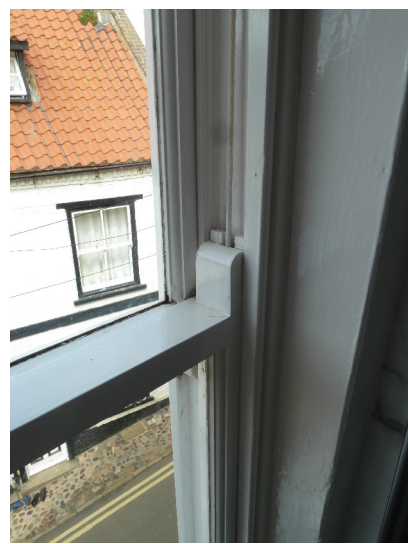
FIRST FLOOR LEVEL BATHROOM. (RHS Viewed Externally).

Cracked paint and surface mould indicates general state of decay. Details at sash horn non-vernacular particularly composite planted sections to sash cord channel. These details also apply to W1.

TILE SURROUND TO WINDOW FRAME IN BATHROOM.

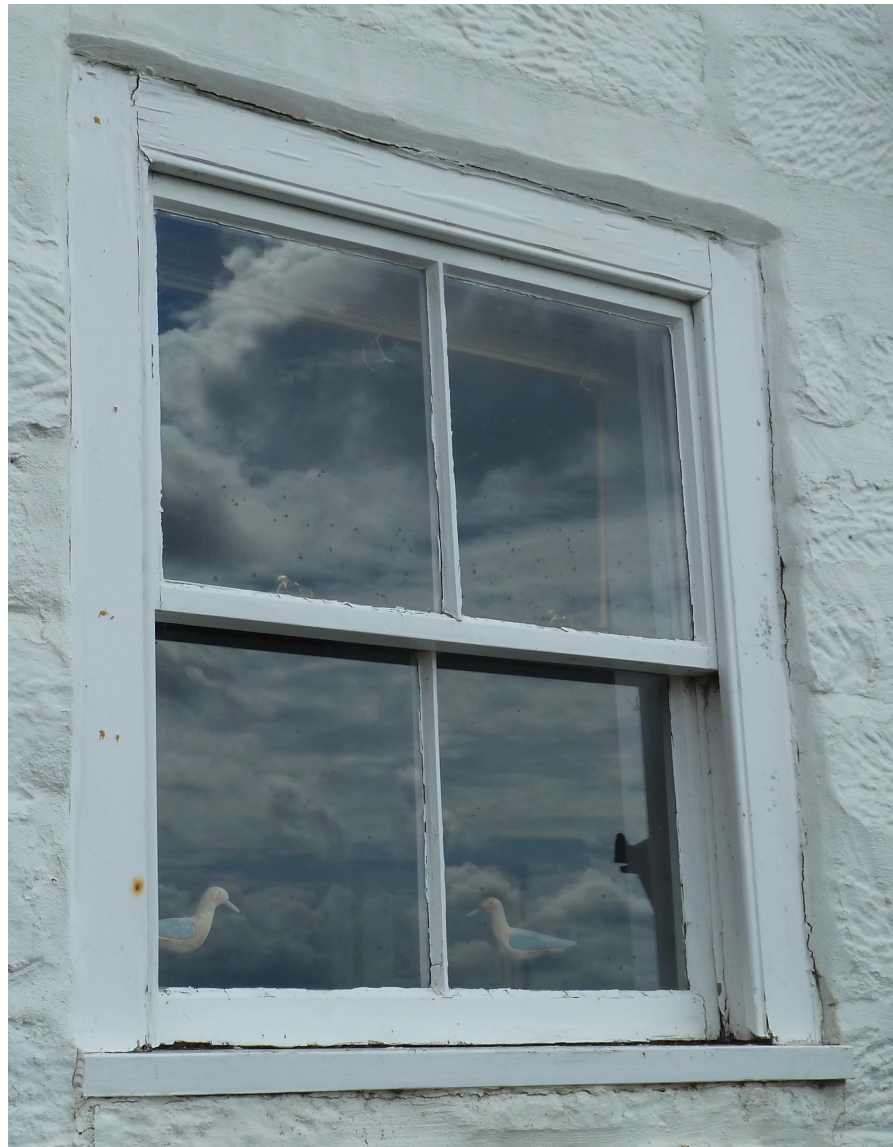
FIRST FLOOR SITTING ROOM . SIDE ELEVATION

The defects are obvious in this frame as the head of the frame can be seen to be cracked and the paint blistered. The joints have opened and the components of the frame visibly decayed.

REPLACEMENT WINDOW FRAMES TO BE TIMBER FOR WHITE PAINT FINISH.

INSTALLATION DETAILS TO MATCH EXISTING FOR ALL LOCATIONS.

MODIFY INSTALLATION AS NECESSARY FOR DEEPER BOX FRAME.

FRAME SECTIONS AS J.HALLAM JOINERY 'EGTON' HERITAGE RANGE.

WHERE REQUIRED EXTEND SILL TO PROJECT BEYOND STRUCTURE USING REBATED AND GLUED SECTION.

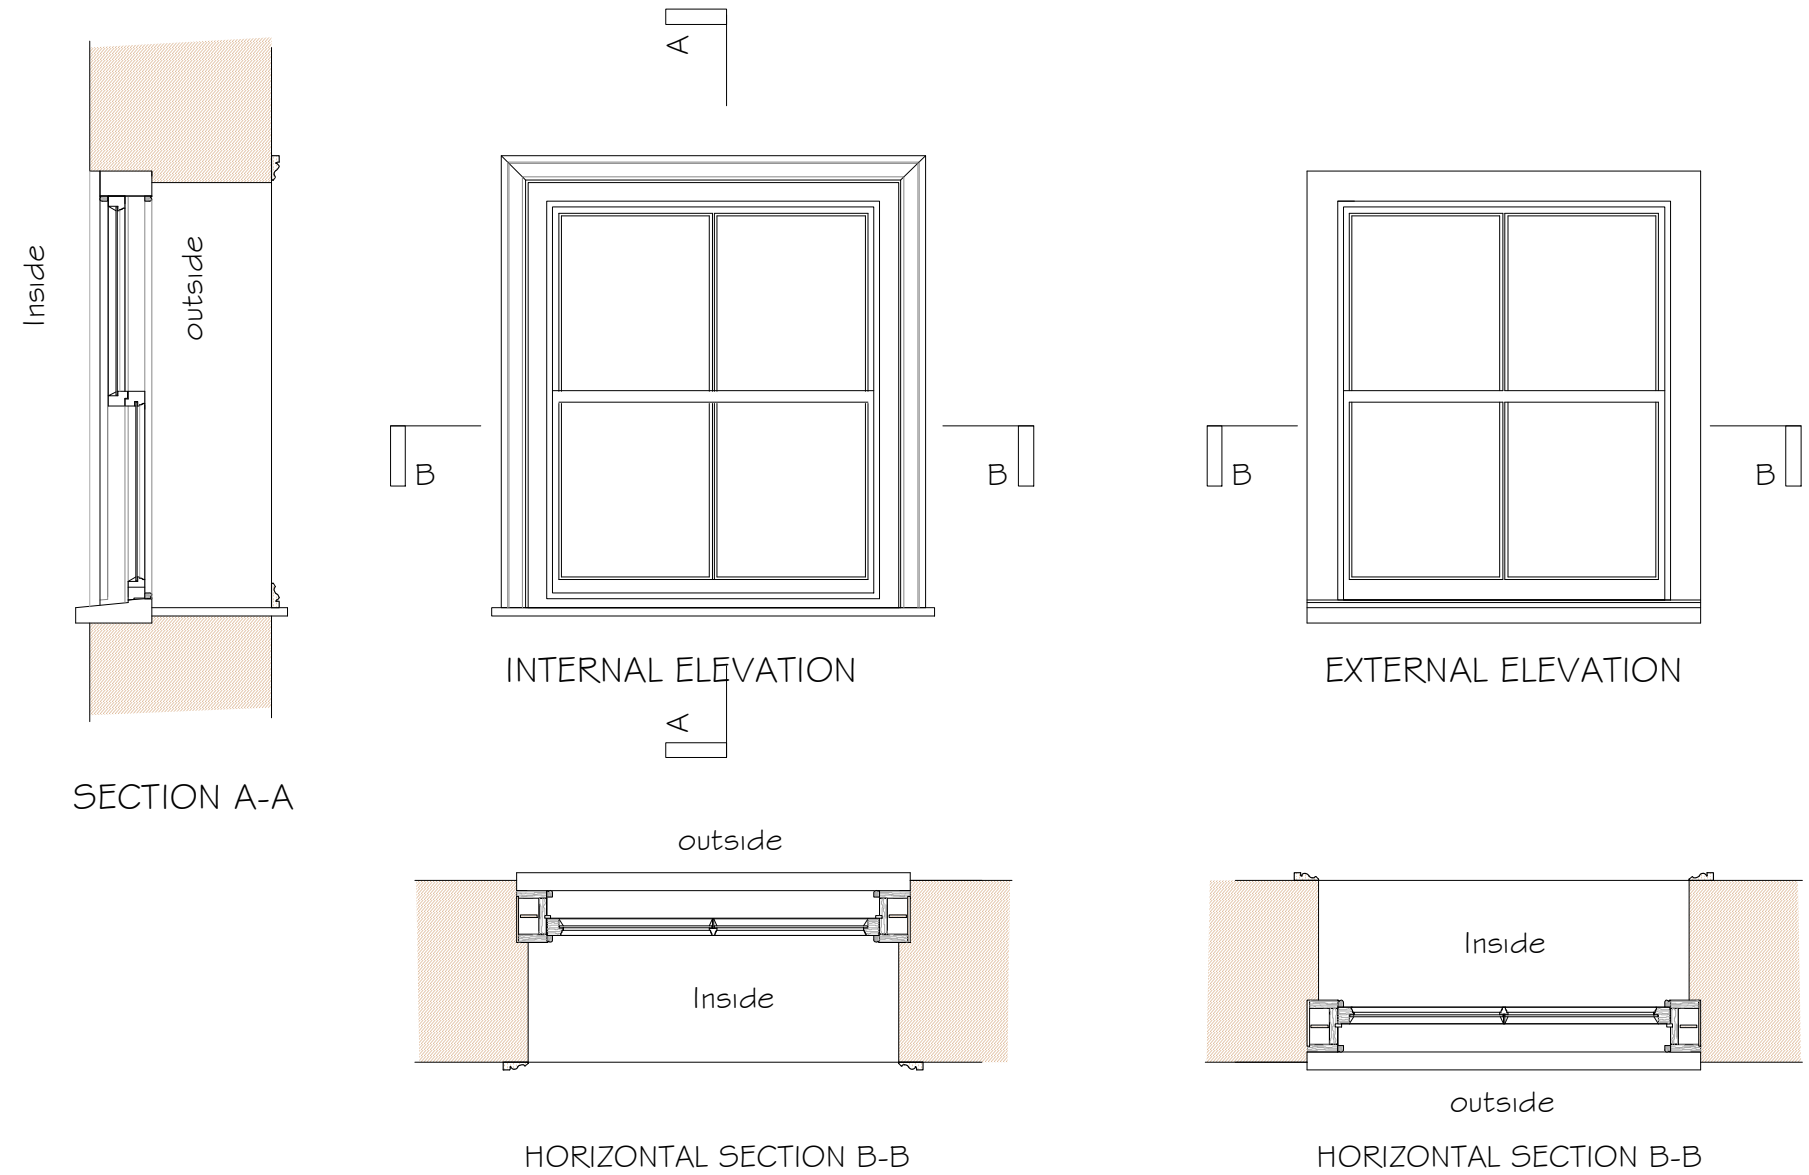
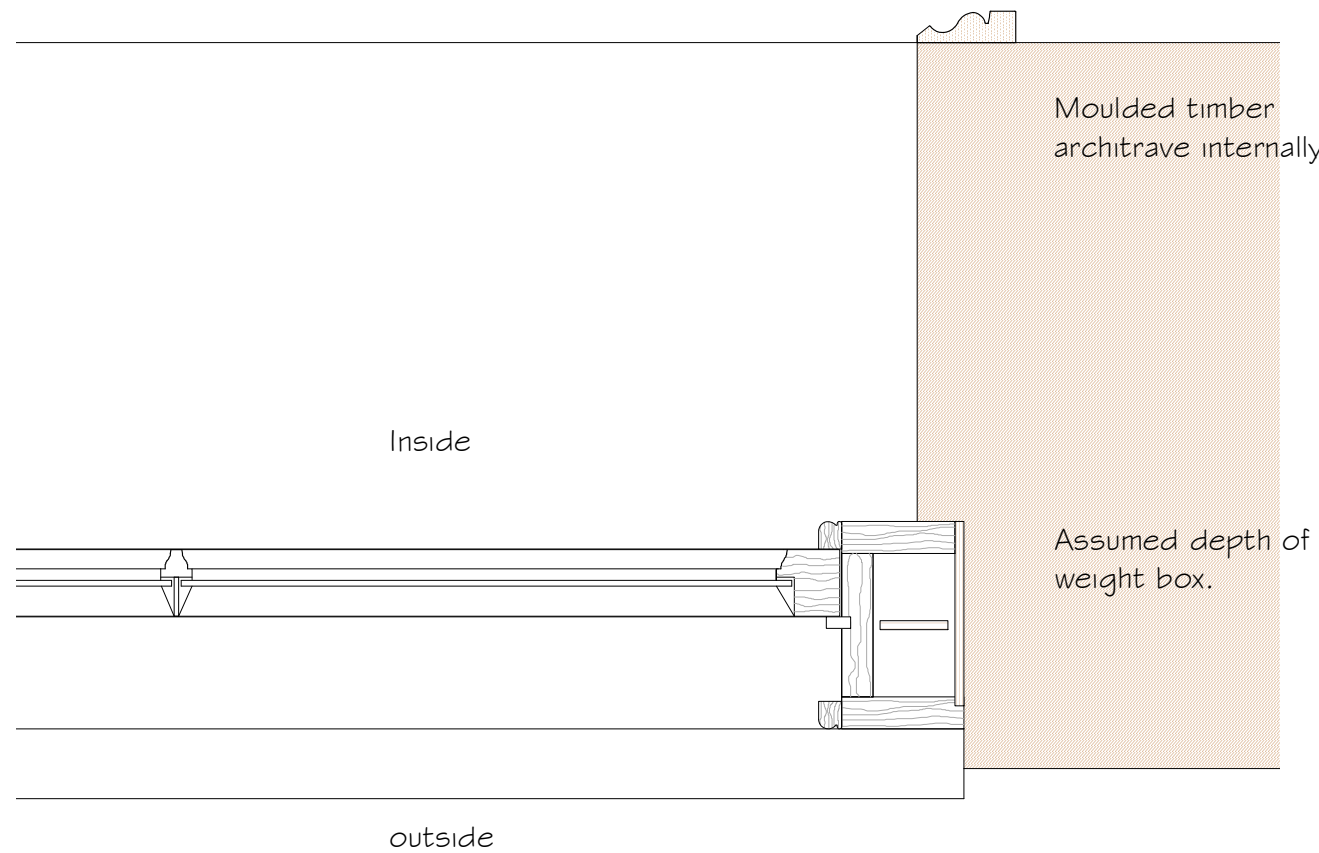
Drawing No. 423/07  
Date: JULY 2023  
Scale: 1/50 Print at A3

TYPICAL DETAILS at JAMB & GLAZING BAR  
Scale 1 : 5

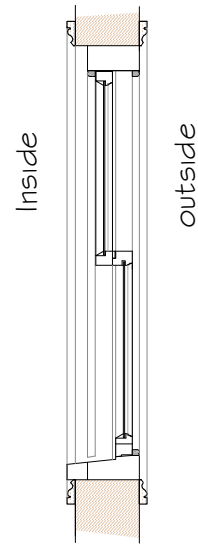
Moulded timber  
architrave internally  
& externally.
