# York House, King Street, YO22 4SH

York House  
King Street,  
Robin Hoods Bay,  
Whitby,  
North Yorkshire  
YO22 4SH

Proposed:  
WINDOW REPLACEMENTS  
at  
YORK HOUSE  
KING STREET  
ROBIN HOODS BAY

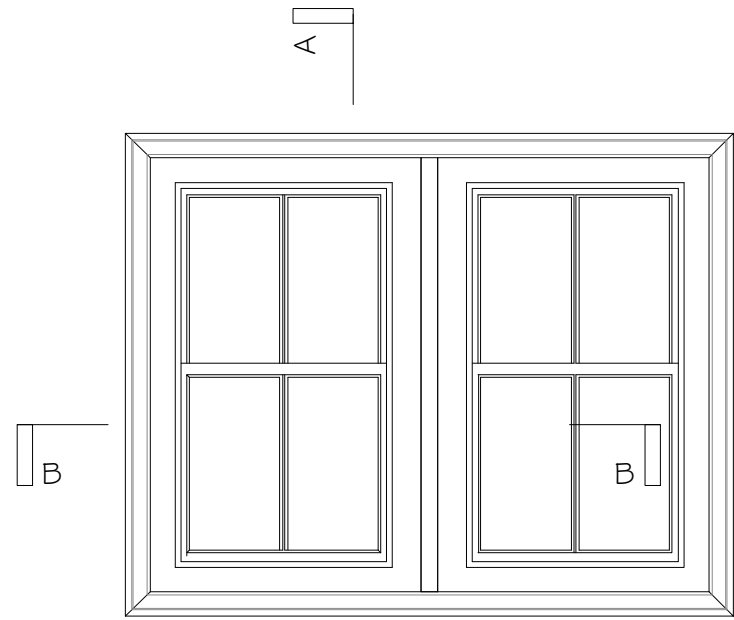
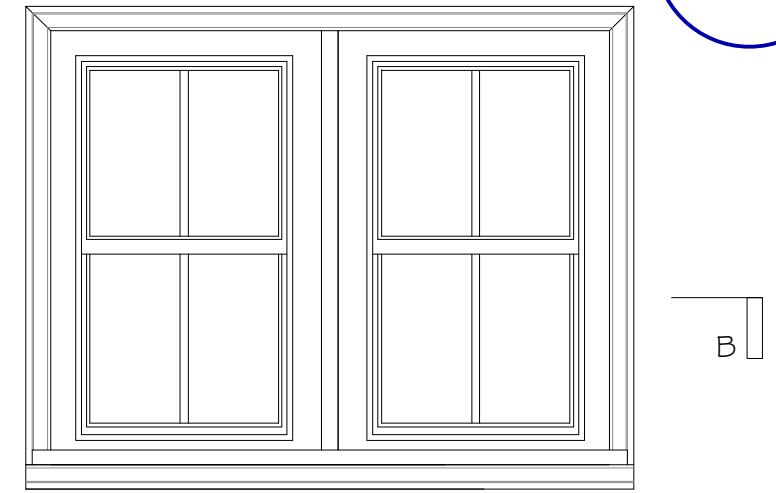
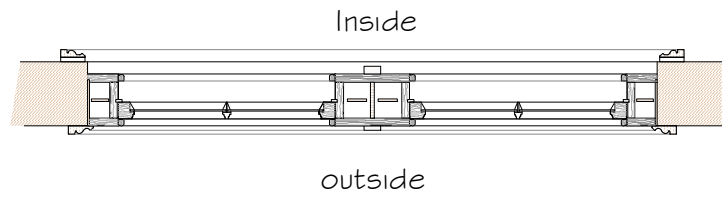
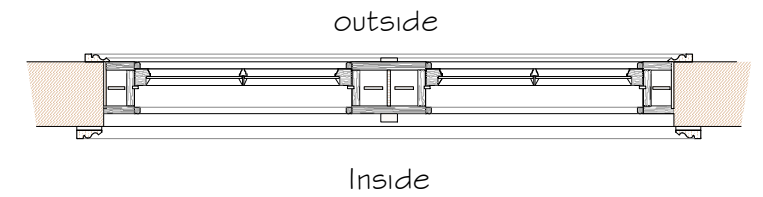
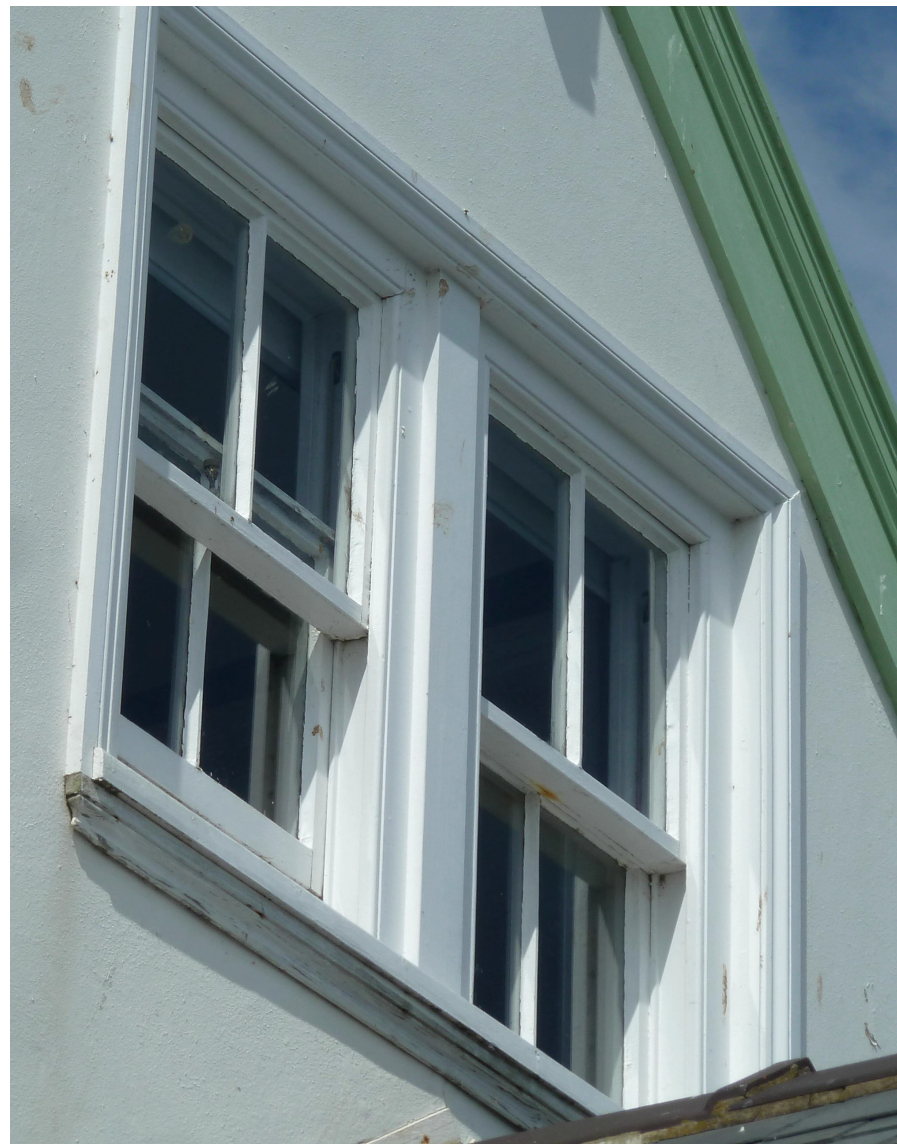
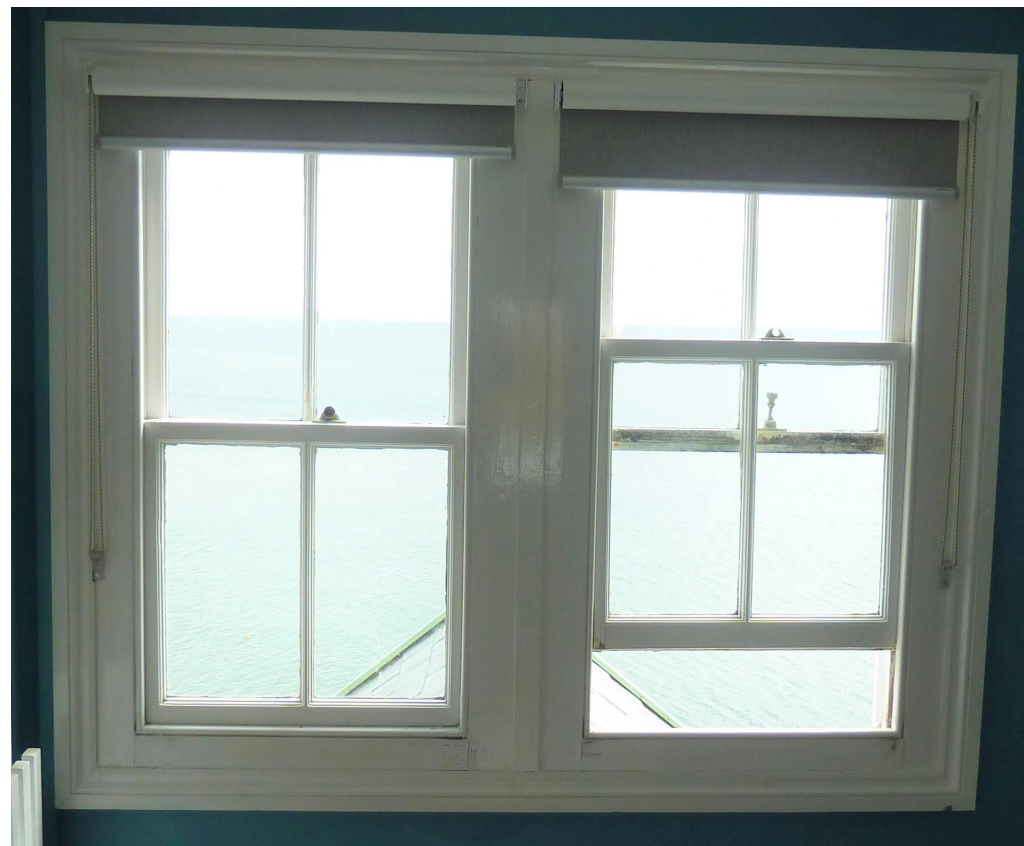
SECOND FLOOR BEDROOM.  
REAR ELEVATION. EXTERNAL VIEW.

NB. Details of frame components as for W3:  
See 1:5 sections drawing 423.07  
Design & manufacture date assumed to be the same.

Moulded timber  
architrave internally  
& externally.

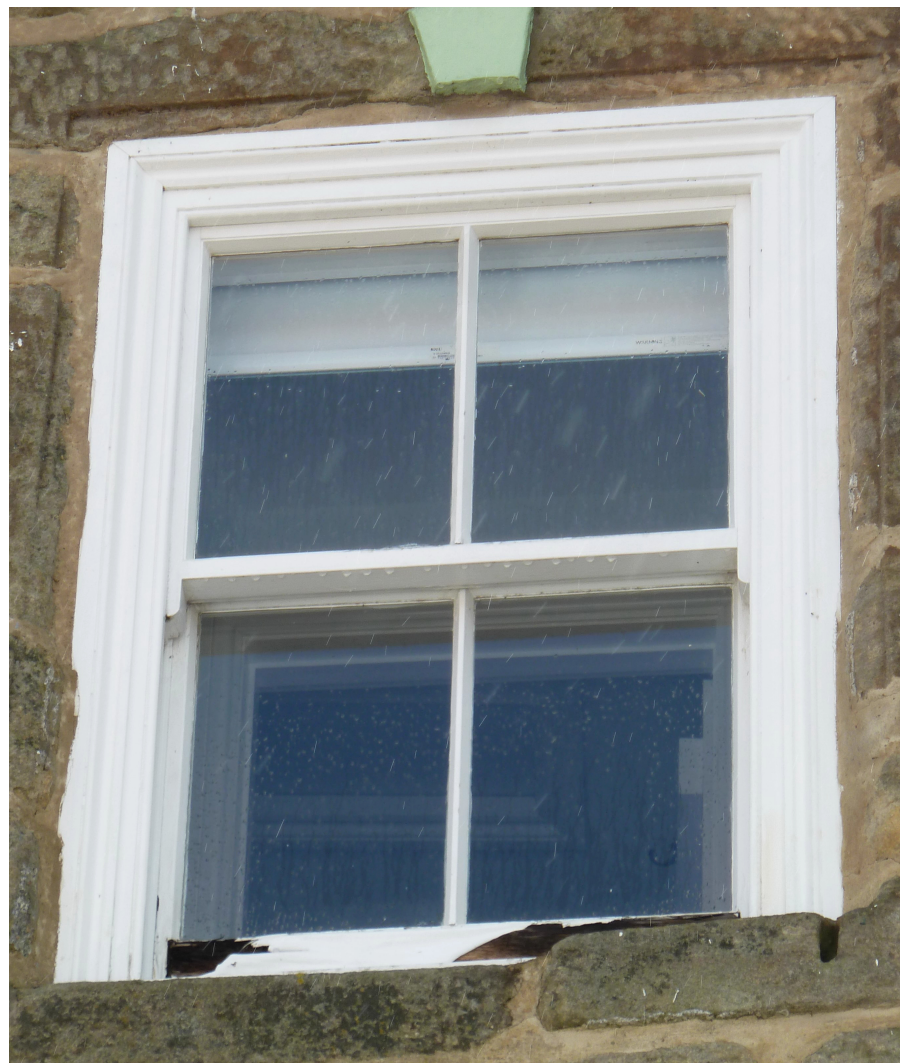
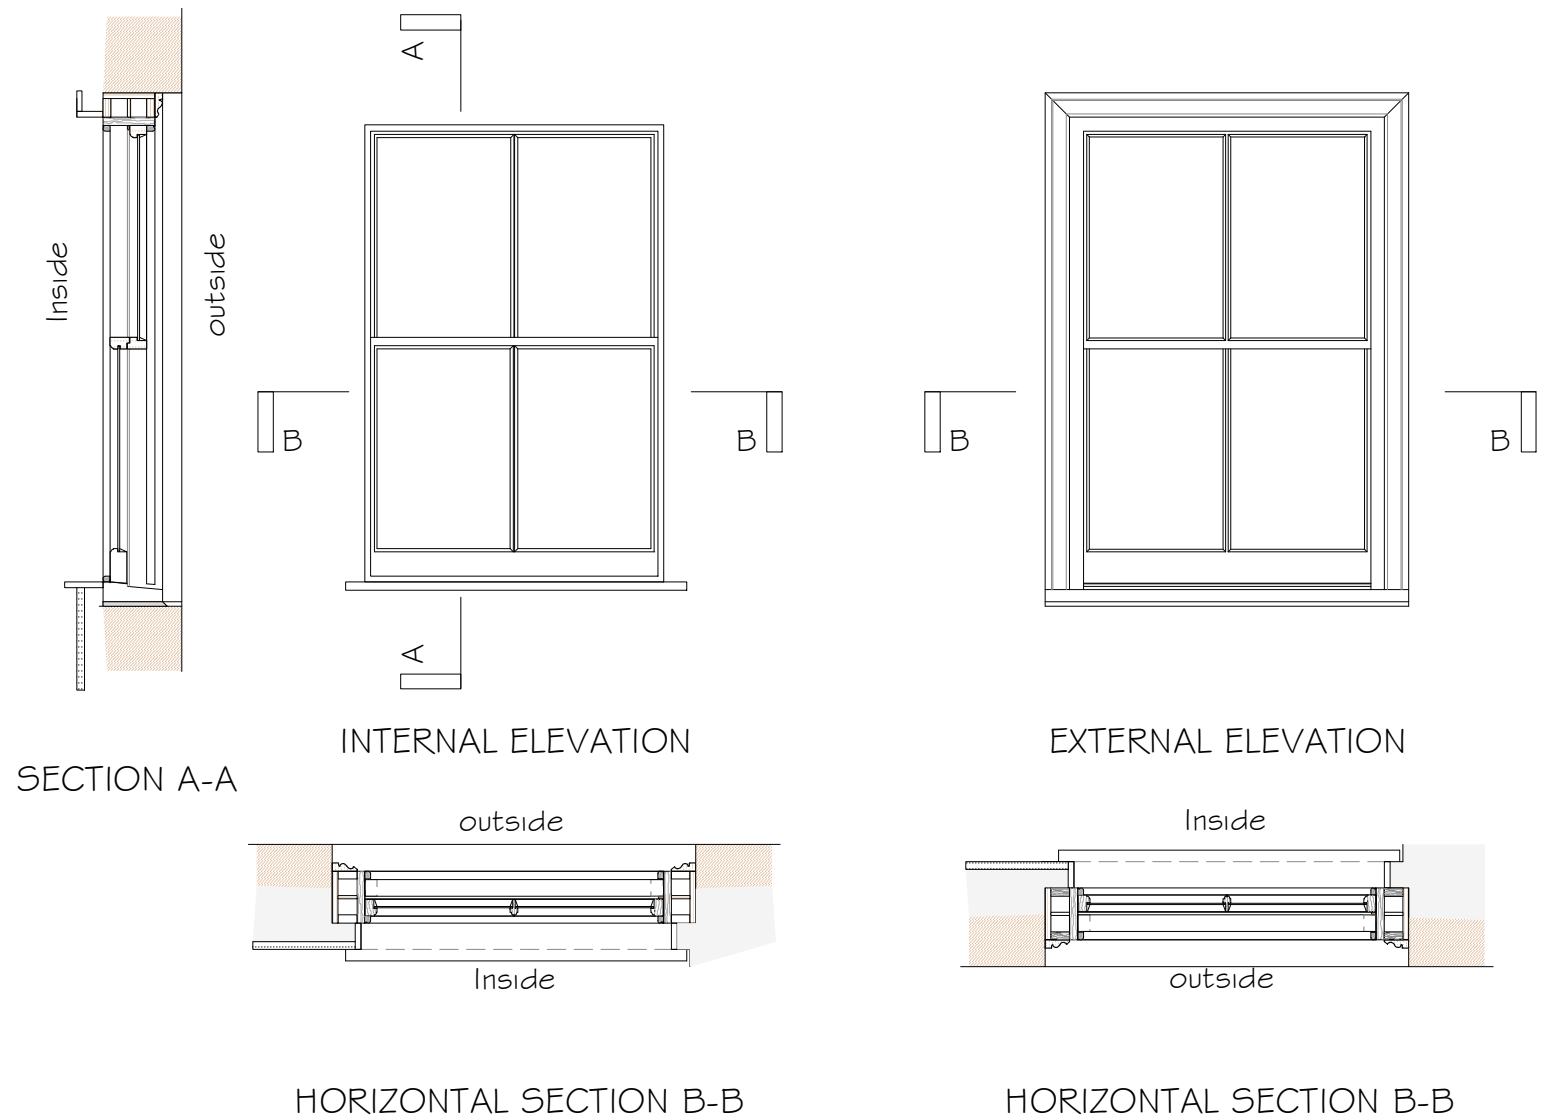
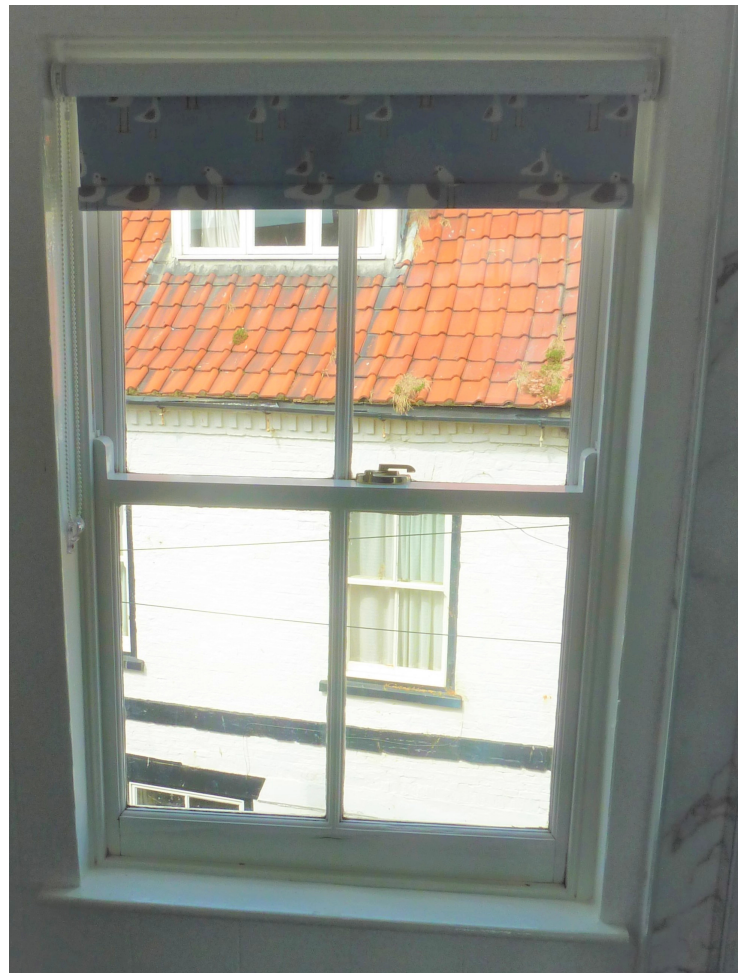
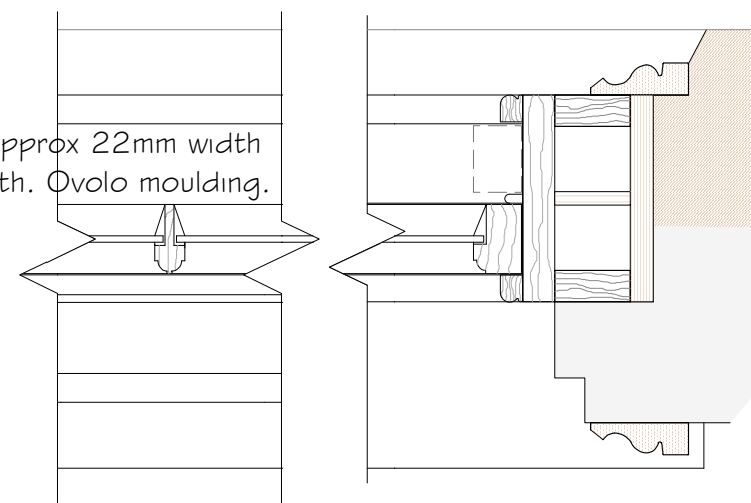
SECOND FLOOR SHOWER ROOM. FRONT ELEVATION: INTERNAL.

Heavily decayed sill and jambs of sash box.  
Non-vernacular horns and composite section sashes.

CDM Advisory: *do not lift sash.*

Glazing bar approx 22mm width x 44mm depth. Ovolo moulding.

Moulded timber architrave internally.

Assumed depth of weight box.

Moulded timber architrave externally.

REPLACEMENT WINDOW FRAMES TO BE TIMBER FOR WHITE PAINT FINISH.

INSTALLATION DETAILS TO MATCH EXISTING FOR ALL LOCATIONS.

MODIFY INSTALLATION AS NECESSARY FOR DEEPER BOX FRAME.

FRAME SECTIONS AS J.HALLAM JOINERY 'EGTON' HERITAGE RANGE.

WHERE REQUIRED EXTEND SILL TO PROJECT BEYOND STRUCTURE USING REBATED AND GLUED SECTION.

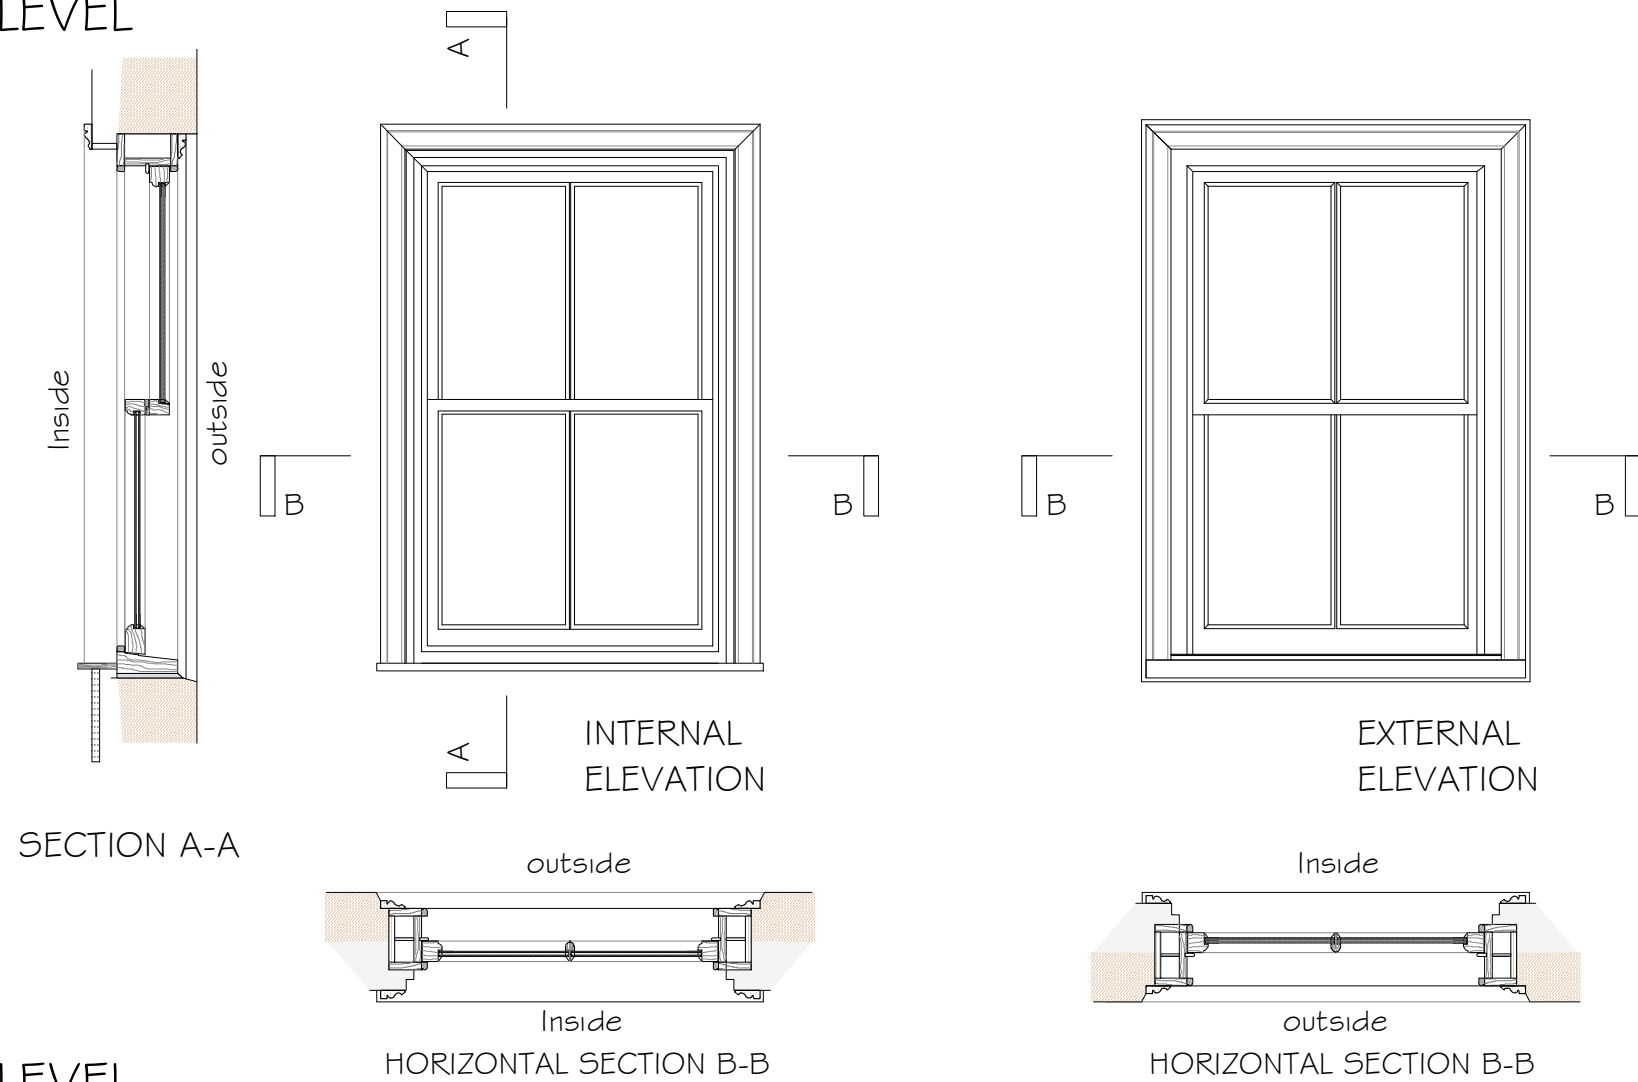
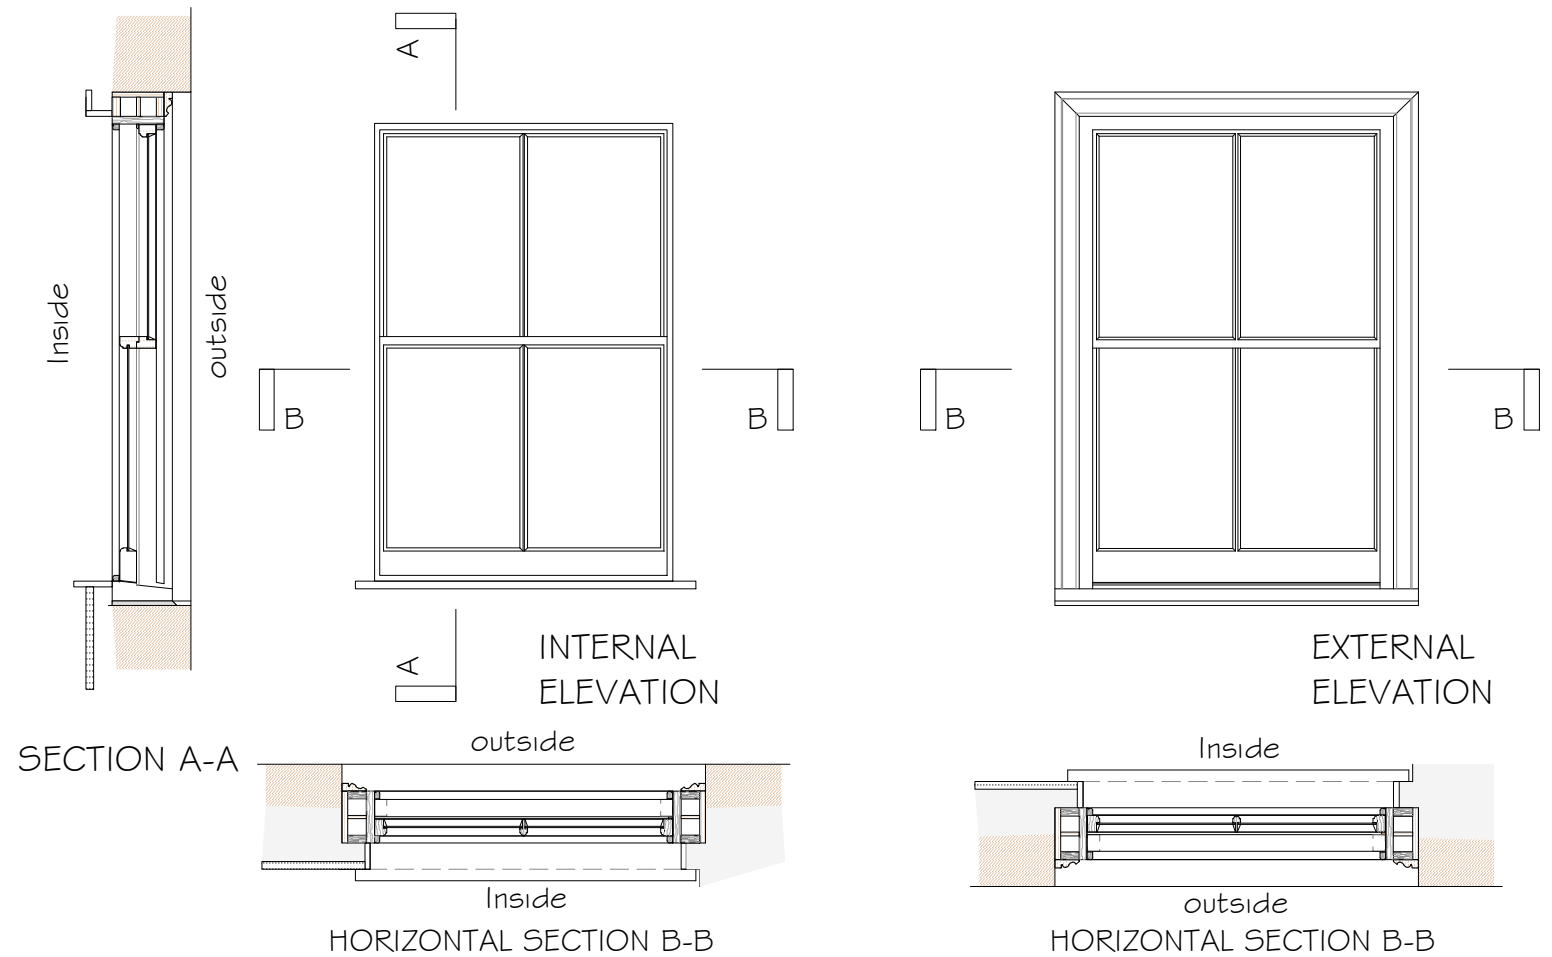
Drawing:  
PROPOSED WINDOW  
SCHEDULE W1 & W2

REPLACEMENT WINDOW FRAMES TO BE TIMBER FOR WHITE PAINT FINISH.

INSTALLATION DETAILS TO MATCH EXISTING FOR ALL LOCATIONS.

MODIFY INSTALLATION AS NECESSARY FOR DEEPER BOX FRAME.

FRAME SECTIONS AS J.HALLAM JOINERY 'EGTON' HERITAGE RANGE.

WHERE REQUIRED EXTEND SILL TO PROJECT BEYOND STRUCTURE USING REBATED AND GLUED SECTION.

REFER TO PHOTOGRAPHS SUBMITTED FOR SPECIFIC DETAILS OF INSTALLATION.

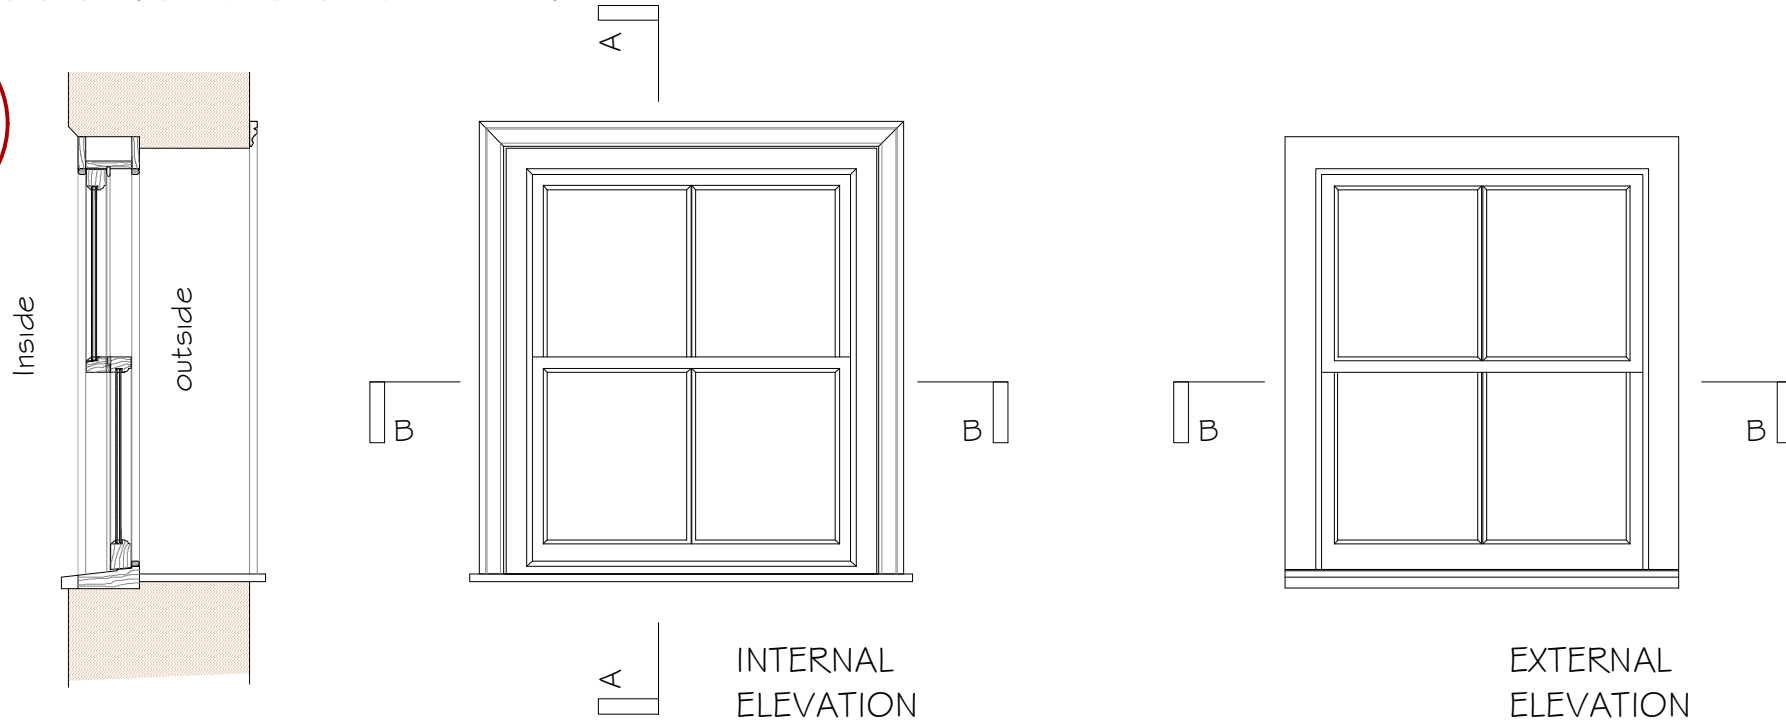
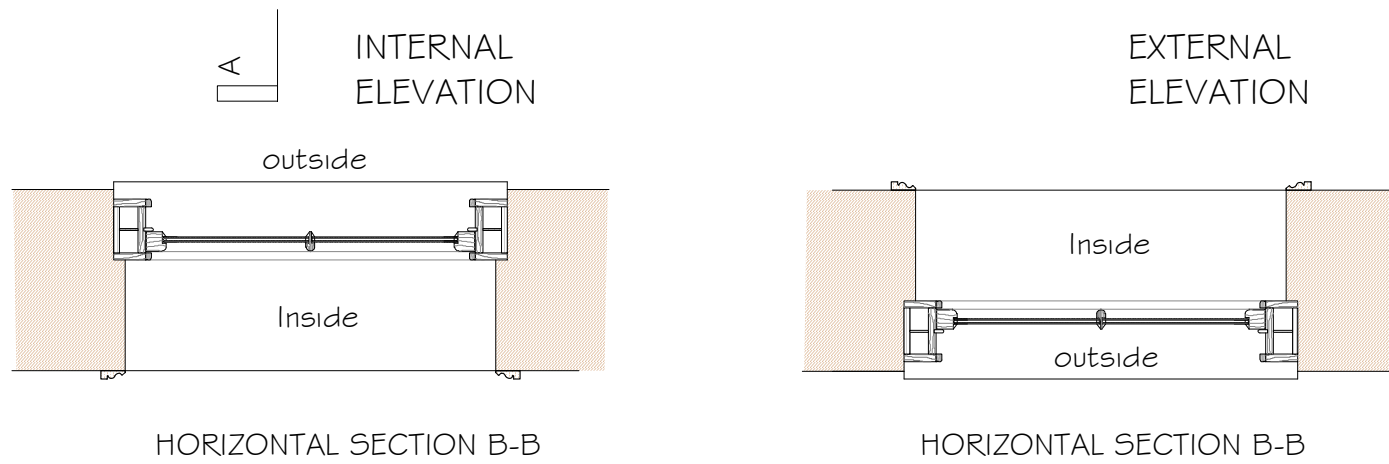
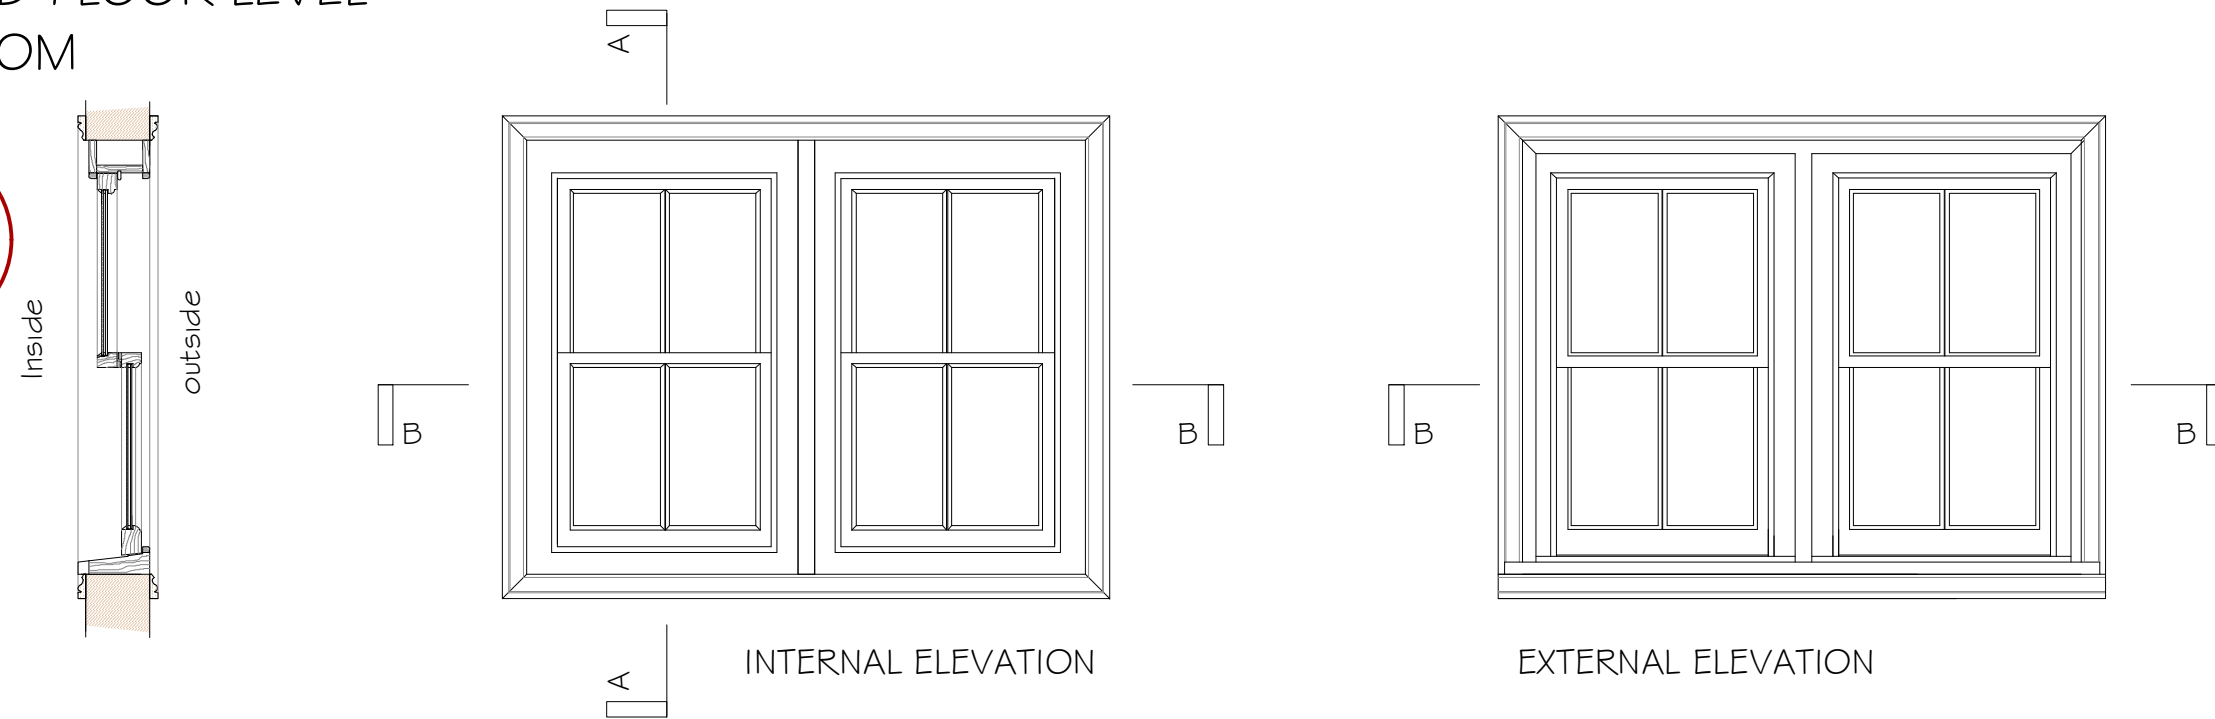
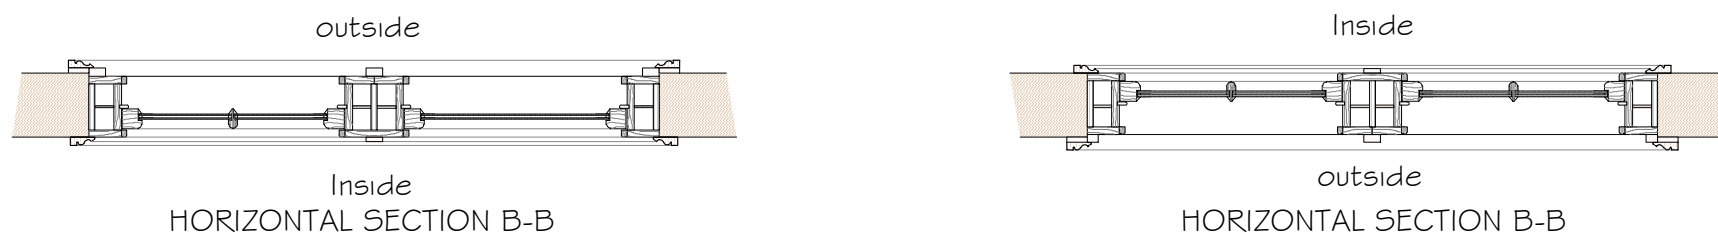
REPLACEMENT WINDOW FRAMES TO BE TIMBER FOR WHITE PAINT FINISH.

INSTALLATION DETAILS TO MATCH EXISTING FOR ALL LOCATIONS.

MODIFY INSTALLATION AS NECESSARY FOR DEEPER BOX FRAME.

FRAME SECTIONS AS J.HALLAM JOINERY 'EGTON' HERITAGE RANGE.

WHERE REQUIRED EXTEND SILL TO PROJECT BEYOND STRUCTURE USING REBATED AND GLUED SECTION.

REFER TO PHOTOGRAPHS SUBMITTED FOR SPECIFIC DETAILS OF INSTALLATION.

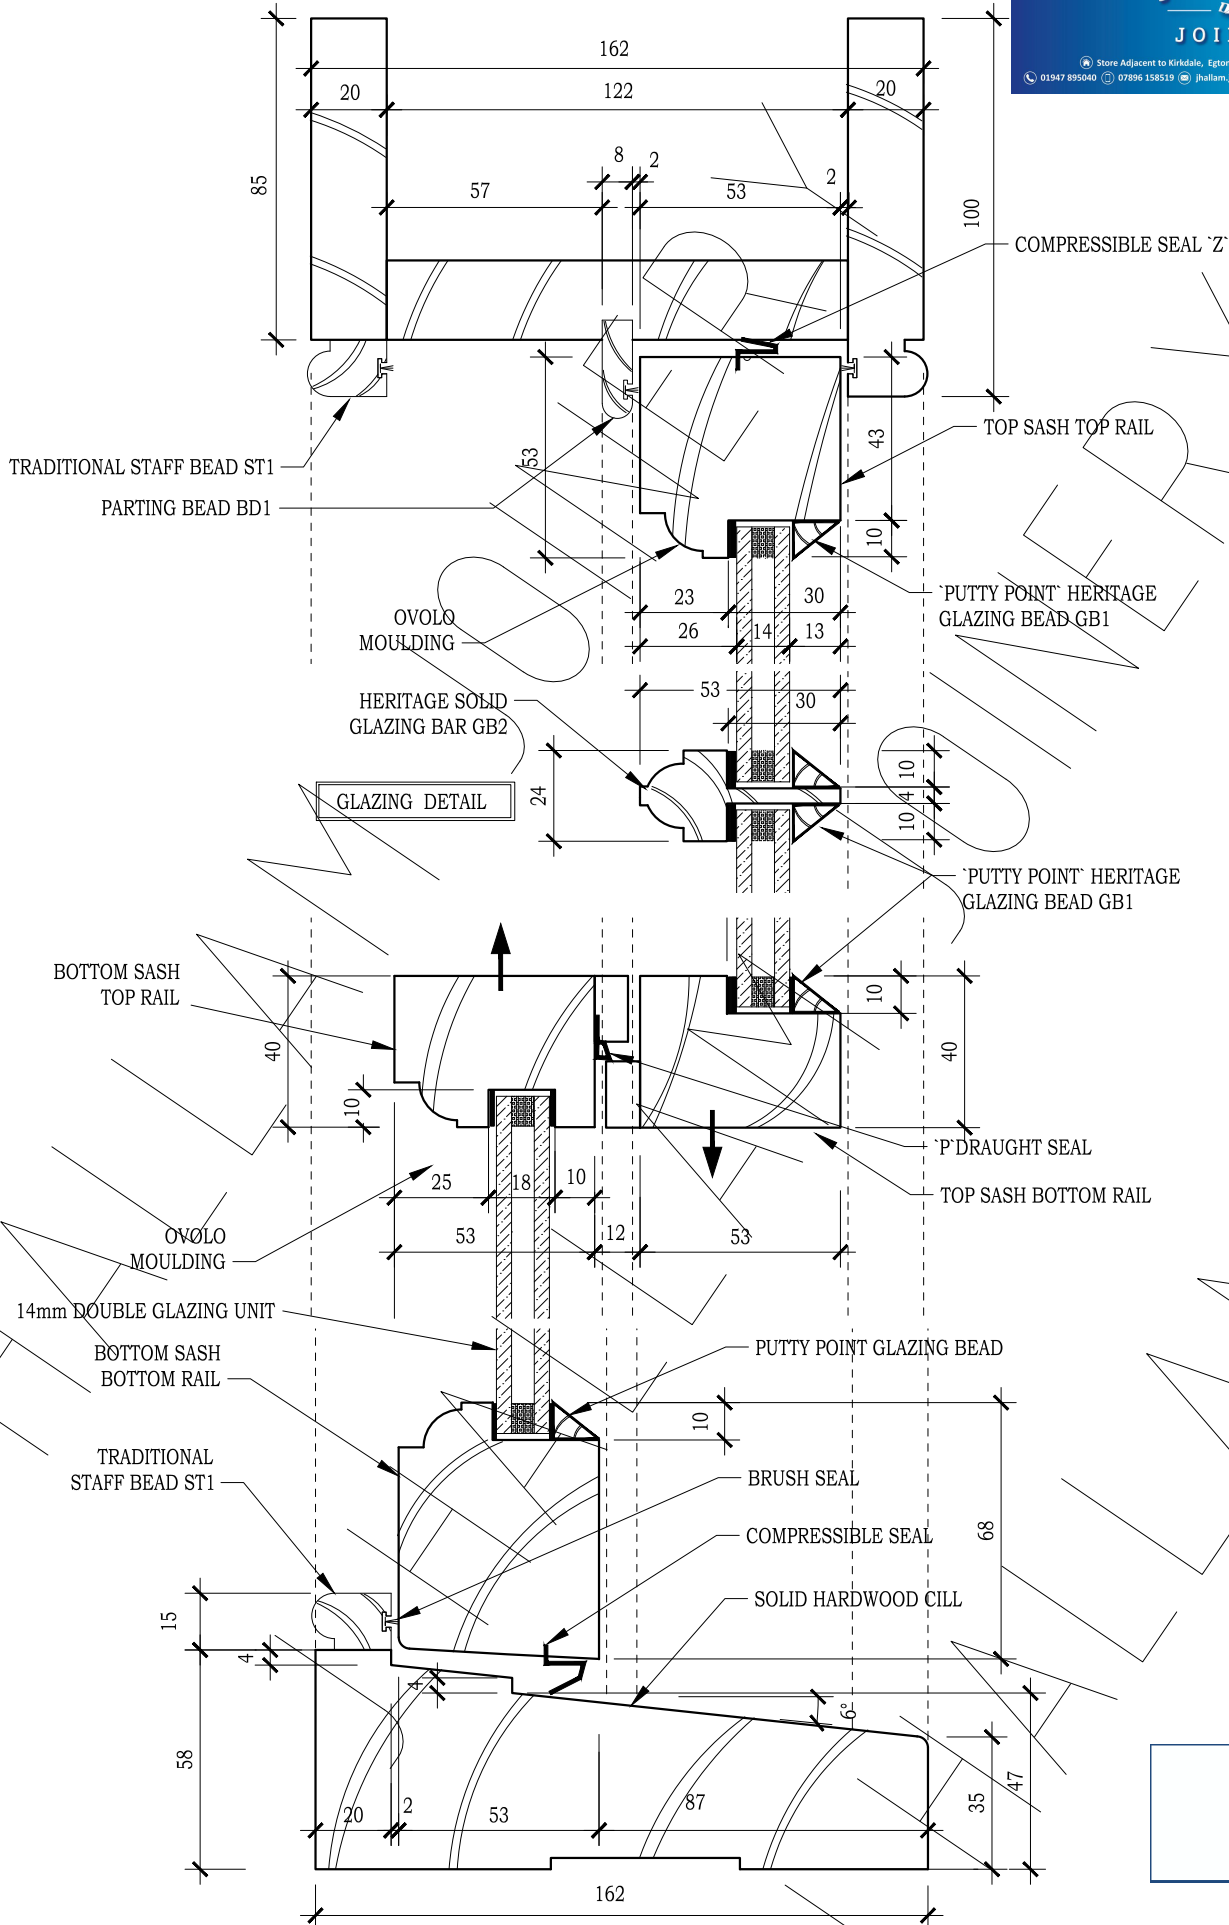
**JOINERY CONSTRUCTION DETAILS FOR 'BOX' SASH WINDOW -  
'EGTON' HERITAGE RANGE**

VERTICAL SECTION A-A SCALE 1:2
