# Combined Heritage, Design & Access Statement

Planning and Listed Building Consent for Domestic Alterations and refurbishment

Atkinson Wood Farm, Easby

Heritage Impact Assessment

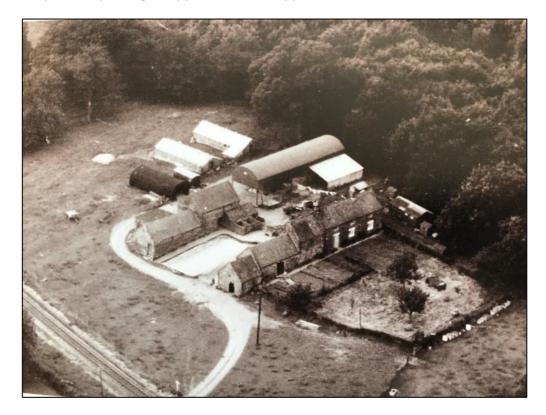
Figure 2: The farmstead in 1956

- 2.25 Of particular note from the photograph are the following points:
  - The location of the original doorway, lying to the west of the position it was in at the point of listing.
  - The arched opening in the gable outbuilding on the western facing end outbuilding.
  - The enlarged opening on the south facing elevation of the end byre.
  - The chicken sheds located on the north eastern part of the site, where the temporary static caravan is now located.
- 2.26 The photograph also shows the original farm entrance, prior to the current entrance being located a few years later on the south side of the site, having passed underneath the railway line.

- 2.23 Photos of the site are included in Appendix A.
- 2.24 An aerial photo taken in 1956 is included below for context of how the site looked previously. A larger copy is available in appendix D.

carried out necessary emergency works to repair the building by putting footings under the west gable and southern wall and returned it to what he considered would have been the original arched opening, using arched stones found on the site and basing his work upon the 1956 photograph of the site.

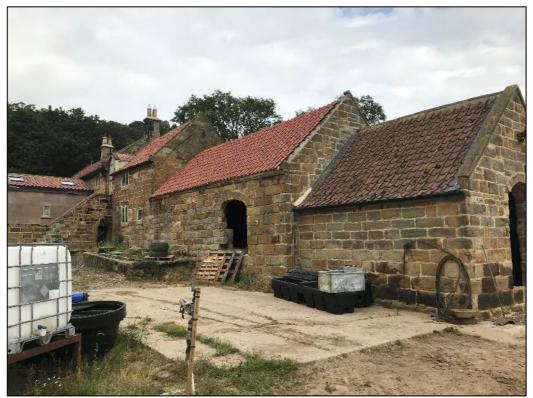
Photo 1 – View of rear of property

- 3.5.1 The rear porch on the northern doorway has been re-clad in stone and extended to provide improved living accommodation. The style of the current works has been considered to be inappropriate to the vernacular tradition and character of the building.
- 3.5.2 An alternative simpler approach is detailed on the proposed plans and will be implemented within 12 months of the date of approval of the revised submission.

- 3.6.1 A series of alterations have taken place to the rear granary steps and adjacent roofline, including the insertion of a small dormer for increased headroom internally.

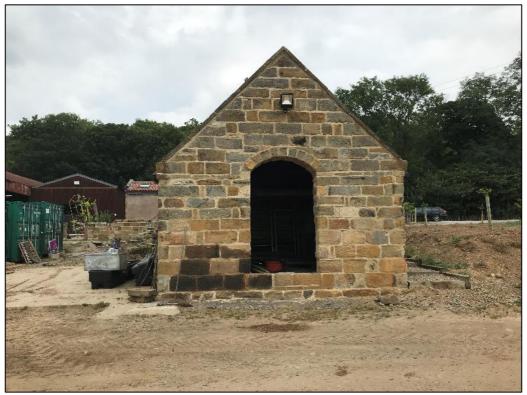
Photo 2 – View of side of property (including repaired/reinstated entry)

3.4.1 The second retrospective Listed Building Consent matter relates to the western gable end. When the applicant took control of the property the gable end opening and south wall showed significant movement owing to not having any foundation and was supported by a rotten railway sleeper, and the gable was in poor condition. Our client

3.4.2 In discussions with the Park's Senior Conservation Officer, it has been agreed that the 1960's era flat opening will be re-instated, using an oak beam sourced from the local woodland.

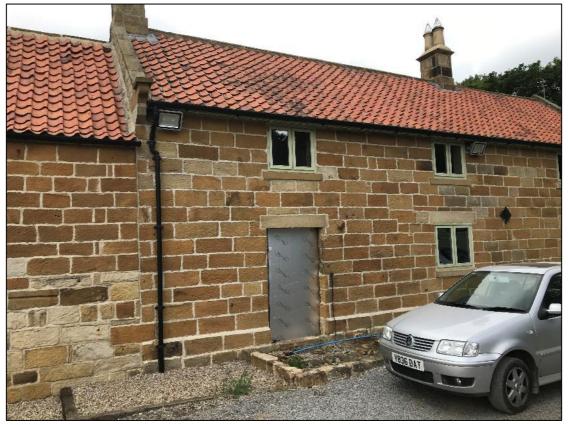
Photo 5 - Door relocated

- 3.3.1 On the principal (south facing) elevation of the property, the doorway of the house has been moved from the right-hand side to the left of the building. Where the door has moved to was previously a window and where the door was has become a window. This is however the original configuration of the dwelling based on the supplied photo evidence which shows a doorway in this location in 1956 (Appendix D).
- 3.3.2 It will be appreciated that this element of work better reveals the historic layout of the building and enhances the external appearance of the building. This element of the proposal significantly improves the significance of the building through sensitive restoration of a layout hidden by modern works.
