**PROPOSED CONVERSION OF REDUNDANT AGRICULTURAL BUILDINGS TO THREE  
NO. HOLIDAY COTTAGES AT THIRLEY COTES FARM, HARWOOD DALE**

## **DESIGN, HERITAGE AND ACCESS STATEMENT**

## **STRUCTURAL SURVEY**

## **THIRLEY COTES FARM, HARWOOD DALE, SCARBOROUGH**

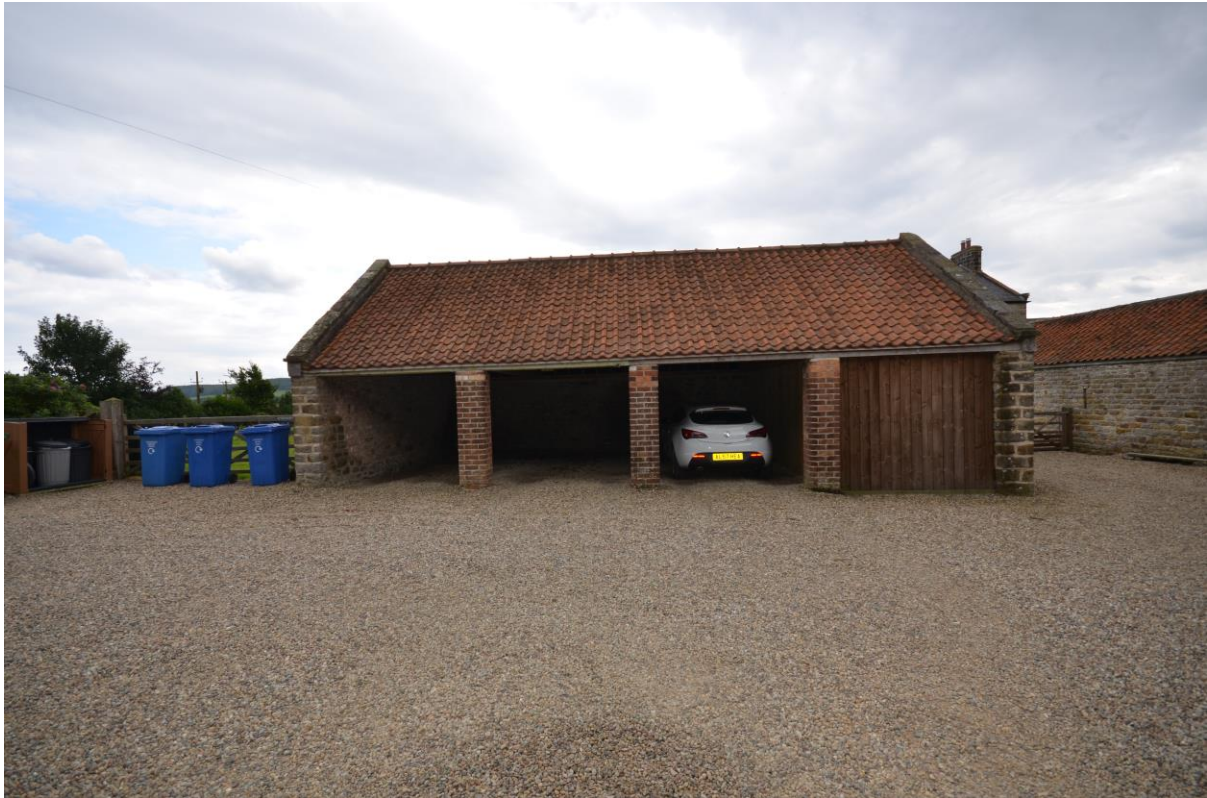
1. North elevation of Pear Tree Barn. This building has been re-roofed and refurbished in the last few years.
2. North elevation of Pear Tree Barn.

Within the last few years this building was refurbished by previous owners as a garage and a store. The roof has been completely replaced with new rafters, purlins and trusses and the walls have been repointed internally and externally. The walls are generally true and do not display any significant movement, the roof also does not display any signs of movement and is in good condition.

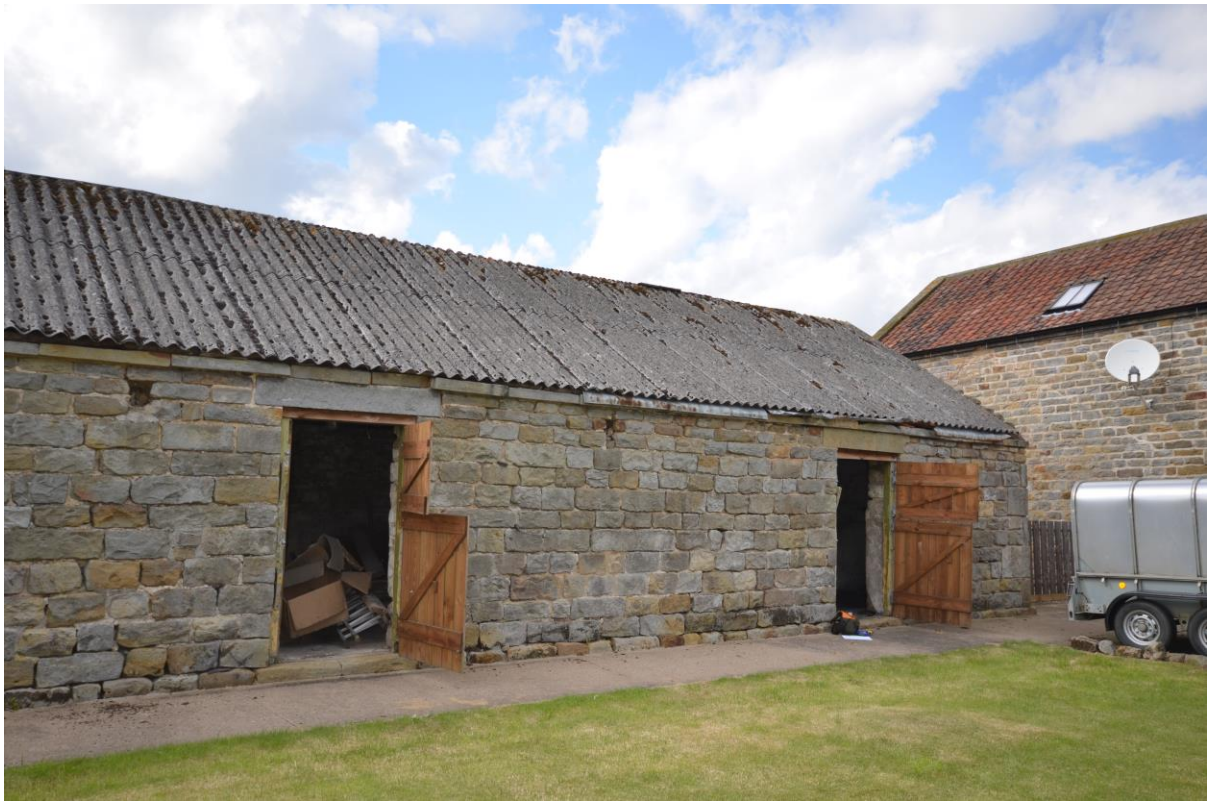
3. East elevation of Mulberry Barn, an asbestos roof was fitted probably in the 1960's.
4. West elevation of Mulberry Barn with an asbestos roof and a pantiled lean-to.

The roof finish to Mulberry Barn in the main is asbestos sheet which probably replaced pantiles in the 1960's. This is probably a chrysotile form of asbestos which is not notifiable but clearly it would be sensible to remove it to a registered tip.

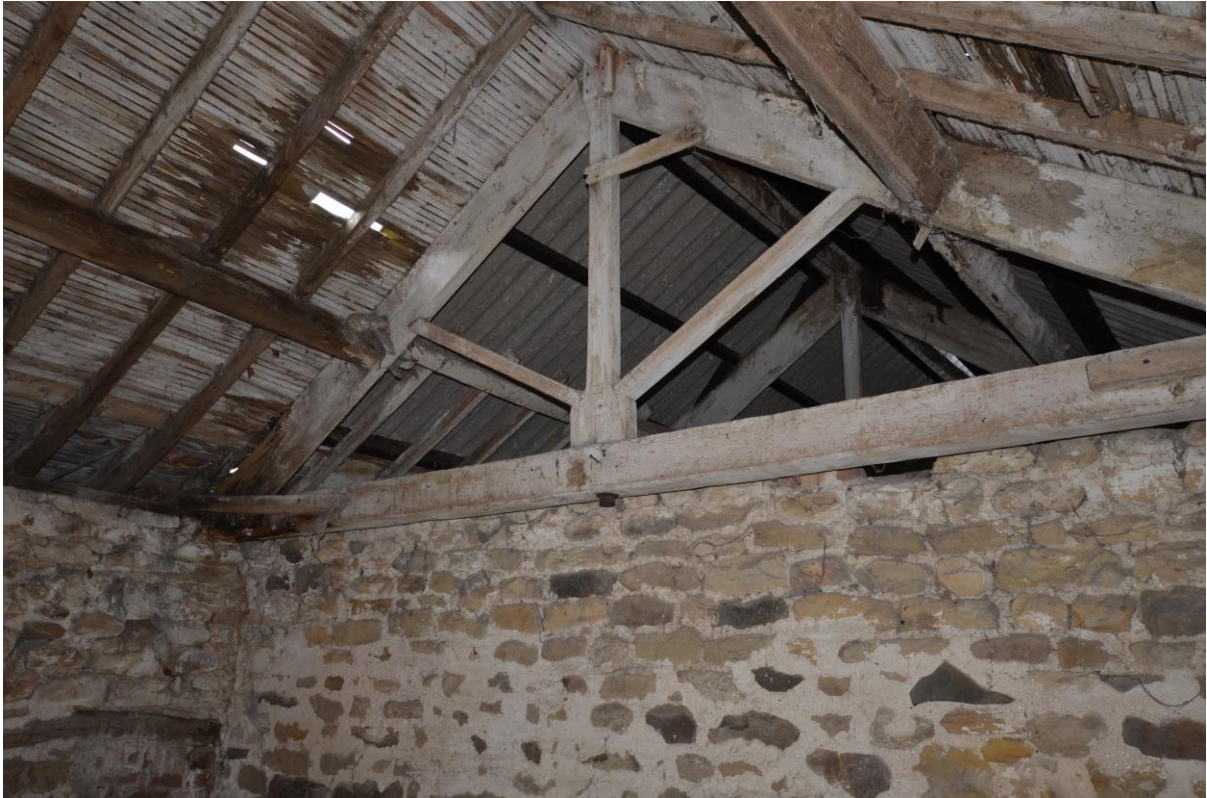
5. Internal view at the junction between Mulberry Barn and Walnut Barn showing the existing king post trusses which are generally in sound condition although there is evidence of damp penetration.
6. General view across the courtyard to Walnut Barn and Mulberry Barn.

The roof is constructed with king post trusses with purlins. These are in reasonably sound condition but may need attention to localised rot where damp penetration has occurred.

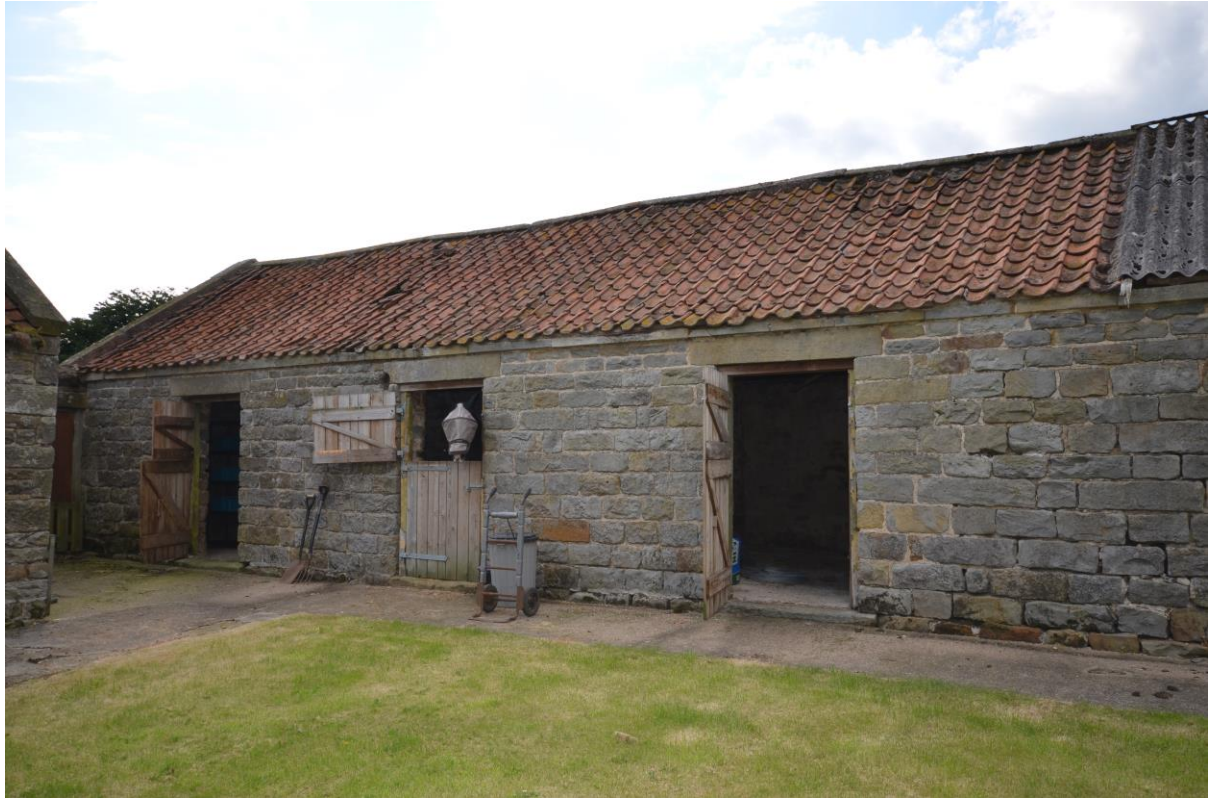
7. View of the eastern elevation of a section of Walnut Barn.
8. View of part of Walnut Barn with the north elevation of the southern range of courtyard buildings.

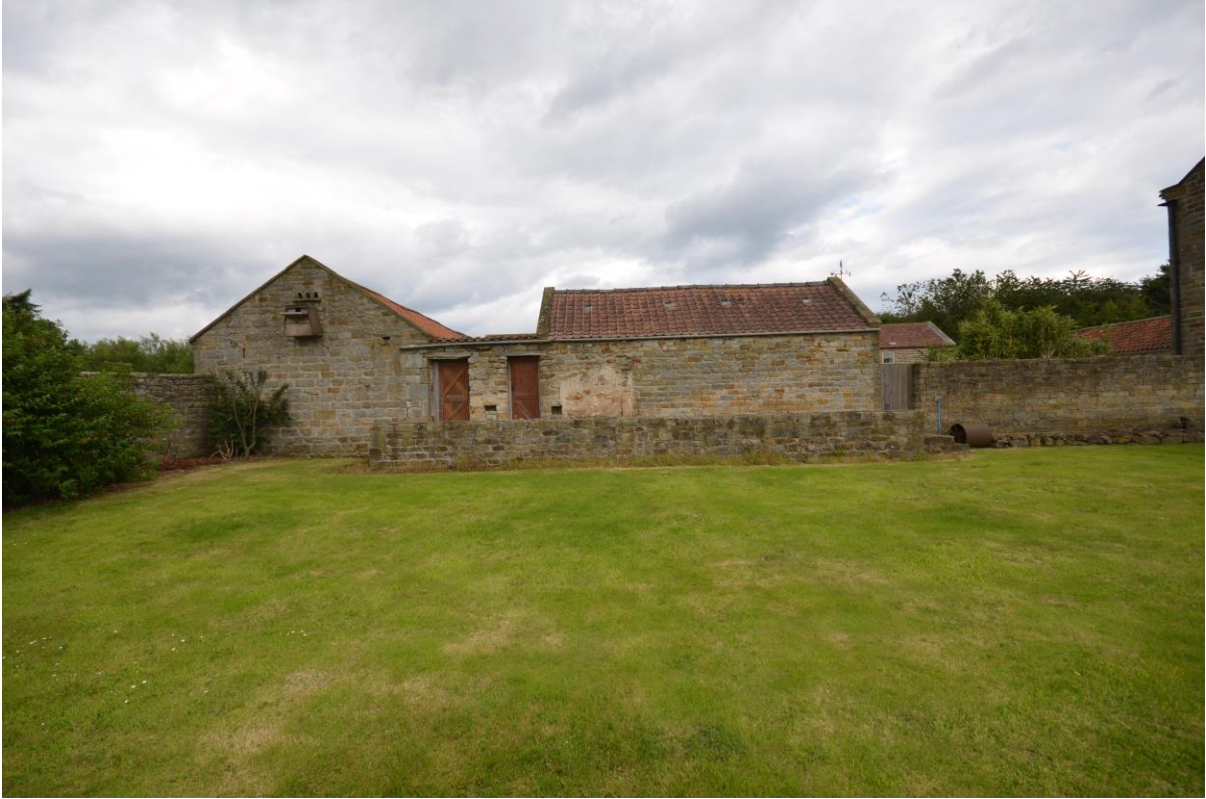
9. South elevation of Walnut Barn, a greenhouse has been removed in the past leaving a plinth wall.
