Station Tavern, Front Street, Grosmont, Whitby, Yorkshire, YO22 5PA

Heritage Statement

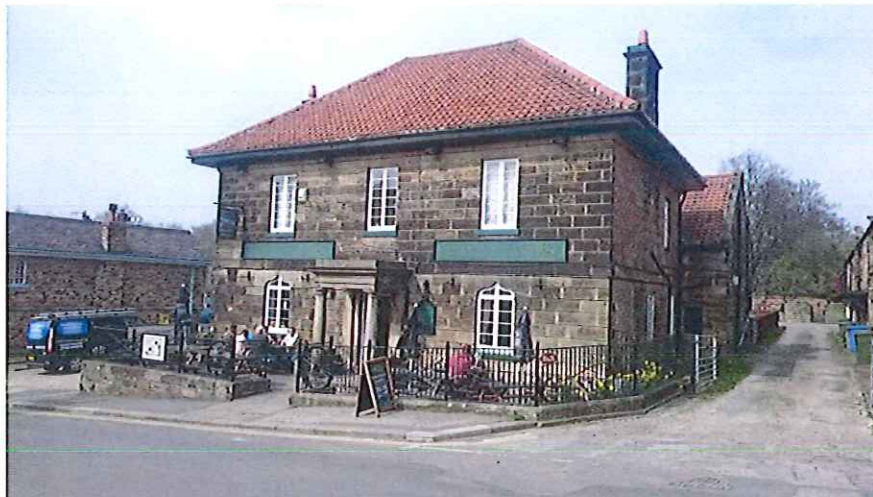
Figure 1 Building prior to stone cleaning front elevation.

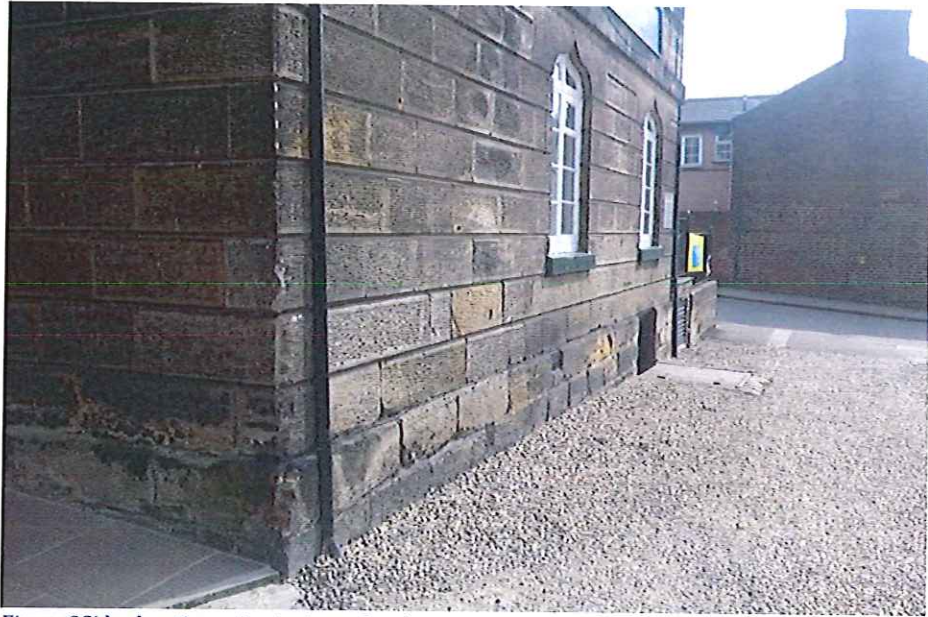
Figure 2 Side elevation prior to stone cleaning.

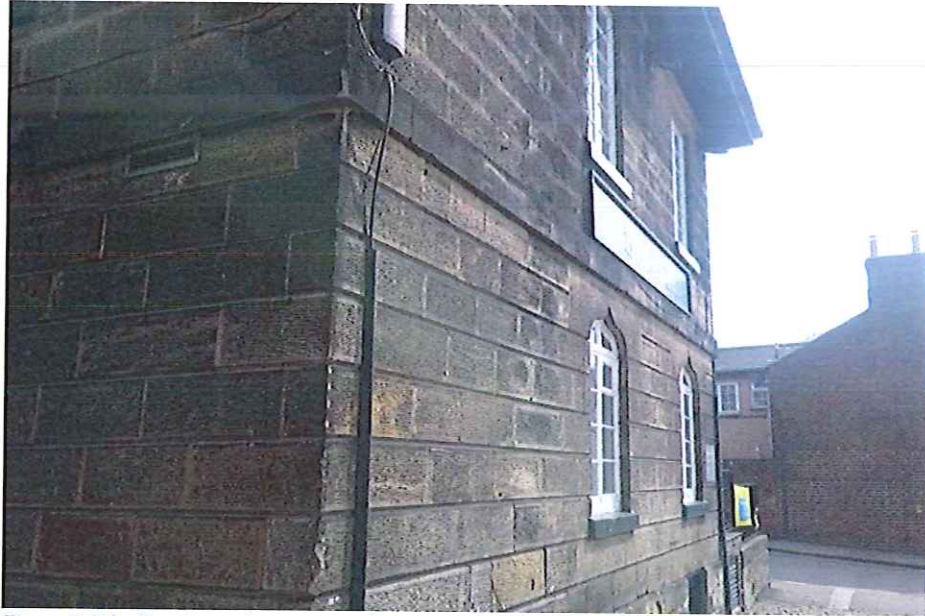
Figure 3 Side elevation prior to stone cleaning.

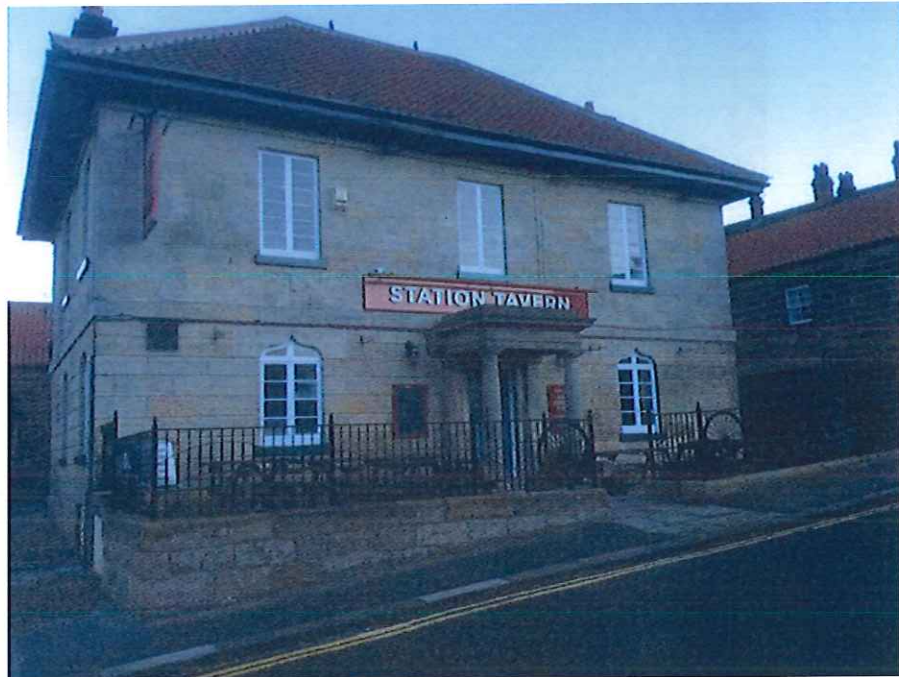
Figure 4 Front elevation after stone cleaning.

In this particular case, the dirt on the stone was very superficial, and a blast pressure of just 4 bar, and an abrasive consumption rate of less than 25kg per hour was entirely capable of removing the dirt, with no apparent loss of stone or pointing. If my employee has any doubt whatsoever (and given that he has been working for me for 12 years using the machine on an almost daily basis.

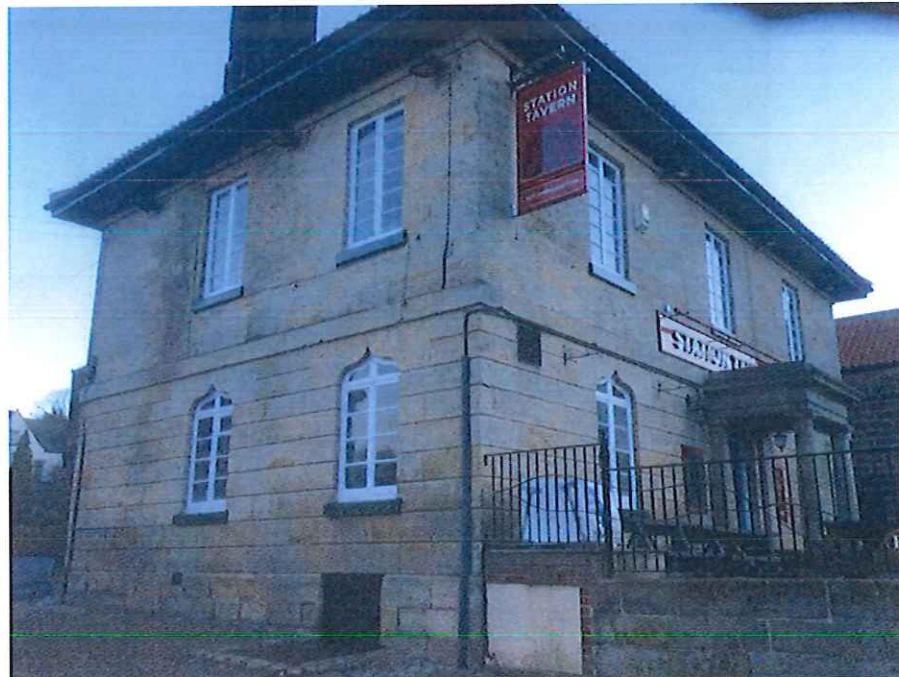
Figure 5 Side elevation after stone cleaning.
