Project : Alterations to include addition of dormers to rear roof slope  
 Location : Browside Farm, Stoupe Brow, Ravenscar  
 Clients : Mr A Alderson & Mr S Fawthrop  
 Title : Existing house floor plans

Project : Alterations to include addition of dormers to rear roof slope  
Location : Browside Farm, Stoupe Brow, Ravenscar  
Clients : Mr A Alderson & Mr S Fawthrop  
Title : Existing house elevations

Project : Alterations to include addition of dormers to rear roof slope  
 Location : Browside Farm, Stoupe Brow, Ravenscar  
 Clients : Mr A Alderson & Mr S Fawthrop  
 Title : Proposed house floor plans

Project : Alterations to include addition of dormers to rear roof slope  
 Location : Browside Farm, Stoupe Brow, Ravenscar  
 Clients : Mr A Alderson & Mr S Fawthrop  
 Title : Proposed house elevations

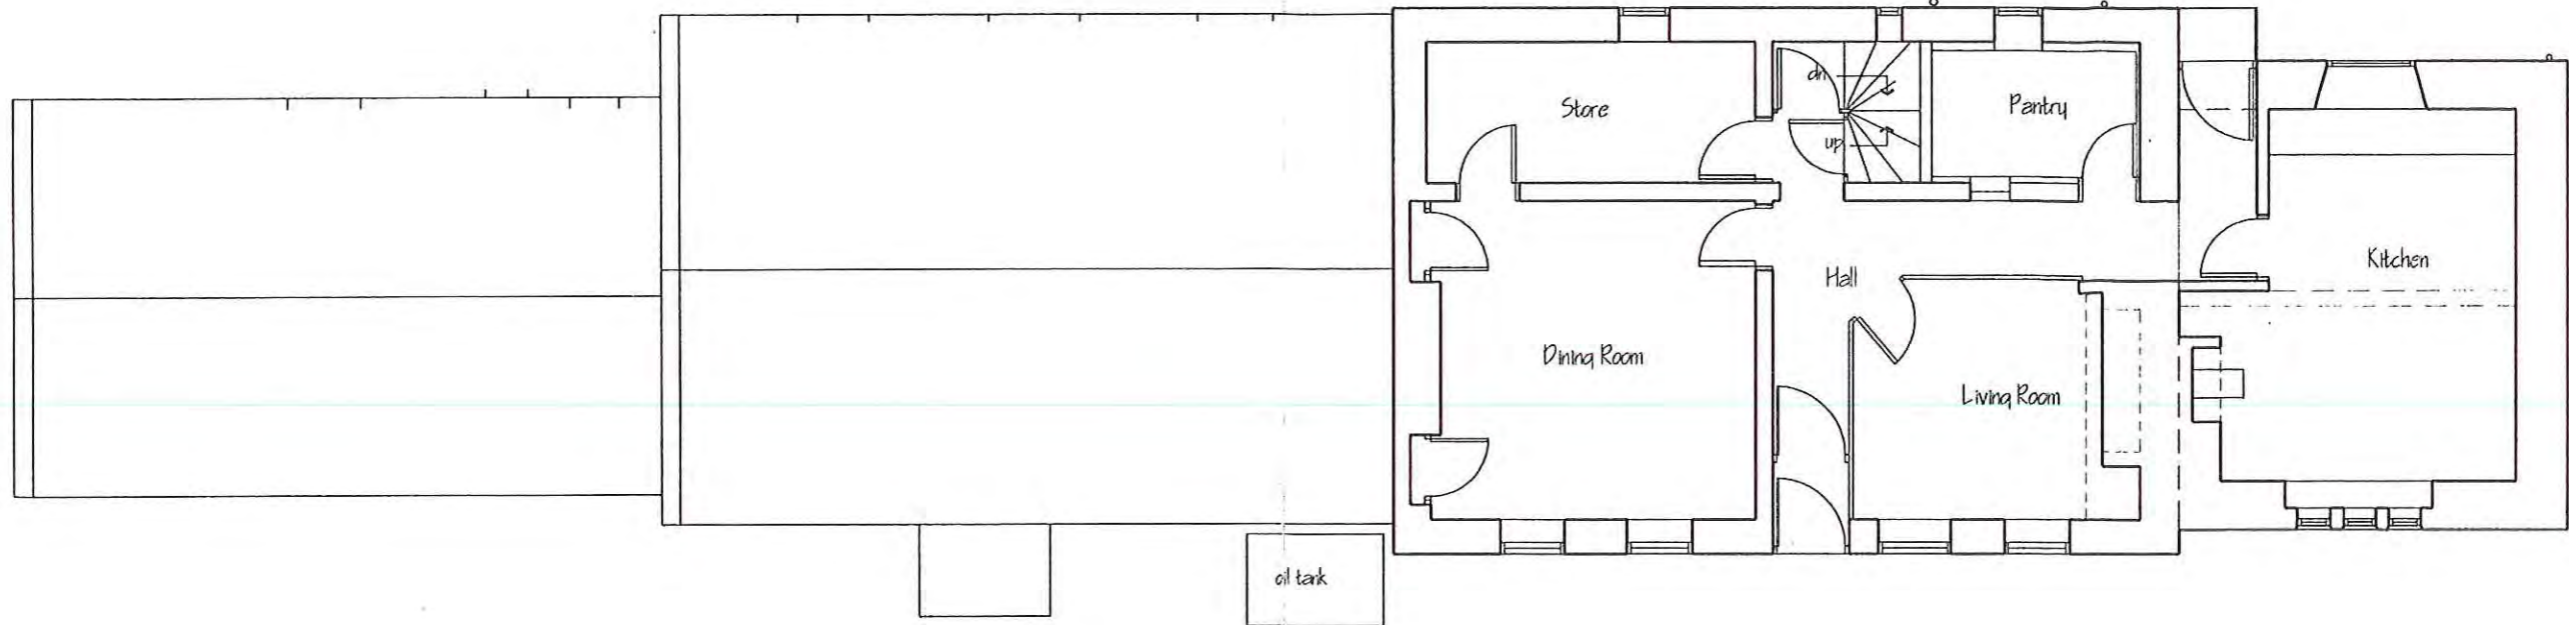
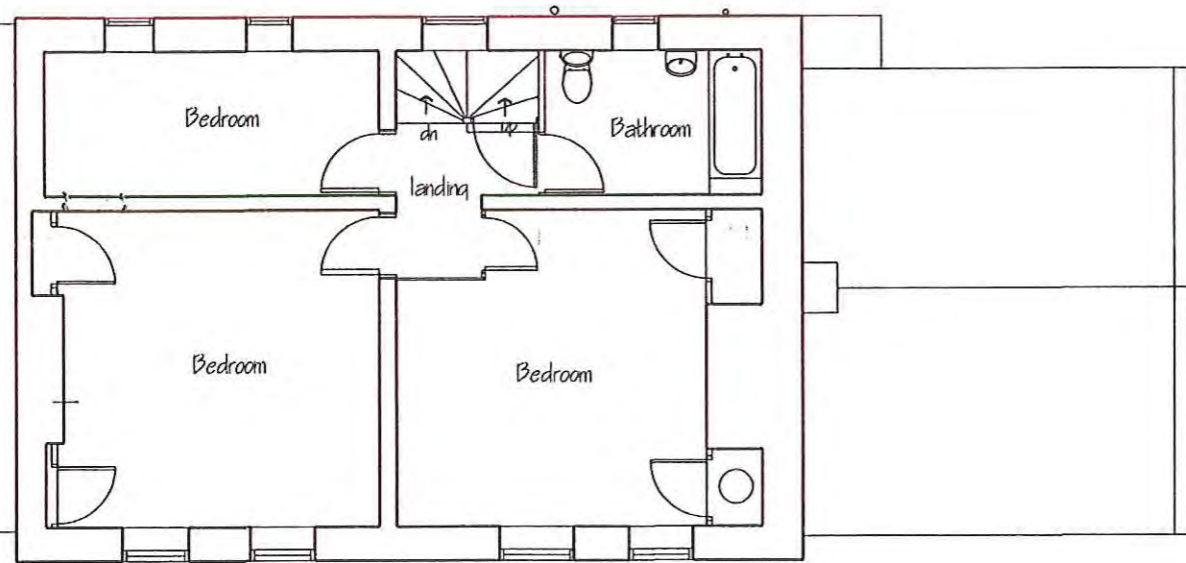
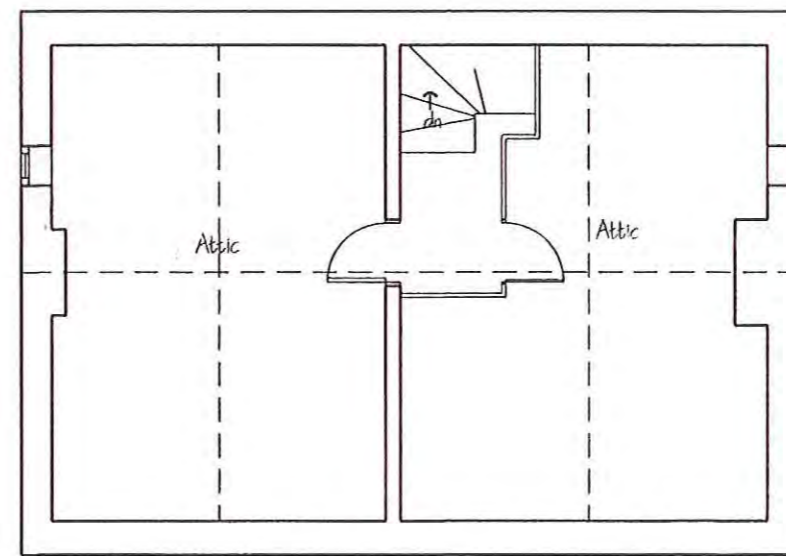
Materials: walls coursed in natural stone, roofs clad with traditional natural clay  
pantiles with stone ridges, copings and kneelers

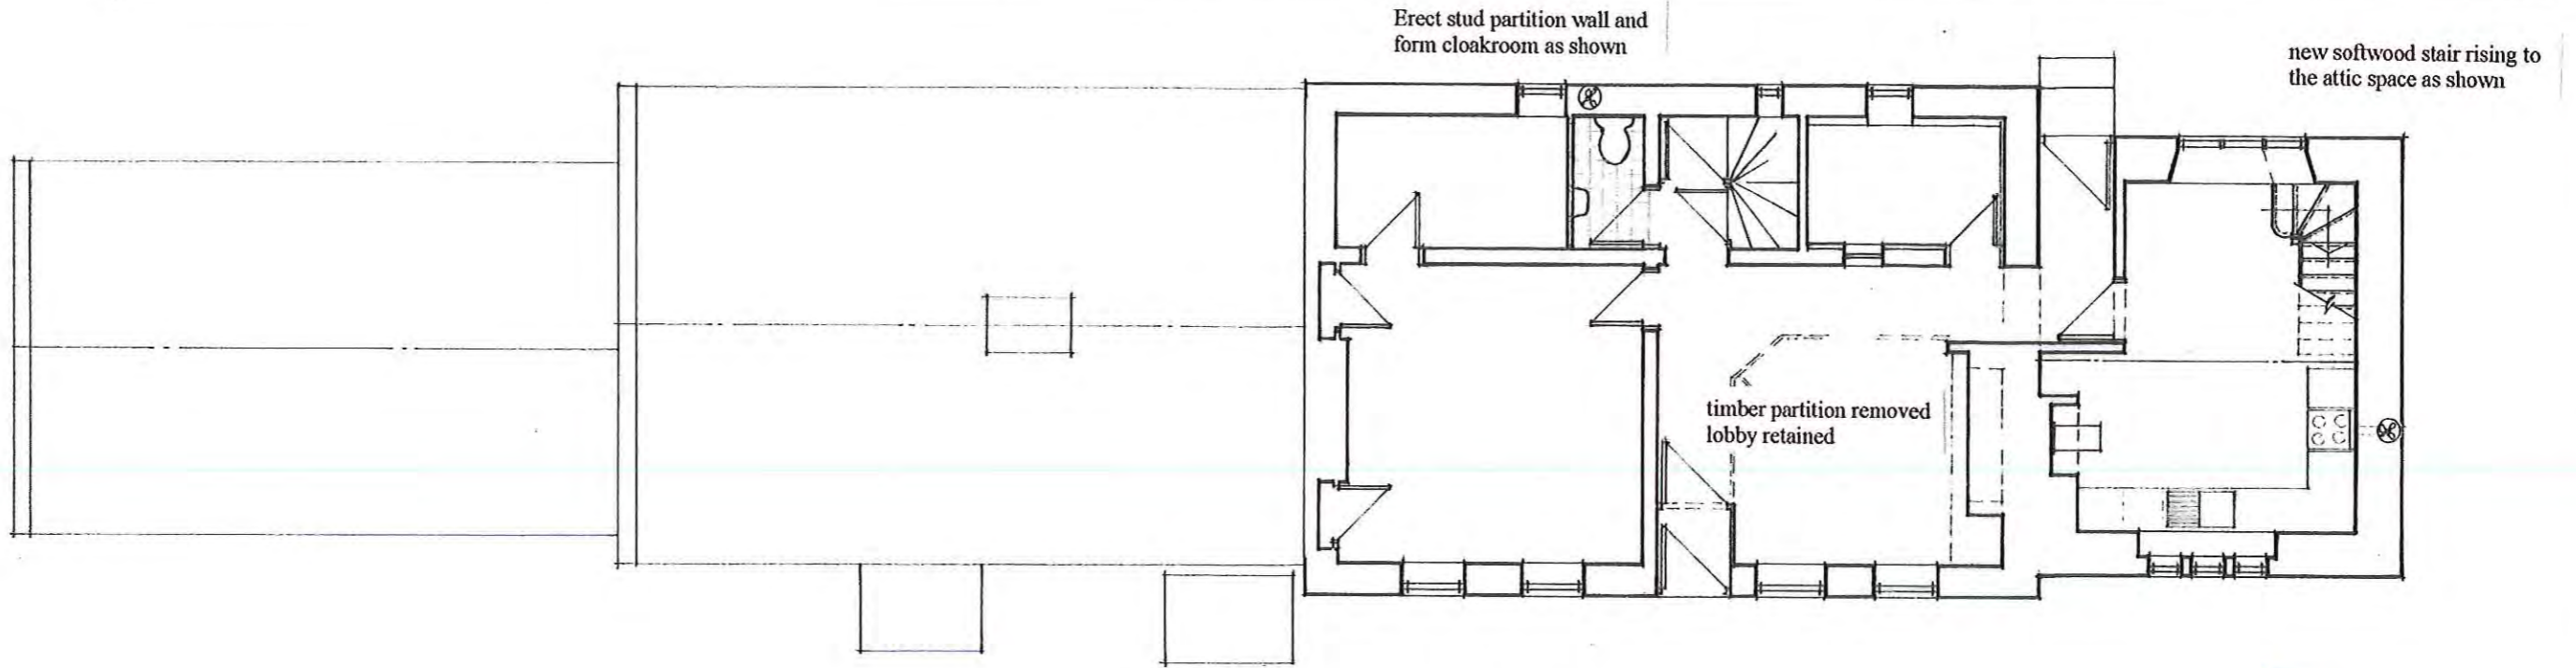
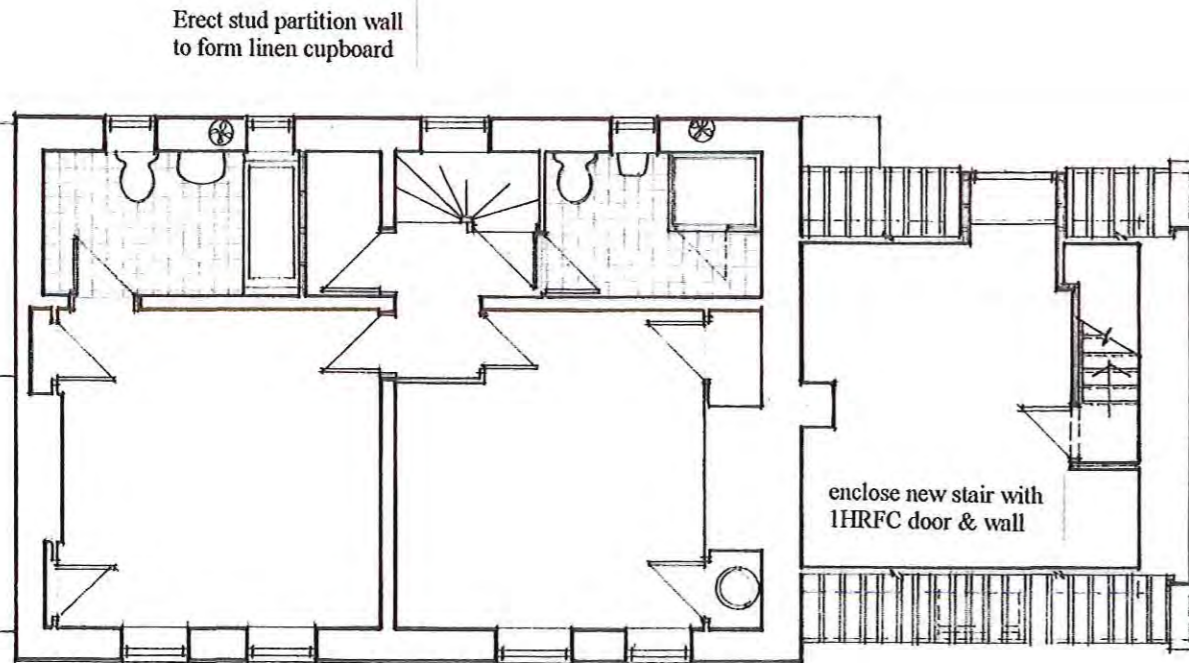
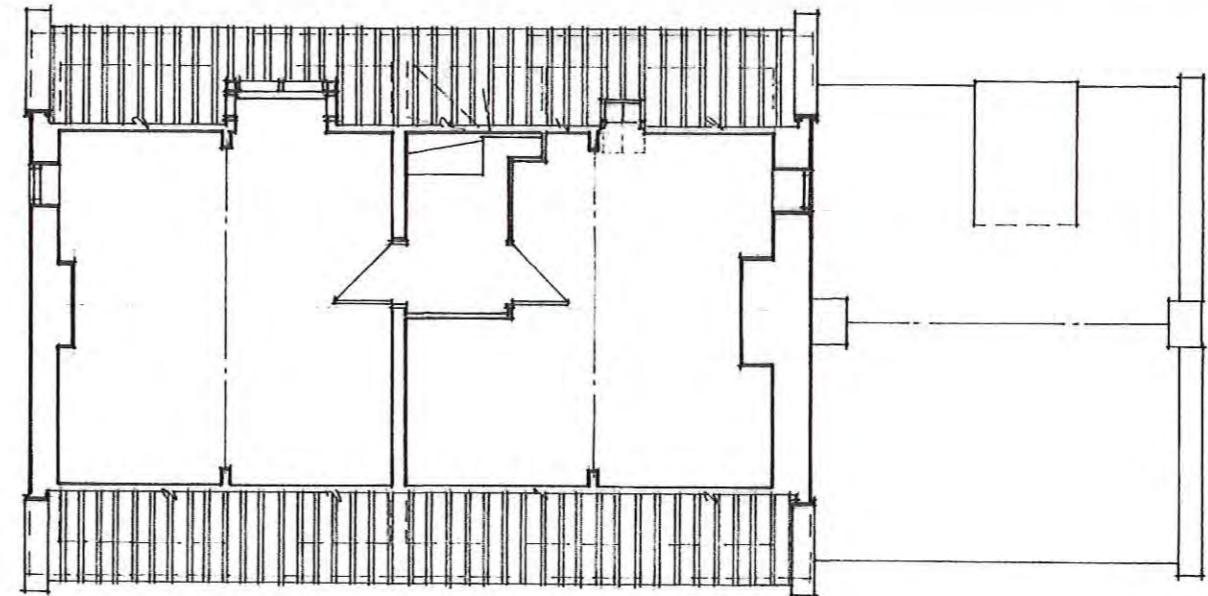
Main house and kitchen roofs reclad using red natural clay traditional pantiles, replace existing stone ridges, trim out and insert the two dormers shown in the rear roof slope and the conservation pattern (escape) rooflight, dormers to be roofed with matching pantiles, cheeks and fascias clad with code 5 milled lead.

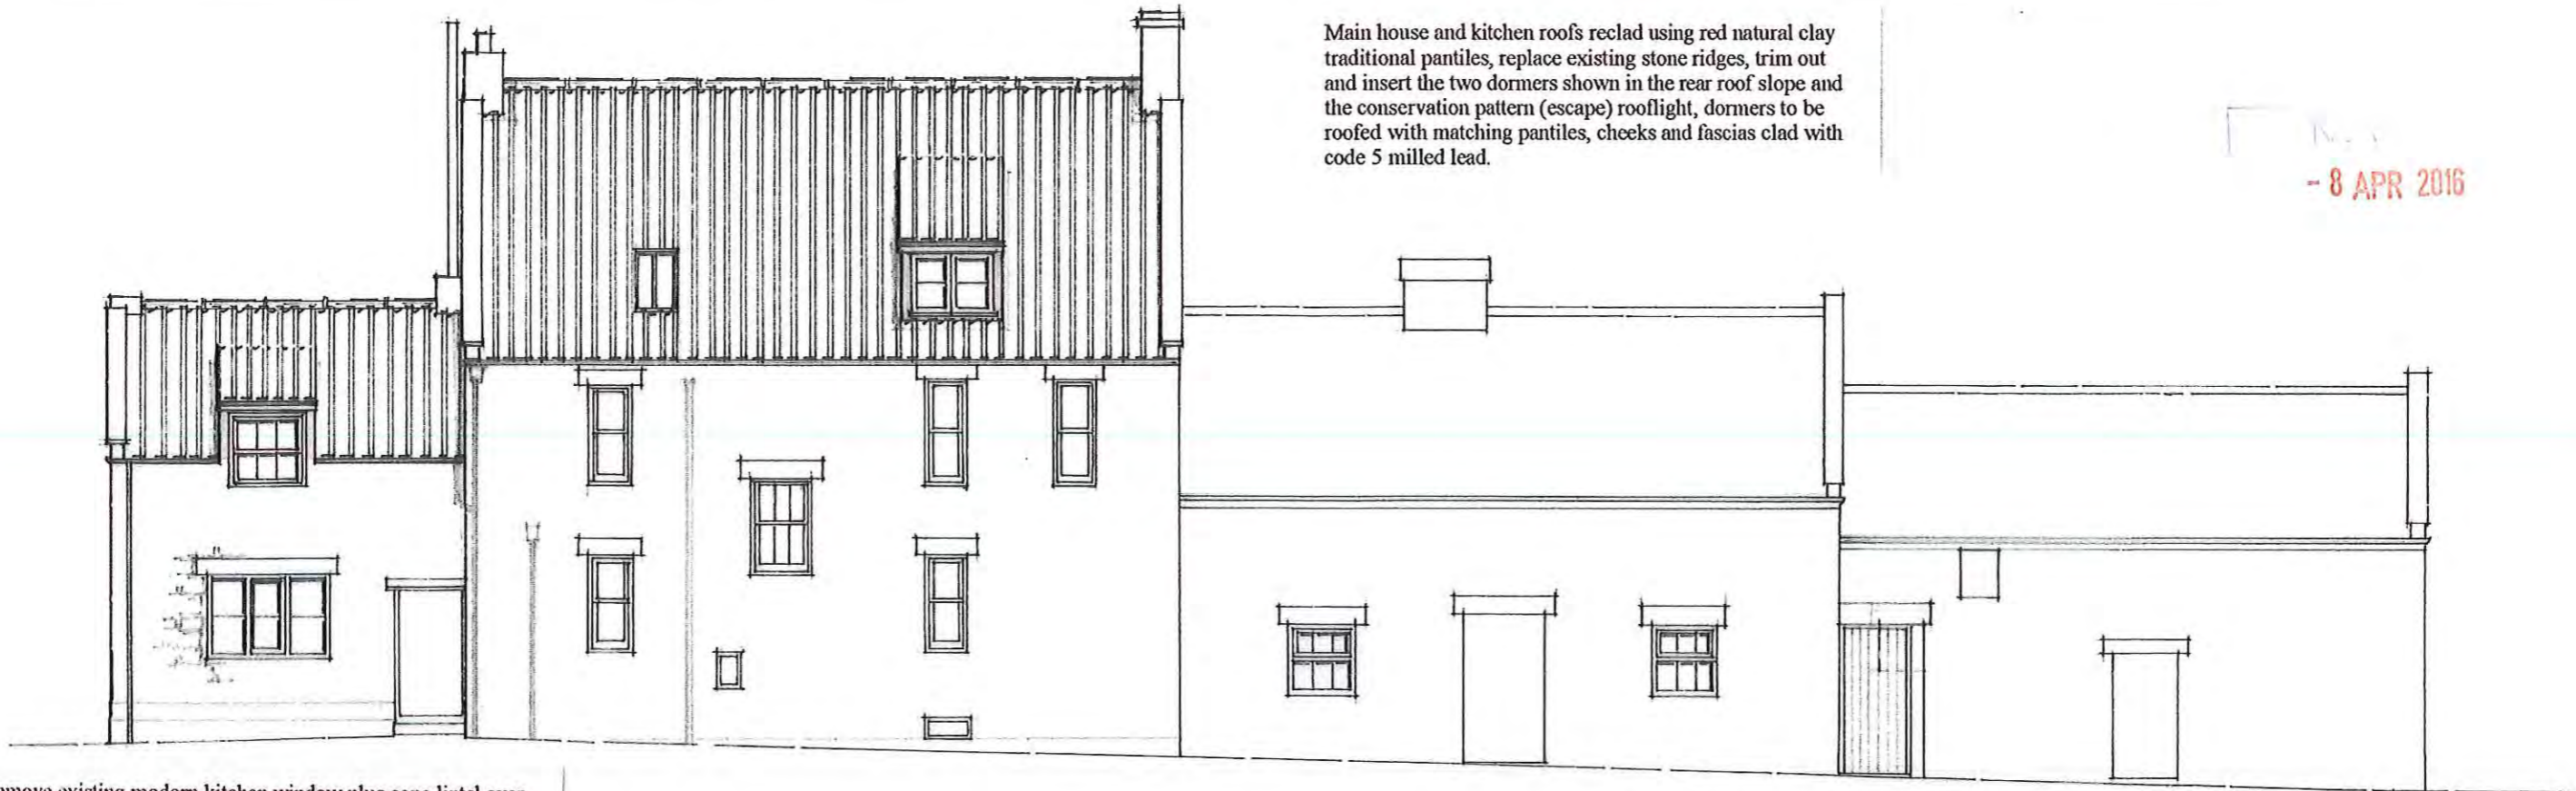
rear (north) elevation

Remove existing modern kitchen window plus conc lintel over, enlarge opening as shown and build in new stone lintel over new Yorkshire light pattern window.

Replace existing damaged steel framed windows in barn with new opening lights as shown, in white painted timber. Open up former doorway in adjacent barn and fit with white painted timber door.

Replacement lintel in stone and enlarged window - 'Yorkshire light' pattern installed.

metal windows replaced with timber frames

former doorway opened up

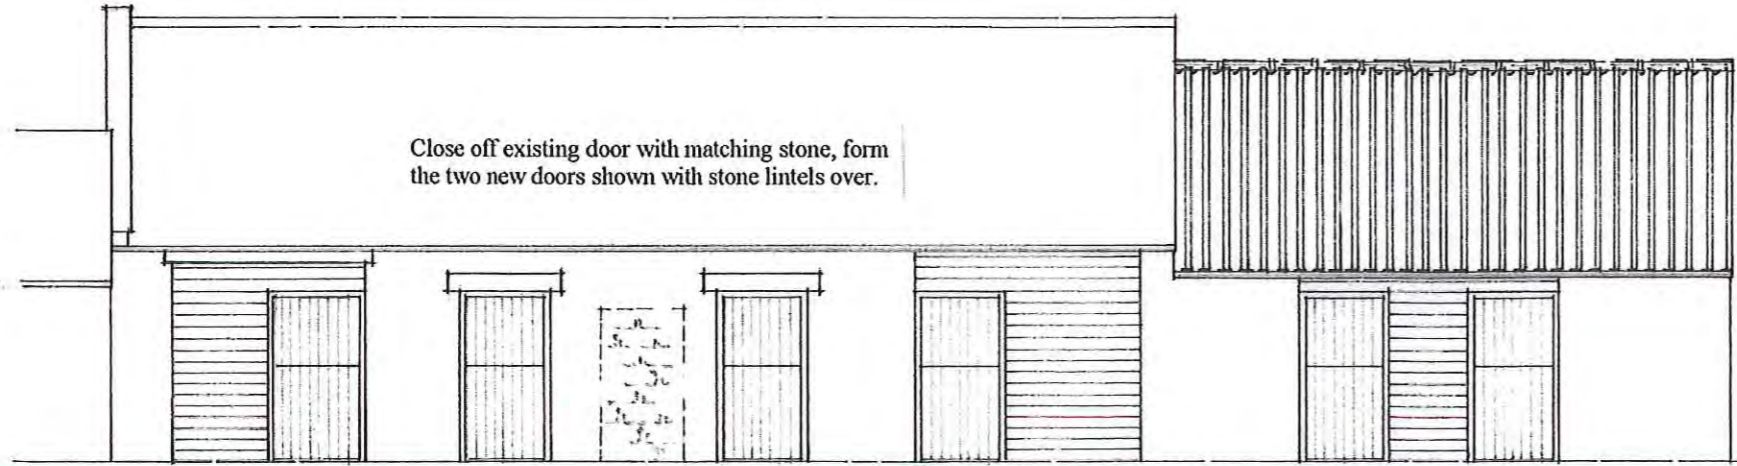
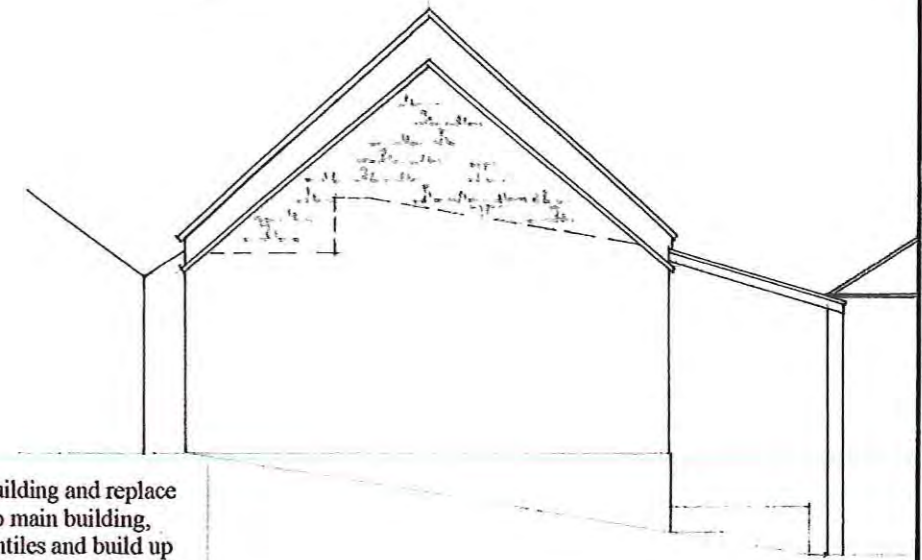
south (front) and east elevations

Frame out existing large openings and close off with horizontal timber boarding, larch or similar.

Remove metal sheeted roof over this building and replace with new framed roof at similar pitch to main building, clad with reclaimed red natural clay pantiles and build up the gable wall as shown with matching stone to suit profile.

*FRONT ELEVATION (SOUTH) stable doors added, openings closed off with timber boarding*

*gable built up in matching stone.*

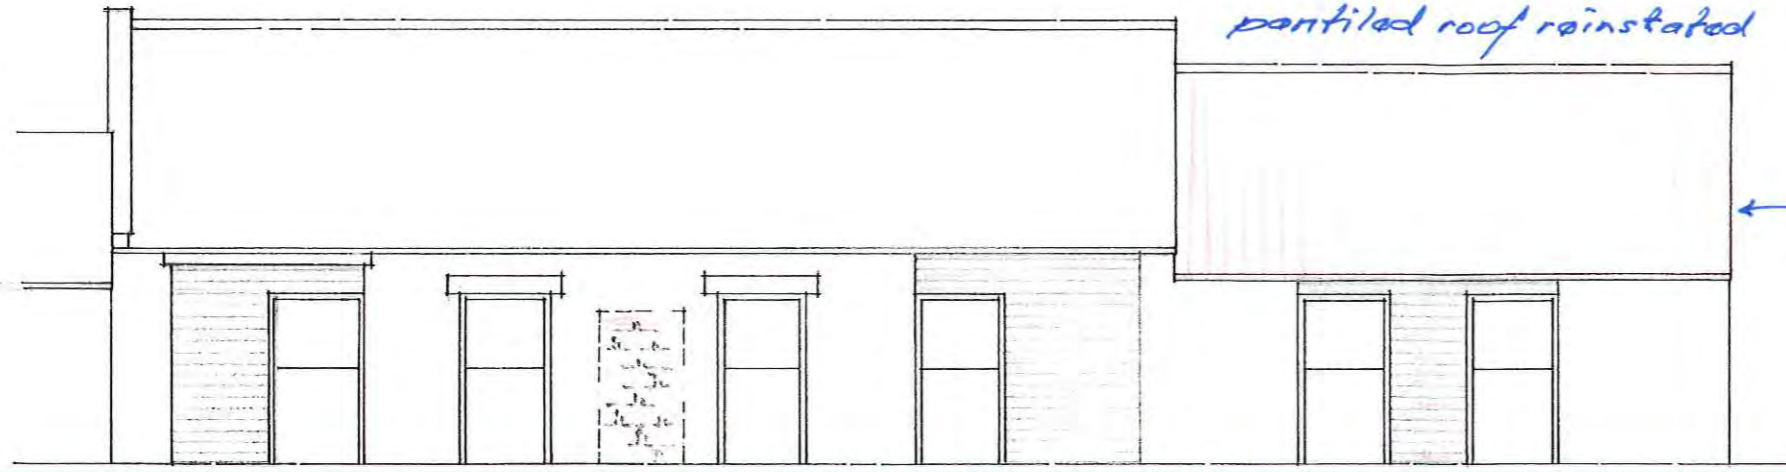
*pan tiled roof reinstated*
