SIRIUS MINERALS PLC - DISCHARGE OF PLANNING CONDITIONS FOR PLANNING APPLICATION NYM/2014/0676/MEIA, THE YORK POTASH PROJECT

CONDITION	NYMNPA 46
REPORT	REMEDIAL ACTION PLAN
SITE	PHASE 3 WORKS AT WOODSMITH MINE, NORTH YORKSHIRE
DOCUMENT NUMBER	40-FWS-WS-70-PL-0005 Rev5

REMEDIAL ACTION PLAN FOR THE PHASE 3 WORKS AT WOODSMITH MINE, NORTH YORKSHIRE

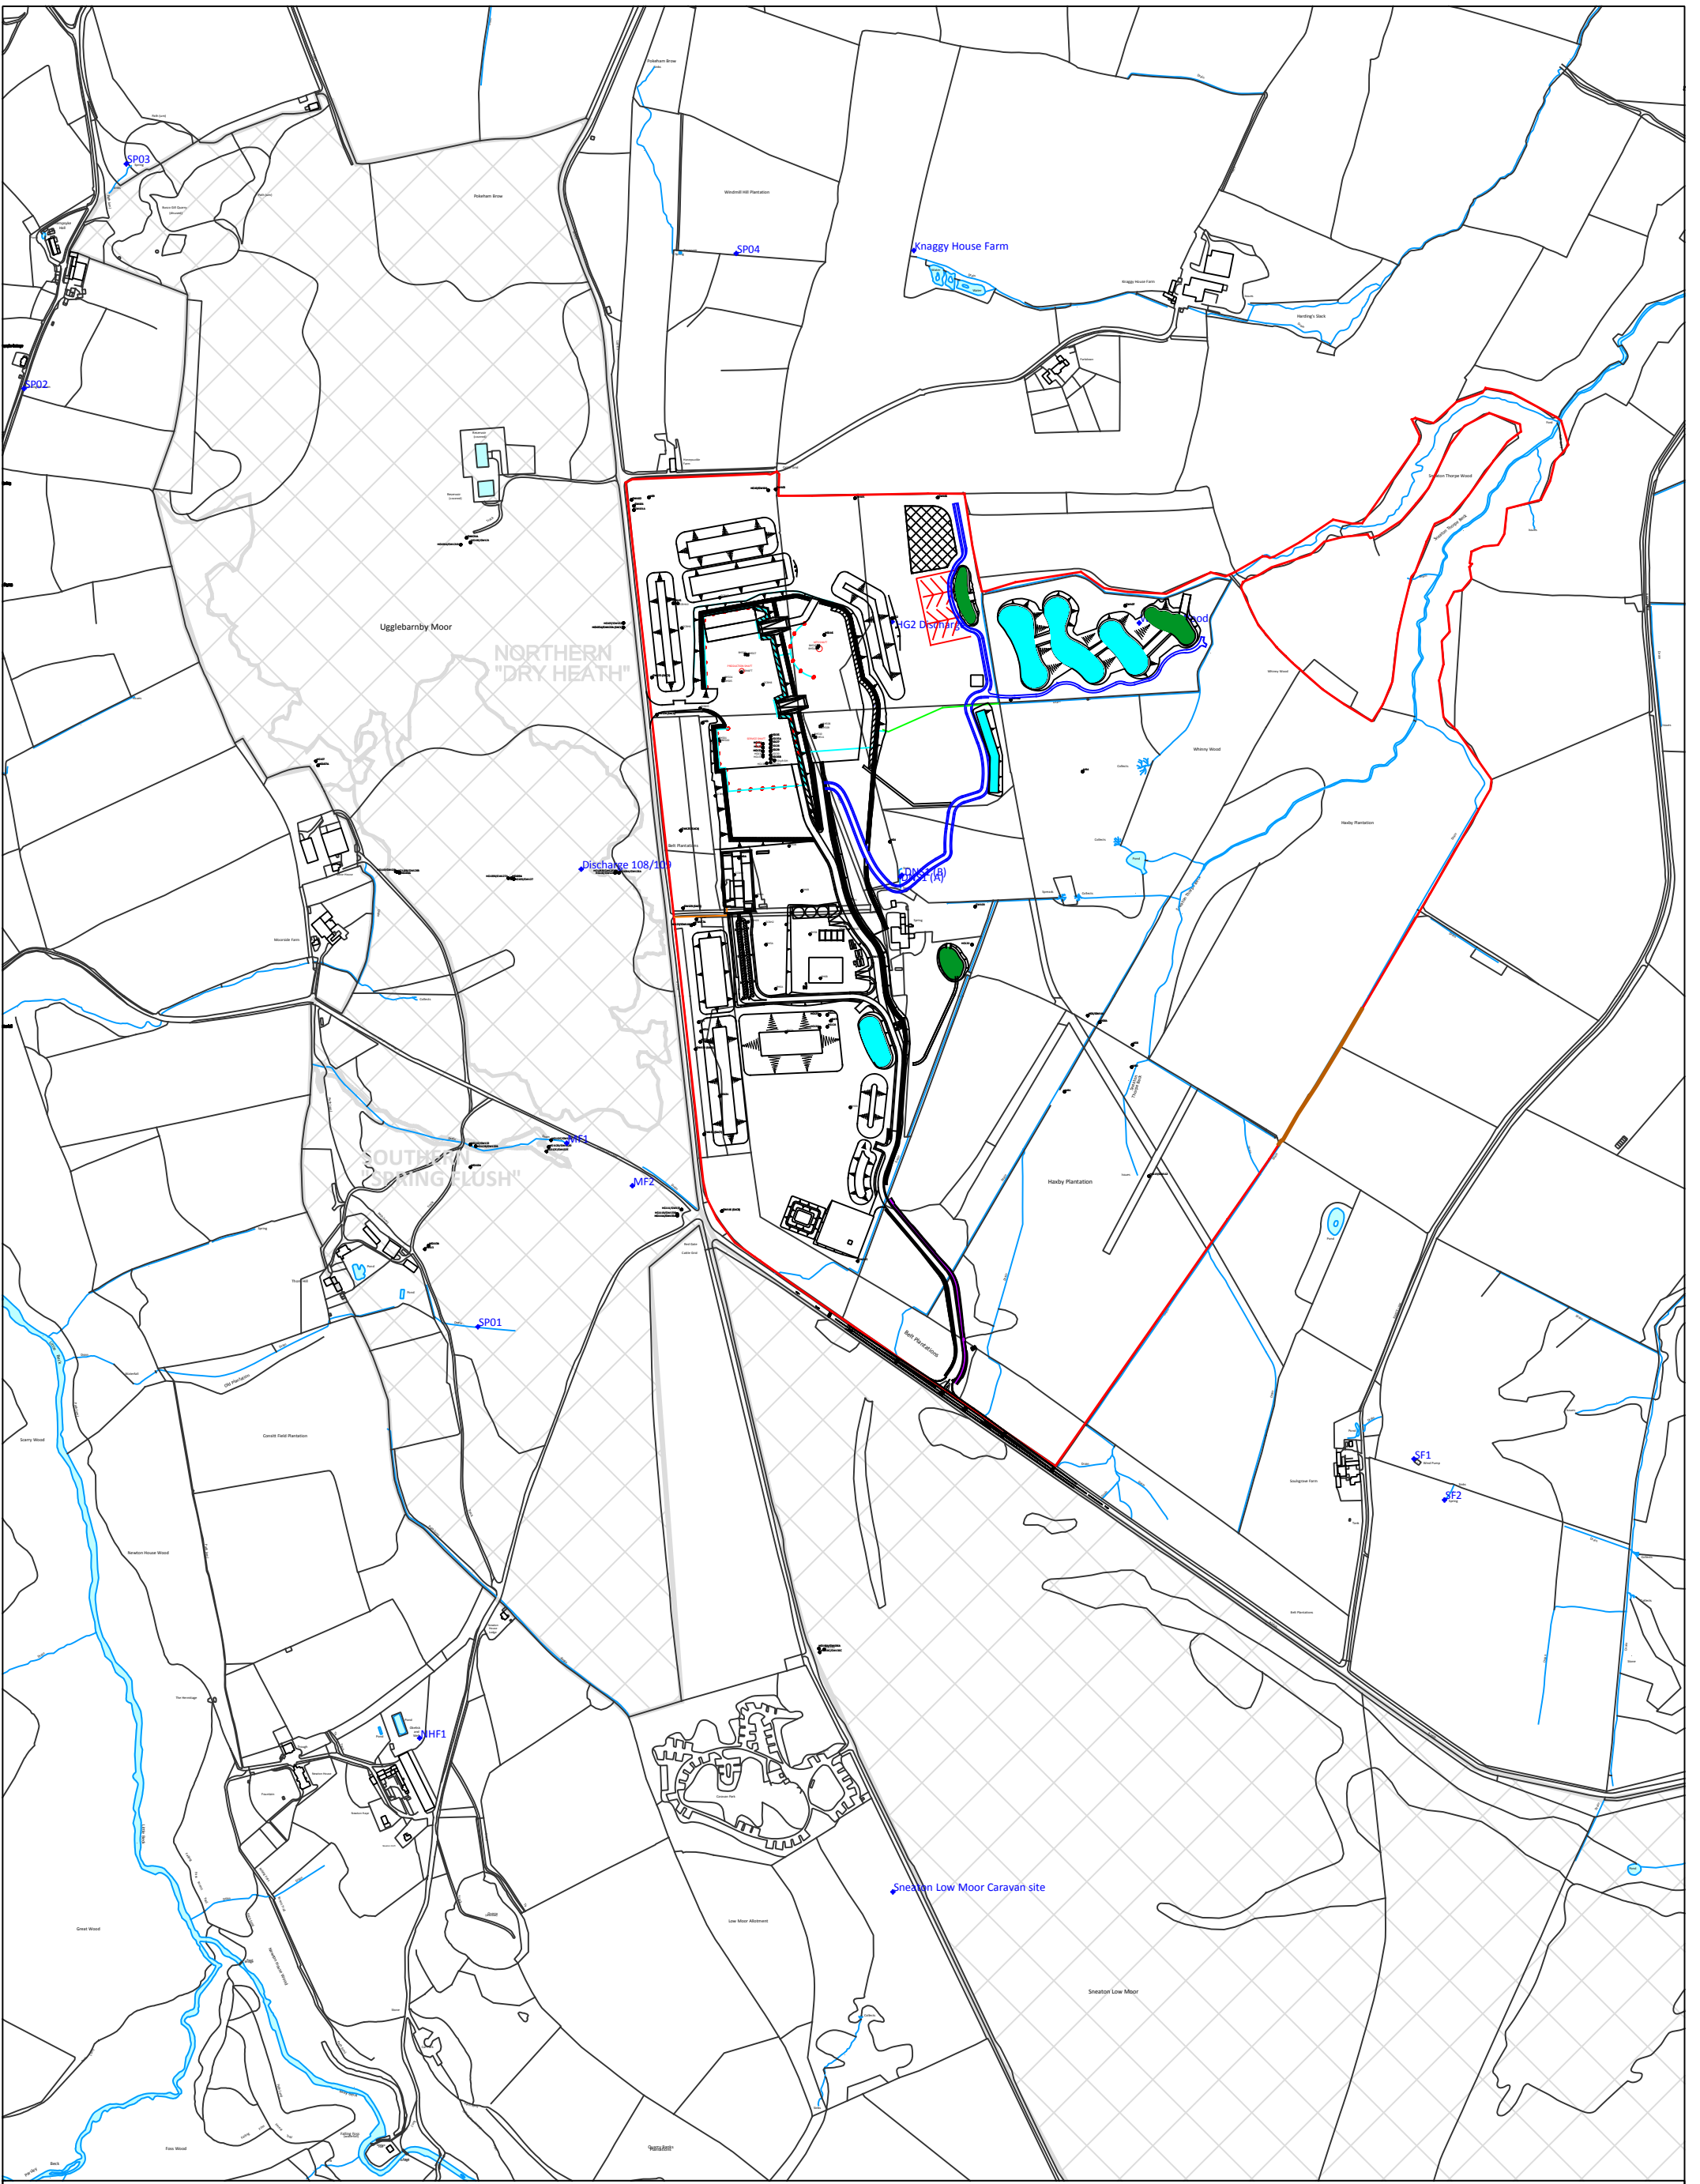
DRAWING TITLE	HYDROGEOLOGICAL RECEPTORS - PHASE 3
PROJECT TITLE	YORK POTASH PROJECT

NOTES / KEY	
SITE OWNERSHIP BOUNDARY	
NYM SAC	
SURFACE WATER	
BOREHOLES	
HYDROGEOLOGICAL RECEPTORS

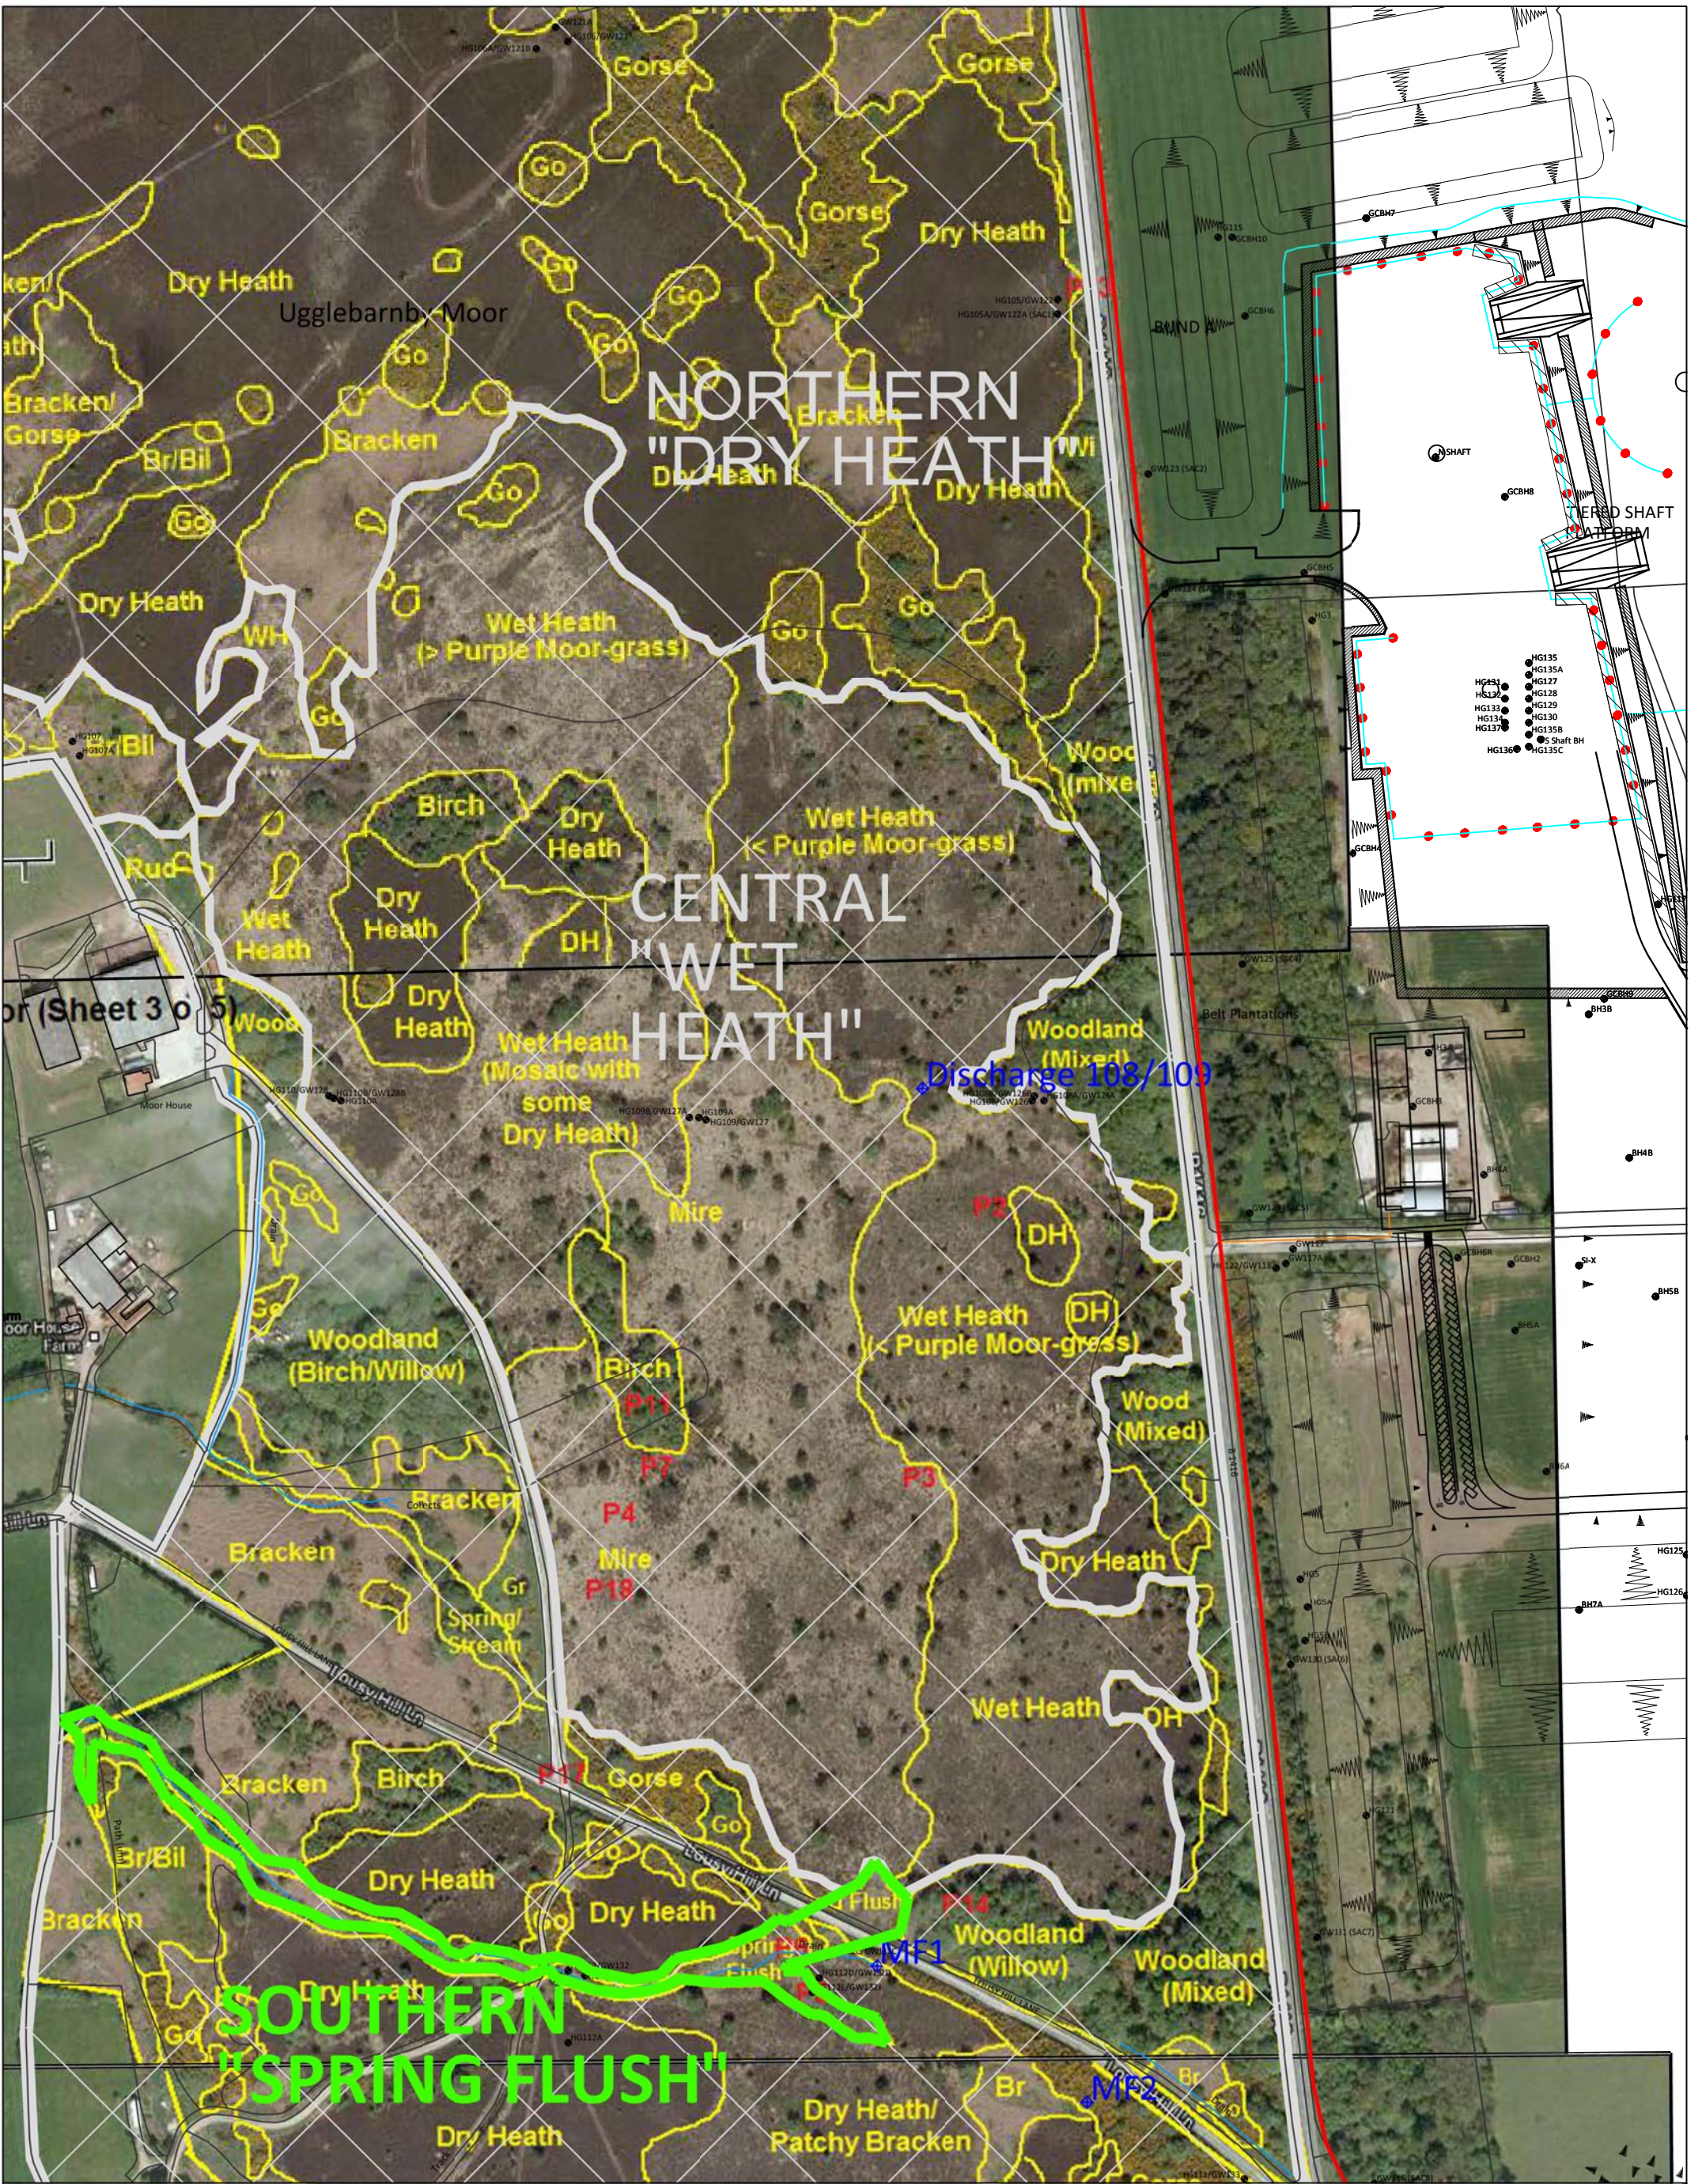
DRAWING TITLE	SPRING FLUSH MONITORING AREA
PROJECT TITLE	YORK POTASH PROJECT

NOTES / KEY	
SITE OWNERSHIP BOUNDARY	
NYM SAC	
SURFACE WATER	
BOREHOLES	
HYDROGEOLOGICAL RECEPTORS	
SPRING FLUSH MONITORING AREA

The objective of the ecological monitoring is to determine whether the Phase 3 Works are impacting on the groundwater dependant flora in the Spring Flush. Any changes in the habitat or its diversity in this area will be compared to changes in the groundwater levels and spring flow rates monitored at Moorside Farm Spring to determine whether these changes in habitat conditions are related to hydrogeological changes.

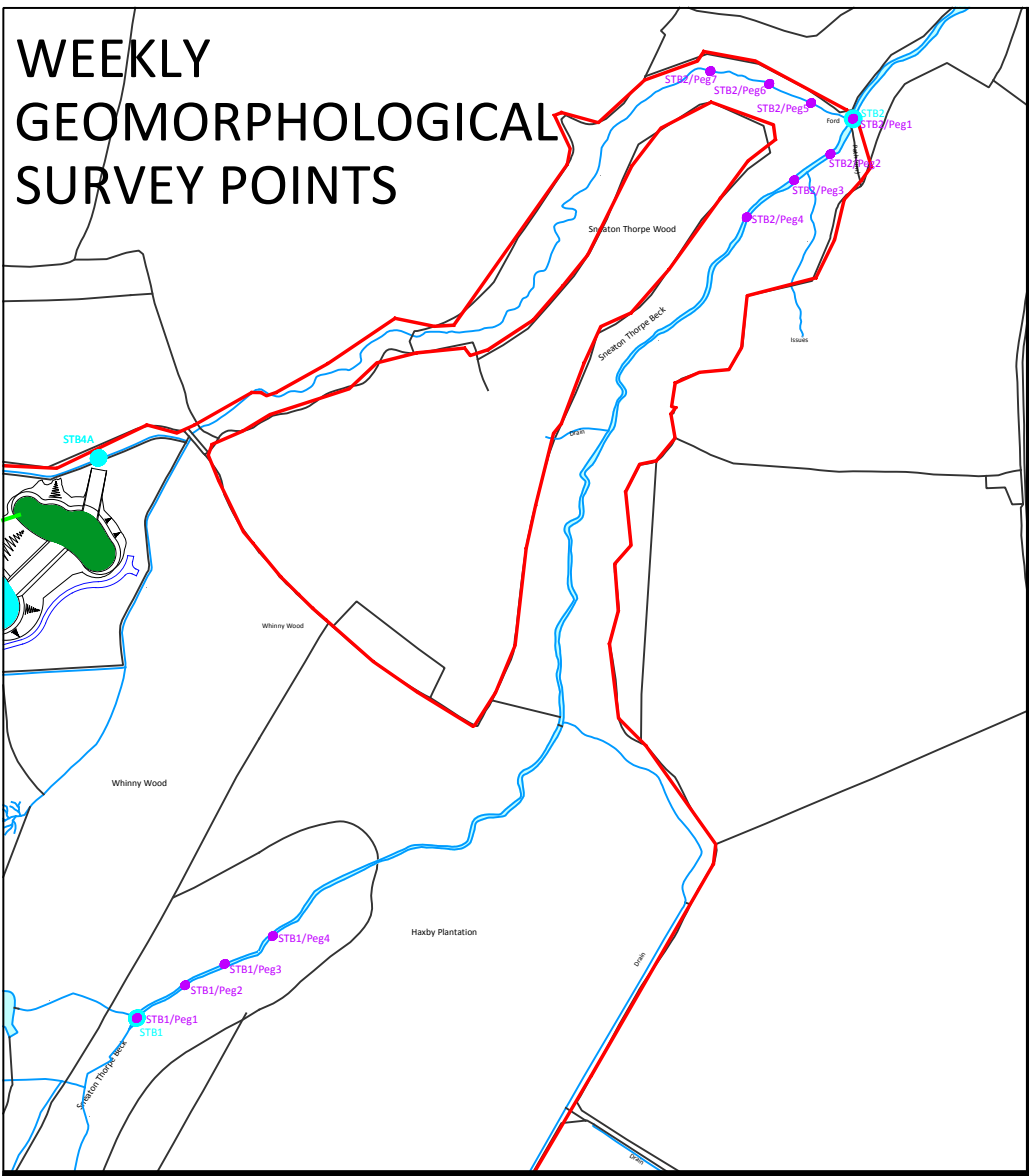
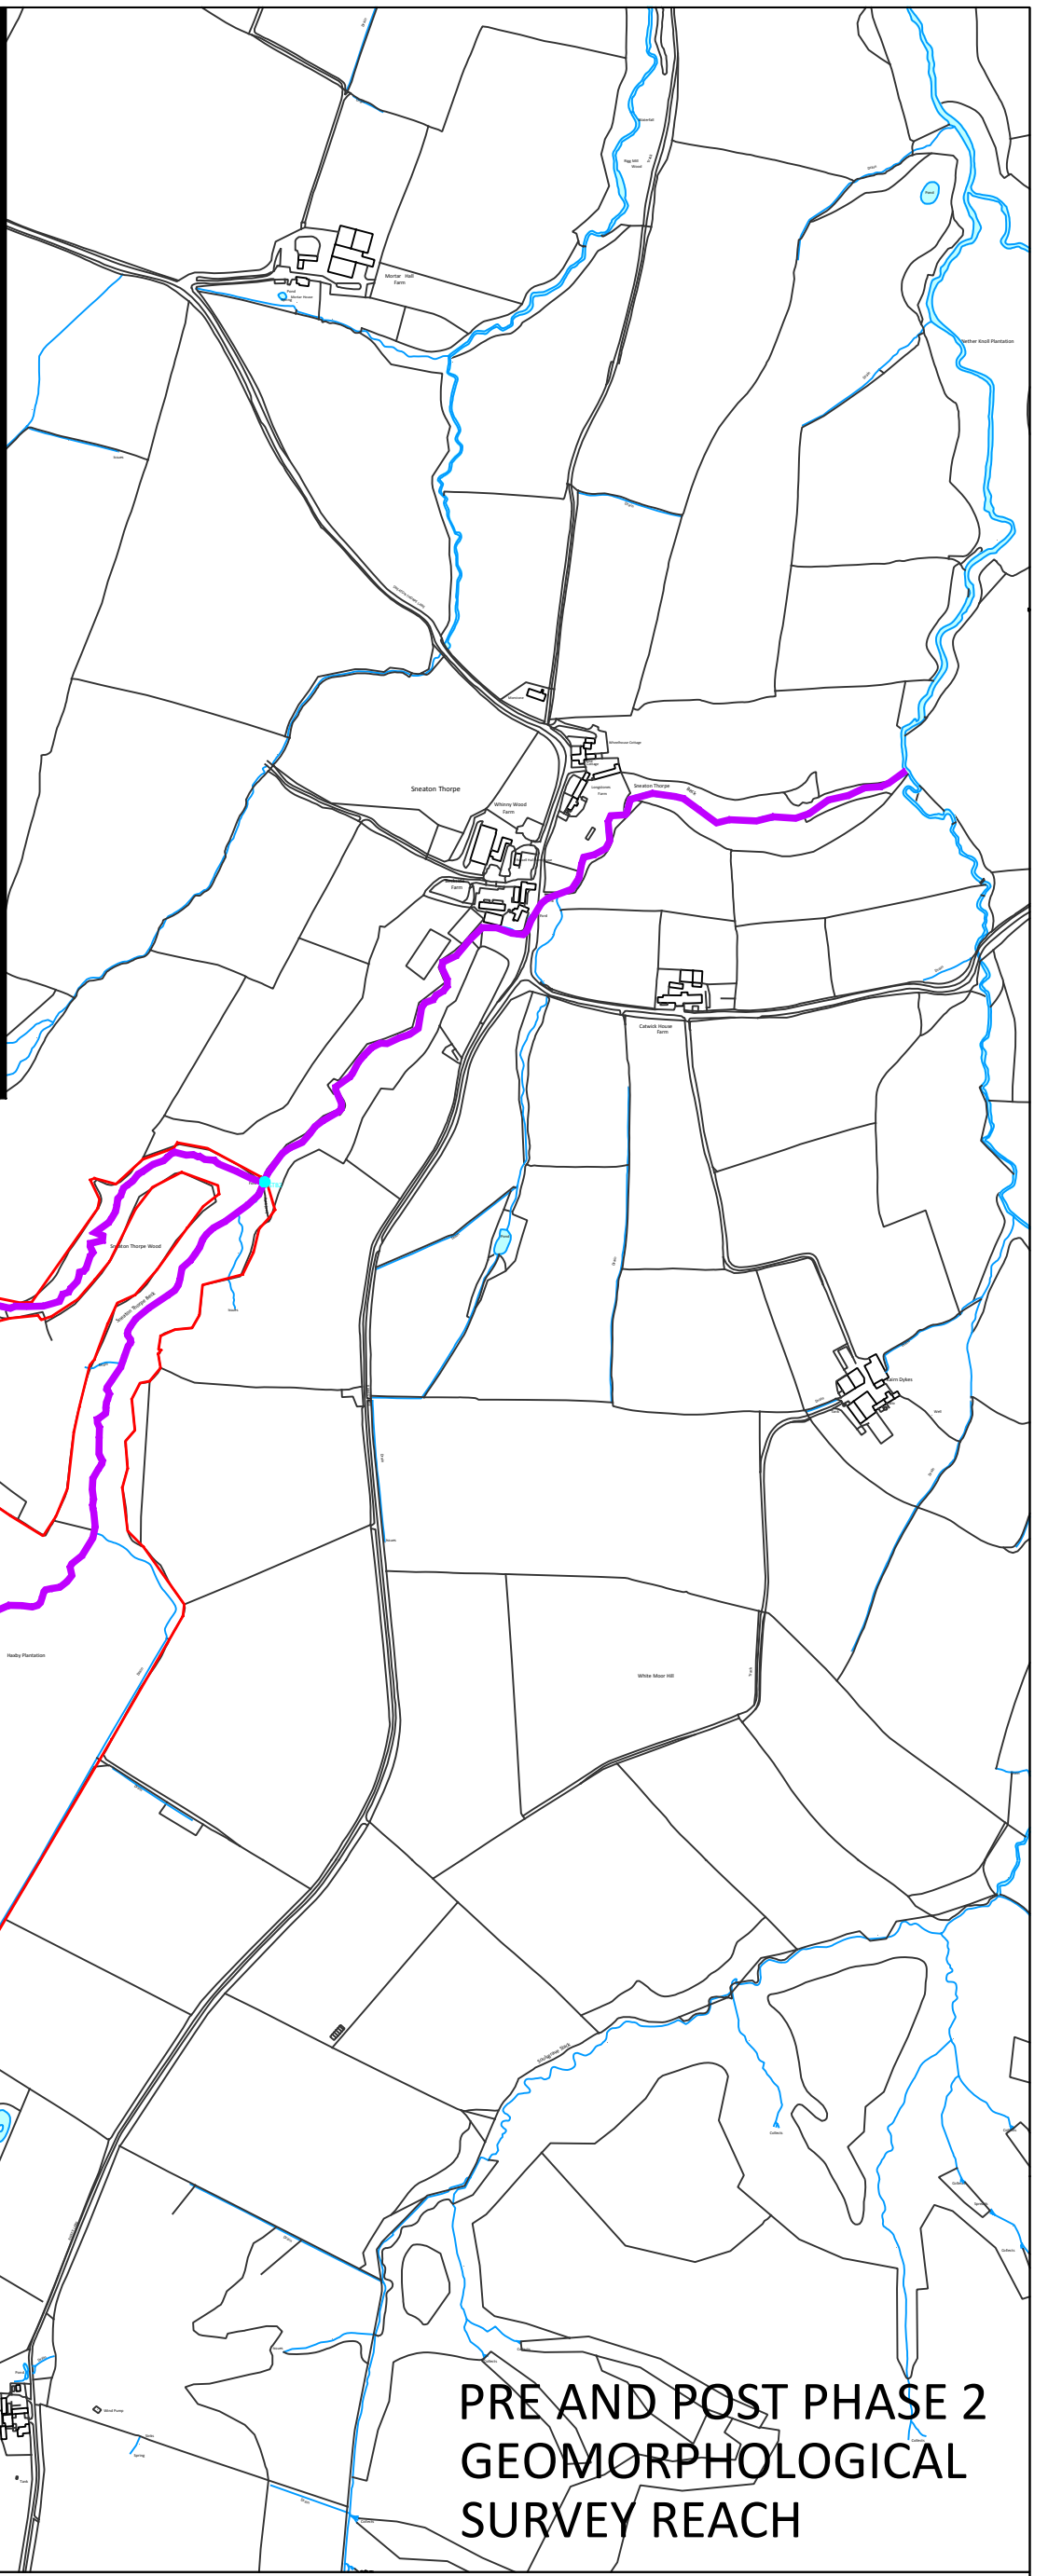
WEEKLY GEOMORPHOLOGICAL SURVEY POINTS

PRE AND POST PHASE 2 GEOMORPHOLOGICAL SURVEY REACH

NOTES / KEY	
SITE OWNERSHIP BOUNDARY	
NYM SAC	
SURFACE WATER	
BOREHOLES	GCBH01
SURFACE WATER MONITORING LOCATIONS	OF1
GEOMORPHOLOGY SURVEY

The construction phase monitoring will be assessed by comparison with the pre-commencement baseline geomorphological conditions to establish evidence of erosion, geotechnical failure, sediment accumulation, vegetation changes, and pollution/discolouration, for which remedial actions to mitigate these changes should be considered.

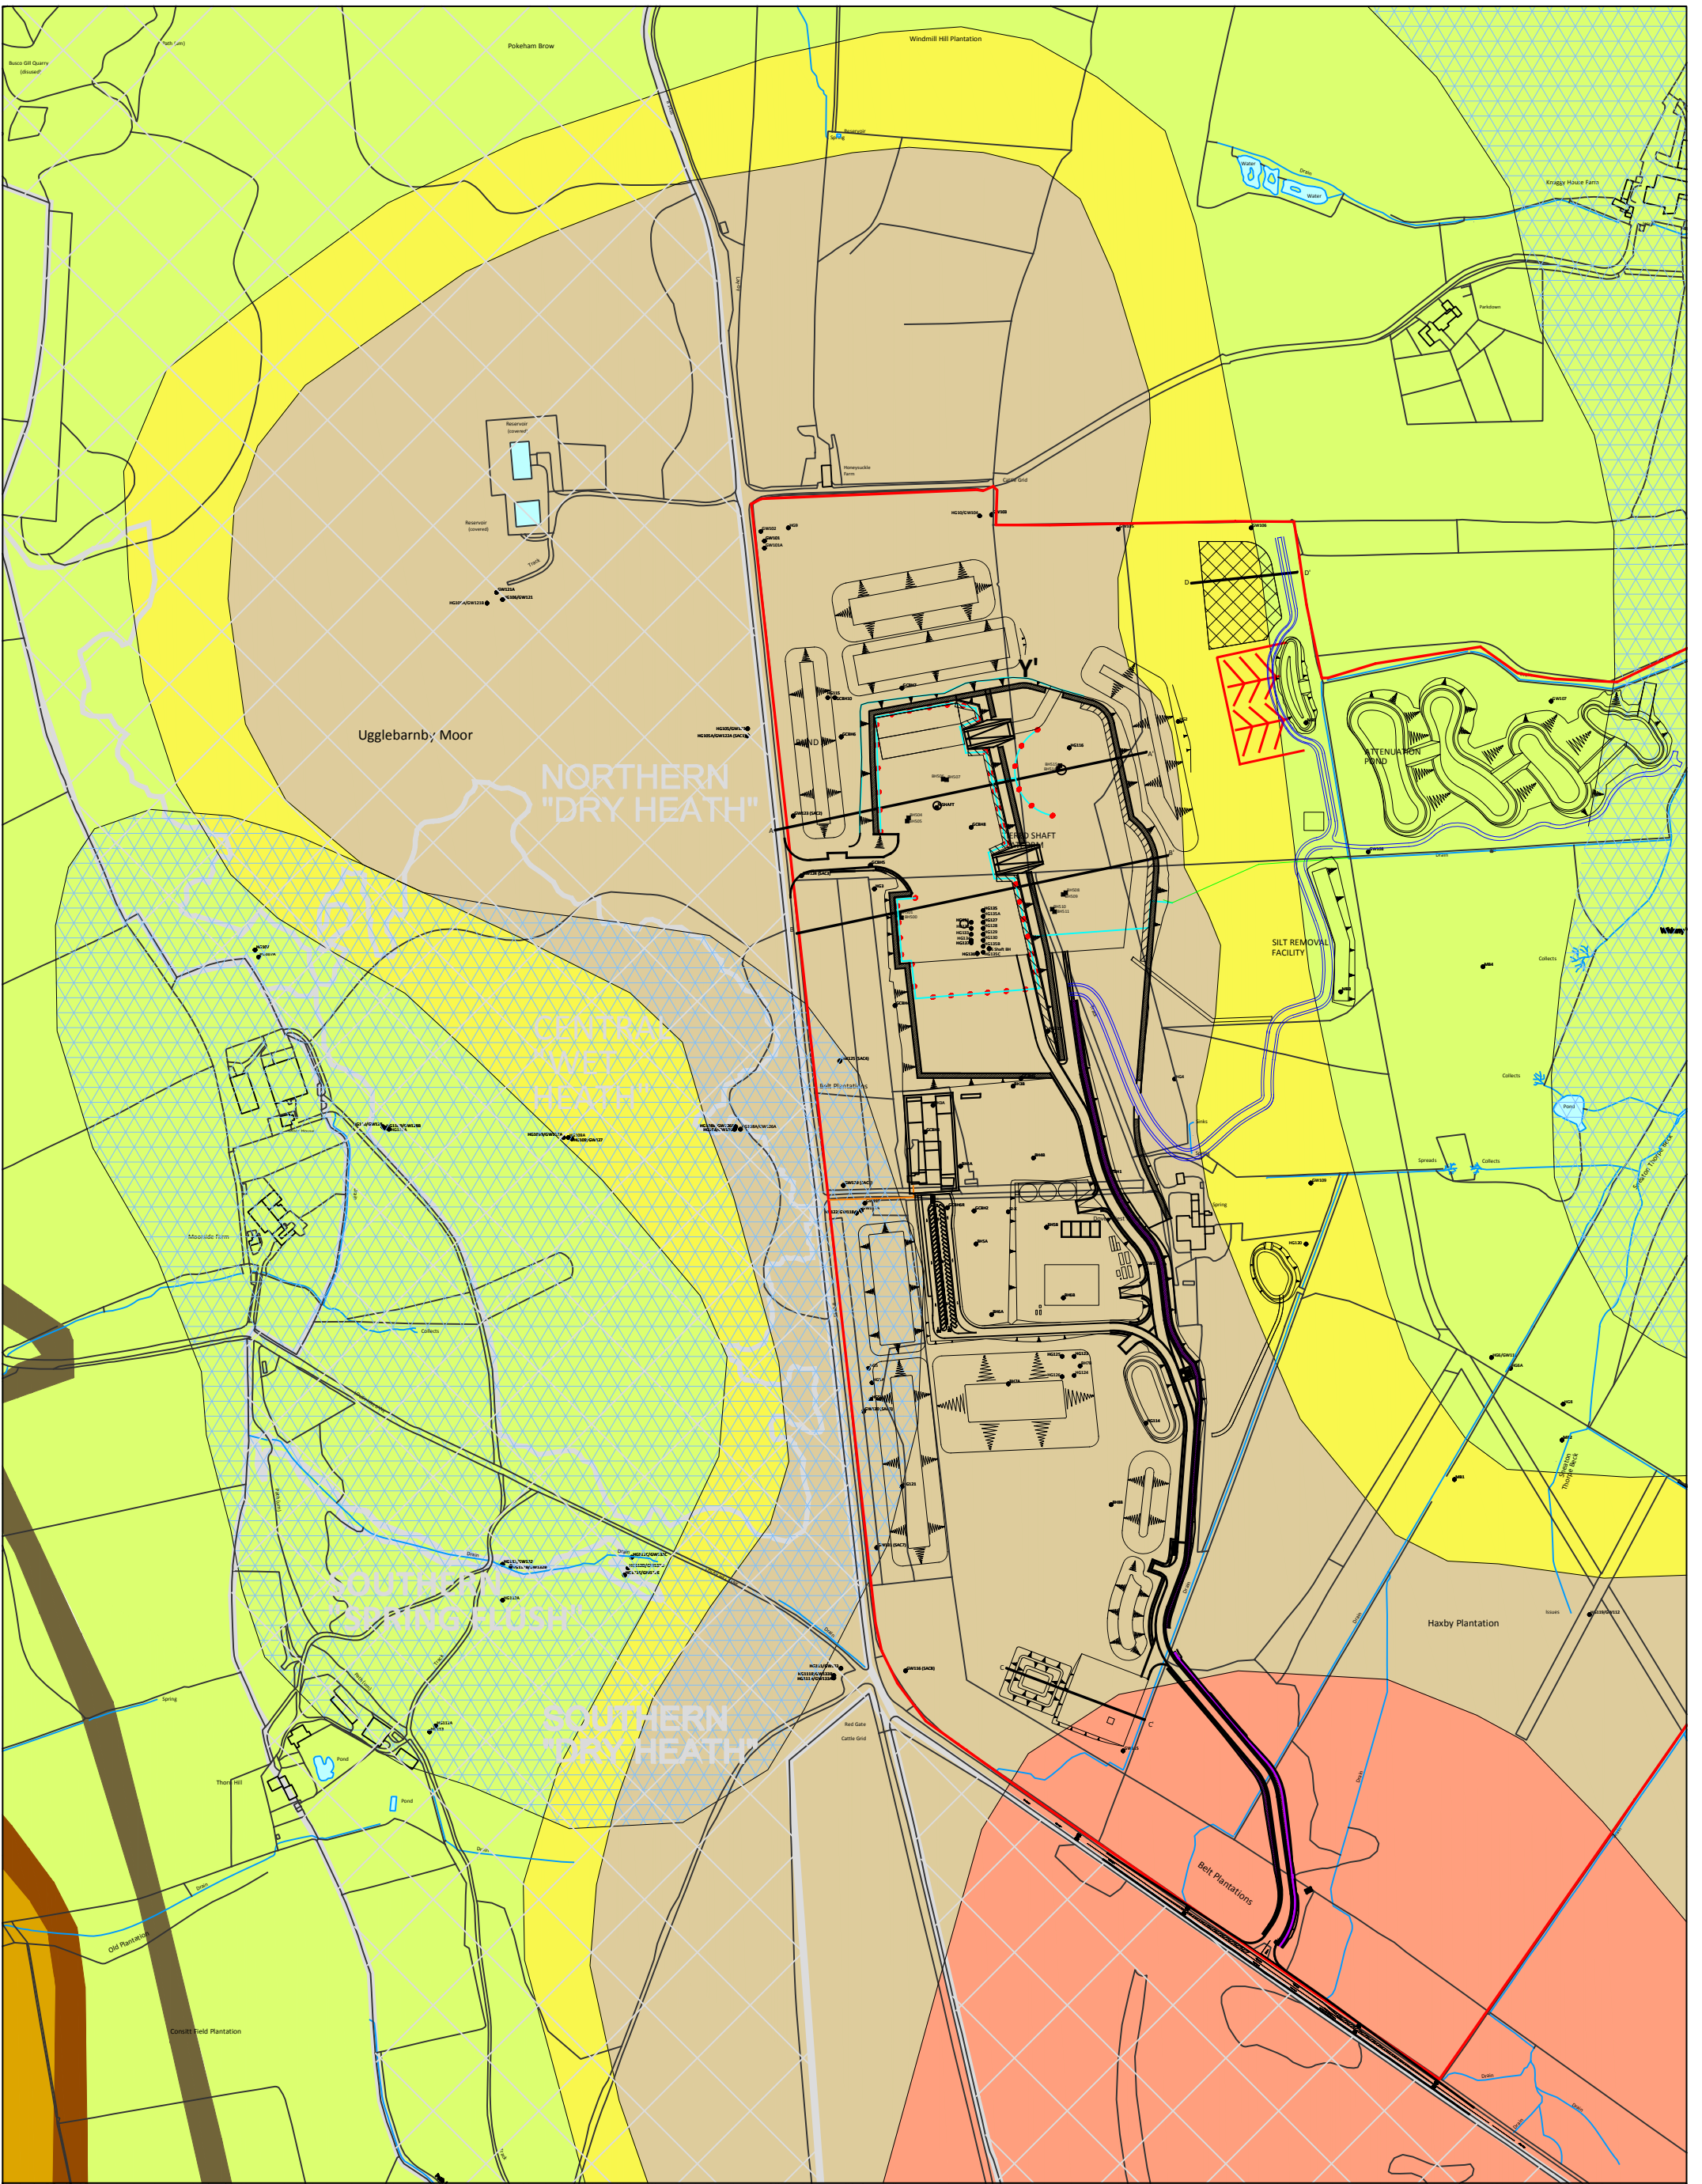
NOTES / KEY SITE OWNERSHIP BOUNDARY ——— NYM SAC ——— SURFACE WATER ——— BOREHOLES — GCBH01 HYDROGEOLOGICAL RECEPTORS — MF2 LINE OF CROSS SECTION ——— CROSS SECTION A-A' and B-B' DRAWING 1433DevOD244 CROSS SECTION A-A' DIAPHRAGM WALL DRAWING 1433DevOD268 CROSS SECTION C-C' DRAWING 1433DevOD266 CROSS SECTION D-D' DRAWING 1433DevOD267	GEOLOGY GLACIAL TILL LONG NAB MOOR GRIT SCARBOROUGH FORMATION CLOUGHTON & SALTWICK FORMATION ELLER BECK FORMATION DOGGER FORMATION WHITBY MUDSTONE		DRAWING TITLE GEOLOGICAL MAP AND LINE OF CROSS SECTIONS		CLIENT SIRIUS MINERALS PLC			
			PROJECT TITLE YORK POTASH PROJECT		STATUS FINAL		PROJECT NUMBER 1433Dev	
			PROJECT TITLE YORK POTASH PROJECT		DRAWN BY CB		DATE March 2017	
			PROJECT TITLE YORK POTASH PROJECT		SCALE 1:5,000@A3/1:2,500@A1		DRG. No. 1433DevOD265Rev1	
Merrington House Merrington Lane Industrial Estate Spennymoor County Durham DL16 7UT
