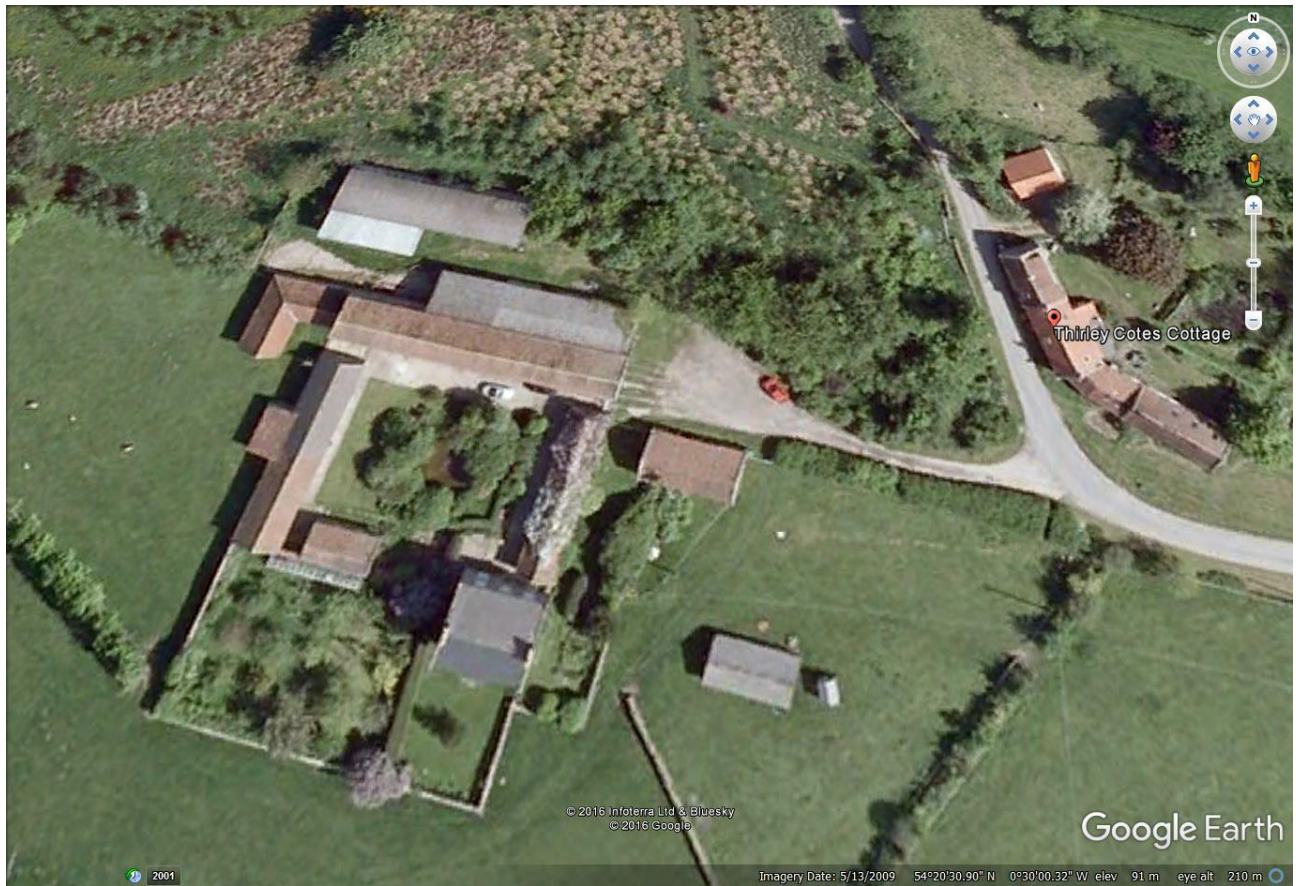
- a. Google Earth of Thirley Cotes Farm dated 2009 (probably still current). This shows Thirley Cotes Farm prior to redevelopment. The two probably framed buildings to the north have been demolished and what appears to be an orchard to the south has become an extended lawn area to the farmhouse.
- b. View from the access way to the car park area. The car park is clearly going to get full at busy times and its proximity to Holly Cottage is clearly not satisfactory. The bin area is also clearly unsightly.

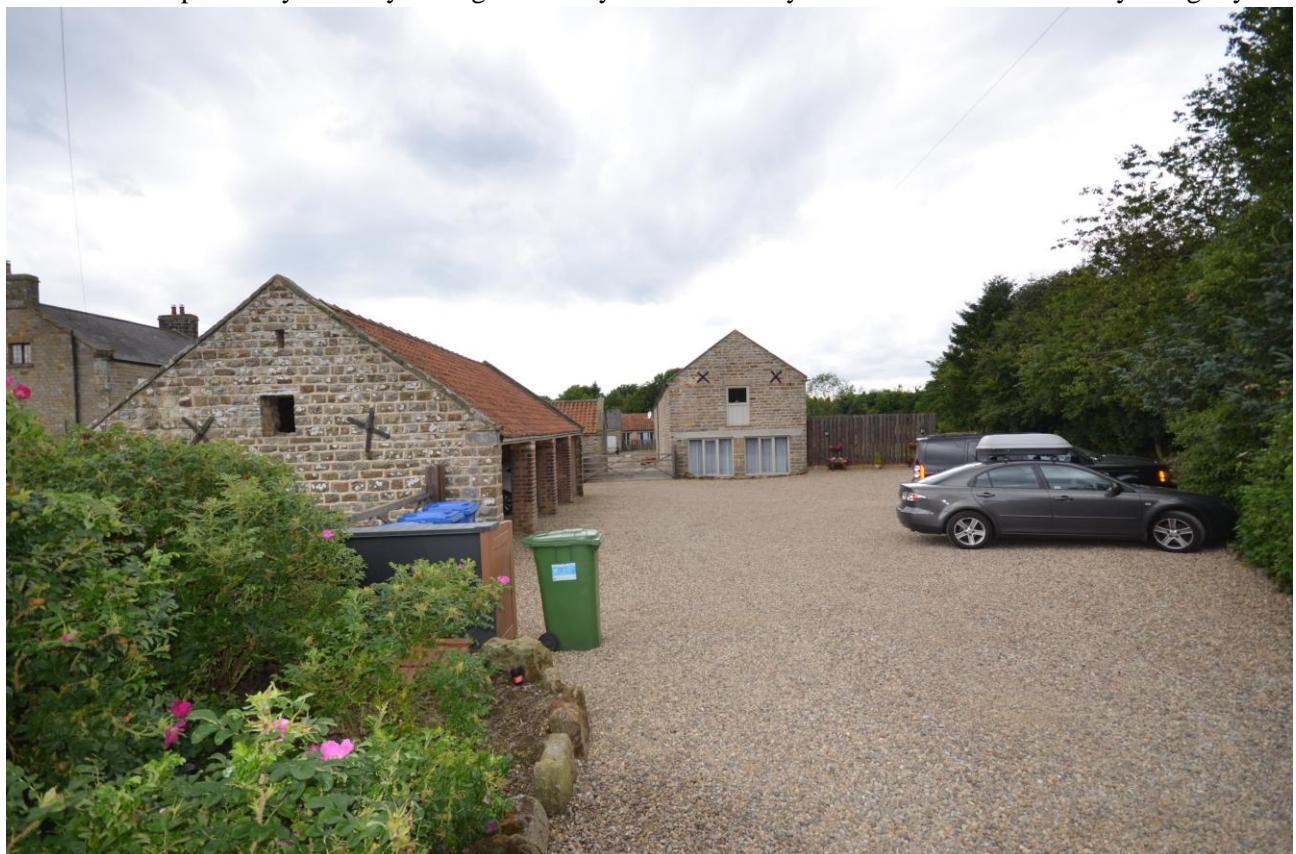
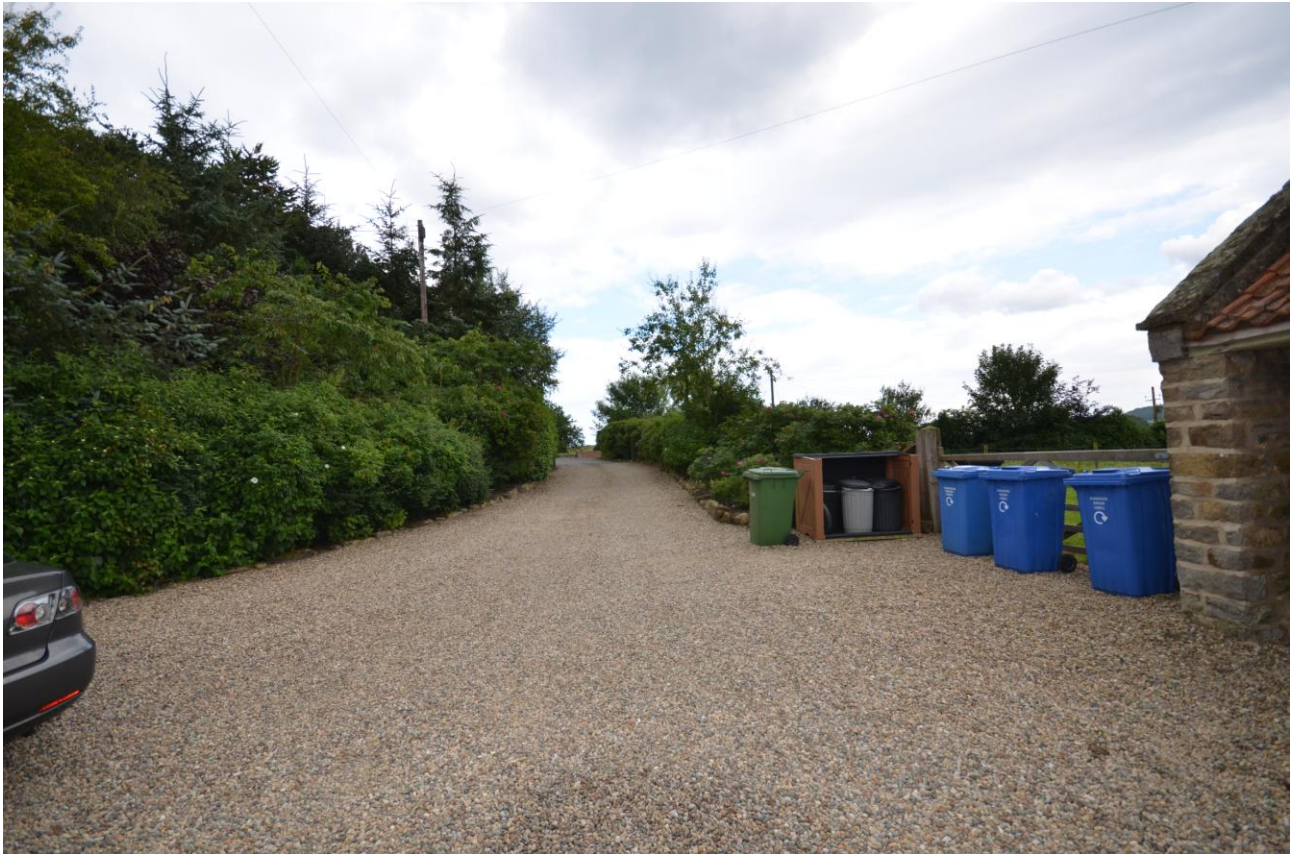
- c. Further view of the access through to the highway with the inevitable bin storage.
- d. View of the rear of the converted cottages. Clearly this shared access and sitting out space is not of the standard achieved by the cottages themselves.

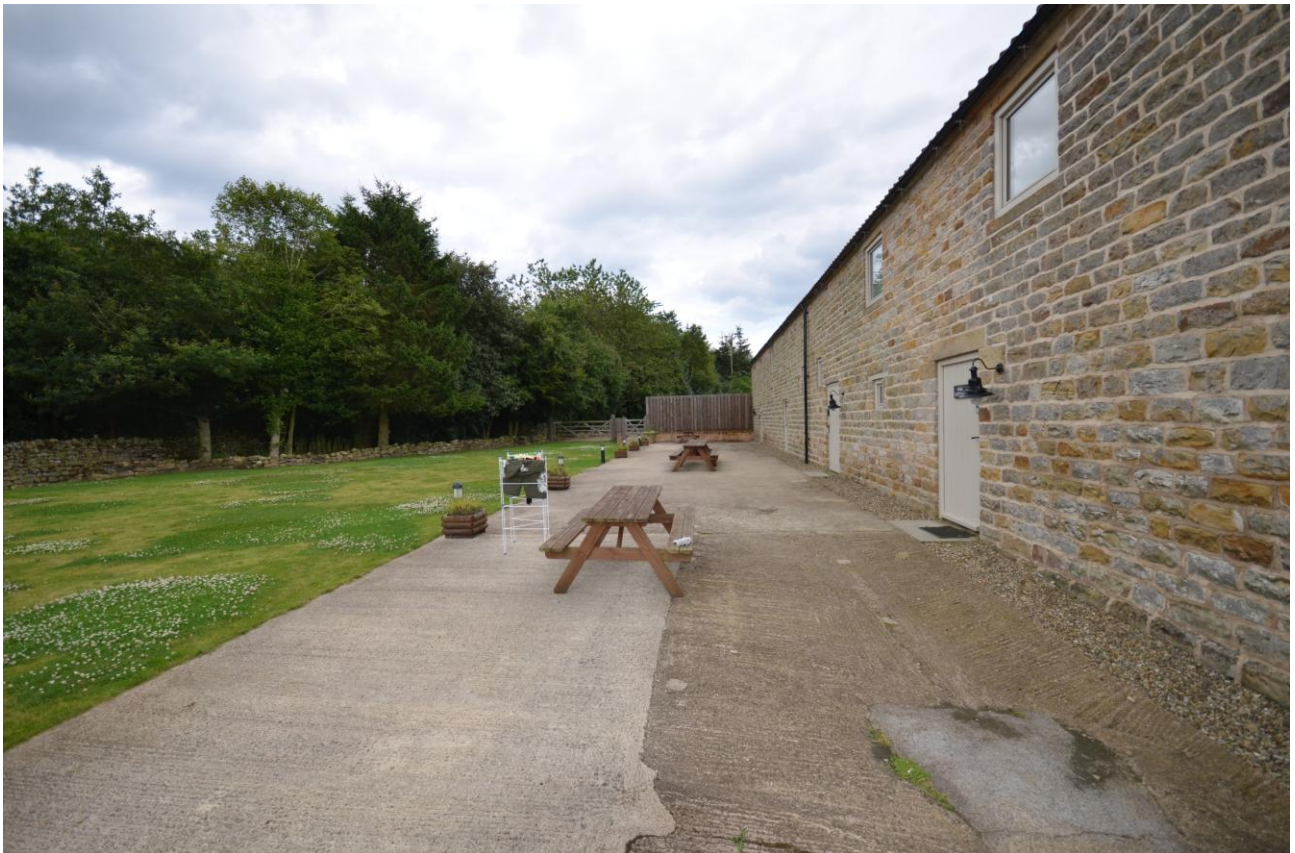
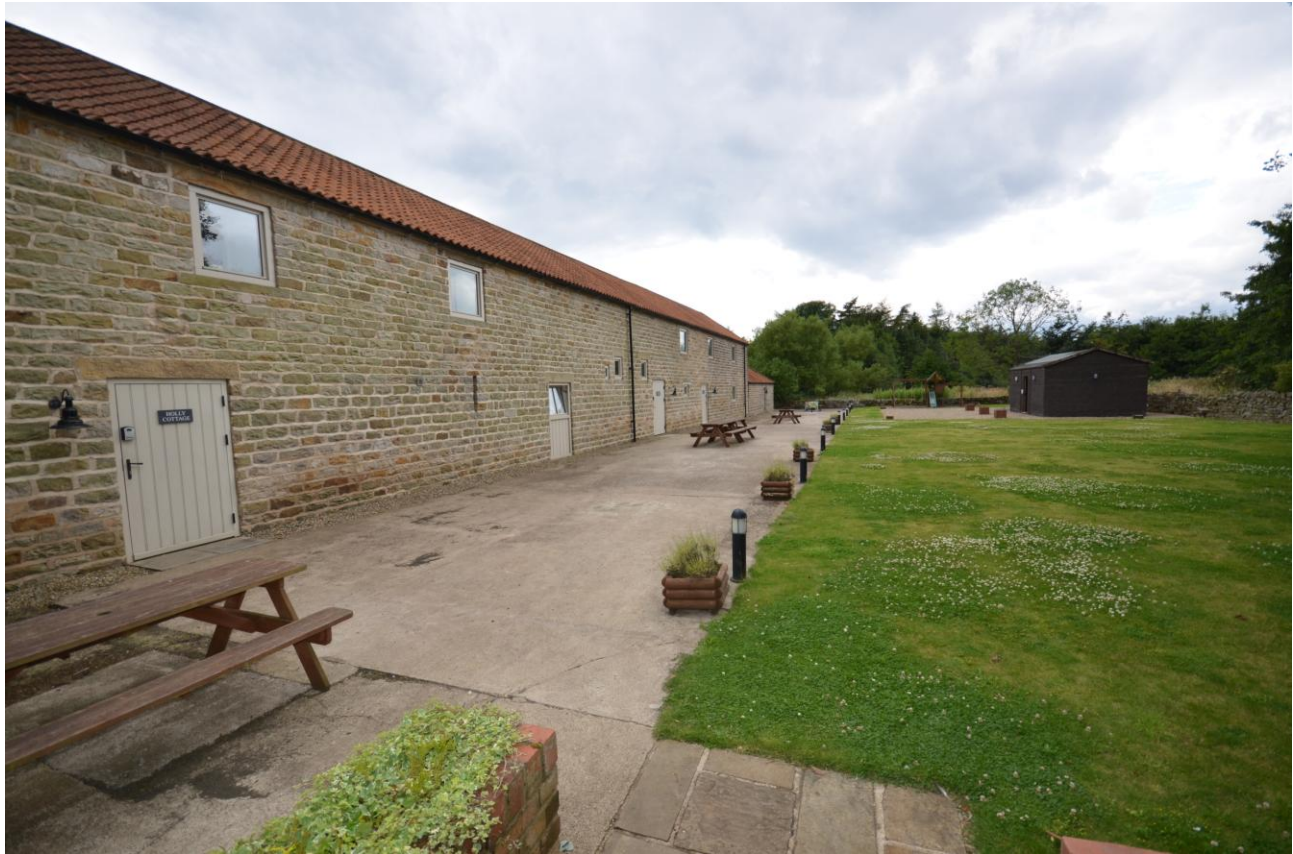
- e. Further view of the shared access and sitting out space to the existing cottages with the common games room and play area to the right hand side.
- f. View of the south facade of Thirley Cotes Farm which is typical of its period and surprising that it has not changed over 200 years. It is proposed to extend the stone terrace area and provide a hot tub to the right hand side of the entrance steps. The hot tub itself will be effectively below the level of the ground floor and therefore out of view except within the garden area.

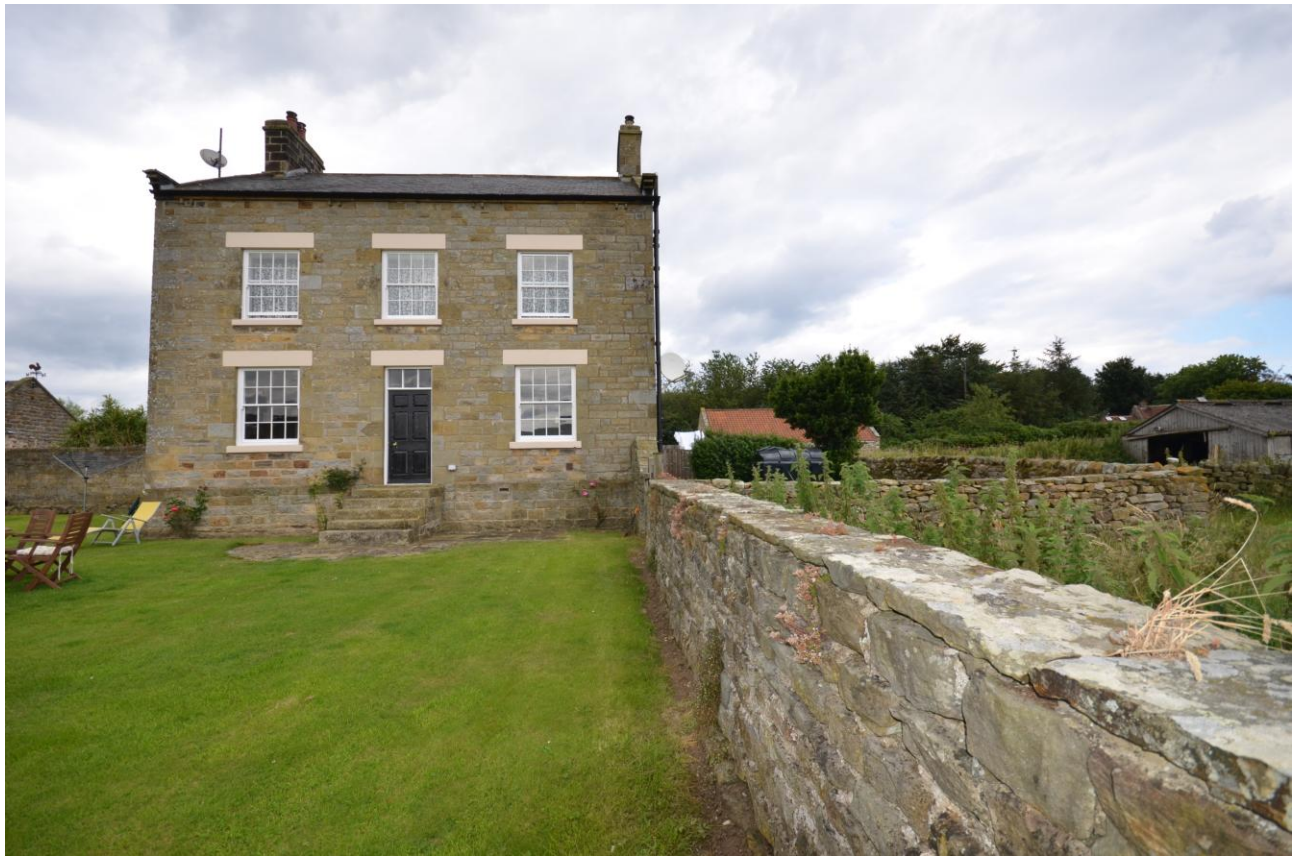
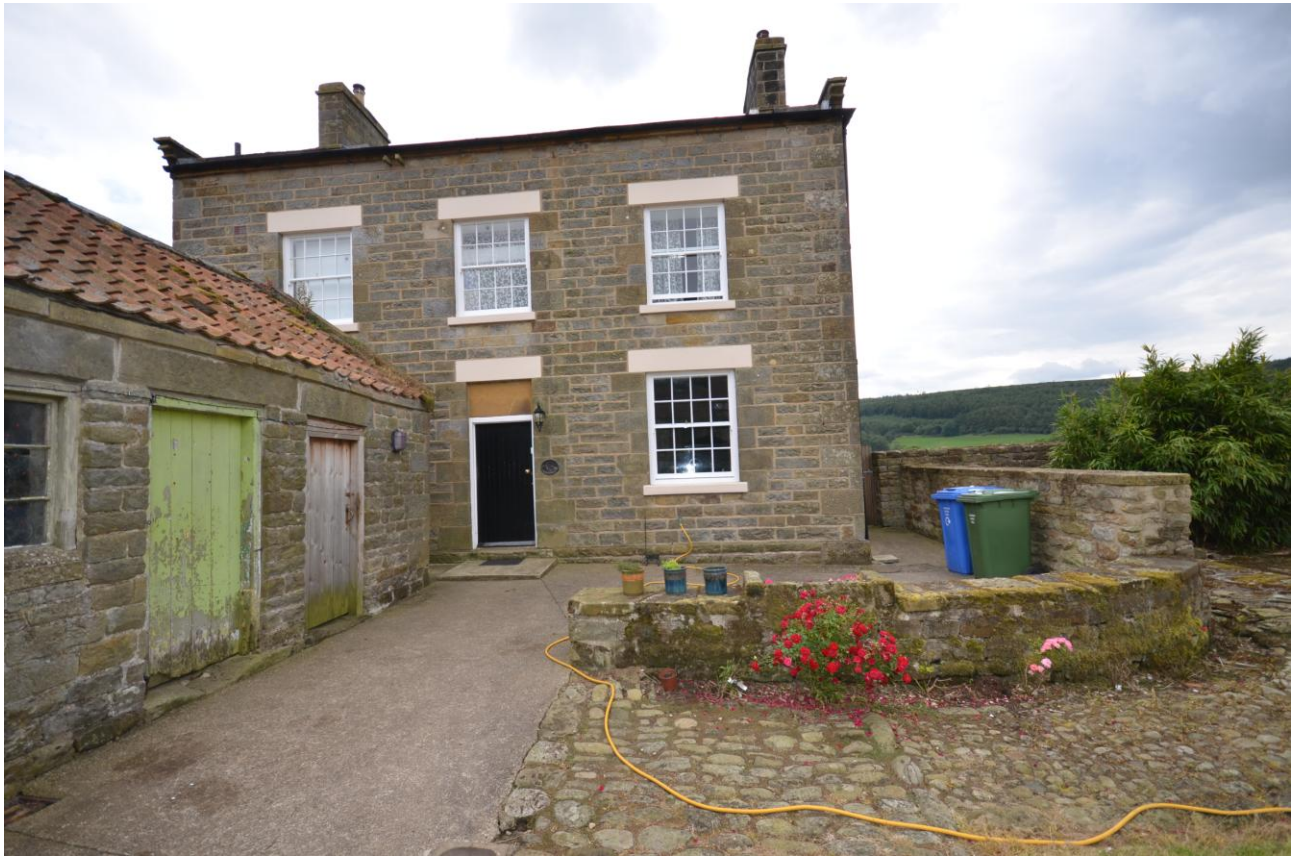
- g. View of the rear of Thirley Cotes Farm which is almost a mirror image of the front. It is proposed that the stone wall is extended round at the upper level and then finished with a five bar gate and fence onto the laundry / store to give enclosure to the farmhouse.
- h. View of the central courtyard, this is generally bounded in concrete and it is proposed that a formal stone paved footpath is extended round the courtyard with gravel margins including planted troughs.

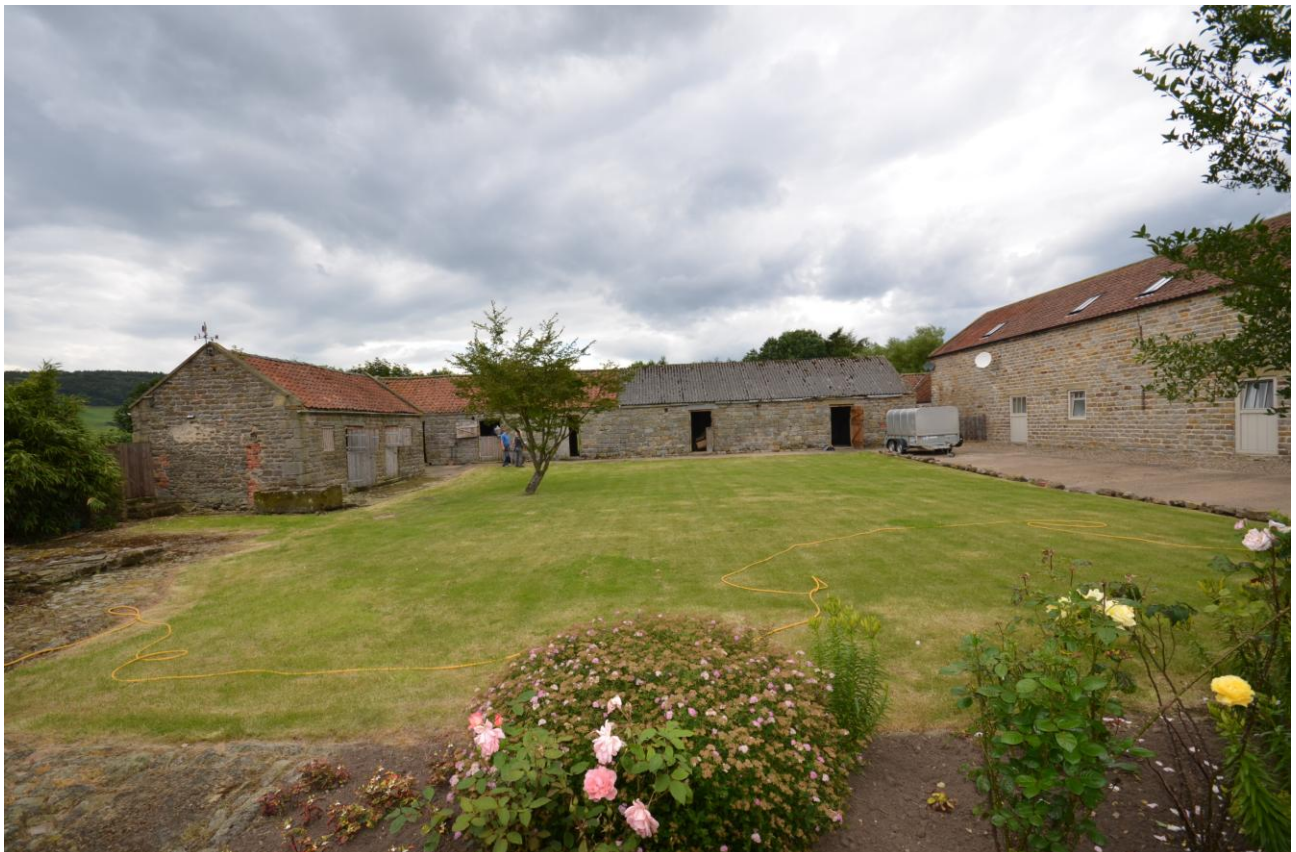
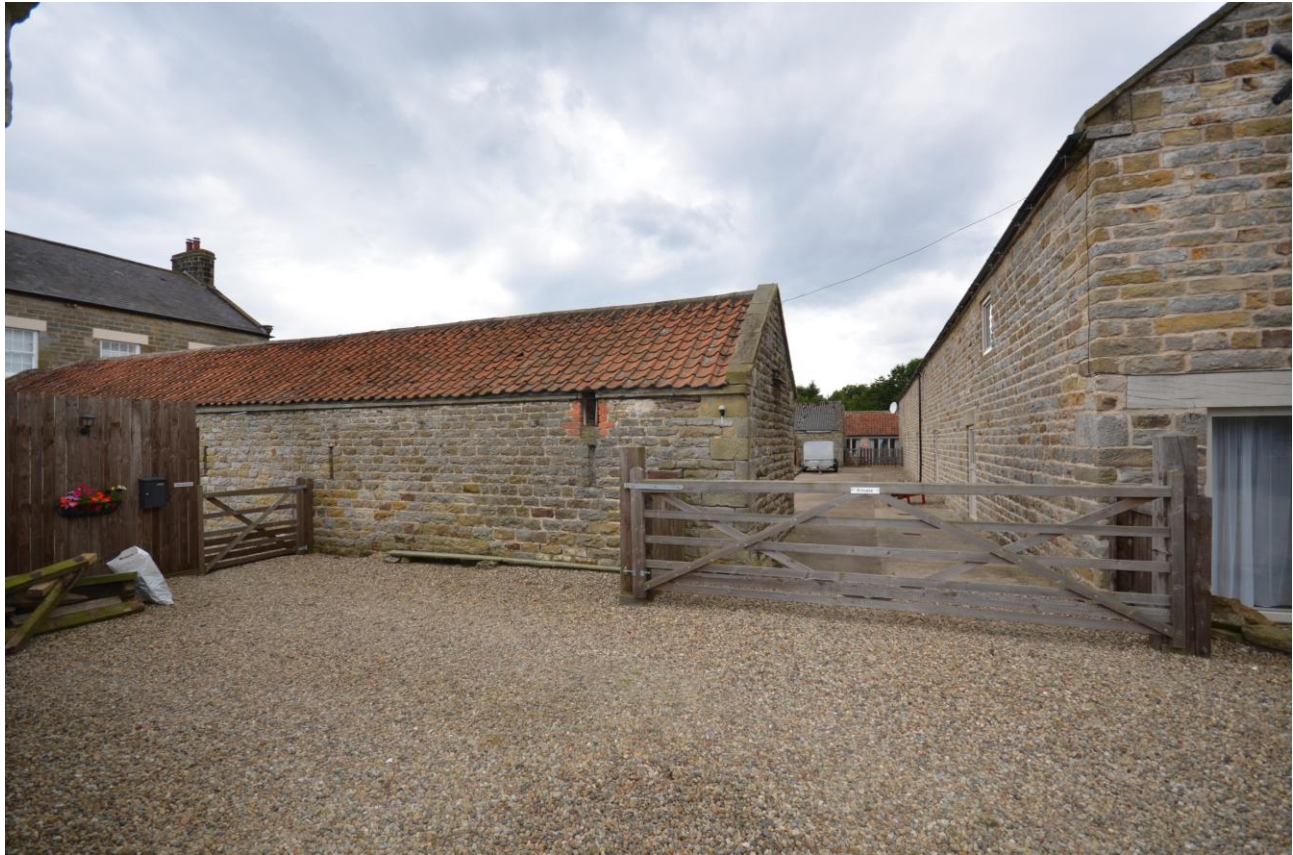
- i. View from the car park to the access to the courtyard to the right and access to the farmhouse to the left. It is proposed that the access to the farmhouse has a five bar gate and matching fence and that the five bar gate and fence is removed completely from the courtyard access. The single storey outbuilding to the centre of the photograph was used as a general store for the development, laundry and for incoming mains services, this has now been refurbished as an office for the development together with laundry and storage facilities. It is proposed that an additional access door is added to the access side of the building for use by guests which will be easier and much more obvious than using the existing door opening into the courtyard area.

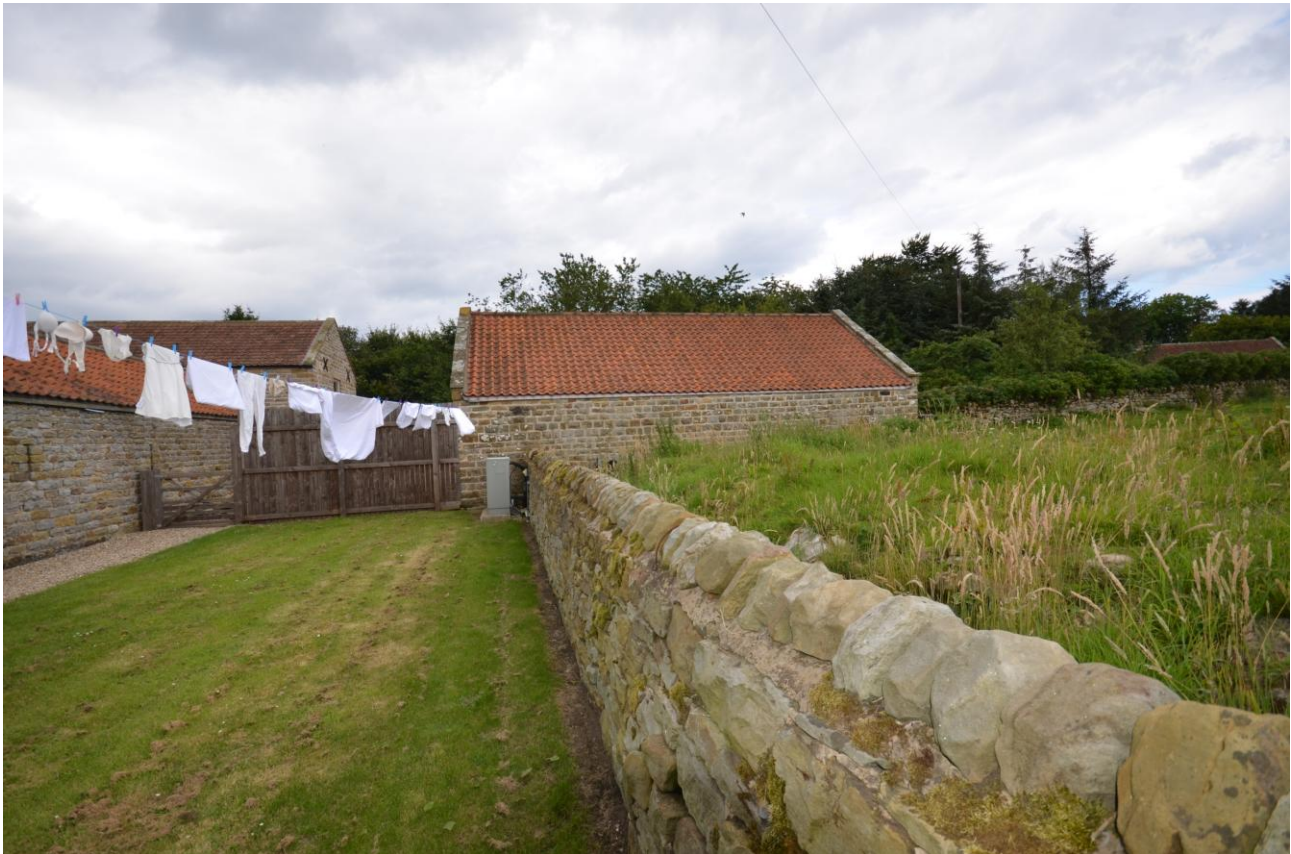
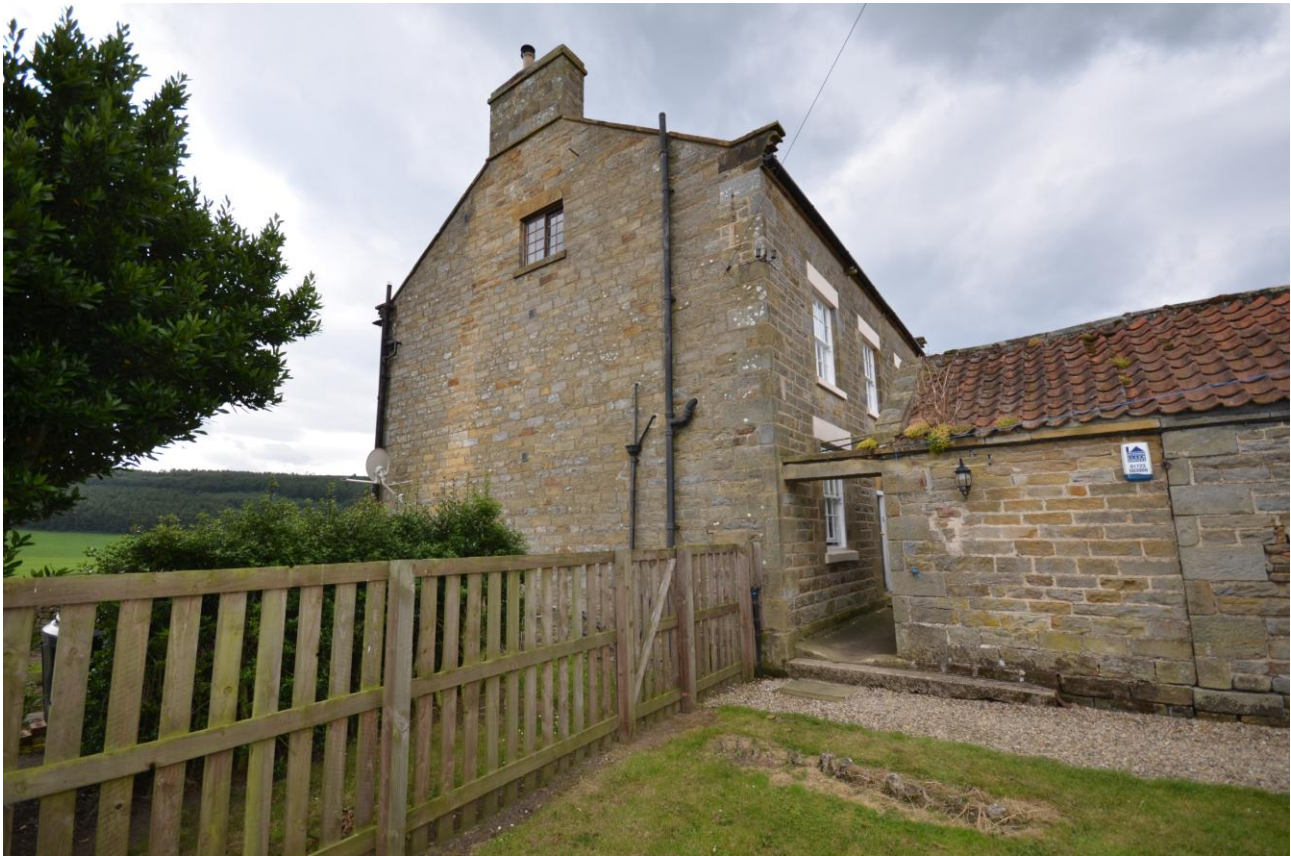
- j. View of the back garden area to the farm house, it is proposed that this is gravelled over as private parking for the farmhouse with a five bar gate to replace the close boarded fencing and pedestrian gate.
- k. View of the east gable of the farmhouse. It is proposed that the boarded fence and gate are removed so that the garden area beyond can be used to give the primary access from the car park to the entrance frontage of the listed building.
