Archaeological Recording at Ebenezer Methodist Chapel,

Rosedale East, North Yorkshire, SE 708 977

Archaeological Recording at Ebenezer Methodist Chapel, Rosedale East SE 708 977

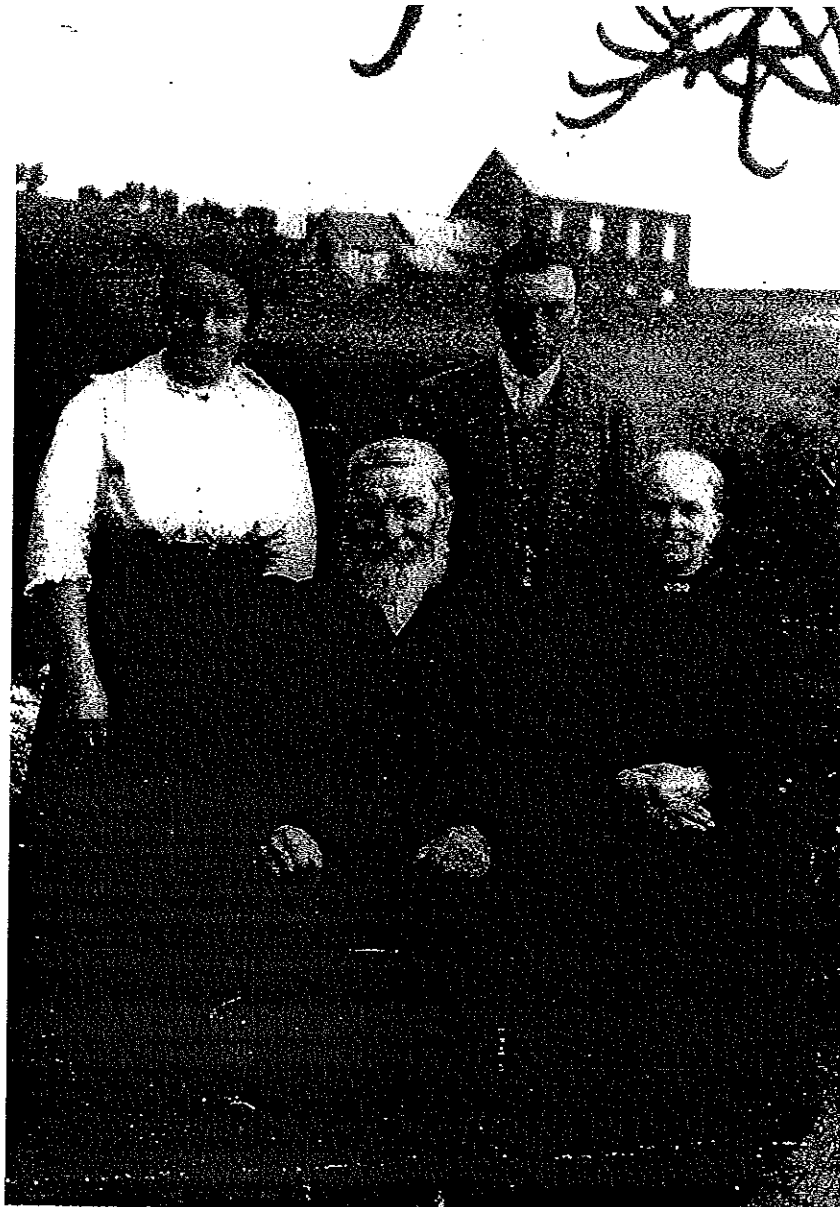
Pl.2 A family at Hill Farm with the Ebenezer Chapel in the background and a range of lower sandstone and corrugated buildings to the west (left). Courtesy of Janet Dring

The date that the chapel was demolished is unknown although a Rosedale resident, Doreen Dale, recalls enjoying a school dinner in the building c.1940 (Sean Doughty, pers. comm.). Plate 2 shows a sandstone building with an entrance to the south and a further corrugated building to the west. It was possible to measure the extent of the sandstone building. It was 9.5m E-W and 6.1m N-S. In the western wall of the Ebenezer Chapel a roofline can be seen to have been inscribed into the wall. This appears to correspond with the buildings in plate 2.

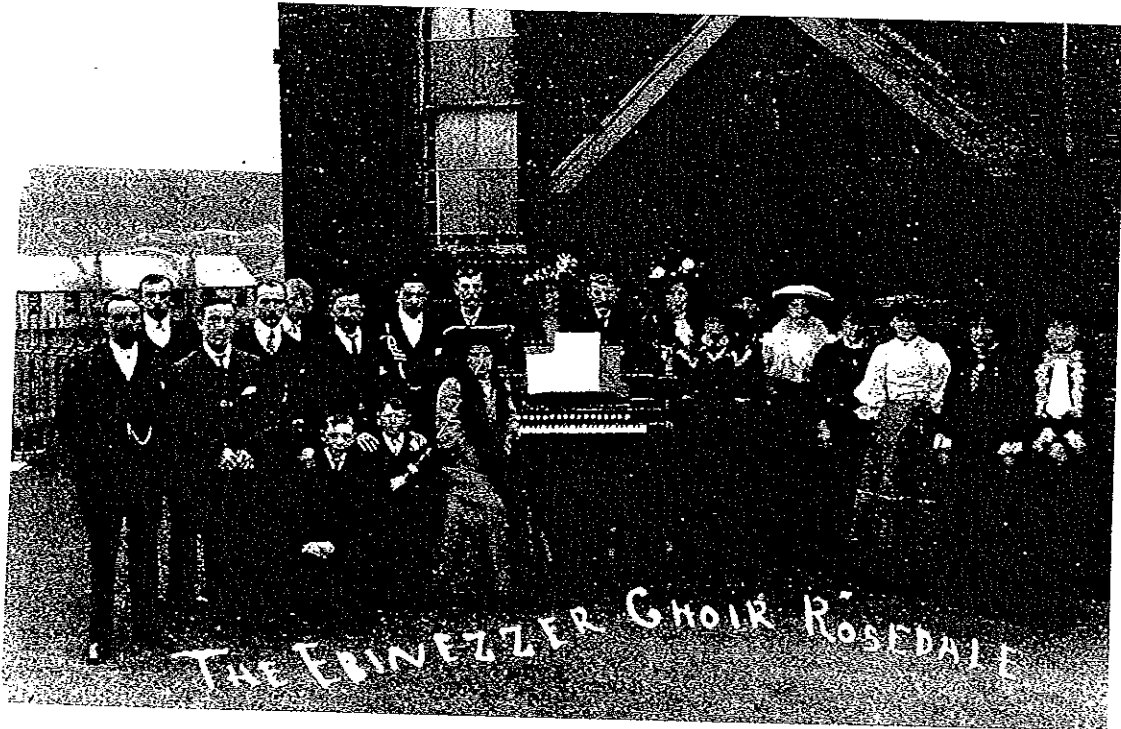
Pl. 4 To show the choir outside the Chapel with the school in the rear of the image (courtesy of Janet Dring)

5.1 The archaeological work has recognised the remains of a sandstone building that is described here as the Rosedale School dining hall. This abuts the Ebenezer Chapel (pl.4). It is thought this may have been the first school at Rosedale East and that this was later replaced by a building to the SE near Hill Cottages (on fig.1 and seen in the background of pl.4). This later school, made of corrugated sheets, was photographed in 1925 (pl.5). At that time the buildings that are the focus of this study are occupied as the school dining rooms.

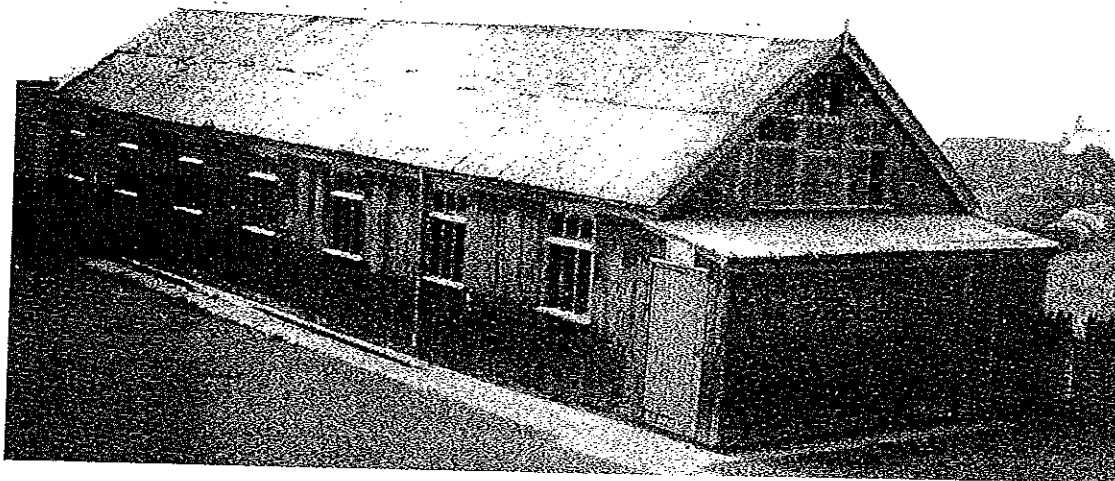
Pl.5 To show the school in a photograph dated 1925 (courtesy of Janet Dring)

5.2 An extension was built to the original school beside the Chapel. This work involved the erection of an entrance on the south side and a corrugated building to the west. It is thought that this work was to build the school dining room to service the corrugated school depicted in plates 4 and 5.
