TREE SURVEY AND ASSESSMENT AT HACKNESS GRANGE HOTEL, HACKNESS, SCARBOROUGH

**TREE SURVEY ON OAK TREE
AT HACKNESS GRANGE HOTEL
SCARBOROUGH**

D.E.R Horticultural Consultancy
01723 870801
Scale 1 : 200
Plan No DER/142A
Date November 2012
Client Mr R.Brooks

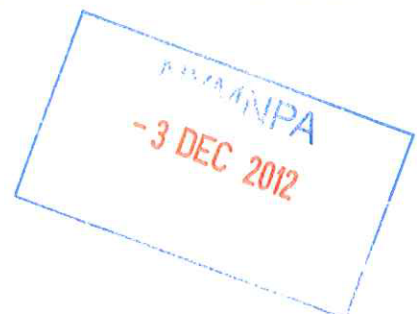
TREE SPECIES Quercus robur (English Oak)

HEIGHT 18/19m

CROWN SPREAD 22/24 metres

CLEAR TRUNK 2metres

TRUNK DIAMETER 1.8metres
 (1metre from Ground level)

APPROXIMATE AGE 250/300 years

OVERALL CONDITION Excellent

REMARKS This is an outstanding tree, probably one of the best of its type in North Yorkshire. The tree appears relatively healthy and exhibits good vigour for its age with only a very limited amount of dead wood or dieback evident. The crown is well balanced and although support to one of the branches has been necessary the overall appearance is excellent. In my opinion there is no reason why this tree should not continue to provide outstanding high amenity value for a considerable number of years to come.

ASSESSMENT It is essential that this tree is protected throughout any works which take place on the hotel or its surrounds. Necessary measures to ensure the branch network and root zone are protected should be undertaken when any work takes place in the vicinity. The proposed extension works are shown on plan No 13352/37A, by Alan Campbell Architects. The measures suggested to protect the tree are outlined on the attached Tree Protection schedule and shown on plan No DER142/B.

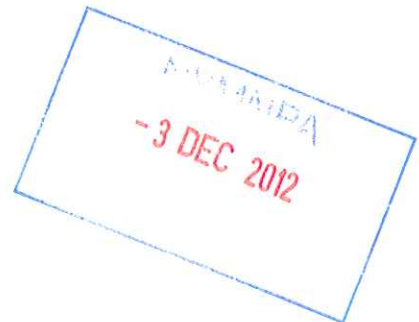
Prior to the commencement of any demolition or construction works protective metal fencing should be erected to the area as shown on plan No DER/142/B. The purpose of this is to ensure that no damage occurs to the branch network or rootzone of the Oak tree numbered 1 on plan. The galvanised metal fence shall be firmly fixed to the ground and remain in place until all construction works are complete.

This fence will create an exclusion zone where none of the following activities will be permitted

- a) No excavation of any kind
- b) No tipping or temporary storage of any materials
- c) No tracking of any type of machinery
- d) No swinging of crane jibs or machinery arms in the air space above the zone.

Following the construction of an extension to the hotel it is proposed to install some paving to the surrounds which will infringe slightly under the canopy and possibly over the edge of the root zone of the oak tree. In order to ensure no detrimental affect to the tree occurs it is proposed that this paving is built above existing levels and no excavation will be undertaken. The paving will be laid on a base of porous material, which will allow water penetration to the roots of the tree.

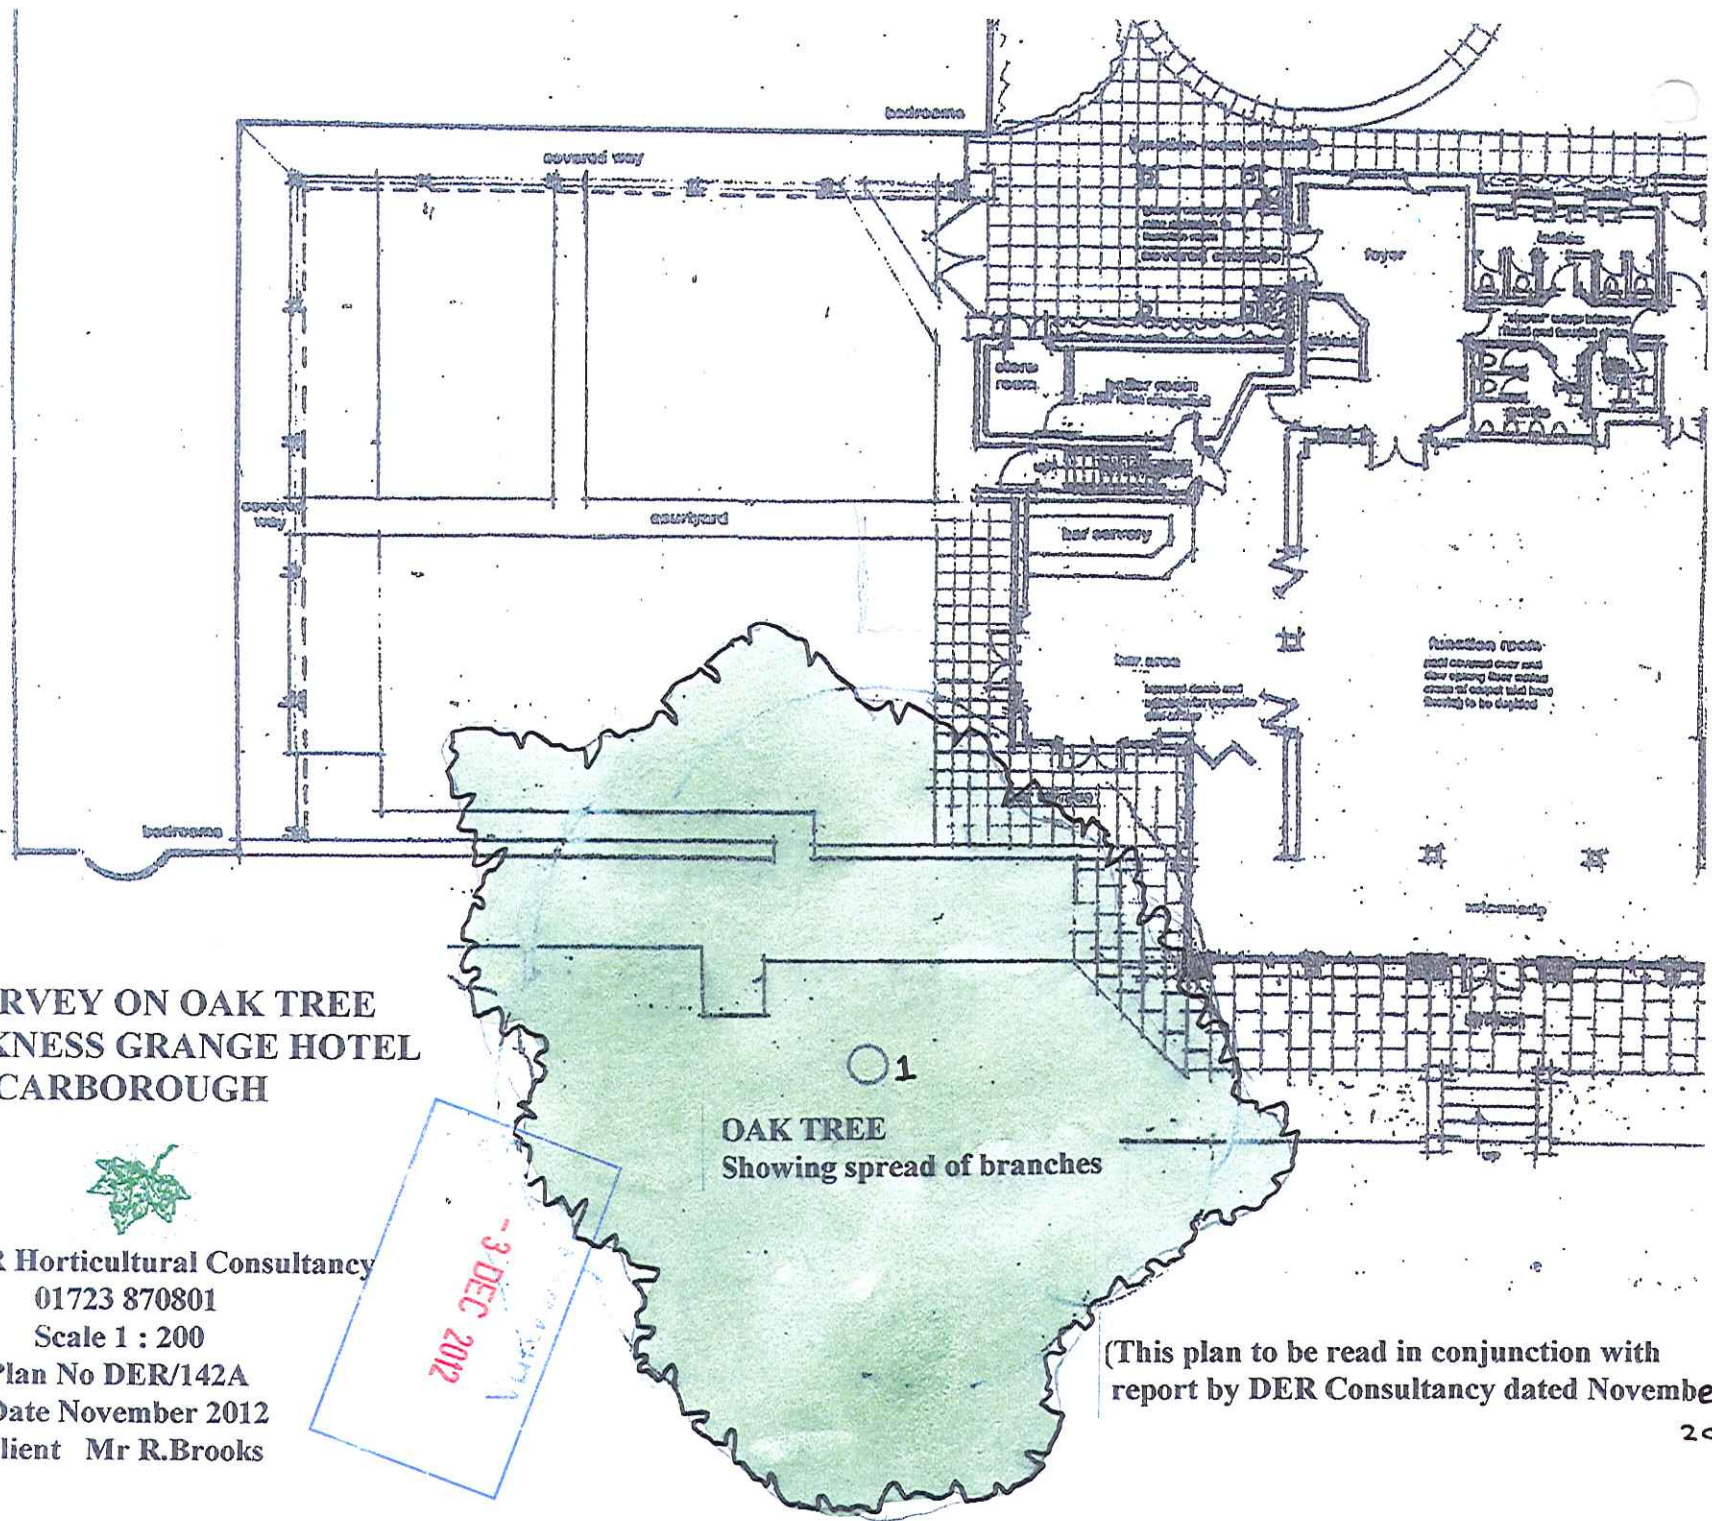
SITE ADDRESS Hackness Grange hotel, tree location shown on plan No DER 142/A

OAK TREE
Showing spread of branches
