Preliminary Ecological Appraisal and Bat Survey Report

20 Dikes Lane, Great Ayton TS9 6HA

August 2019

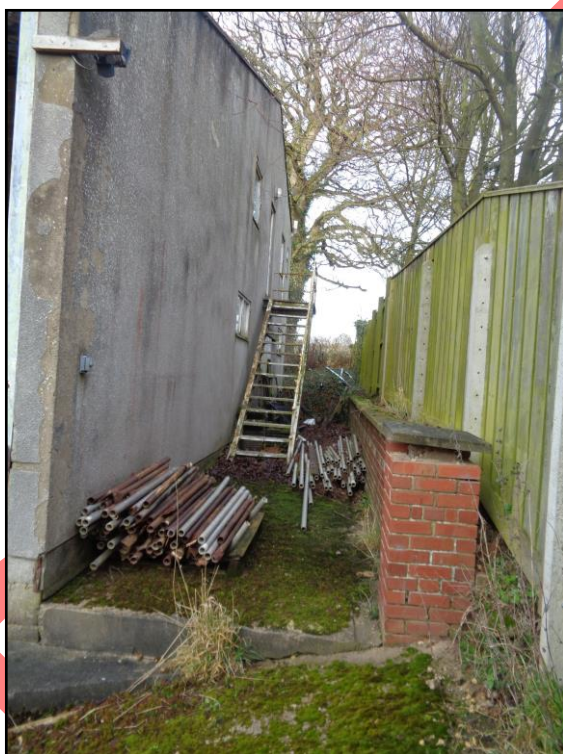
Two natterers bats were noted entering the building from within the open barn on the south east elevation. Three common pipistrelle bats were noted entering the building *via* a gap below the window on the north east elevation.

Figure 18. North eastern elevation

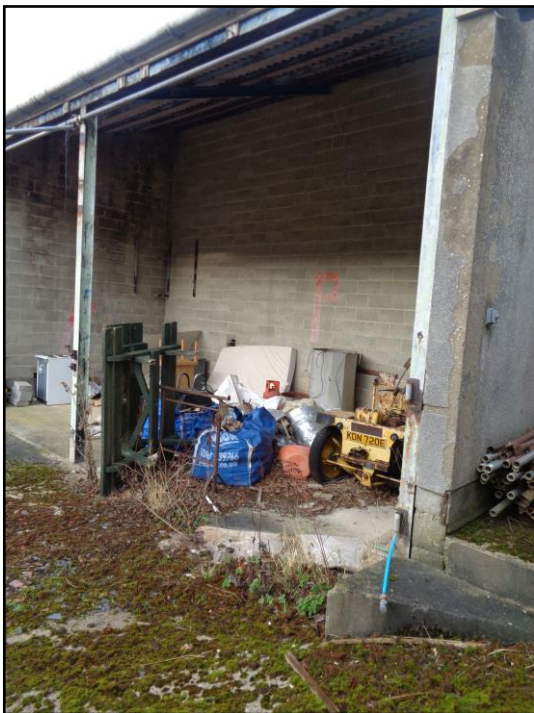
Figure 19. South eastern elevation with fascia board present

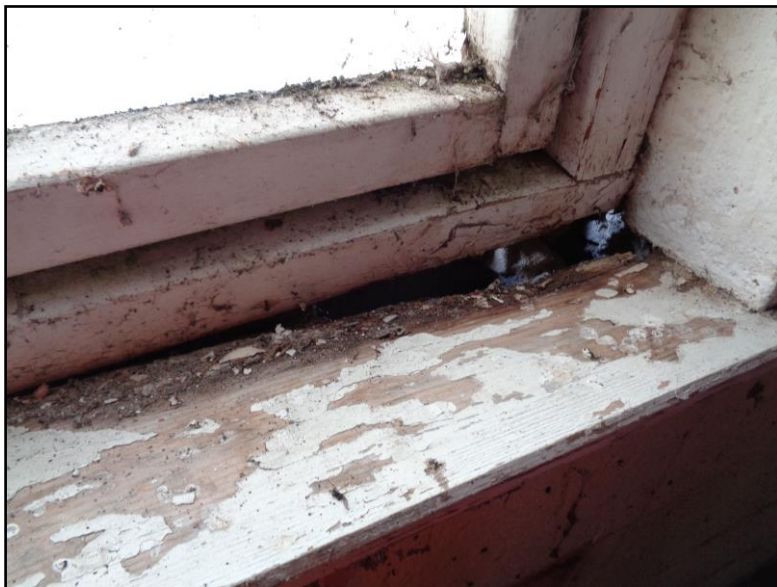
Internally signs of damp can be seen underneath the roof, particularly in the corners. In places the whitewash from the breeze block constructed walls is peeling. The single glazed windows in wooden frames are in a poor state of repair and the rot damage has created access gaps to the outside. Bird droppings were noted in the upper floor, but no evidence of nests.

Figure 24. Example of first floor windowsills

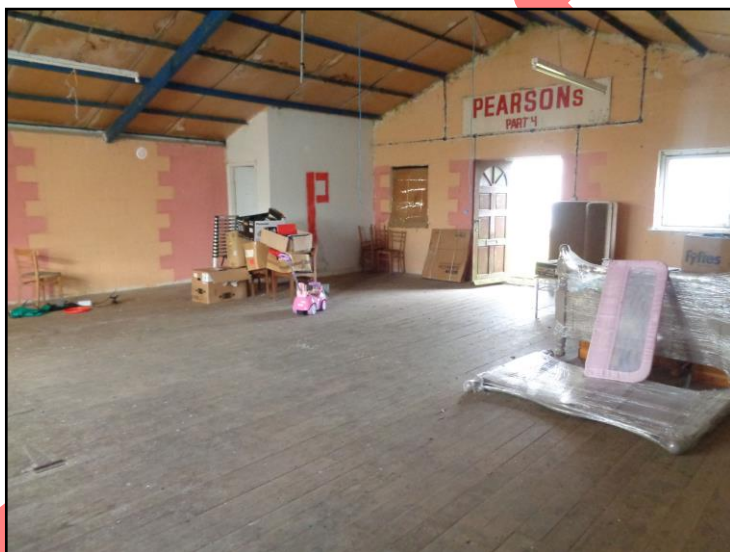
Bat droppings were noted across most of the upper floor (TN8) with a couple of areas where they were denser, suggesting access/roost locations. These were predominately in the north west, north east and south east corners (TN10). Gaps were present between asbestos sheets in the roof. Endoscope inspection showed very few cobwebs present in these gaps.

Figure 25. First floor open room (W.C. in far corner)

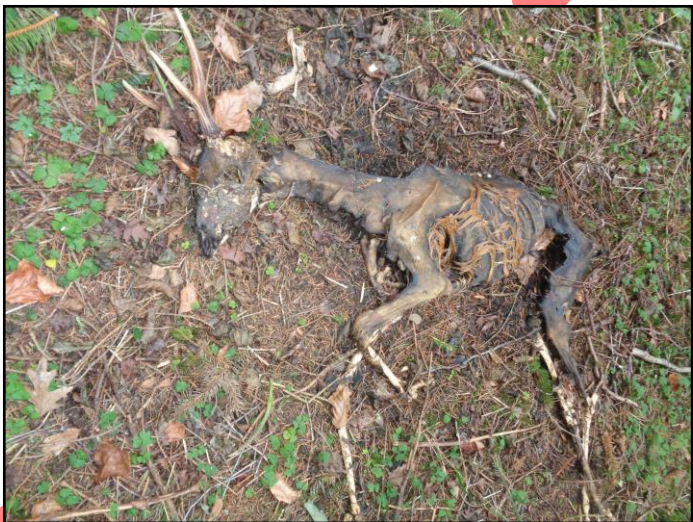
Figure 46. Evidence of deer (TN19)

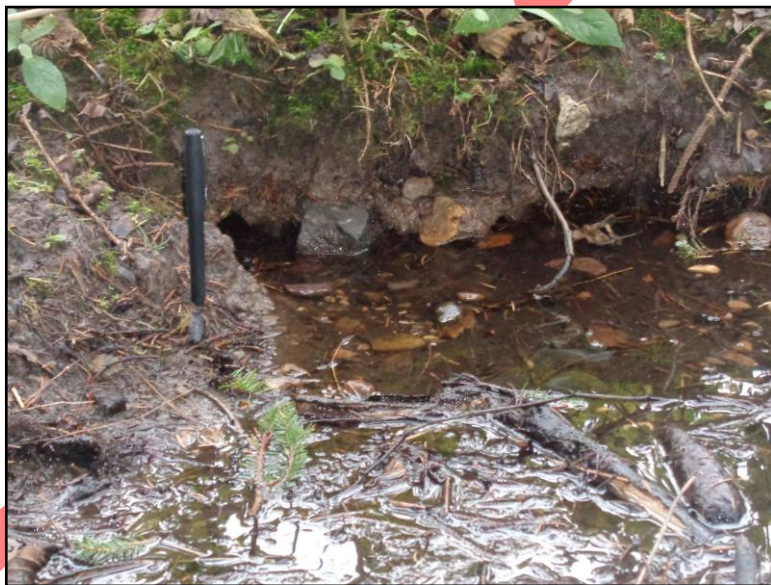
Figure 49. Holes by
ephemeral pond (pen for
scale) – **TN17**

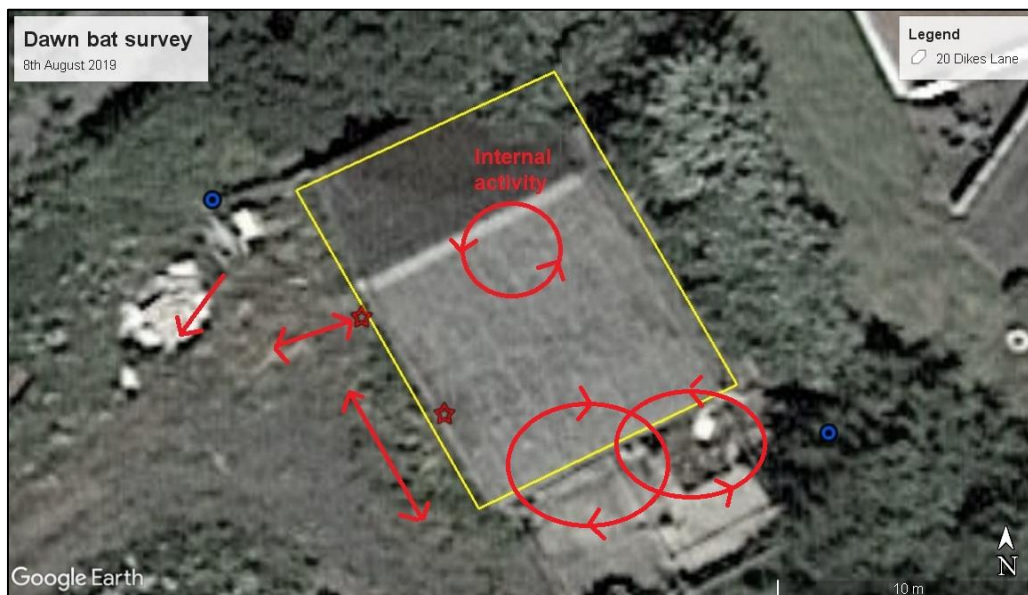
A common pipistrelle roost of 3 bats was noted around the window ledge on the SW elevation left hand window. Closer examination from inside the building revealed an external gap which led into the wall cavity. A natterers' roost of 2 bats is located in the upper room of the building. The bats enter the premises *via* a gap in the upper south west corner of the open barn.

Figure 60. Flight lines, roost entrances and surveyor locations¹⁴

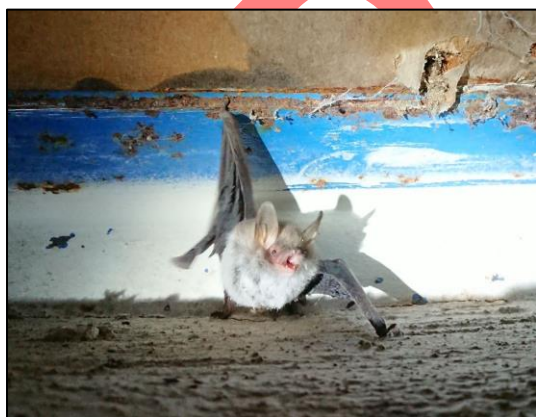
Figure 61. Natterer's bat in upper room

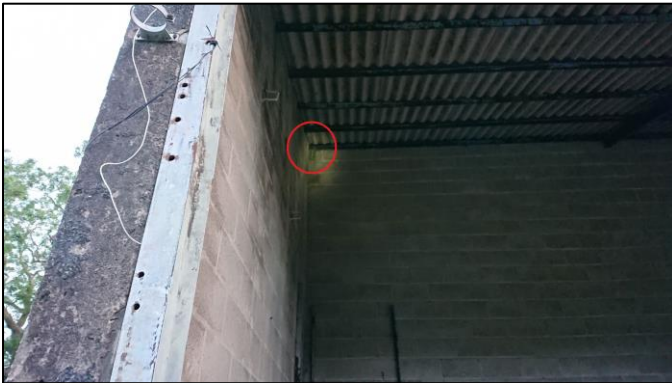
Figure 63. Natterer's roost entrance

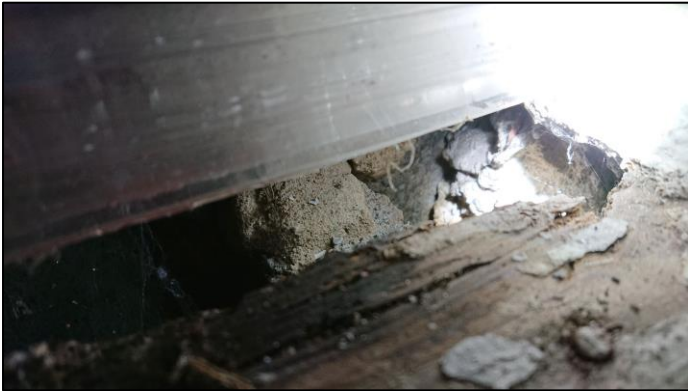
Figure 67. Crevice roost of common pipistrelle roost entrance – plastic sheeting temporarily removed.

The plastic sheet on the windowsill covering the common pipistrelle roost MUST be left *in situ*. Removal will alter the roost conditions and may constitute a criminal offence. A bat loft for natterer's bats should be created during the renovation works. Integrated features suitable for bats will be required to be incorporated. Full details will be provided with the Natural England Mitigation Licence application.

- The plastic sheet on the windowsill covering the common pipistrelle roost **MUST** be left *in situ*. Removal will alter the roost conditions and may constitute an offence until the appropriate mitigation is in place.
