**Archaeological Standing Building  
Recording**

**Lodge Hill Farm**

**Egton Grange**

**July 2021**

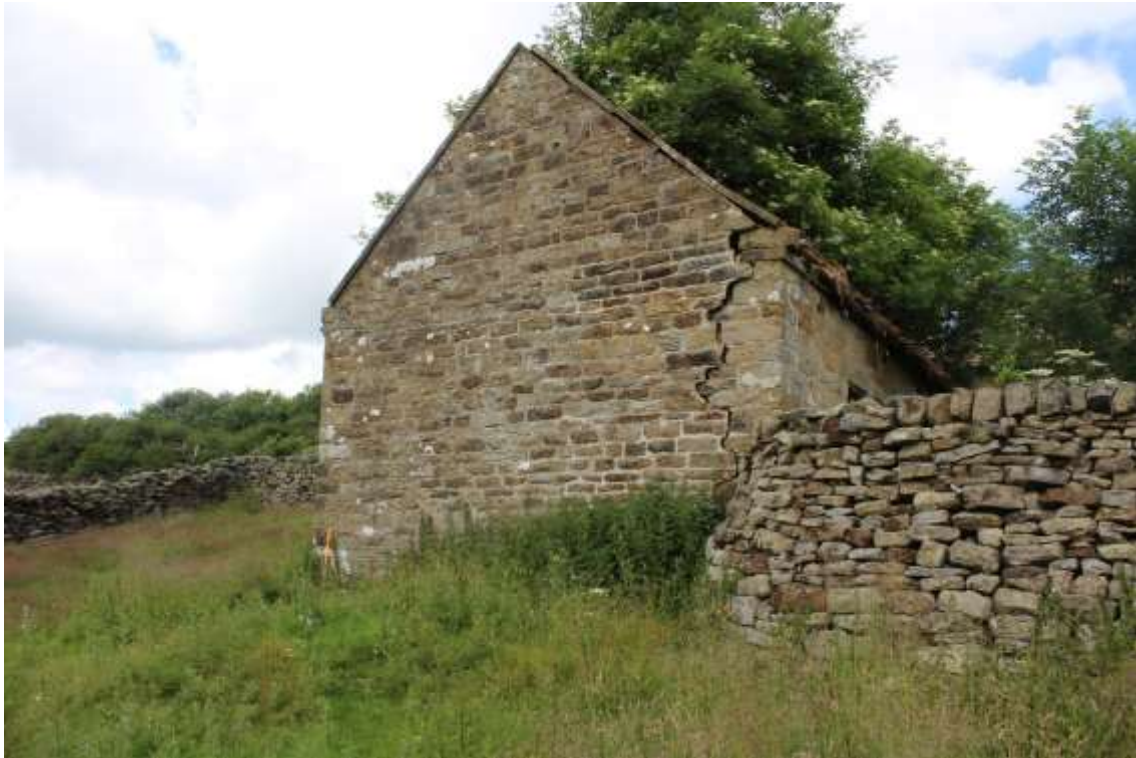
*Plate 115: External view NW of S and E-facing elevations of building No.3*

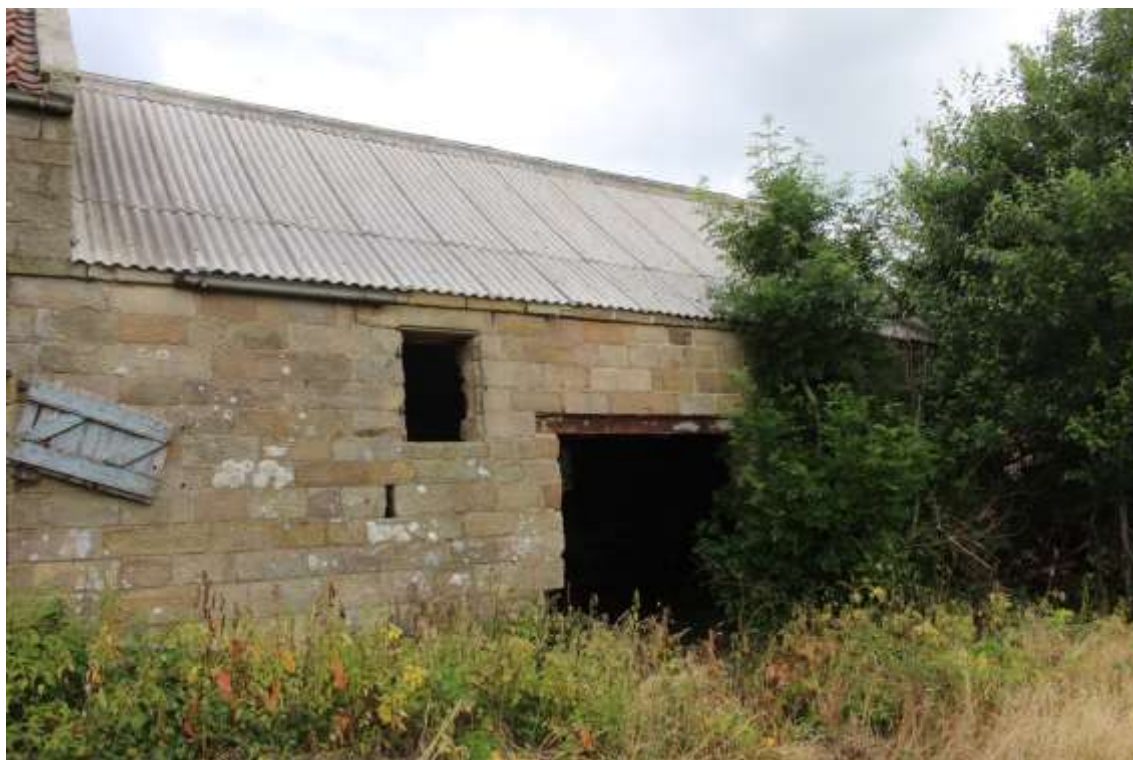
*Plate 120: External views N of the second section of the S-facing principal elevation*

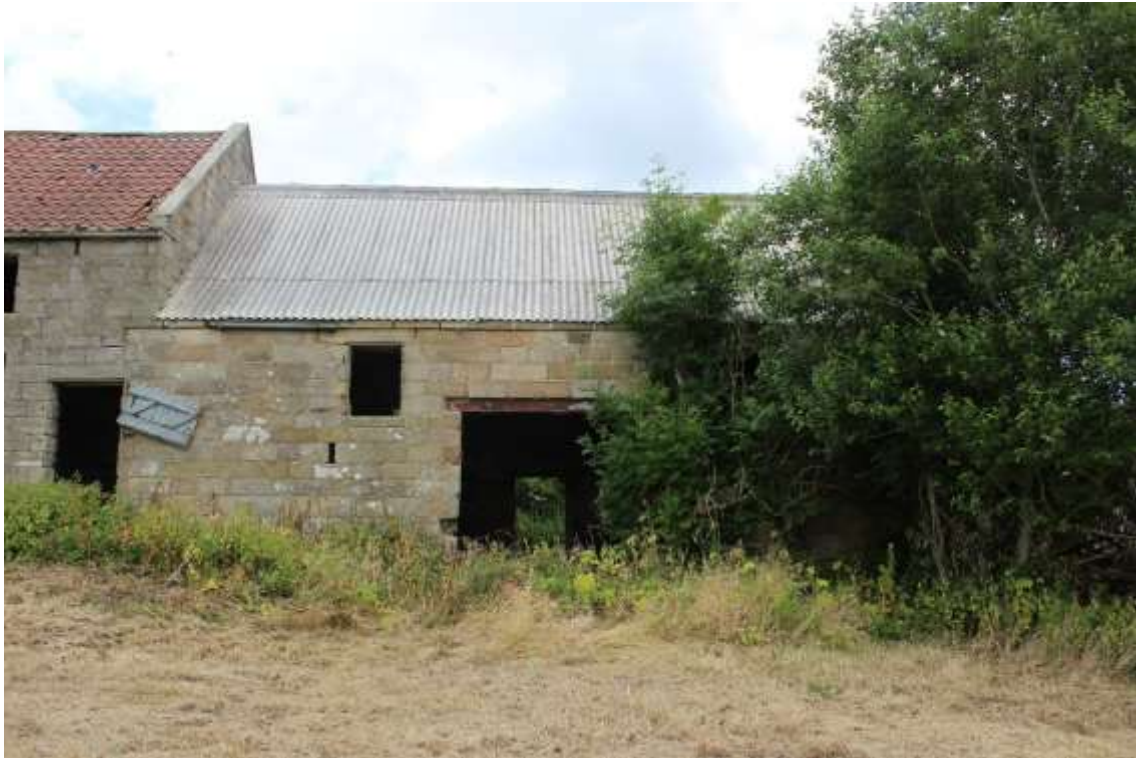
*Plate 121: External views N of the second section of the S-facing principal elevation*

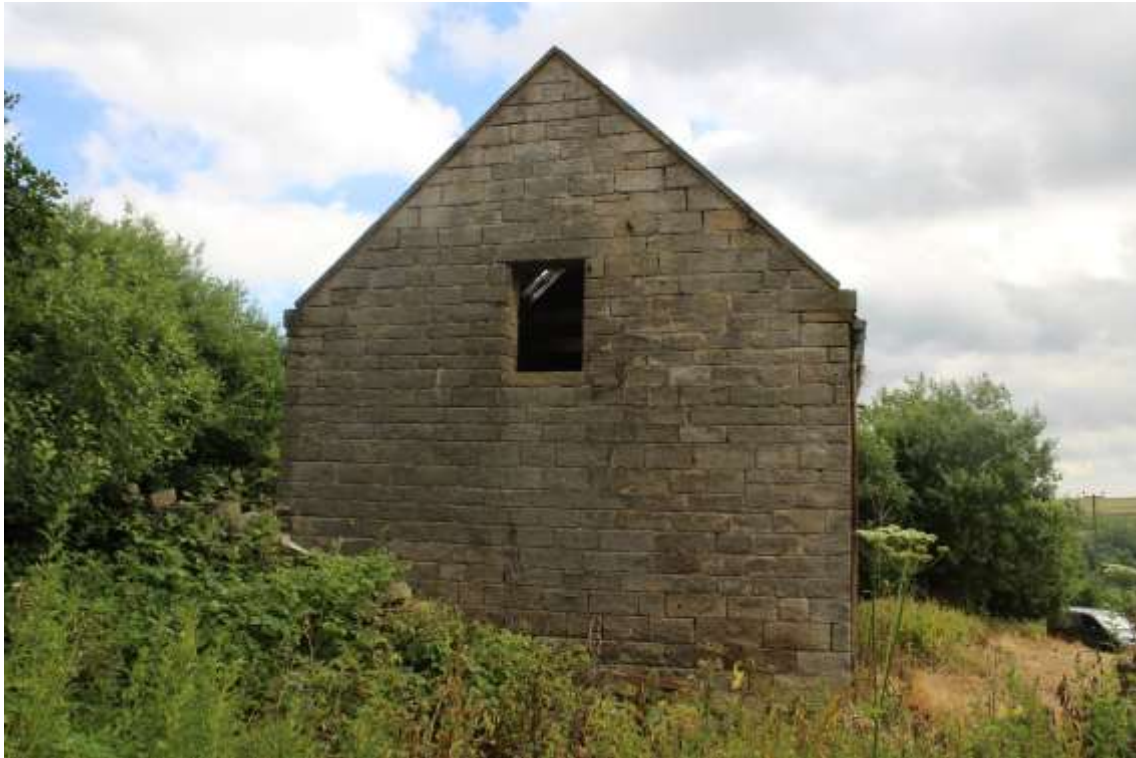
of the entranceway. The third and lowest section was obscured by trees and was in a state of partial collapsed (*Plate 122*). Earlier elevation drawings (*Fig. 9*) show two entrances. The W-facing gable end has a loading hatchway or window within the roofline with iron hinge brackets (*Plate 123*).

*Plate 123: External view E of W-facing elevation of Building No.4*

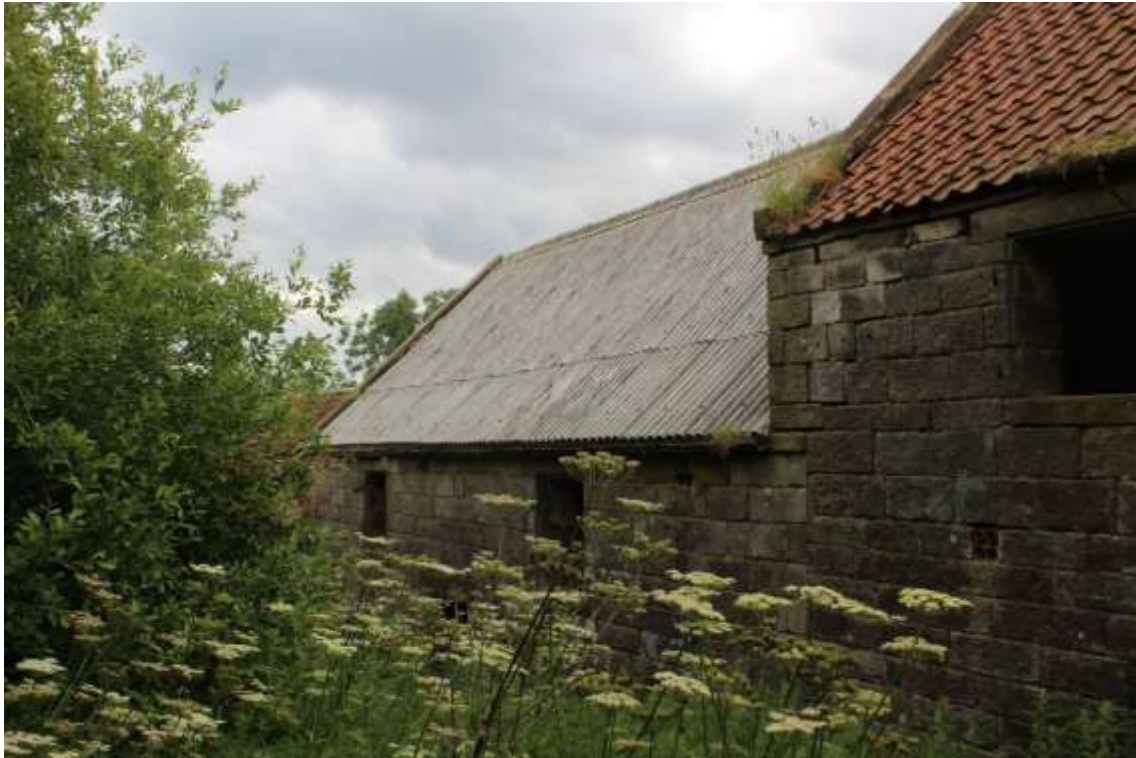
The N-facing elevation (*Plates 124-126*) is similarly staggered over three levels representing the different portions of the barn. The first section has two windows at either end of the roofline with a line of vents beneath (*Plate 124*). The second section (*Plate 125*) has a doorway and wooden lintel with two windows either side of the door at the roofline. A series of ventilation holes were noted beneath the eaves of the roof and a tie pin is located towards the W end of the building section. No features of note were seen within the third section of the building (*Plate 126*). The E elevation was entirely obscured by the tree-line but a widow or loading hatchway could be seen. Earlier aerial photography shows a nesting hole and roosting ledge on the E-facing gable end of the building.

*Plate 125: Oblique external view SSE of N-facing elevation of Building No.4*

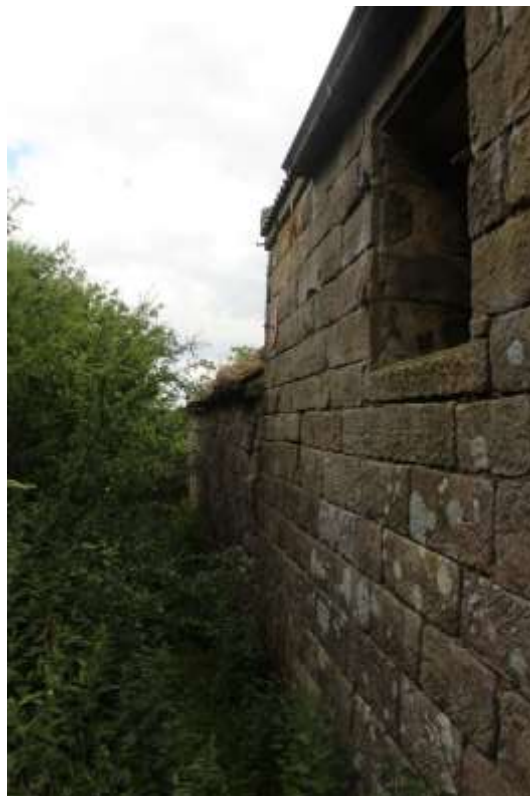
*Plate 126: Oblique external view ESE of N-facing elevation of Building No.4*

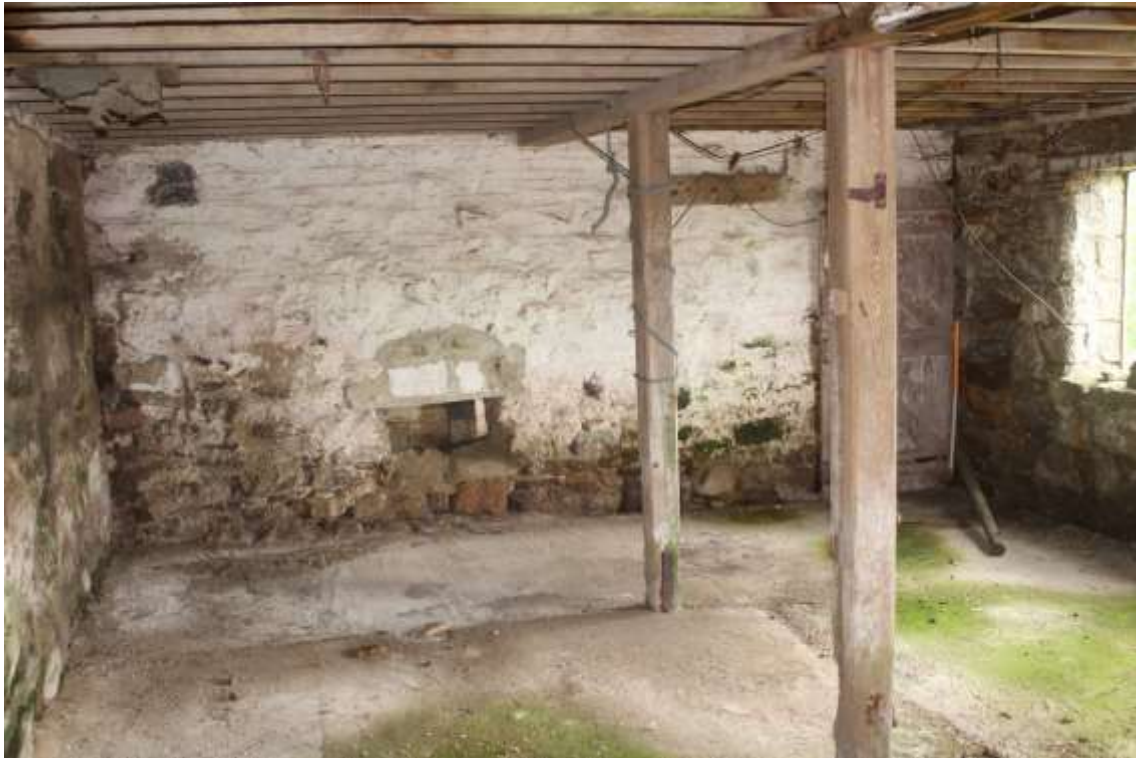
The first compartment opens N (*Plates 127-135*) from the main farmyard and is lit by two windows within the S wall (*Plate 130*). A second door within the SE corner of the room leads into the adjacent compartment (*Plate 127*). It has a concrete floor, whitewashed walls and three timber struts supporting an upper-floor storage area that was inaccessible for health and safety reasons (*Plates 131-132*). The roof structure visible through holes in the ceiling is of a simple king-post truss construction. A hole in the E wall had evidently relatively recently been knocked through into the adjacent compartment (*Plate 134*). Fixtures on the N wall align with the struts, suggesting the room was subdivided to form three bays (*Plate 135*).

*Plate 127: Internal view ESE of the first compartment of Building No.4*

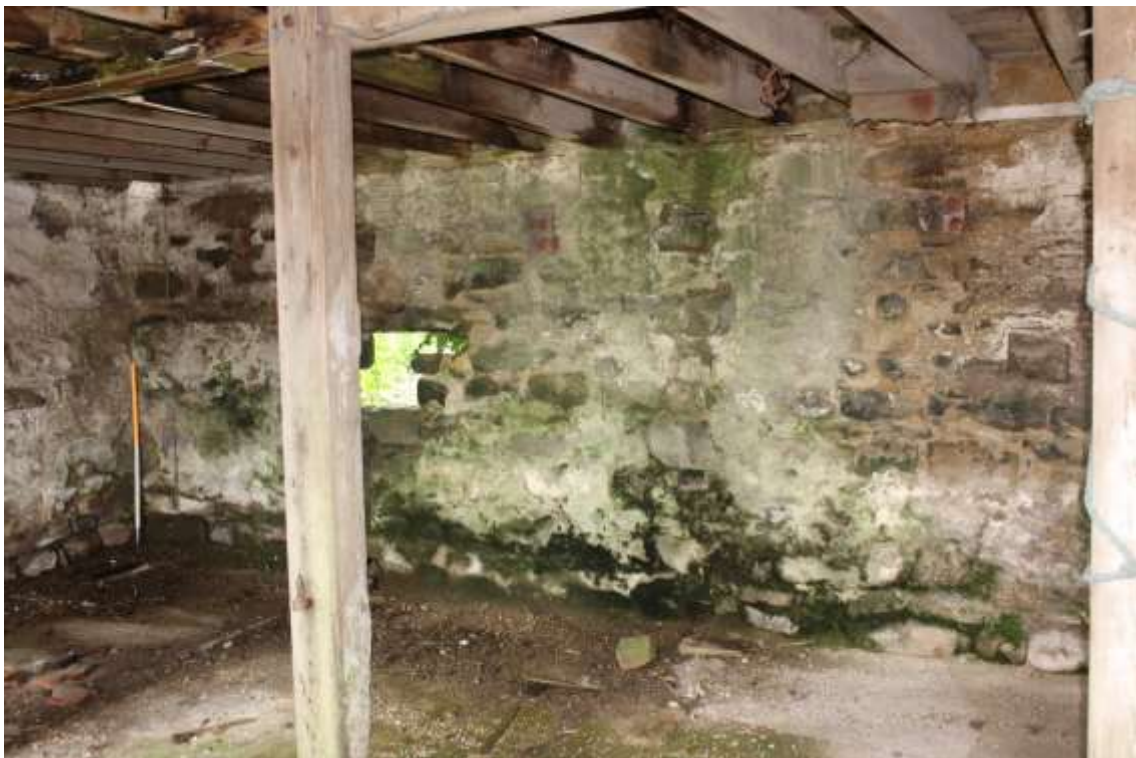
*Plate 128: Internal view NW of the first compartment of Building No.4*

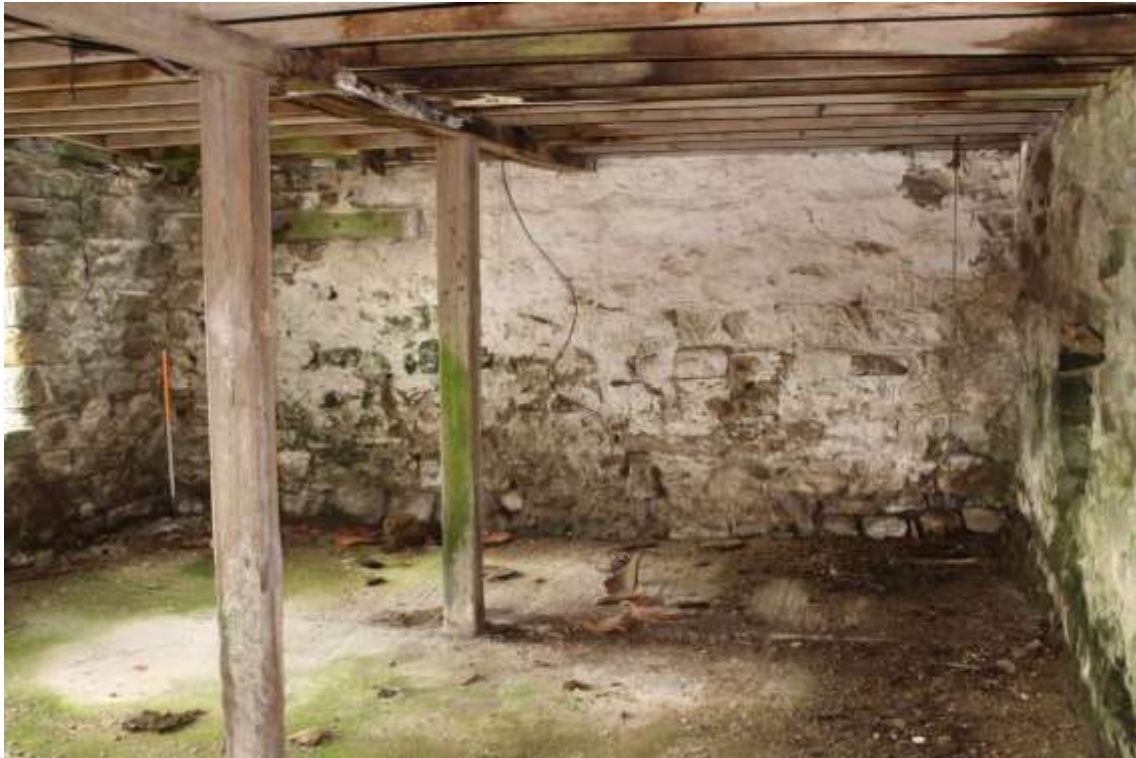
*Plate 129: Internal view WSW of the first compartment of Building No.4*

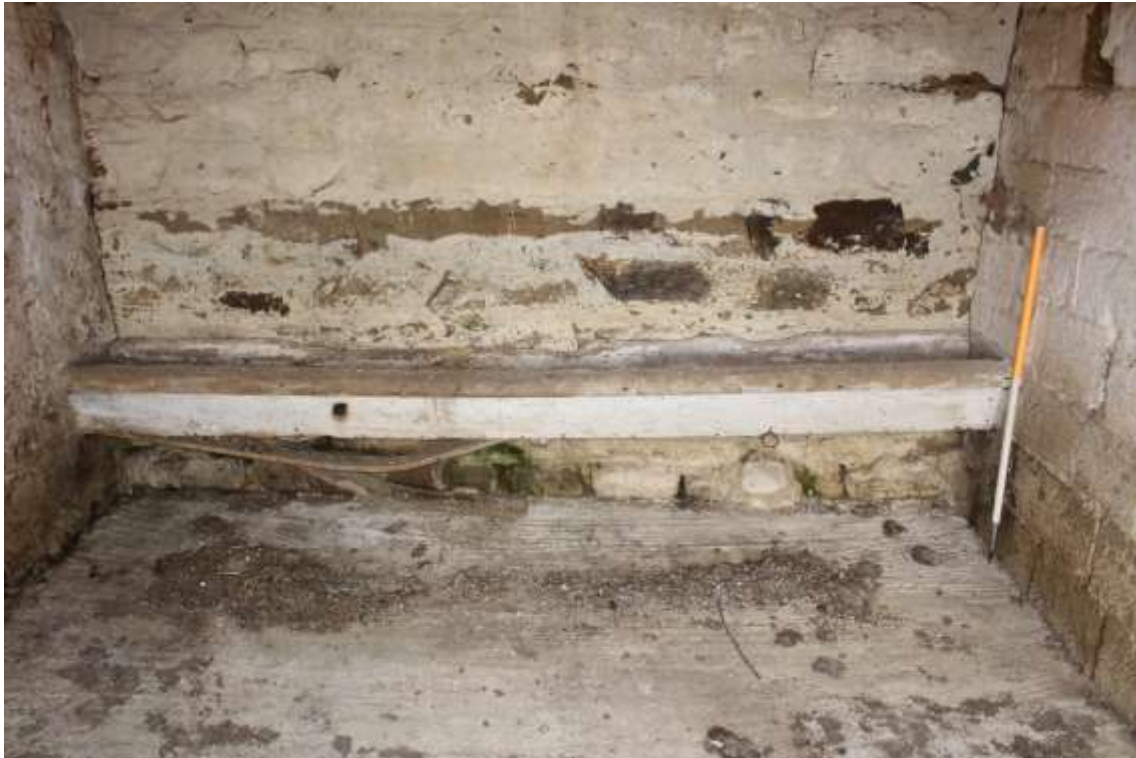
The second compartment (*Plates 136-141*) opens N from the main farmyard and connects with the adjacent compartments by means of doors in the SW and SE corners of the room. A surviving stable door and wooden trough (*Plate 137*) at the rear of the room suggest it was used as a loose box. The room has a concrete floor, whitewashed walls and two timber struts supporting an upper storage area which could not be accessed for health and safety reasons. The room is lit by a window in the S wall (*Plate 139*). An internal window looks into the adjacent compartment to the E (*Plate 140*).

*Plate 137: Internal view N of a wooden trough within the second compartment of Building No.4*

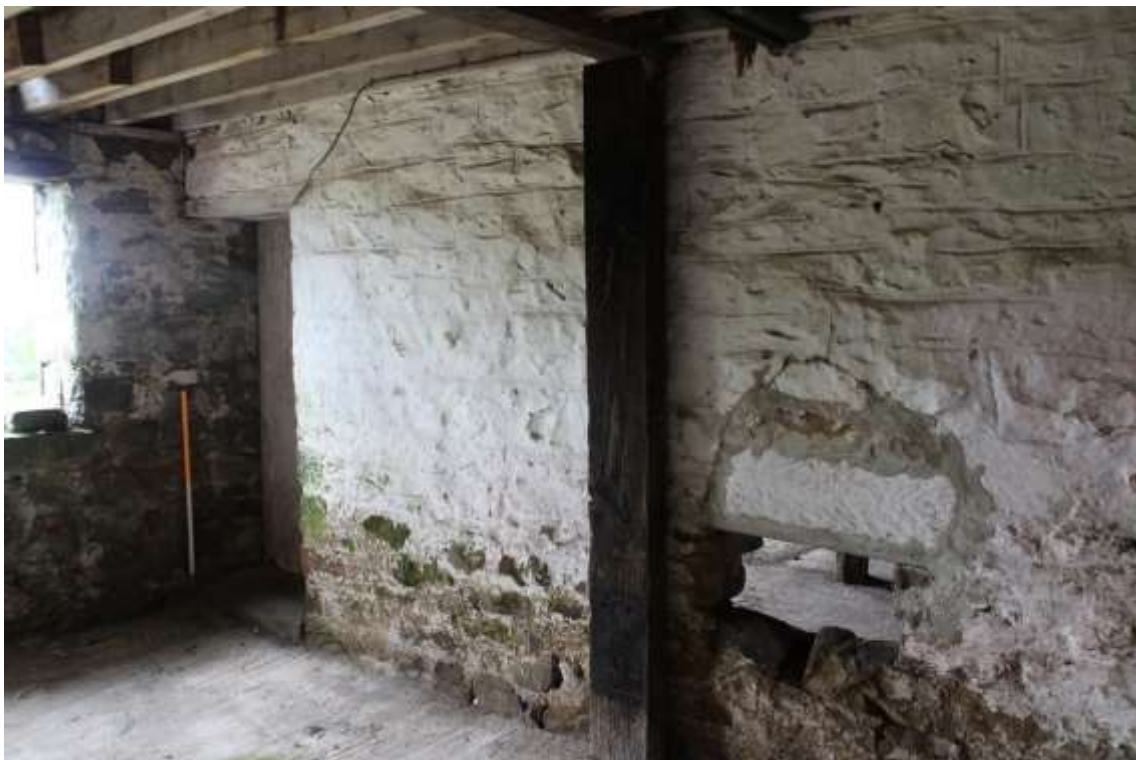
*Plate 138: Internal view SW of the second compartment of Building No.4*
