3.0 HISTORY OF CLIFF HOUSE

Mason Clark Associates (MCA) was commissioned by Shaw & Jagger Architects, on behalf of the property owner, to provide an initial structural opinion relating to the proposal to construct a two-storey extension at the rear (east elevation) of the property.

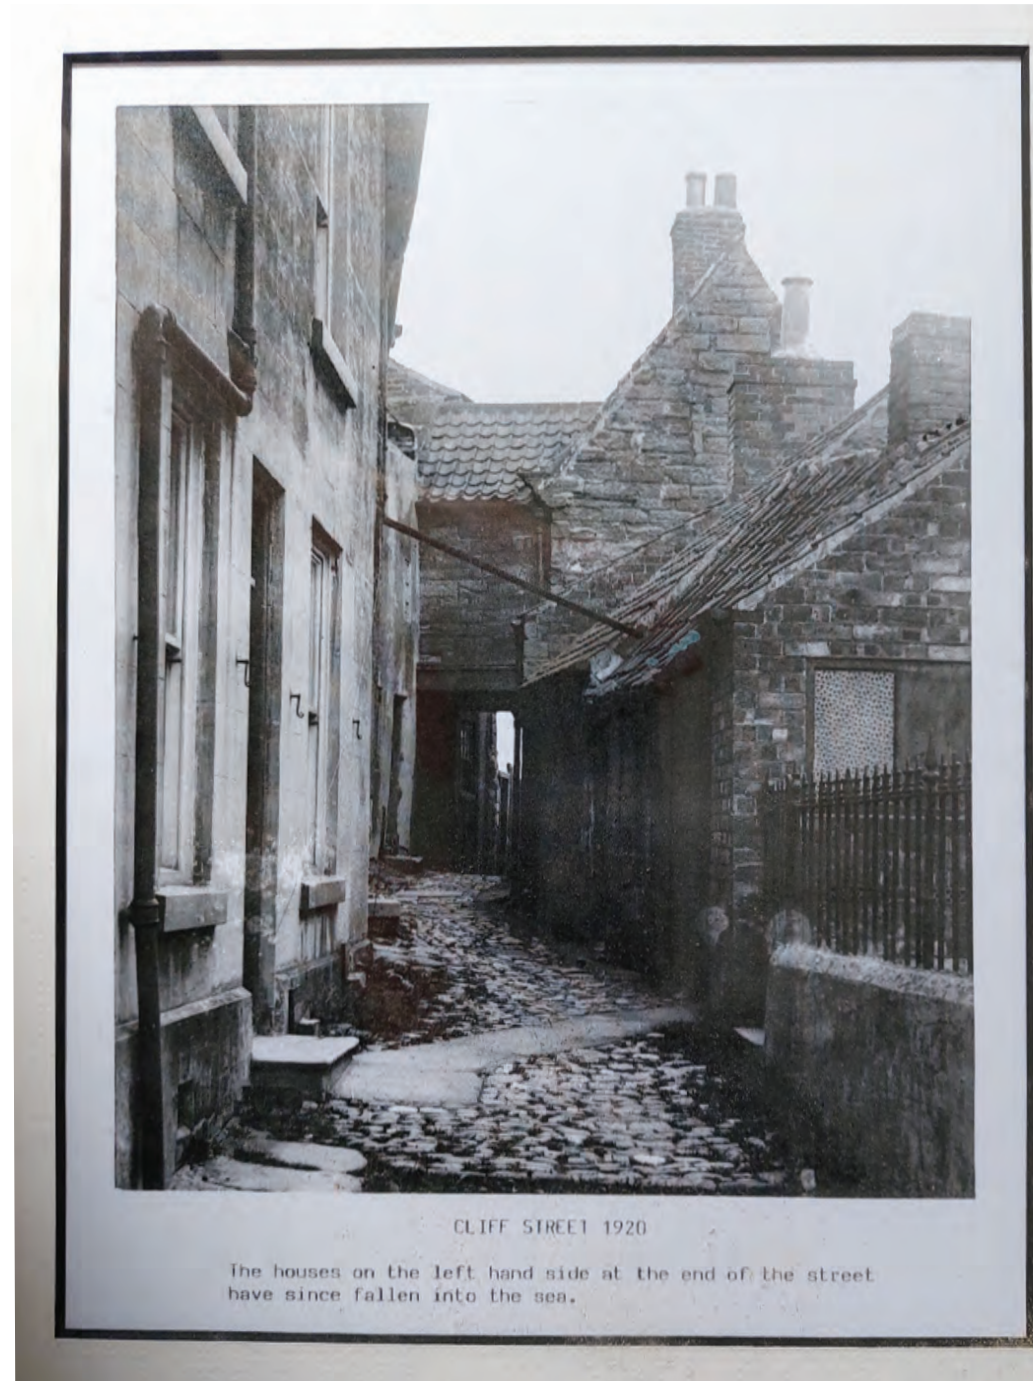
Photograph from 1920 of Cliff House. The adjoining buildings are still visible

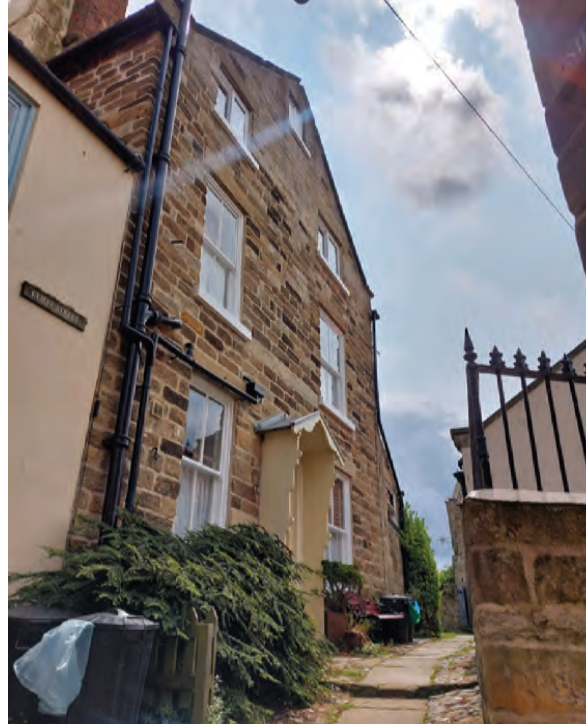
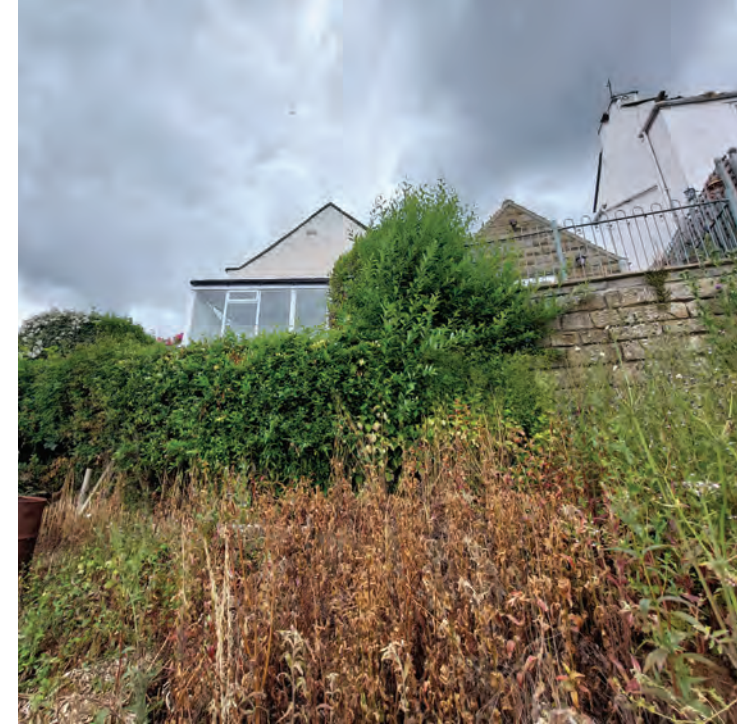
Photos of Cliff House

Cliff House is in good condition considering its age and exposure to the sea. A detailed condition survey and repair schedule have been completed. Key areas for repair include:

- Creating a breathable roof space
- Repair copings and flashings
- Remove the remaining render and re-point (re-render if required)
- Remove internal gypsum plaster for lime plaster
- Complete overhaul of windows
- Repair water ingress issues to lean-to
- Resolve damp issues and ventilation issues to the ground floor
- Overhaul of downpipes and gutters

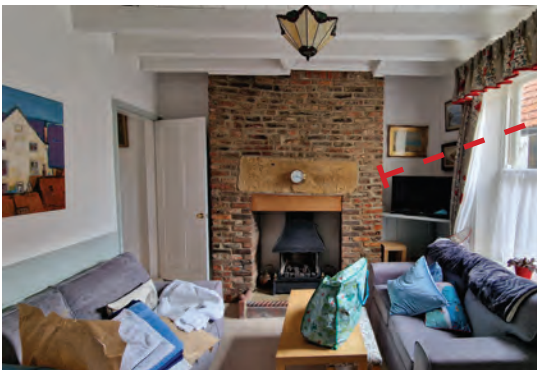
Fireplace to living room

- There is also some damp and condition issues particularly to the ground floor it feels very high in humidity with lack of ventilation the water the fireplace is wet to touch. Further investigation should be made under the stairs to the floor and to this wall.

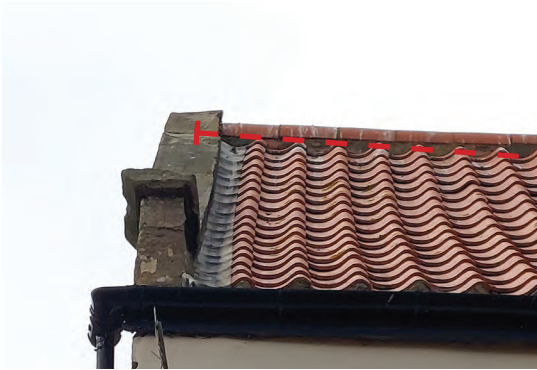
Copings

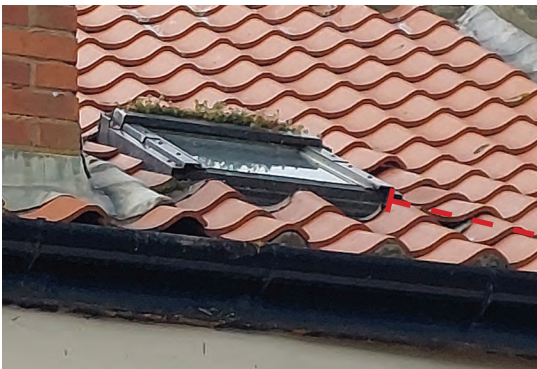
Velux window

There is the possibility of installing a more appropriate window to the roof perhaps even consider a dormer, as this is very common place within Robin Hoods Bay and noted within the conservation area appraisal. It is also worth considering any intervention look to resolve the damp problems particularly to the ground floor - there is currently a lack of air flow and movement and opening the ground floor to the sea face would help resolve this issue. General maintenance and resolving the condition of the conservatory would be beneficial.

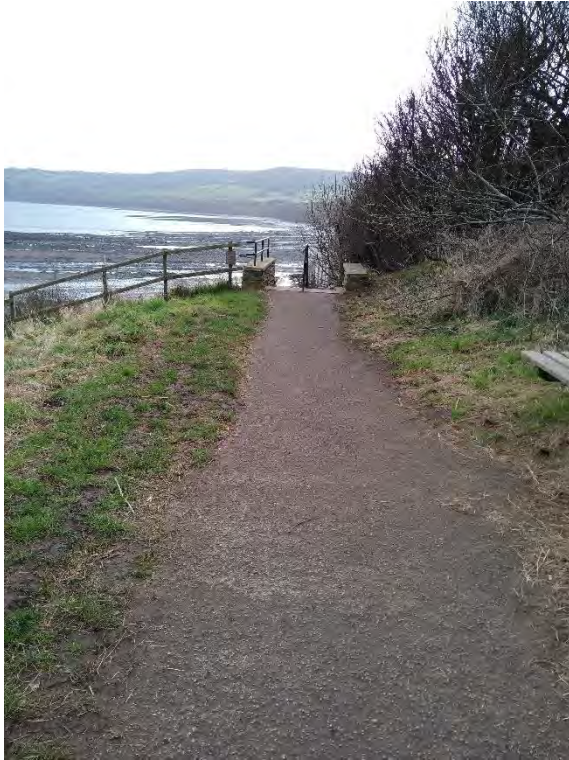
07 Pedestrian access along the footpath leading to sea wall.
